MV SCOT PIONEER

Fatal injury to a crewman during cargo operations

Belview Port, Waterford

27 October 2011

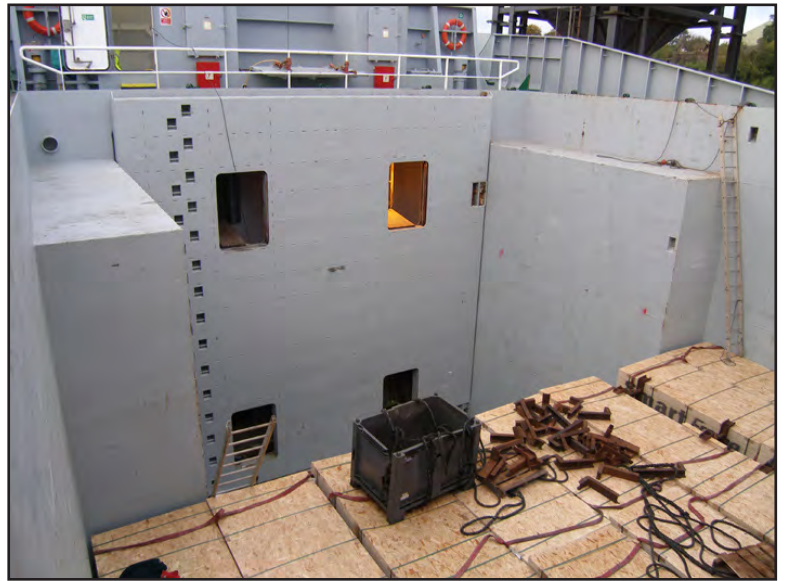
Figure 1: Forward portable bulkhead

The forward portable bulkhead had four openings (**Figure 1**) which were 0.95m wide and 1.35m high and could be sealed with wooden shuttering if required. Access to and from the bottom of the cargo hold from the forecastle deck was via an access trunk that contained two vertical ladders, separated by a landing (**Figure 2**). At cargo deck level was an opening that led from the access trunk to the 1.22m void space between the hold's forward bulkhead and the forward portable bulkhead. The hold was then accessed through either of the lower openings in the portable bulkhead. There was a similar opening in the access trunk at the level of the landing between the two vertical ladders.

The upper openings in the portable bulkhead were provided by the shipbuilder solely to assist with the ventilation of the hold, not to facilitate access. The wooden footbridges had not been provided by the shipbuilder but were on board when Scott Pioneer changed ownership in 2008. The use of the bridge to access the hold was infrequent, being only possible when a part-cargo was loaded.

- Removed both the wooden footbridges and the forward portable bulkhead from *Scot Pioneer*.
- Modified the access arrangements to the hold, including the fitting of guards or closures on openings as necessary.

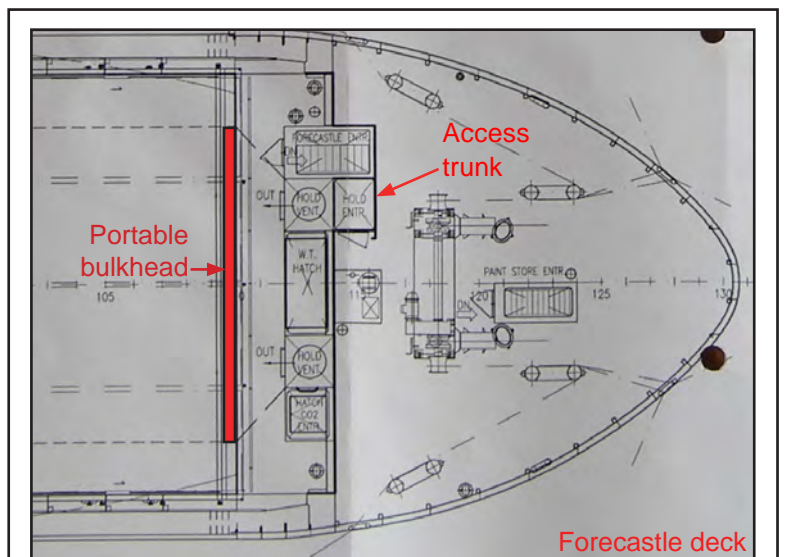
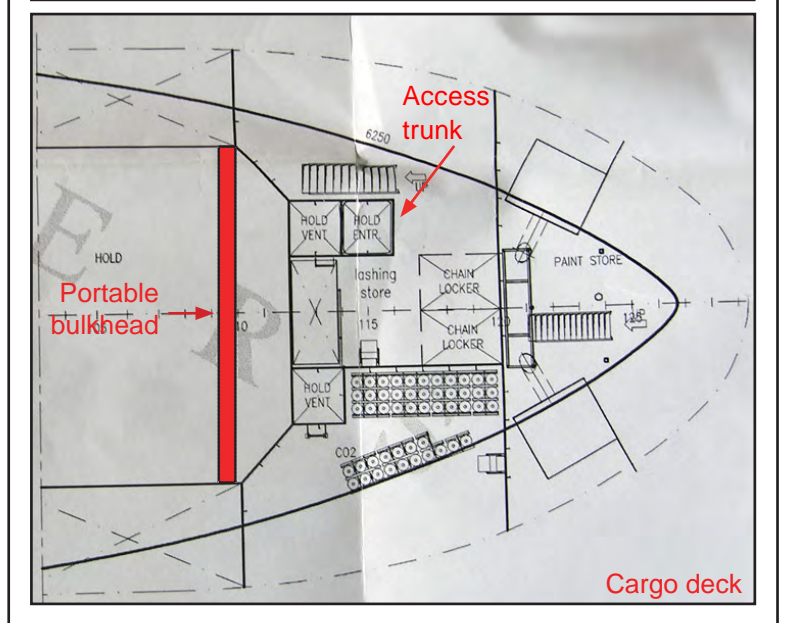
Figure 2: Positions of portable bulkheads

Scot Pioneer's single hold had a capacity of 4929m³ and was equipped with three portable bulkheads to facilitate the simultaneous carriage of different cargoes. When not in use, two of the portable bulkheads were stowed at the aft end of the hold. The third portable bulkhead was stowed in the forward part of the hold and was rarely used (Figures 1 and 2). Narrowing of the hold prevented the forward portable bulkhead from stowing flush with the forward bulkhead, and when in its stowed position there was a 1.22m void between the forward portable bulkhead and the end of the hold. The portable bulkheads were fitted with recessed vertical ladders on

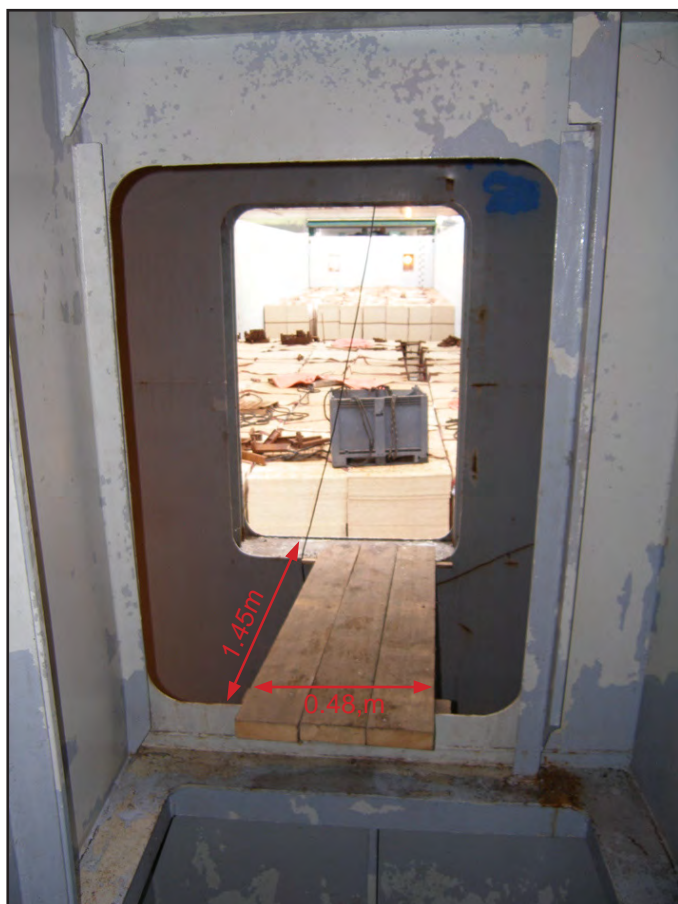
Figure 3: Wooden bridge access to hold

To enable access to the cargo hold when the lower bulkhead openings were obstructed by cargo, a wooden footbridge had been constructed that spanned the gap between the opening by the landing of the access trunk and the upper opening on the port side of the portable bulkhead (**Figure 3**). The footbridge was 5.2m above the bottom of the hold and was made of three planks of wood joined by timber cross-braces at each end, that also retained it in position. A similar bridge provided access between the upper opening on the starboard side of the portable bulkhead and a store recessed in the forward bulkhead in which one of the cargo hold floodlights was mounted (**Figure 4**).

- The narrow wooden footbridge between the forward portable bulkhead and the access trunk was not fitted with guard rails or toe boards
- The openings at either end of the footbridge were not high enough to allow the crew to pass through without stooping
- To access or leave the footbridge at the forward end required the crew to step over the opening at the top of a vertical ladder
- The aft end of the footbridge was 1.37m above the packaged cargo below.
- The void space between the bulkheads was not well lit, particularly when the hatch covers were closed.

The use of the footbridge as a means of access to and from the cargo hold was therefore unsafe and did not meet the criteria for the safe movement of personnel or the standards for hold access detailed in the Code of Safe Working Practices (CoSWP) for Merchant Seamen.

Although the upper openings in the forward portable bulkhead were designed to ventilate the cargo hold, it is clear that the openings were used by the ship's crews as a means of access soon after the vessel entered service in 2006. The wooden footbridges were in place when the vessel changed ownership in 2008, and their basic construction (**Figure 3**) indicates that they were possibly manufactured on board.

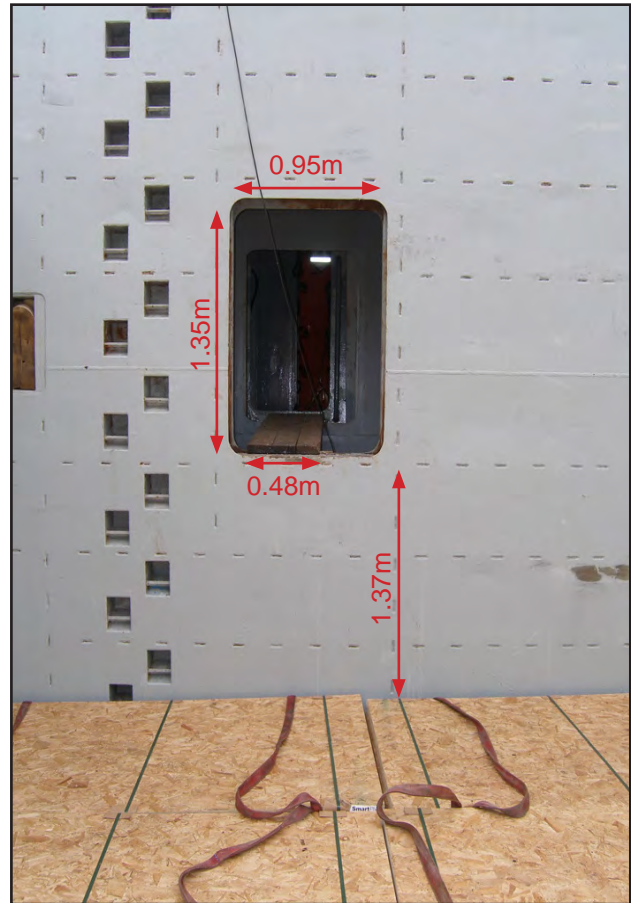
Figure 5: Upper opening in forward portable bulkhead

Loading commenced at 1040 and the ship's crew went for lunch 20 minutes later. At 1200, the chief officer, the cadet, Jorge and another AB met on the forecastle in readiness to start securing the cargo that had been loaded into the forward part of the hold. The cargo securing clamps were lowered by derrick from the forecastle onto the cargo at the forward end of the hold on three wooden pallets and in a plastic bin. Air bags and dunnage were also dropped into the hold. The crew then entered the hold either by climbing down the recessed ladder set in the forward portable bulkhead (**Figure 1**) or by climbing down the access trunk vertical ladder and crossing the footbridge leading to the upper opening on the port side of the forward portable bulkhead (**Figure 5**).

Nobody saw Jorge fall, but it is clear that he must have fallen as he tried to exit the cargo hold via the upper opening in the forward portable bulkhead. This was the only route available as the usual access from the bottom of the hold through the lower opening in the bulkhead was blocked by cargo, and the recessed ladder was no longer viable as its top was blocked by the forward hatch covers. There were no portable ladders available or rigged further aft.

- Strongly advised the owners and operators of other Icerunner 3650 ships fitted with a forward portable bulkhead, that crews should not use the upper opening in the forward portable bulkhead to access the hold unless a proper risk assessment has been conducted and a safe means of access, which guards against a fall from height, has been provided.
