SUMMARY

Grounding of FV *GOLDEN PROMISE* on the Island of Stroma 7 September 2011

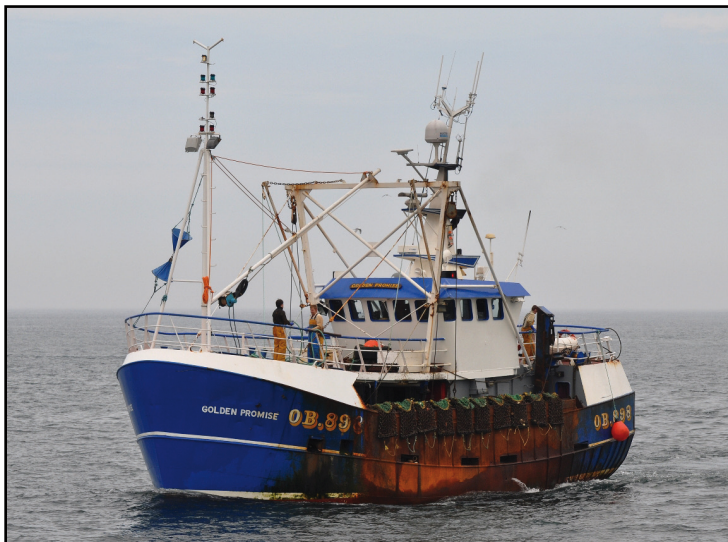
Figure 1: *Golden Promise*

Golden Promise (Figure 1) was a 19m UK-registered scallop dredger, owned and operated by John MacAlister (Oban) Ltd. The owner operated a fleet of five scallop dredgers, with an associated company, The Star Trawler Co Ltd, operating a further two scallop dredgers. *Golden Promise* was built in 1997 and was used to dredge for scallops around the coastline of Scotland, landing her catch every 3 or 4 days.

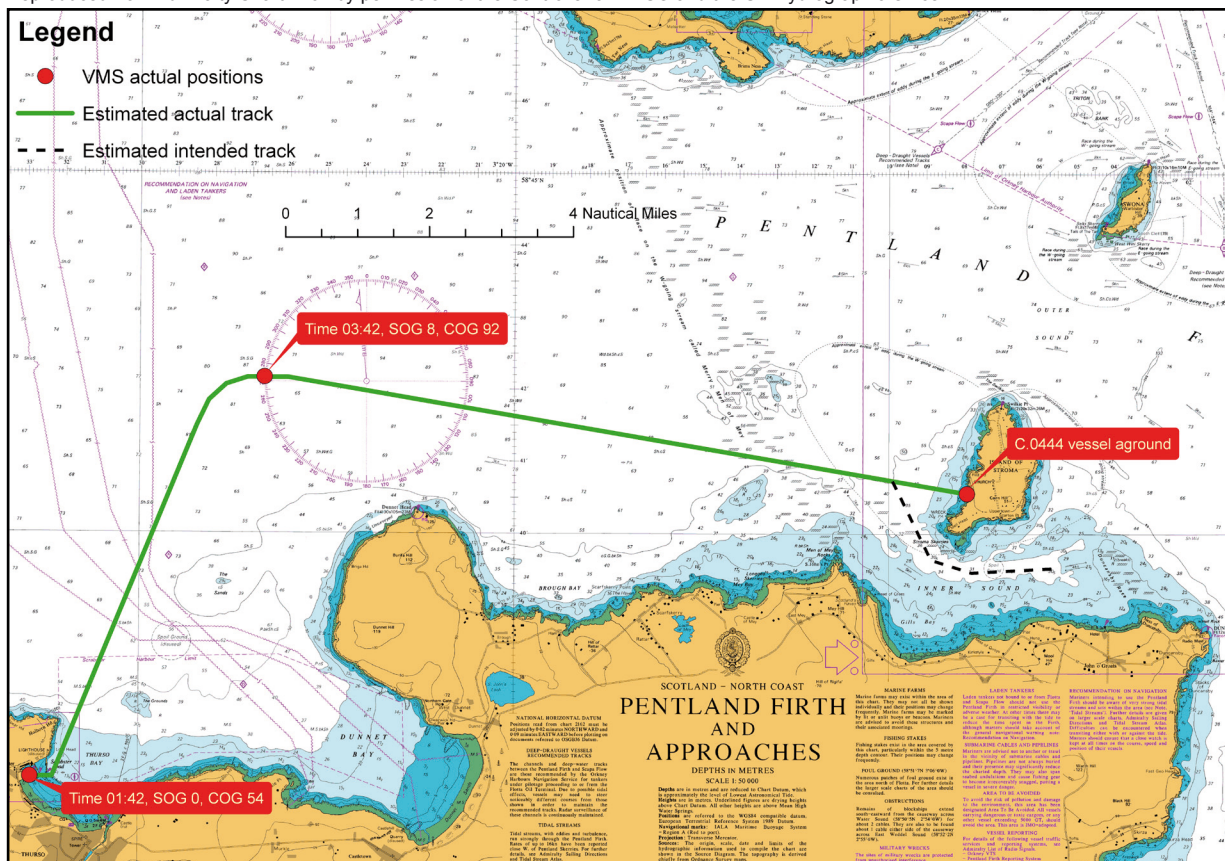
Figure 2: Chart showing broad estimated track of vessel

The skipper navigated the vessel into the firth using the autopilot (**Figure 2**) and, by 0342, had turned her onto an easterly heading. His initial intention was to transit the main channel. However, the conditions were better than expected, with westerly winds of force 3 to 4, a slight sea and good visibility. He therefore decided to take the

Golden Promise was making around 9 knots when she ran aground on the Island of Stroma in position 58° 40.6'N 003° 07.9'W, at about 0444 (**Figure 2**). The grounding woke the skipper.

Golden Promise ran aground when the skipper, who had been alone in the wheelhouse, fell asleep and failed to make the required course alteration to navigate to the south of the Island of Stroma. No data was available to confirm the vessel's track prior to the accident, other than the Vessel Monitoring System (VMS) position transmitted by the vessel at 0342 (**Figure 2**). By this time, the vessel was already on an easterly heading, and her actual track until she grounded would have been influenced by the tidal stream. At some point after altering course onto this easterly heading, the skipper fell asleep.

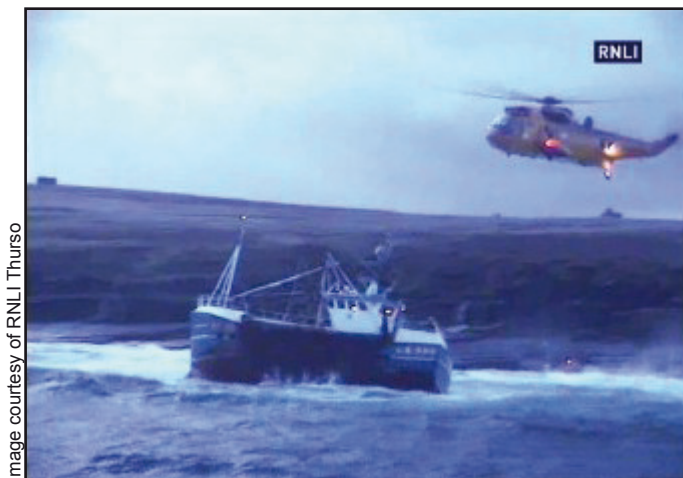
Figure 3: RAF rescue helicopter on scene

The ALBs arrived on scene at 0535 and 0536 respectively followed, at 0602, by the RAF rescue helicopter (**Figure 3**). The crew were airlifted ashore, uninjured. No alcohol or drug testing was conducted following their arrival in Lossiemouth at 0642. There was no pollution, but the vessel subsequently sustained damage and was declared a constructive total loss (**Figures 4a,4b and 4c**).
