## Summary

At 1026 (UTC +1) on 9 August 2011, *CSL Thames*, a Maltese registered self-discharging bulk carrier, grounded briefly in the Sound of Mull while on passage from Glensanda to Wilhelmshaven. The vessel sustained bottom damage to her hull, including a 3-metre fracture to one of her water ballast deep tanks, which flooded. There were no reported injuries or pollution.

## Grounding of *CSL THAMES* in the Sound of Mull 9 August 2011

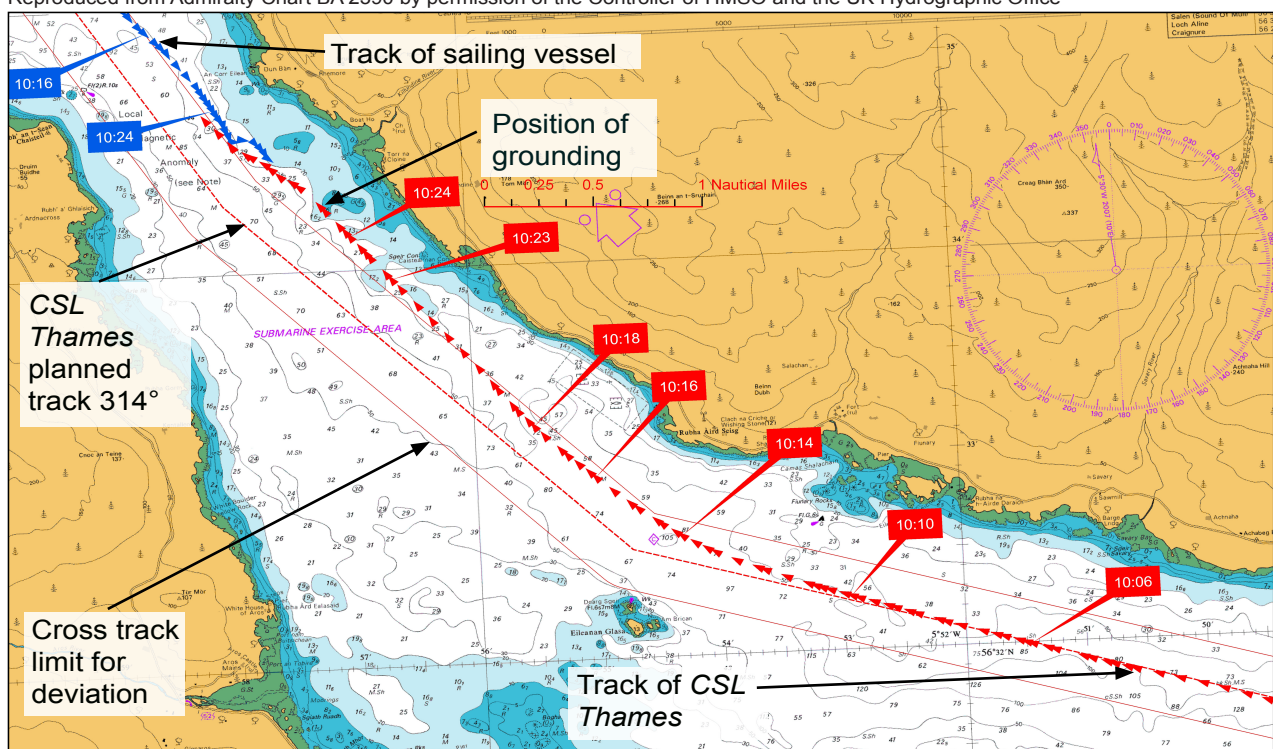
**Figure 1: AIS tracks of *CSL Thames* and sailing vessel**

At 1006 (**Figure 1**), with *CSL Thames* on a heading of 290°(T) at a speed of 12 knots, the master instructed the helmsman to engage the autopilot and then handed the con to the third officer, who stood facing the starboard radar display, with the

At 1010, the third officer interpreted from the ECDIS display that *CSL Thames* was about 1 mile from the next planned waypoint; he also estimated that a sailing vessel he could see on the starboard bow would be ahead of *CSL Thames* when she was steady on her new course. Intending to leave the sailing vessel to port, he decided to turn early and, by adjusting the autopilot, initiated a slow alteration of course to starboard towards the next planned course of 314° (T). At 1014 (**Figure 3**), as *CSL Thames's* heading was passing 308°(T), the third officer acquired on the radar an automatic identification system (AIS) target of the sailing vessel at a range of 3.6 miles and on a bearing of 318.5°(T). At 1016, with *CSL Thames* approaching her planned course of 314° (T), he decided to continue the alteration to starboard to place the sailing vessel onto the port bow. At 1018, *CSL Thames* was on a heading of 321° (T) when the third officer observed another small vessel right ahead at about 1 mile range. With the intention of leaving the small vessel to port, he continued altering course to 324° (T). The ECDIS anti-grounding warning zone alarm then activated on the display, but no audible alarm sounded.

At 1025, *CSL Thames* grounded in position 56° 34.3'N, 005°57.2'W at a speed of about 12 knots (**Figure 4**). The contact with the seabed lasted 16 seconds and caused the vessel to vibrate loudly. This prompted the master to return to the conning position and to look at the ECDIS display. Recognising that his vessel had run aground, he instructed the helmsman to switch to manual steering and ordered the wheel to hard-a-port. The sailing vessel also altered course to port and both vessels narrowly avoided colliding with each other.

The third officer's decision to prematurely initiate a turn to starboard before *CSL Thames*'s next waypoint was based on an assumption that the sailing vessel would follow an approximately reciprocal course to *CSL Thames*'s next planned course. He perceived that the planned alteration of course would result in the two vessels being placed at risk of collision, and therefore he opted to alter course early to keep to the starboard side of the Sound. Soon afterwards, he acquired the sailing vessel's AIS target on the radar display bearing 318.5° (T). This required him to alter *CSL Thames*'s course further to starboard than originally intended to bring the sailing vessel onto *CSL Thames*'s port bow. The third officer then saw another small vessel ahead, which he presumed to be crossing from starboard to port. In again opting to leave this vessel to port, the third officer altered course further to starboard and onto a track that would cause *CSL Thames* to run aground within 10 minutes.

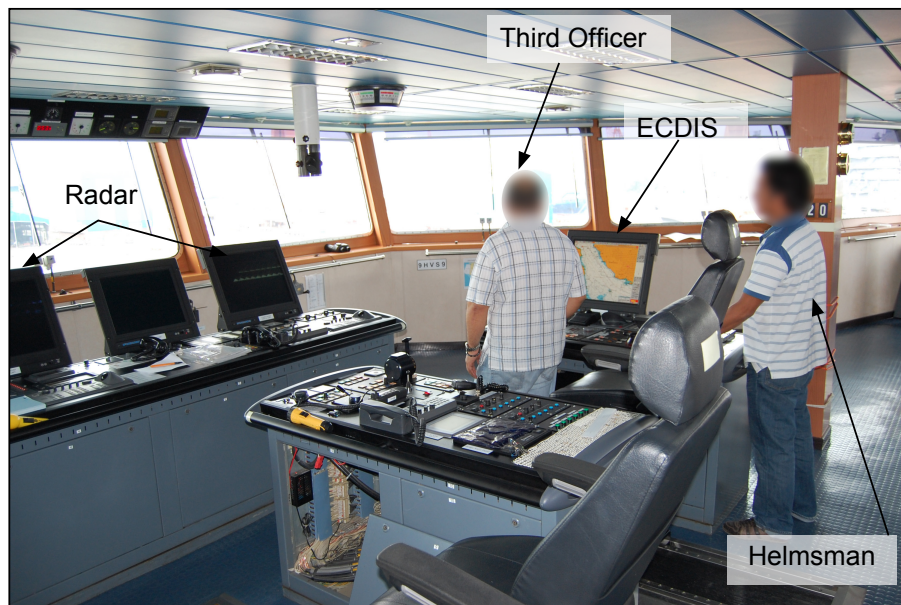
**Figure 2:** View of ECDIS and position of bridge team

ECDIS display to his right (**Figure 2**). The master increased the volume on a portable compact disc player that had been playing music on the bridge since the pilot disembarked, and moved to the communication centre on the port side of the bridge to send routine departure messages.

While the third officer relied on the ECDIS as the primary means of navigation, he did not appreciate the extent to which he needed to monitor *CSL Thames*'s position and projected track in relation to the planned track and surrounding hazards. The ECDIS display was orientated so that the OOW had to face to starboard to look at the screen (**Figure 2**). Although this might have been ergonomically satisfactory for routine navigational watchkeeping, the third officer's overriding priority during the period leading up to the accident was collision avoidance, which required him to look ahead. Had the ECDIS display been located in front of him, he would have been more likely to routinely consult it when monitoring the navigational situation.

3. Had the ECDIS display been located in front of him, the third officer would have been more likely to routinely consult it when monitoring the navigational situation.

- Repositioned the main ECDIS unit adjacent to the starboard radar to enable the officer of the watch to view the display while facing forward.
- Reconnected the ECDIS unit to the bridge alarm monitoring unit to provide a functioning audible alarm.
- Arranged for *CSL Thames's* bridge officers, and the management company's DPA and nautical superintendent to attend an 'equipment specific' training course on the ECDIS type fitted on board.
- Arranged for the fleet's bridge officers to attend a bridge resource management course.
- Arranged for the nautical superintendent to provide onboard ECDIS training to the fleet's other vessels fitted with ECDIS or electronic charts.

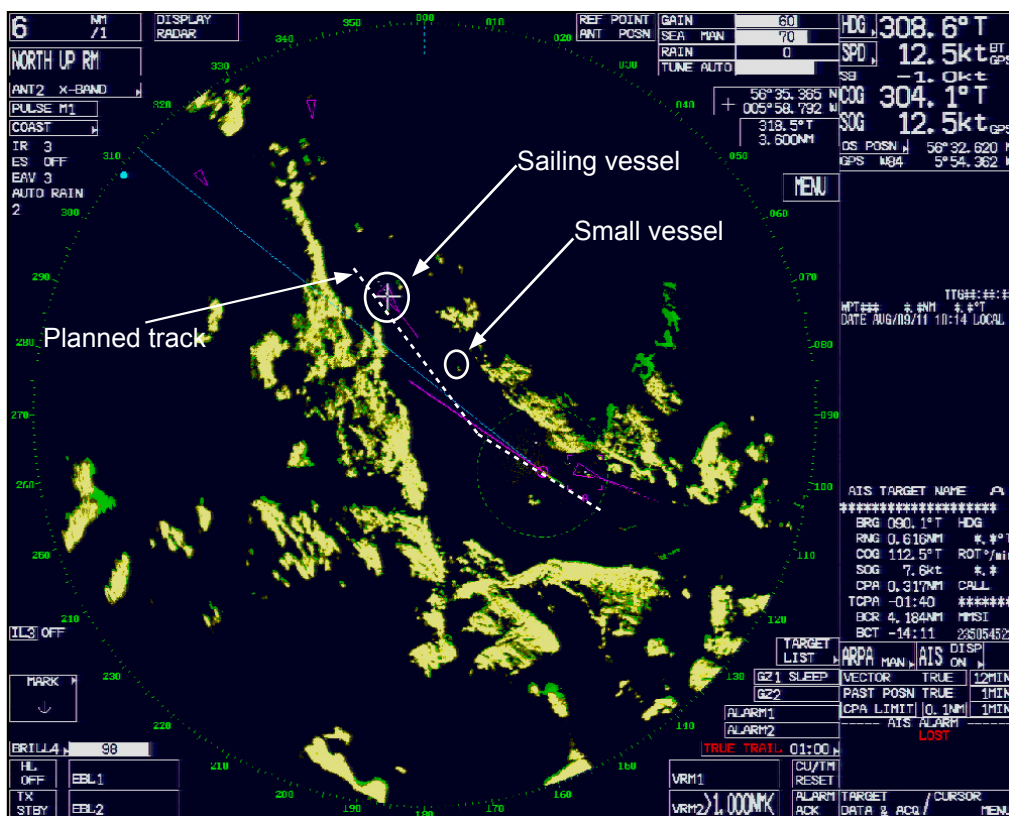
Figure 3: Radar display at 1014 - overlaid with planned track

The third officer was required by Rule 7 of the COLREGS<sup>4</sup> to determine if a risk of collision existed before taking action. Analysis of *CSL Thames*'s radar recording indicates that, had the third officer followed the planned track in accordance with the passage plan, the other two vessels would have passed clear on her starboard side (**Figure 3**).

2. Analysis of *CSL Thames's* radar recording indicates that, had the third officer followed the planned track in accordance with the passage plan, the other two vessels would have passed clear on her starboard side.

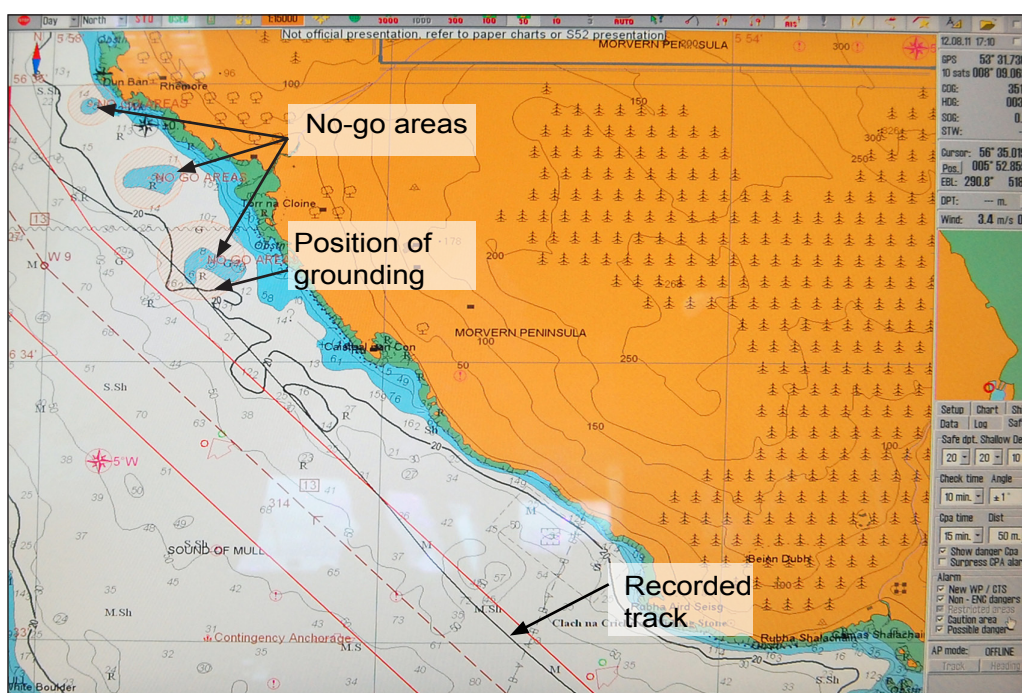
Figure 4: ECDIS display showing recorded track

The third officer was unaware that *CSL Thames* was heading into danger. He had last looked at the ECDIS display immediately before initiating *CSL Thames*'s turn to starboard at 1010. The ECDIS display anti-grounding warning zone alarm activated at about 1018. However, the focus of the third officer's attention was on collision avoidance, and involved him looking ahead through the bridge windows and monitoring the radar display.

A safety contour setting of 10 metres was inappropriate for *CSL Thames*'s draught of 10.63 metres. Taking into account the height of tide of 1.4 metres and an estimated squat of 0.9 metre, the vessel would have grounded at a charted depth of 10.13 metres, before crossing the safety contour. Although the ECDIS anti-grounding warning zone visual alarm activated, the audible alarm, which should have alerted the third officer to the fact that *CSL Thames* was heading into danger, did not function. This was because the ECDIS unit was not connected to a loudspeaker or buzzer capable of sounding an audible alarm, contrary to the IMO's performance standards<sup>5</sup>.
