Report on the investigation of  
the grounding of

***Karin Schepers***

at Pendeen, Cornwall, UK on

3 August 2011

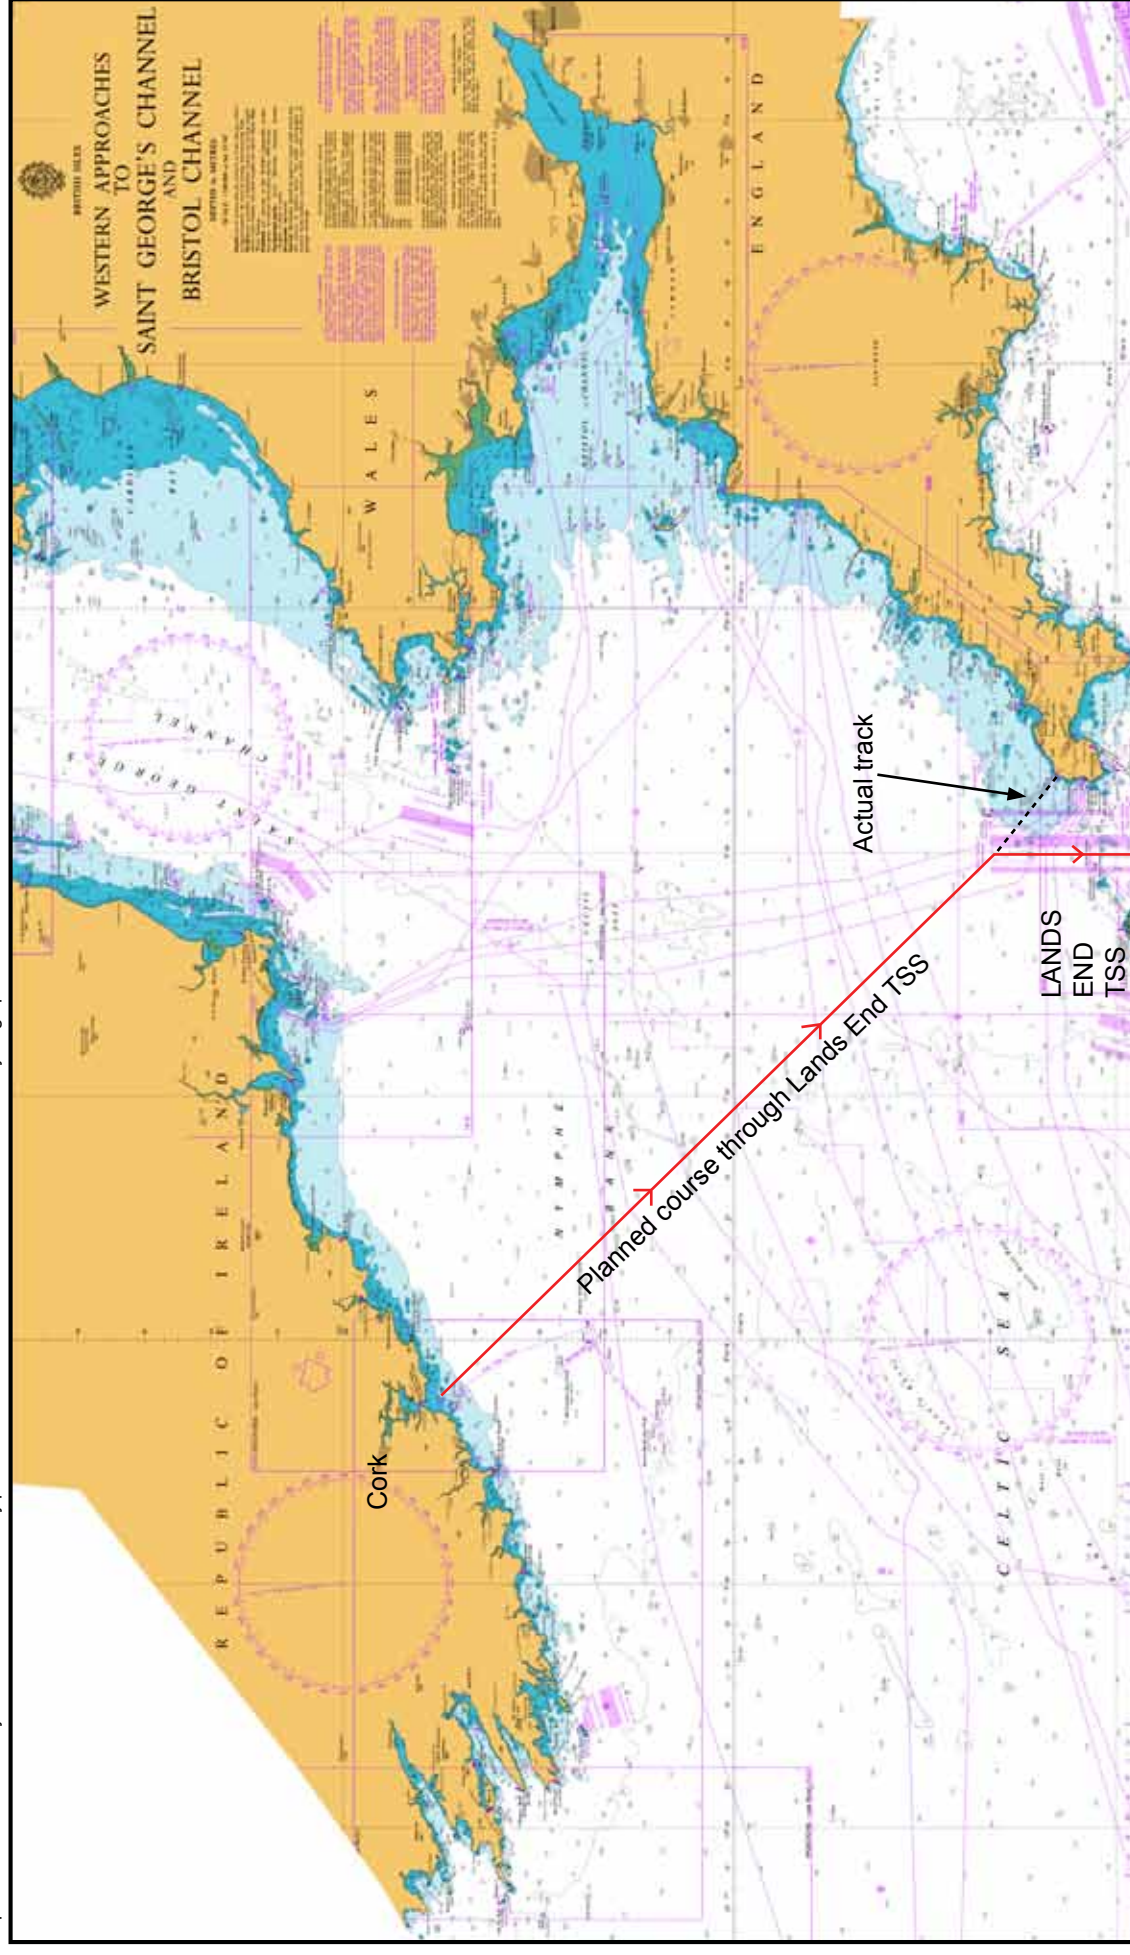
**Figure 1:** Chartlet showing *Karin Schepers'* planned course from Cork to the Land's End TSS and actual track

At 0426 *Karin Schepers* reached her planned alteration of course position at the entrance to the south-bound lane of the TSS. However, the vessel did not alter course and continued on a heading of 135°, at 16.6 knots, as she crossed the north-bound lane of the TSS, passing within 2 miles of a vessel in that lane at 0456 (**Figure 3**).

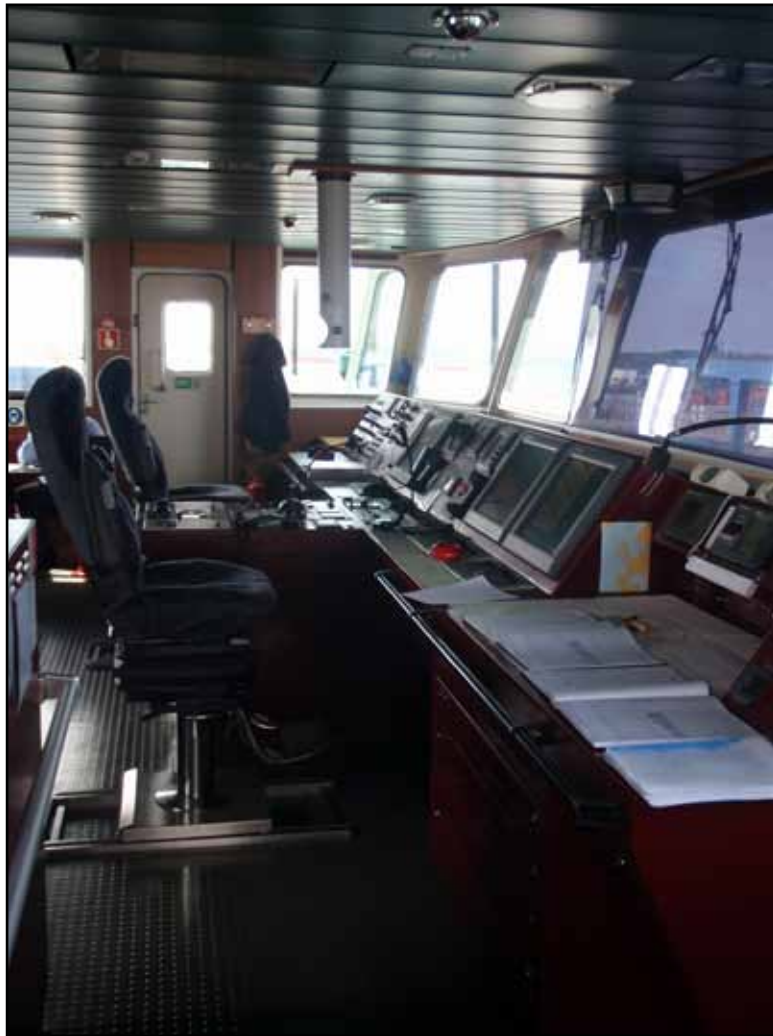
**Figure 2:** *Karin Schepers*' wheelhouse showing bridge chairs

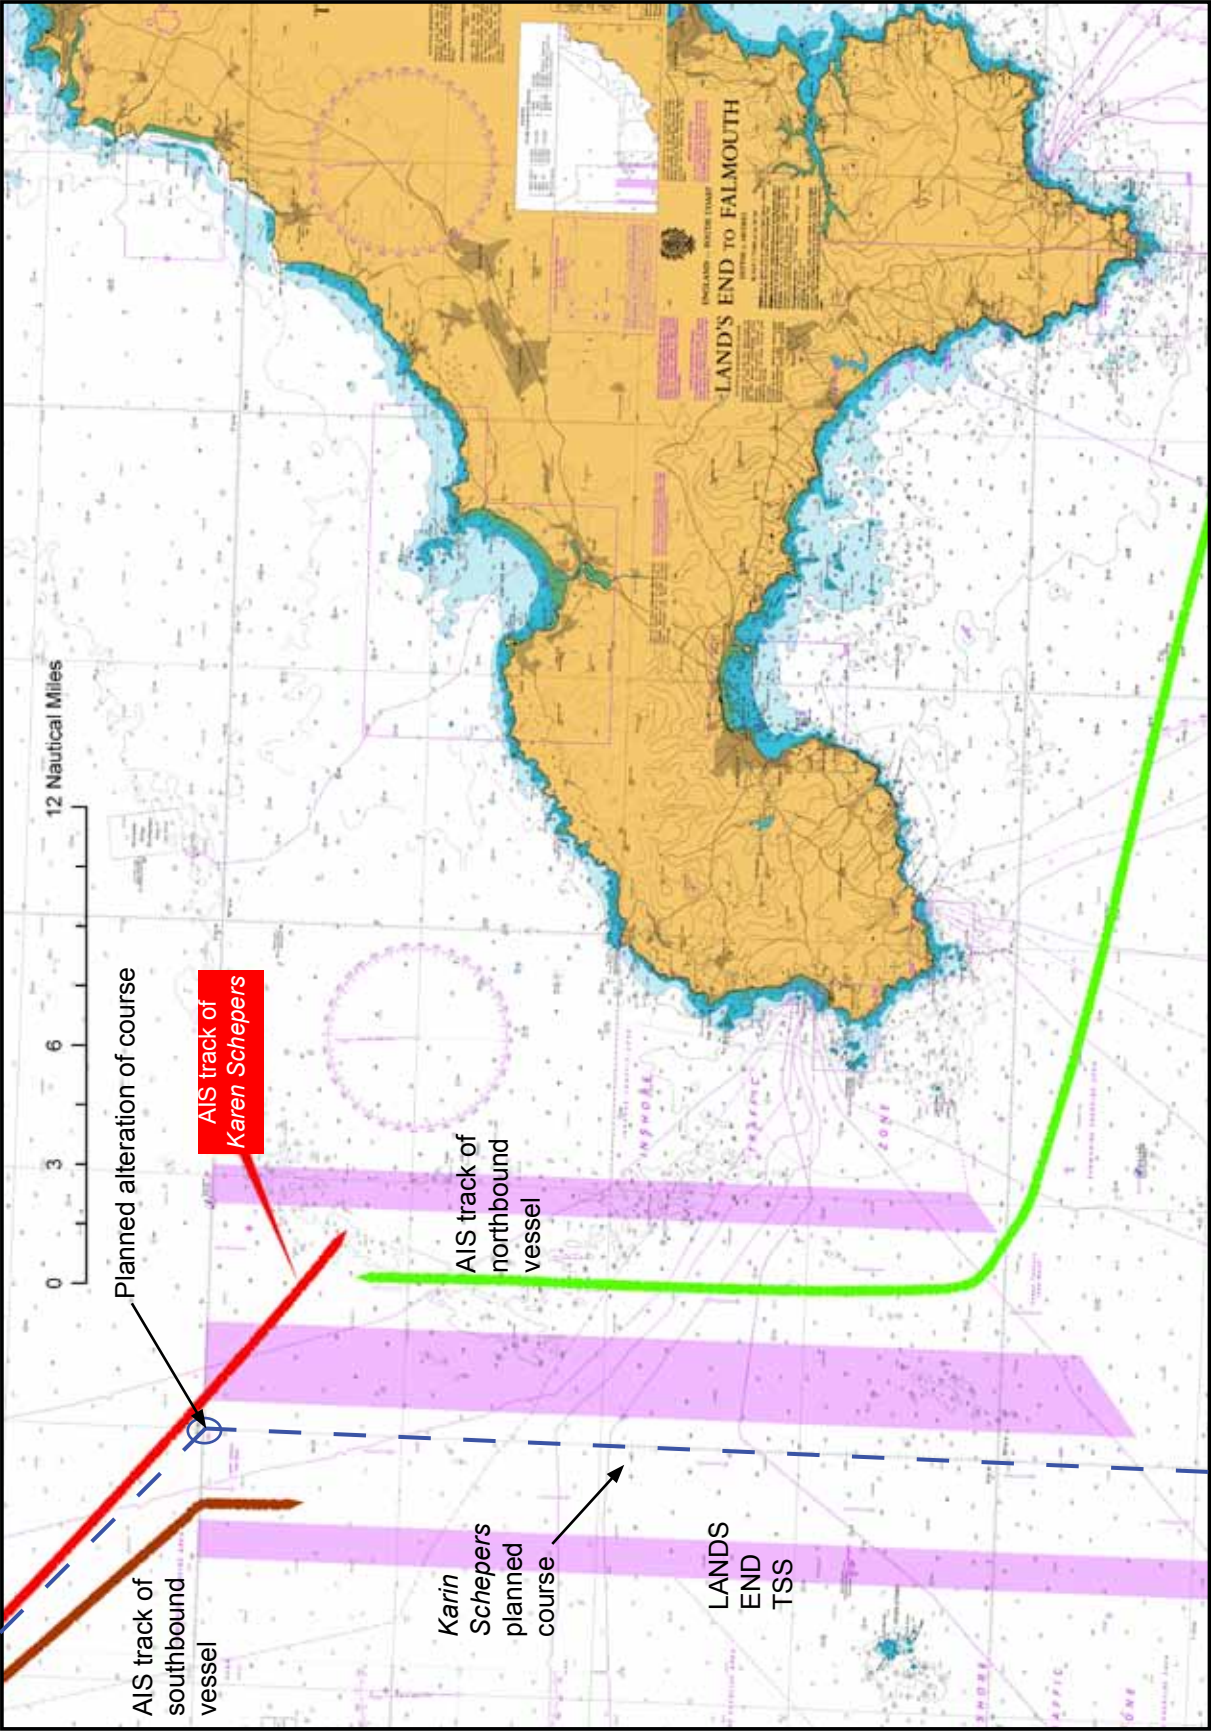
Figure 3: AIS track of Karin Schepers and other vessels in the vicinity at 0456

*Karin Schepers* failed to alter course to enter the south-bound lane of the TSS, and crossed the north-bound traffic lane in a manner contrary to Rule 10<sup>6</sup> of the Collision Regulations.

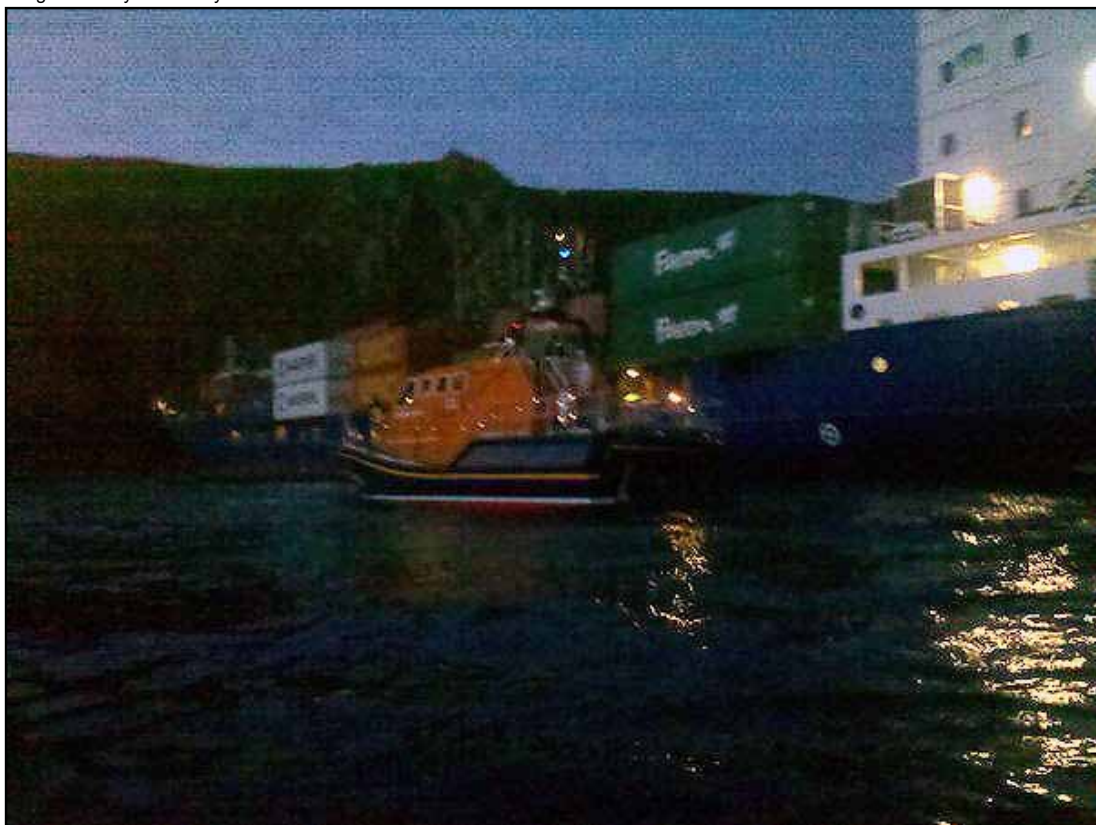
At 0605 the Sennen Cove lifeboat arrived on scene (**Figure 4**) and the St Ives lifeboat was called out. A few minutes later a coastguard cliff rescue team arrived on the cliffs above the vessel, from where they had a good view of *Karin Schepers* (**Figure 5**), and they updated Falmouth MRCC on the situation.

**Figure 4:** Sennen Cove Lifeboat alongside *Karin Schepers*

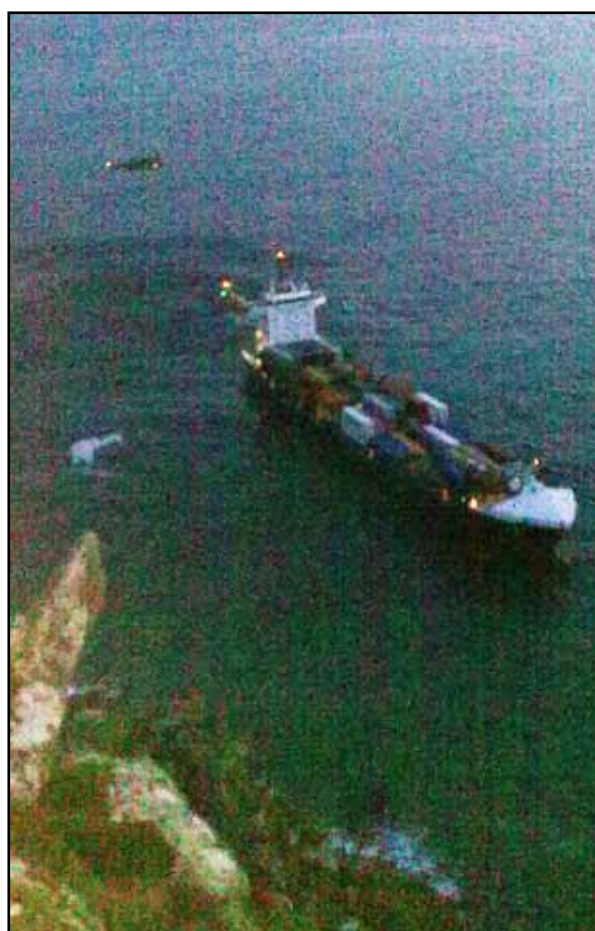
**Figure 5:** *Karin Schepers* aground - viewed from cliff top (with helicopter and lifeboat on scene)

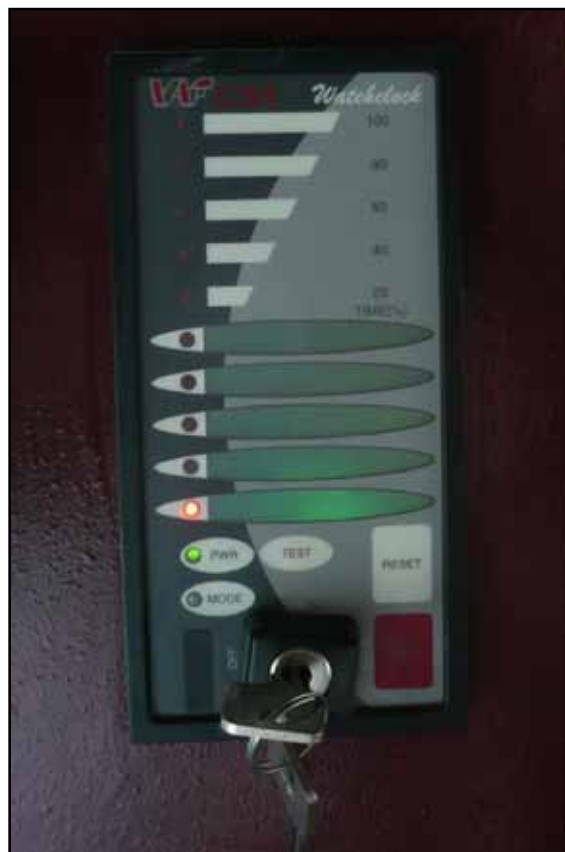
A BNWAS was fitted on *Karin Schepers* (**Figure 6**), but it was not turned on at the time of the accident, and evidence indicates that it had not been used for several months.

**Figure 6:** Bridge Navigational Watch Alarm System

The failure to use the BNWAS is another indication that the vessel's SMS was ineffective. It is important that audits are robust and of sufficient scope to provide evidence that companies' SMS procedures are being complied with at all times.

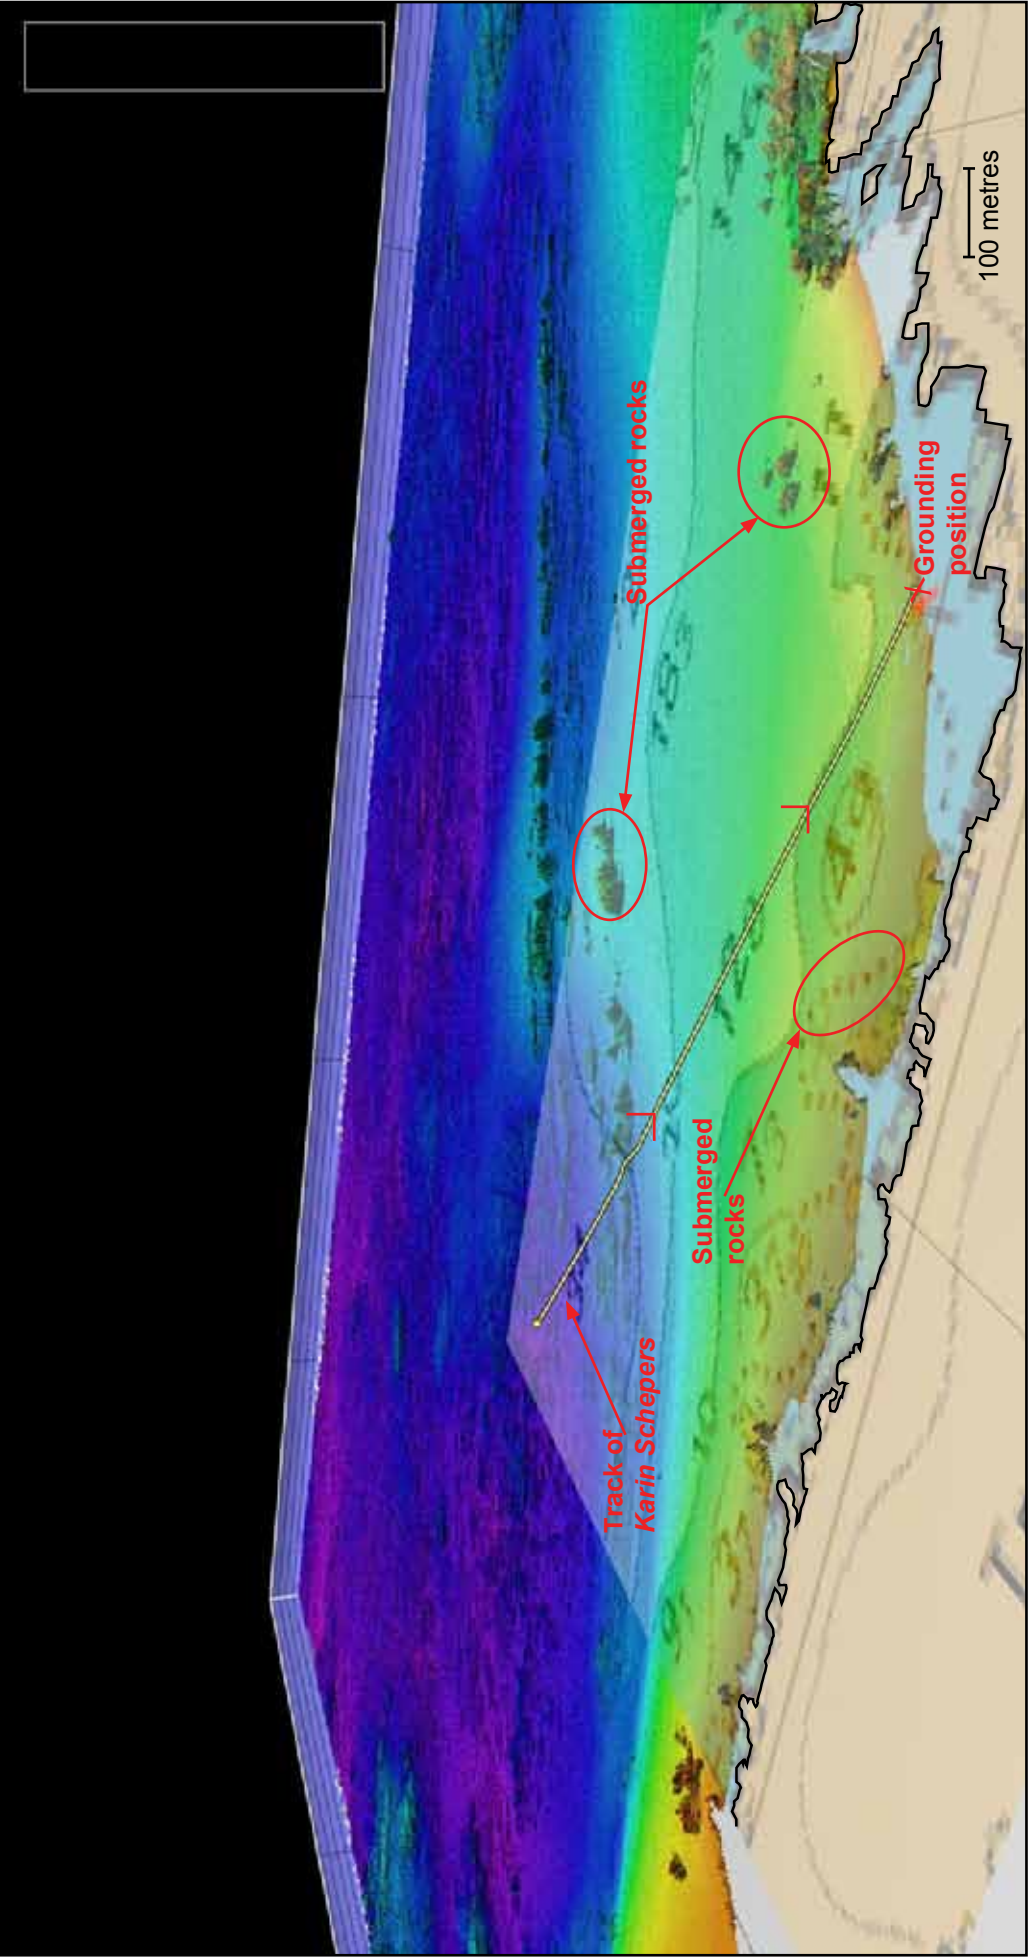
It was extremely fortunate that *Karin Schepers* grounded on an isolated area of sand, and suffered no damage (**Figure 7**). However, the attempt to refloat the vessel before an assessment had been made of her condition was ill-considered. The master should have consulted the emergency checklist provided for grounding situations (**Annex F**) which would have guided him to obtain soundings inside and outside the vessel in order to gain a thorough assessment of the vessel's condition before any further action was taken.

**Figure 7:** Track of Karin Schepers towards grounding position (overlayed on latest MCA hydrographic survey of area)
