Report on the investigation of the  
derailment of the hatch-lid gantry crane on board

***Blue Note***

while alongside in Londonderry, Northern Ireland

22 July 2011

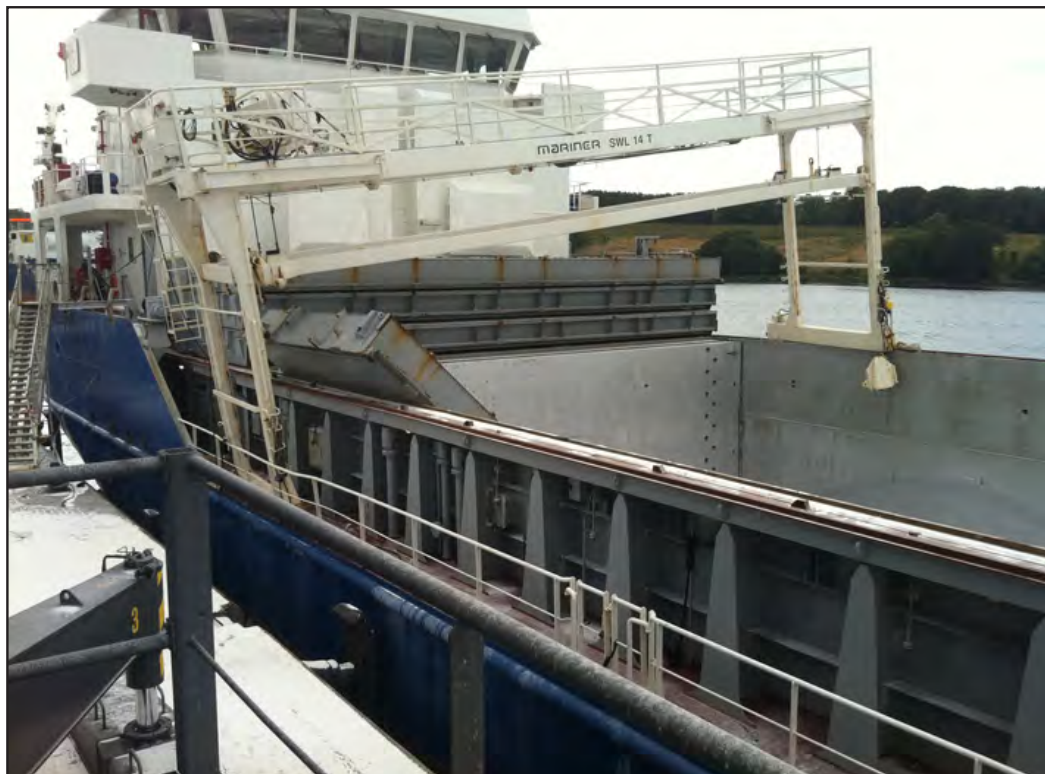
**Figure 1:** Position of crane and hatch-lid following the accident

The crane had travelled approximately 10 metres when the port side of the lid fell from the lifting hooks. The hatch-lid pivoted momentarily on the starboard hooks before the additional weight bent the starboard lifting sockets and the lid crashed into the starboard legs of the crane and came to rest on the bottom of the hold (**Figure 1**). The crane derailed and three of the four wheels were detached. The

chief officer was thrown overboard and into the water between the quayside and the ship; the AB was left hanging by his hands over the cargo hold; and the third officer fell onto his knees at the control station. All three men suffered minor injuries and were able to get themselves to safety without assistance.

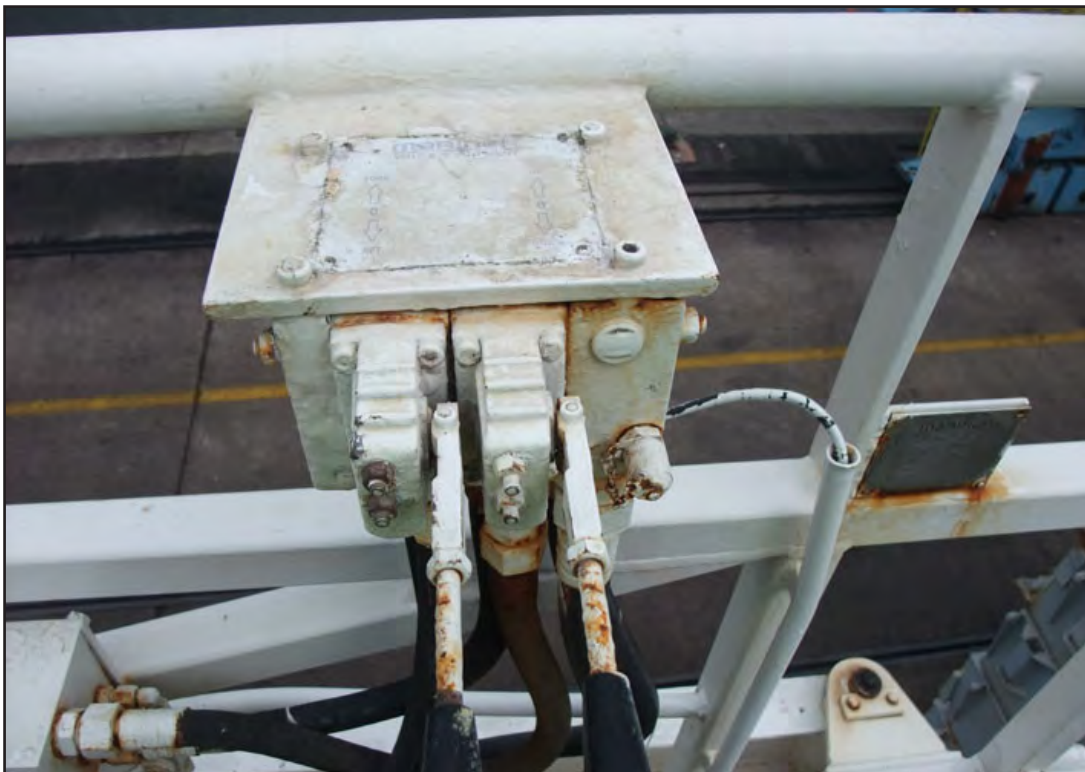
**Figure 3:** Control station

The crane was driven from controls situated on the starboard side of its upper platform (**Figure 3**). One lever raised and lowered the lifting spreader and a second drove the crane forward and aft along its rails. Apart from the labelling of the control levers, there were no operating instructions at the control position.

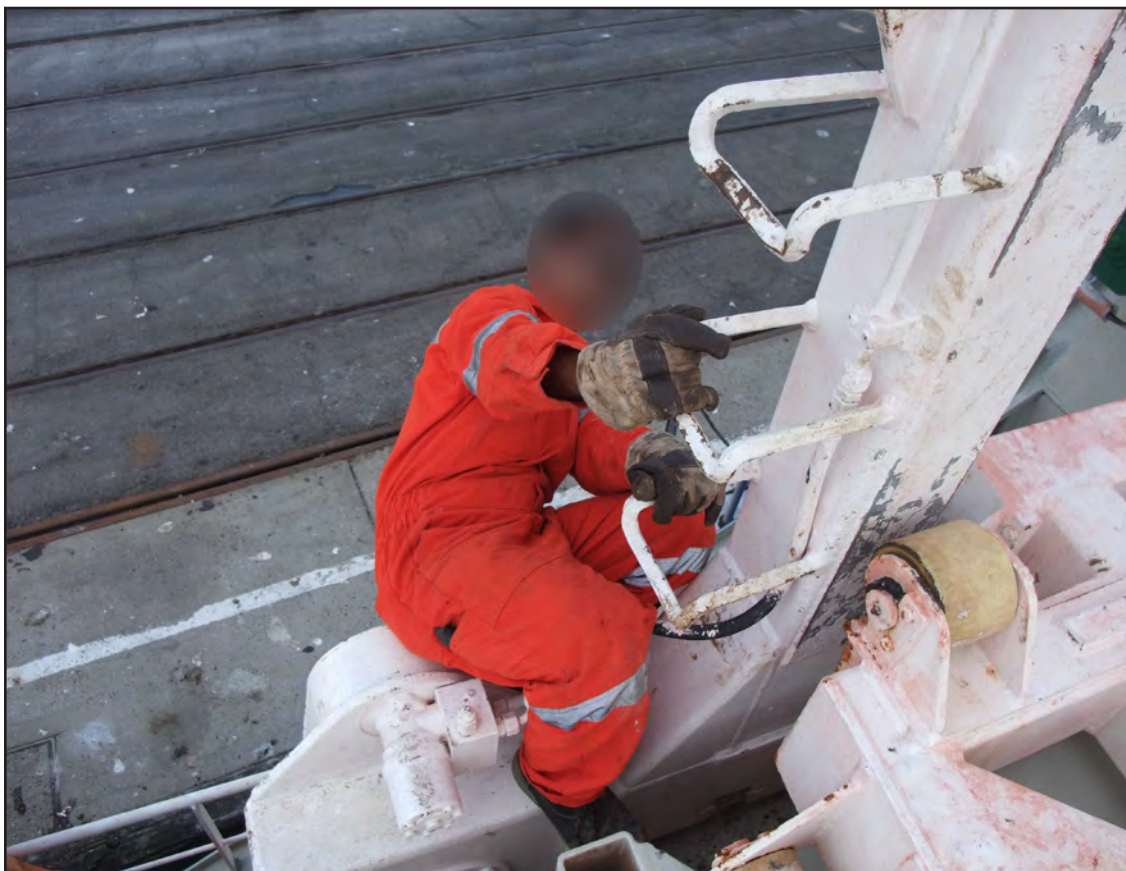
**Figure 8:** Demonstration of checking the hooks (*Blue Carmel*)

The manufacturer's instructions stated that the crane could be operated with two men: one at the controls and one at the hatch coaming level to ensure that the lifting hooks were engaged. The crew of *Blue Note* operated the crane with three men as they felt this was a more efficient way to check both the port and starboard hooks.

It was intended that the person checking that the hooks had engaged would stand on the deck. However, this was difficult to achieve on *Blue Note* because the height of the hatch coaming obscured the view of the lifting hooks. Consequently the crew stood on the forward wheel units to check that the hooks were engaged. They did this by holding on to the hand-holds and leaning out around the structure of the crane to get the best view of the lifting sockets on the side of the hatch-lid (**Figure 8**). There was no platform or ladder fixed to the crane that would have enabled them to view the hooks from a safer position.

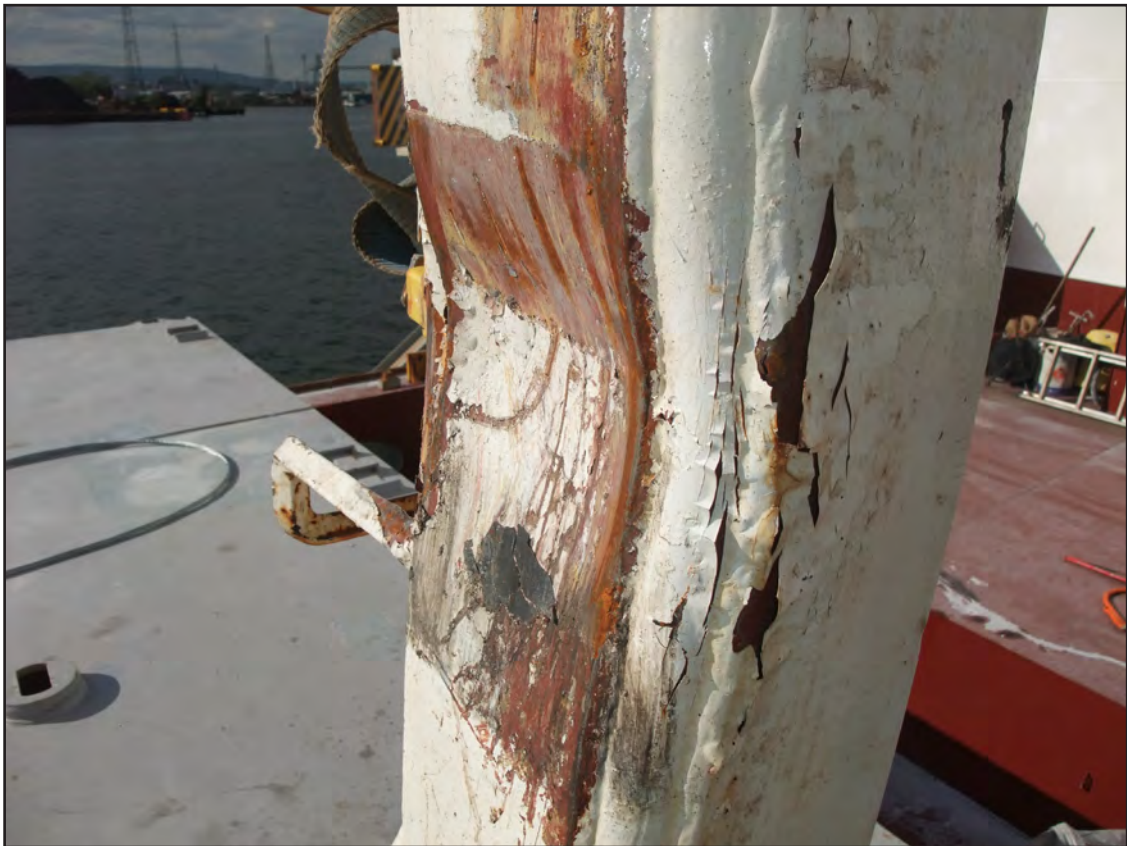
**Figure 9:** Impact damage on the starboard, forward vertical pillar

Both of the starboard side vertical pillars of the gantry crane were bent from the impact of the hatch-lid (**Figure 9**). Several hydraulic hose assemblies had been damaged and the hydraulic power pack had been displaced. The hour counter on the electrical panel next to the control station read 360 hours.

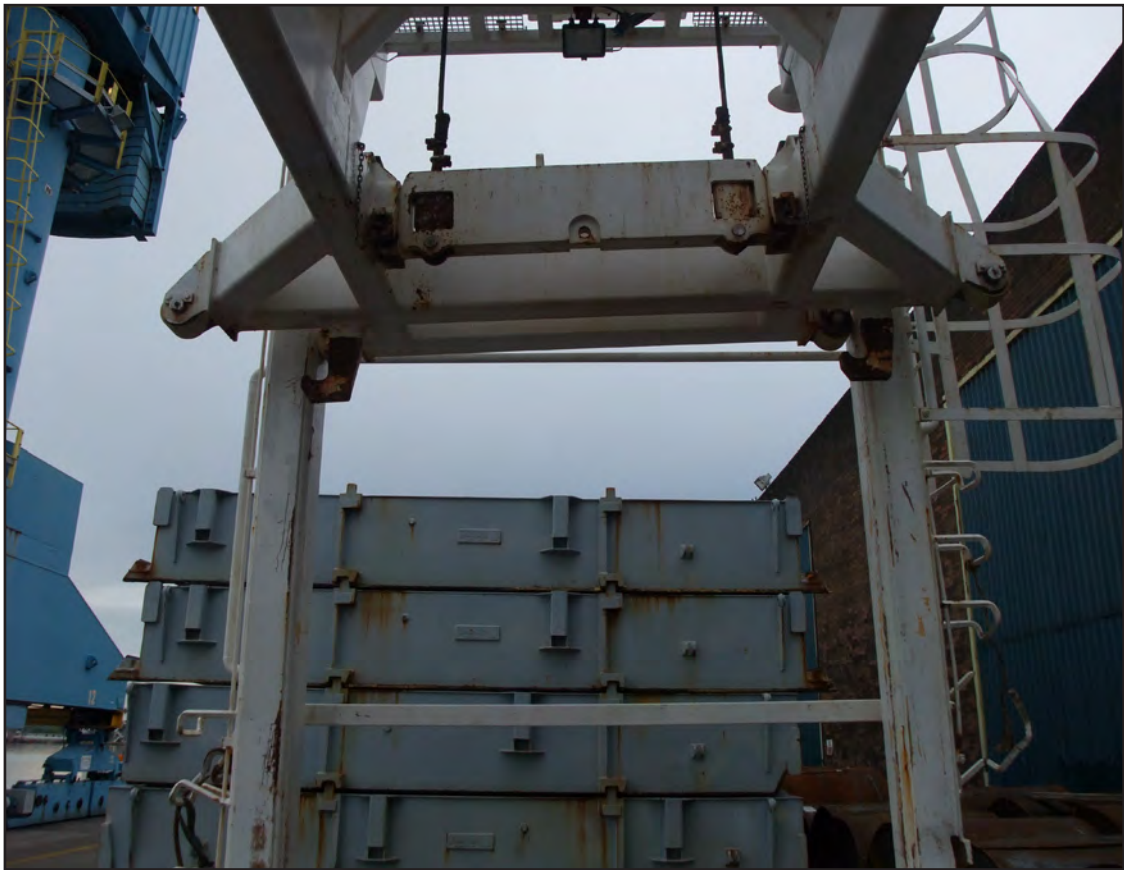
**Figure 10:** Incline of the spreader

It was noted that the spreader was not level (parallel with the gantry), with the forward end sitting lower than the after end (**Figure 10**). It was found that none of the locking nuts on the bottle screws that adjusted the lengths of the spreader's wires had been secured (**Figure 11**).

The effect of the spreader not being parallel to the gantry would have caused the lifting hooks to be at different heights relative to the hatch-lid. This, in turn, would have meant that the hooks engaged with the lifting sockets a varying amount and would not have borne an equal proportion of the load. It is conceivable, in an extreme case, that one of the hooks did not carry any load at all. The risk of a hatch-lid then slipping off a hook completely would also have been exacerbated by the spreader having a slight forward incline and the jerky movement of the crane when coming to a halt.

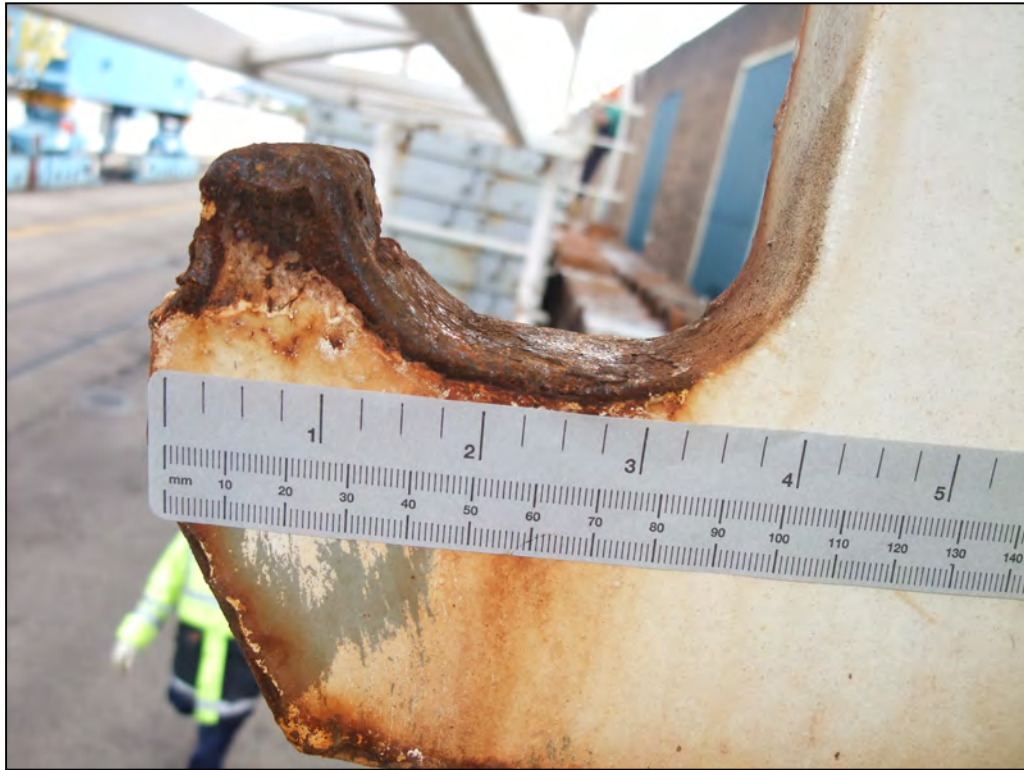
**Figure 12:** Port aft hook

The four hooks were still firmly attached to the spreader. The end of each hook was found to be approximately 15mm shorter than in the original design drawings (**Figure 12**) and 25mm shorter than a hook that was intended for use in another crane which was presented to MAIB inspectors during a visit to the Mariner Ship's Equipment factory in Turkey (**Figure 13**).

The length of the ends of the crane hooks on *Blue Note* was less than that shown on the original drawings and significantly less than a representative hook that was provided by the manufacturer to MAIB inspectors during the investigation. While some erosion of the hook ends could be attributed to wear and tear in operation, with 360 hours on the counter and the material confirmed to be of a suitable specification for use, it is probable that they had not been cut to the intended dimensions during manufacture.

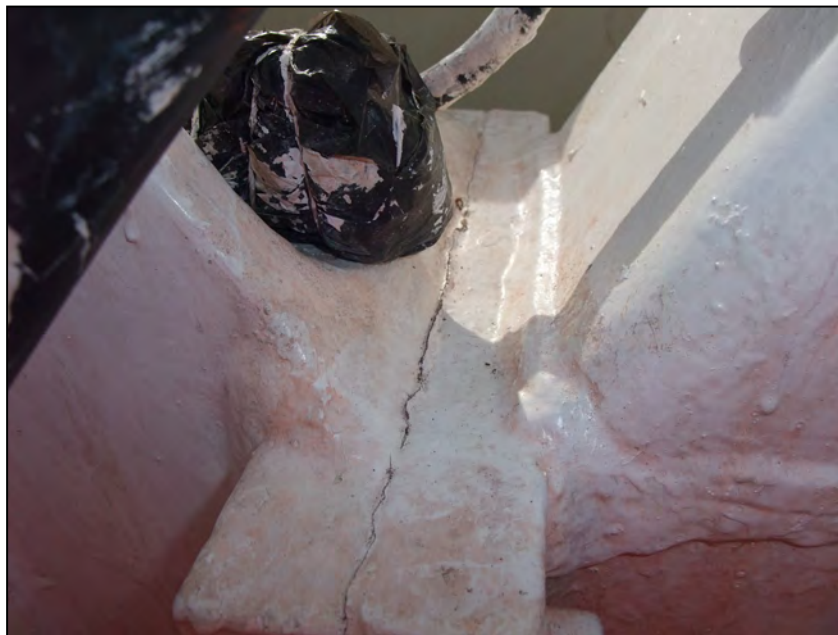
**Figure 14:** Cracked paint indicating movement between wheel unit and crane (*Blue Carmel*)

- The four lifting hooks were shorter than shown in the design drawings
- The joints between the wheel units and the crane were showing signs of flexing (**Figure 14**) and hence cyclic fatigue loading
- There were no records of maintenance or a plan for maintenance of the crane
- The crew operated the crane in exactly the same way as *Blue Note*'s crew: exposing themselves to harm when riding on the wheels or when checking to see if the hooks were engaged.

The crane's maintenance schedule (**Annex D**) required that the wheel securing bolts had to be kept tight so that the forces were borne by the much larger central pin. Any flexing in the joint would cause the load to be transferred to the bolts; cycling of this load would lead to fatigue stresses accumulating in the wheel securing bolts,

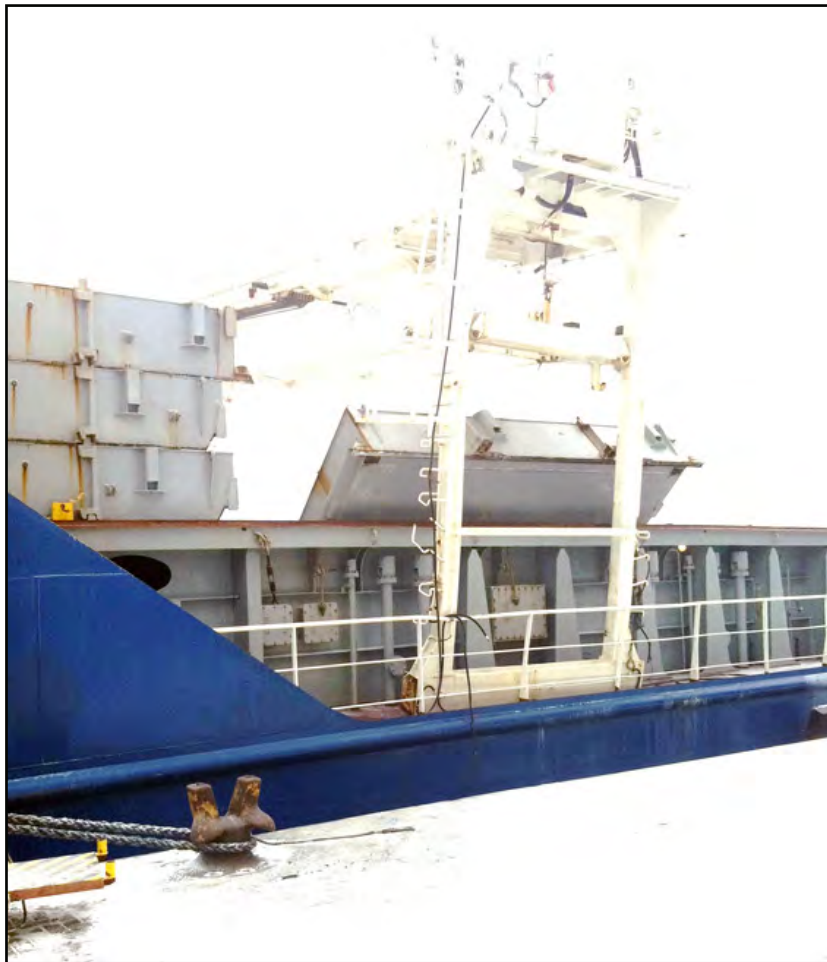
**Figure 15:** Position of the fallen lid in relation to the stacked lids

Photographs taken immediately after the derailment show that the hatch-lid that was being transported was still several metres short of the stack of stowed hatch-lids (**Figure 15**). The two did not make contact with each other and this was not the cause of the derailment.

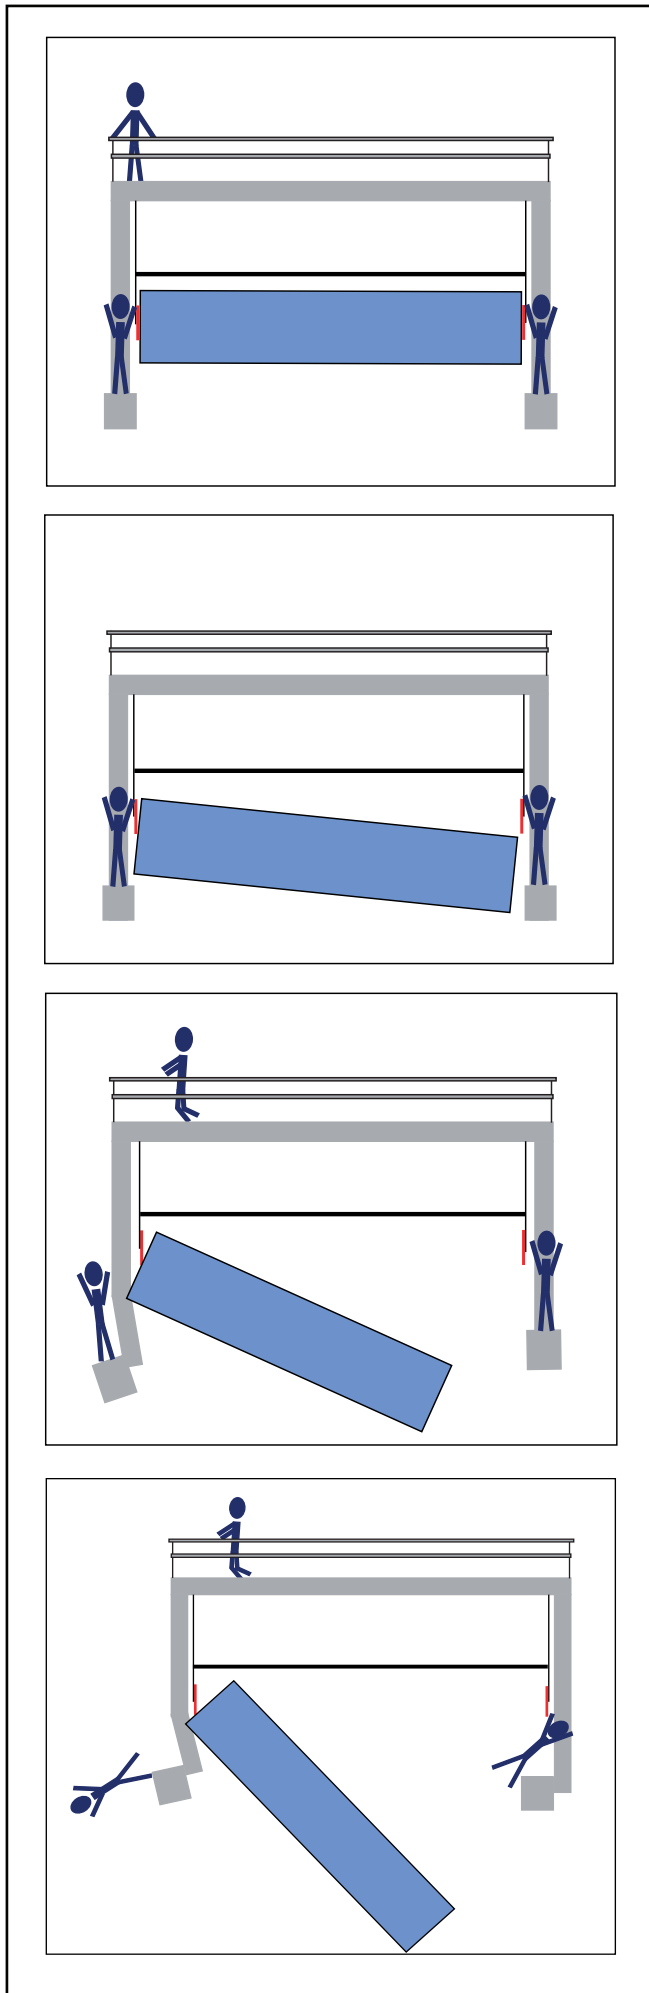
**Figure 16:** Sequence of the derailment

The most likely cause of the accident is that one or both of the port side hooks was not fully engaged, and this was not seen by the AB. The AB incorrectly reported to the chief officer that the hooks were engaged, and this was passed on to the third officer. The hatch-lid was lifted and the crane then travelled aft. A juddering movement as the crane moved or came to an abrupt halt, combined with the forward leaning spreader, then triggered the port side of the hatch-lid to come free from the hooks.

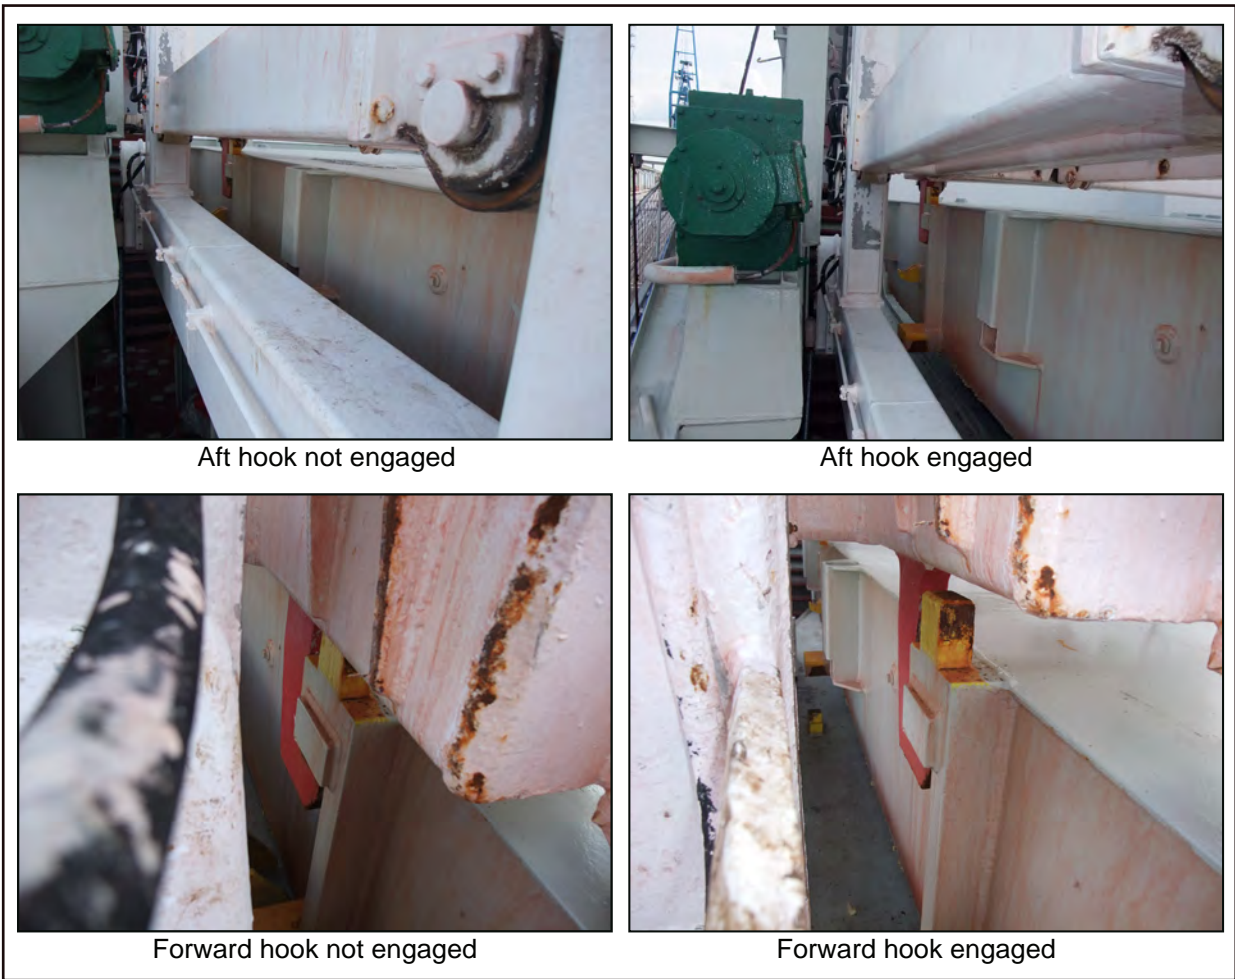
**Figure 17:** Visibility of engaged/disengaged hooks (*Blue Carmel*)

Even when a crew member was standing on a wheel unit and leaning out, it was not readily apparent when the short, unpainted hooks were fully engaged in the sockets (**Figure 17**). It was even more difficult to confirm that the hooks were engaged if the lifting sockets were in shadow during bright sunlit conditions (**Figure 18**). In the absence of a positive means of indication, as a minimum aid, the ends of the hooks should be painted in a contrasting colour to show when they are properly engaged. This should be done as part of the commissioning process during installation, and retrospectively to all other units already in service.

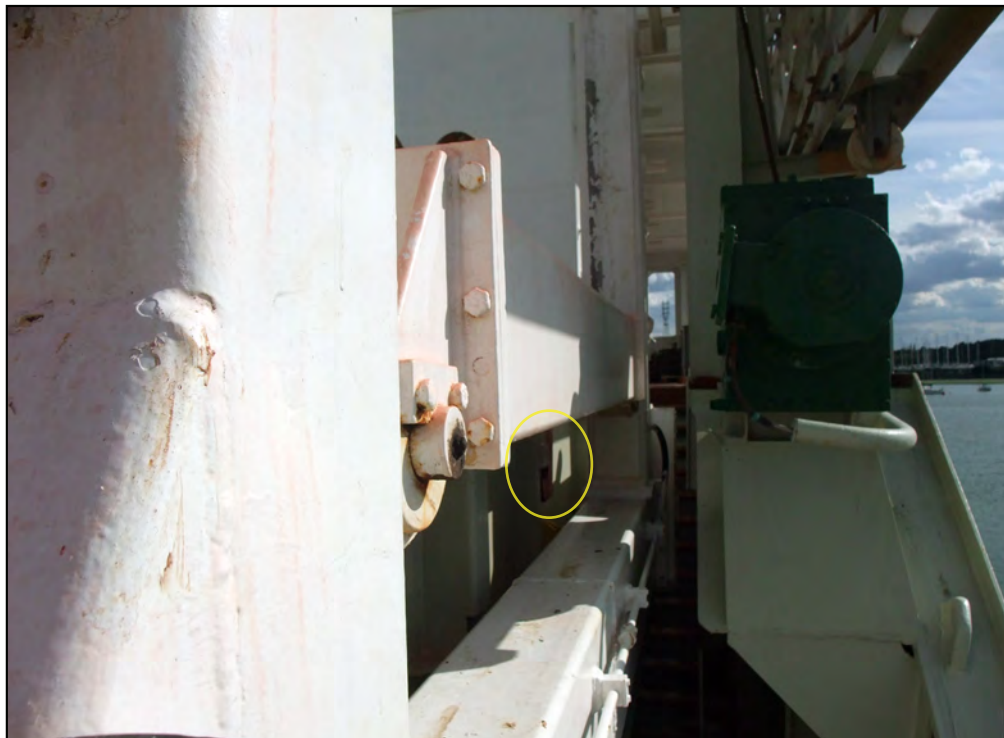
**Figure 18:** Aft hook in shadow (*Blue Carmel*)

The design of the crane did not lend itself to safe operation. The hand-rails that were fitted above the wheels gave the false impression that it was acceptable for crew to ride on the wheel units as the crane moved, and added to the opportunity to do so. Furthermore, the crew had no other facility that gave them a safe position from which they could check that the lifting hooks were properly engaged. Therefore, they were obliged to make this judgment by looking at the hooks from a distance and with the hooks in varying conditions of light and shadow.

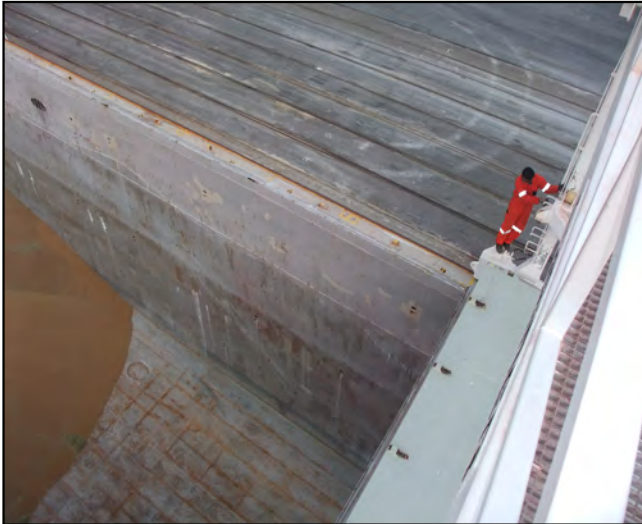
**Figure 19:** Risk of falling into the hold  
(*Blue Carmel*)

A proper risk assessment of the crane operations should have prompted the crew to use safer working methods. However, if riding on the wheel units is deemed essential, then a properly considered, safe method should be provided.
