Laboratory examination and failure analysis of the gantry crane wheel securing bolts

THE TEST HOUSE (CAMBRIDGE) LTD. JOB AND REPORT REFERENCE: T11285

LABORATORY EXAMINATION AND FAILURE ANALYSIS OF M16 GANTRY CRANE WHEEL SECURING BOLTS FROM THE VESSEL BLUE NOTE

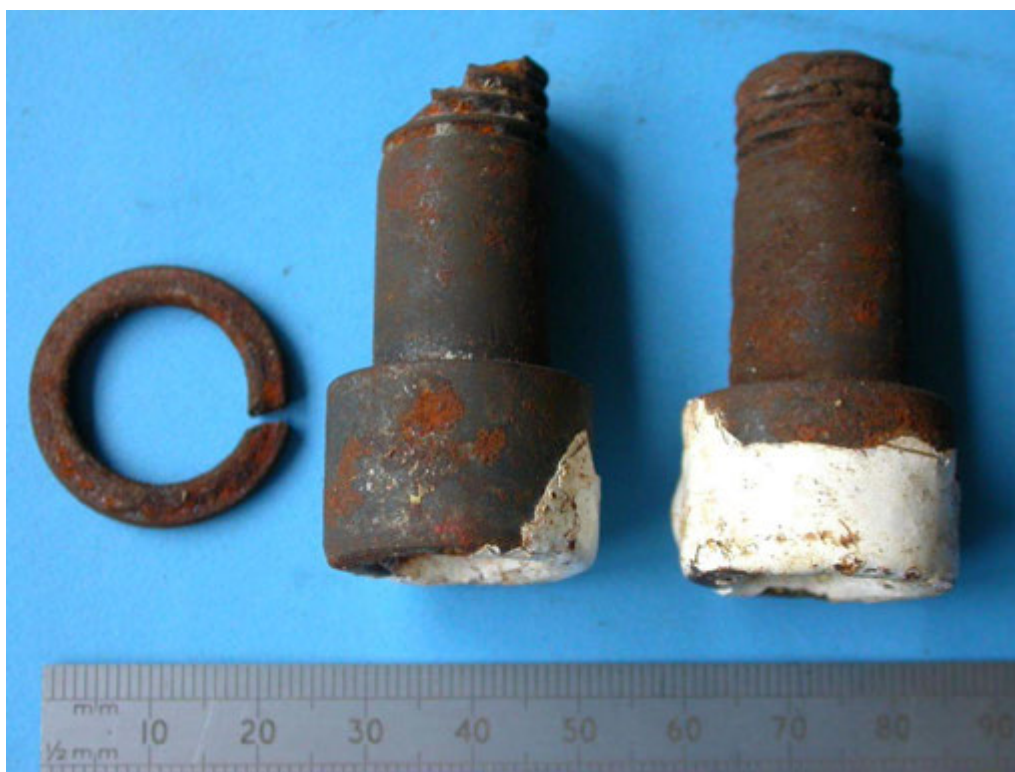
This sample set comprised two cap head end fracture halves, both of which had fractured in the threaded section (Figure 1). One exhibited a shear like fracture at 45° to the bolts principal axis (Figure 2) and its fracture surface was seen to be quite rusted (Figure 3). The second bolt exhibited what potentially looked like a fatigue fracture, which was orientated at 90° to the bolts principal axis (Figure 4). The fracture surface of this second bolt also exhibited evidence of moderate rusting (Figure 5).

Figure 1: Fractured cap head bolt sample halves, received 3rd August 2011.

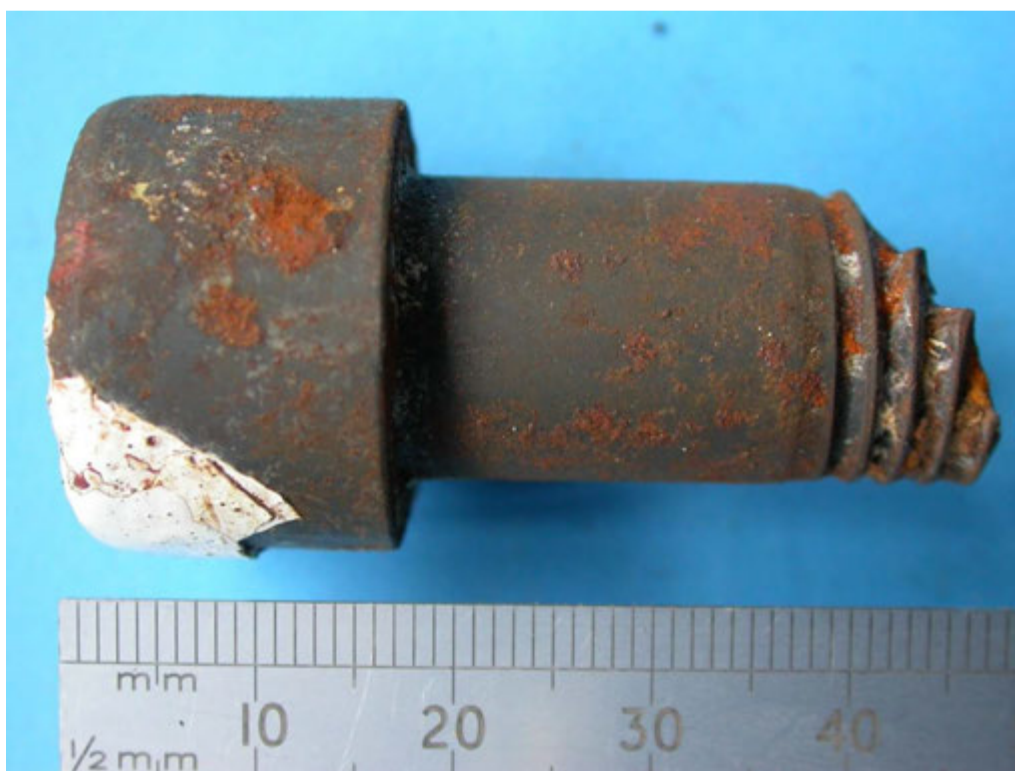
Figure 2: Detail of figure 1, showing bolt half exhibiting 45° degree shear like fracture.

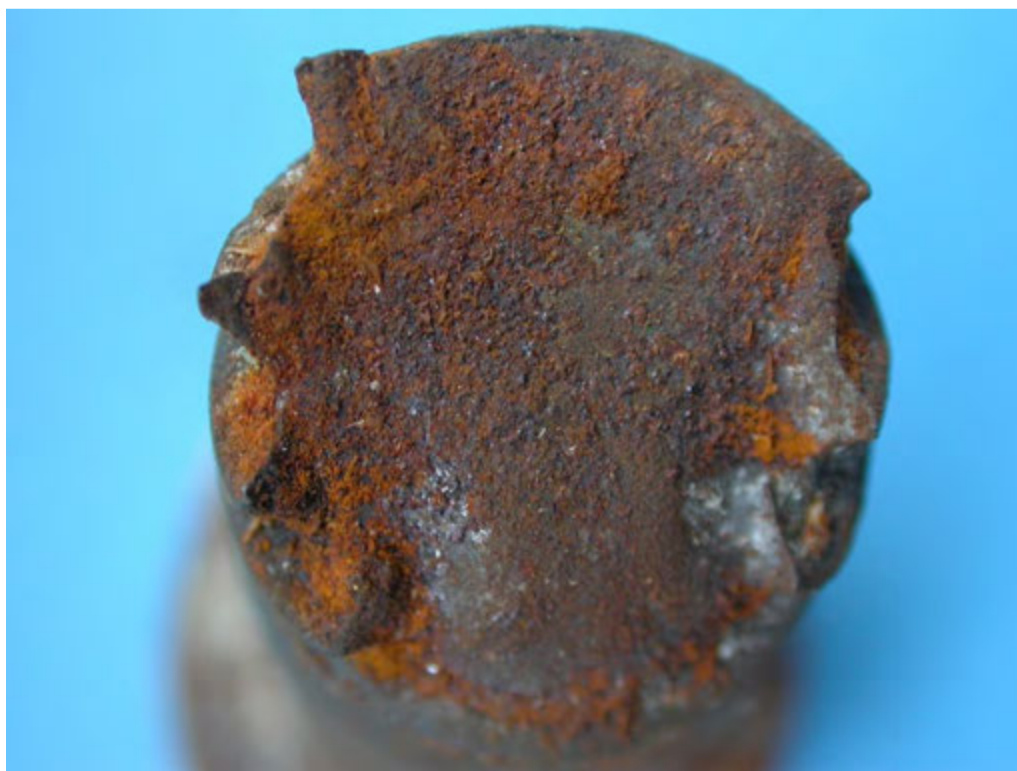
Figure 3: Detail of figure 1, showing rusted fracture surface of the bolt half exhibiting a shear like fracture.

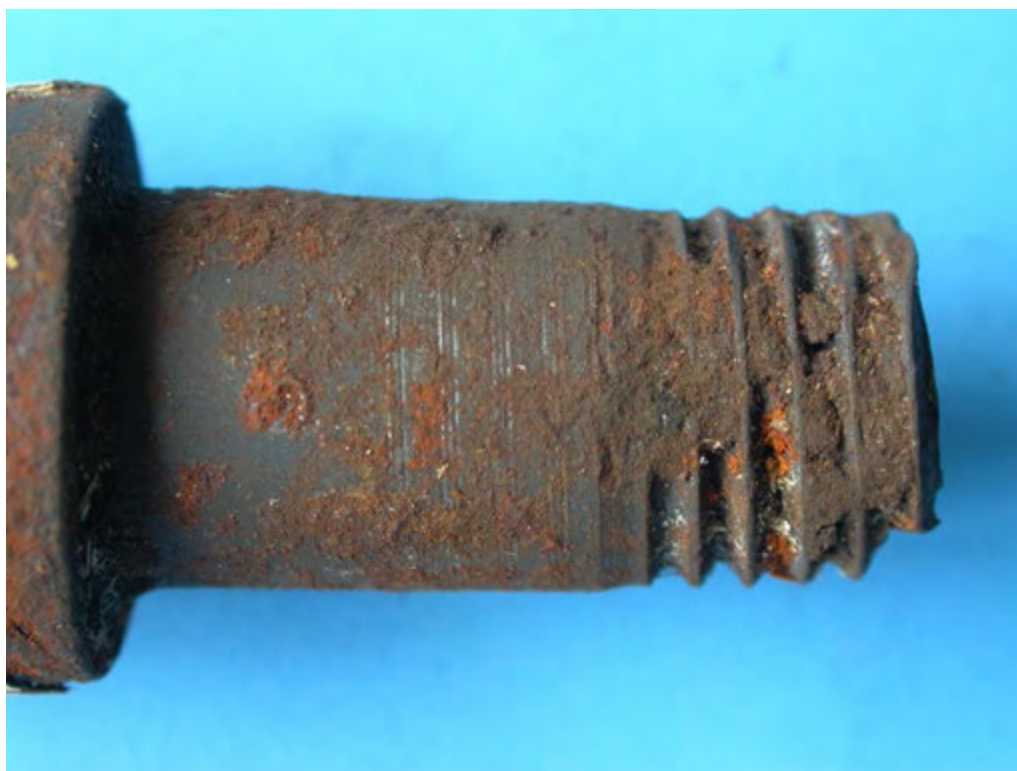
Figure 4: Detail of figure 1, showing a bolt half exhibiting fatigue like fracture at 90° to the fasteners principal axis.

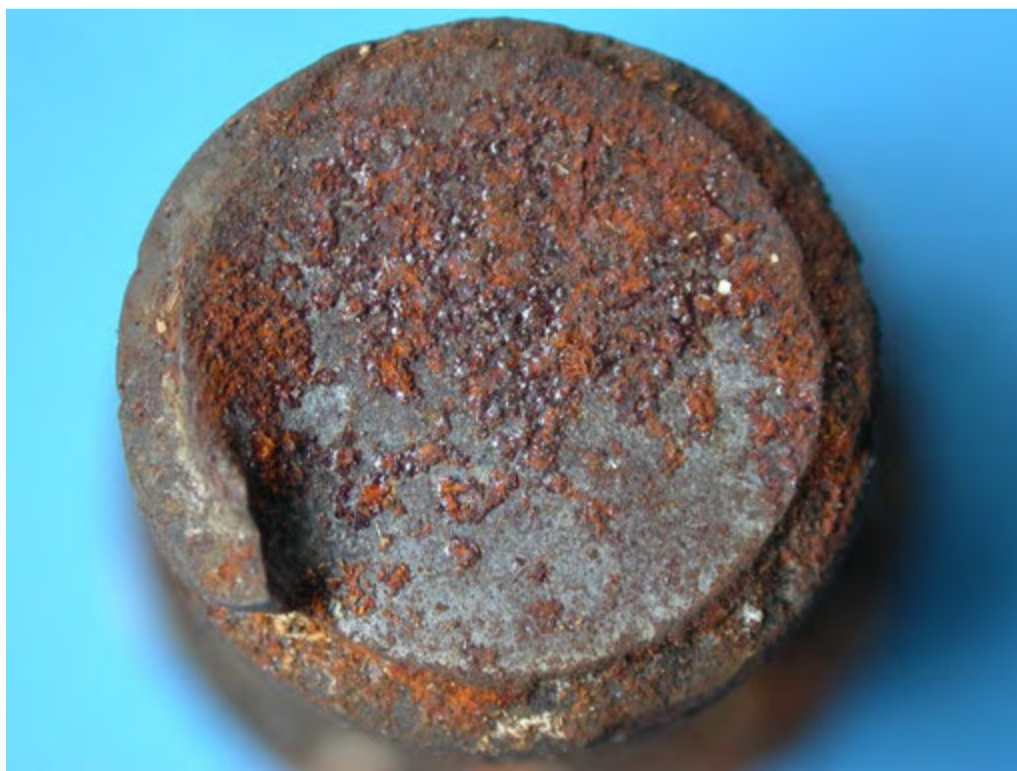
Figure 5: Detail of figure 1, showing rusted fracture surface of the bolt half exhibiting a fatigue like fracture.

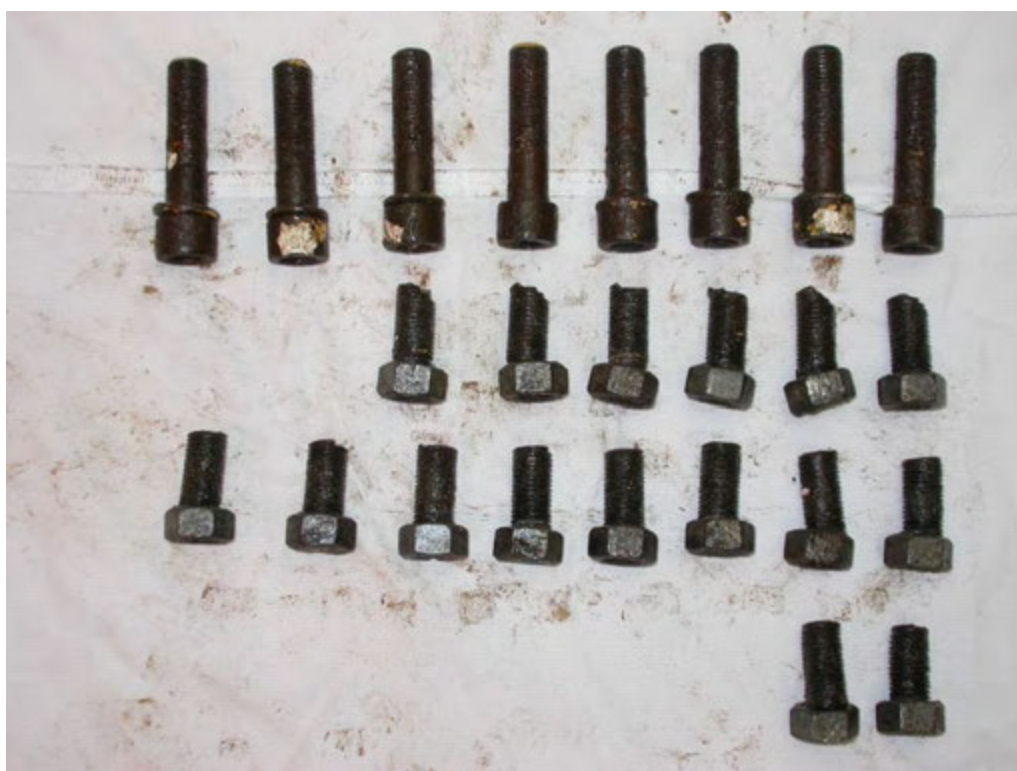
This second sample set comprised eight unfractured bolts and sixteen threaded end fracture halves (Figure 6 and 7), two of which exhibited saw cut end faces (Figure 7).

Figure 6: Un-fractured cap head and threaded end bolt fracture halves received 8th August 2011.

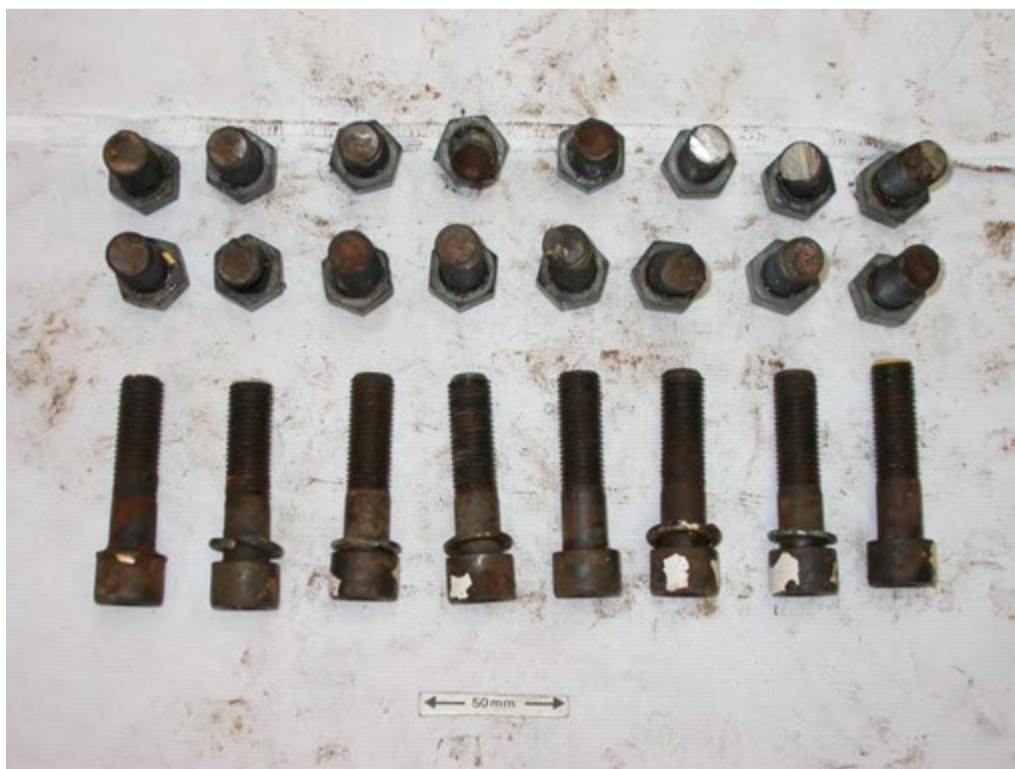
Two fracture halves exhibited bright freshly sawn ends (Figure 7) and the prevailing fracture type in these two items could obviously not be established.

Figure 7: Bolt samples received 8th August, showing 8 un-fractured, 4 exhibiting 45° shear like fractures, 10 exhibiting fatigue like fractures and 2 with sawn faces.

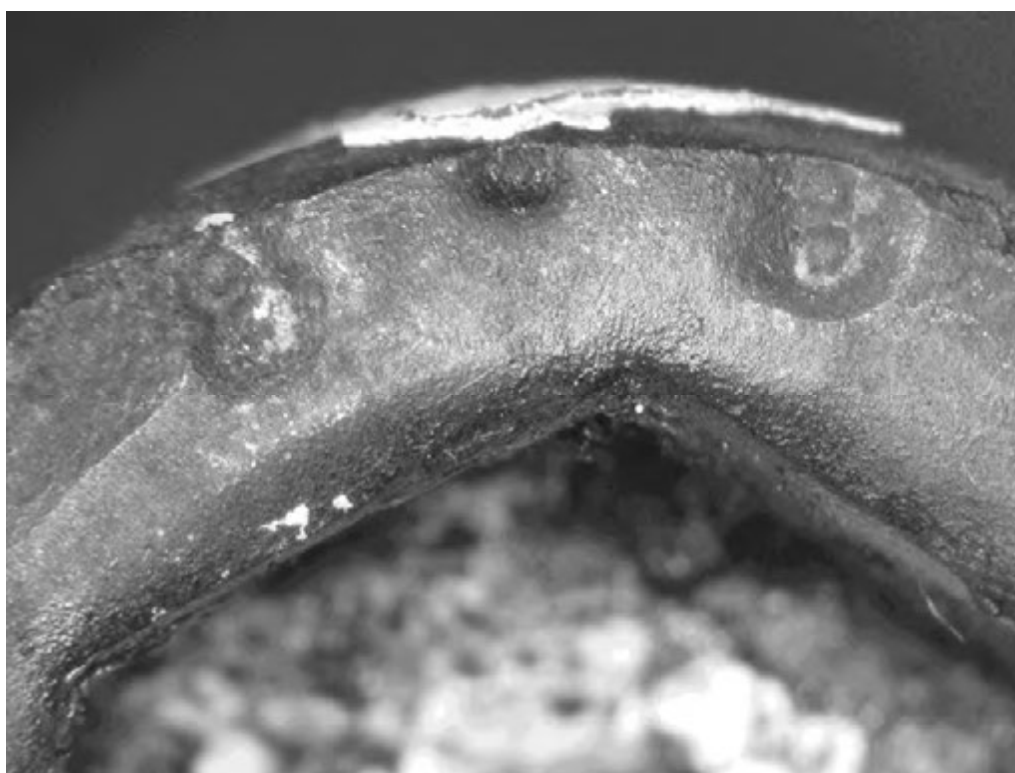
to be standard metric M16 x 2mm pitch. Heads of the bolts exhibited hard stamping marks (Figure 8), which were taken to signify that the bolts were of strength grade 8.8. The plain ends of some bolts exhibited traces of prior zinc or cadmium like plating (Figures 9 and 10). In the main any prior protective plating had long since corroded away and the bolt surfaces exhibited significant general rusting and pitting corrosion (Figures 11 and 12).

Figure 8: Bolt manufacturers head marking, which were read as 8.8 (strength grade 8.8).

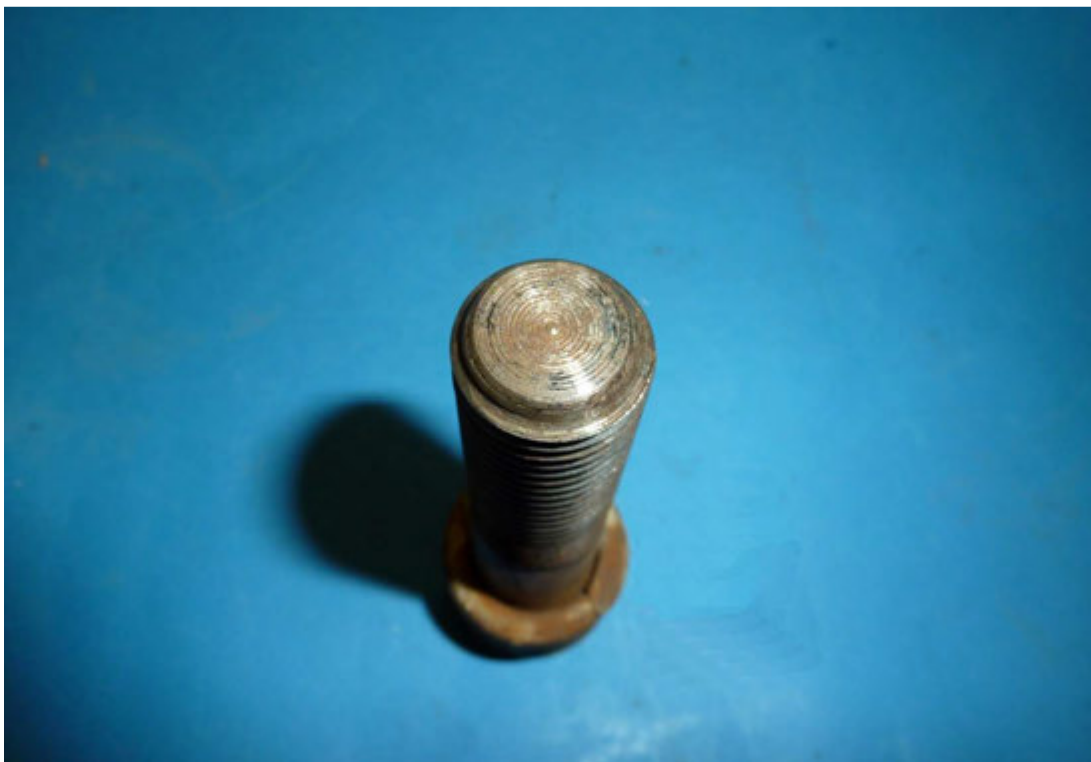
Figure 9: Un-fractured bolt, showing evidence of prior plating at its threaded end.

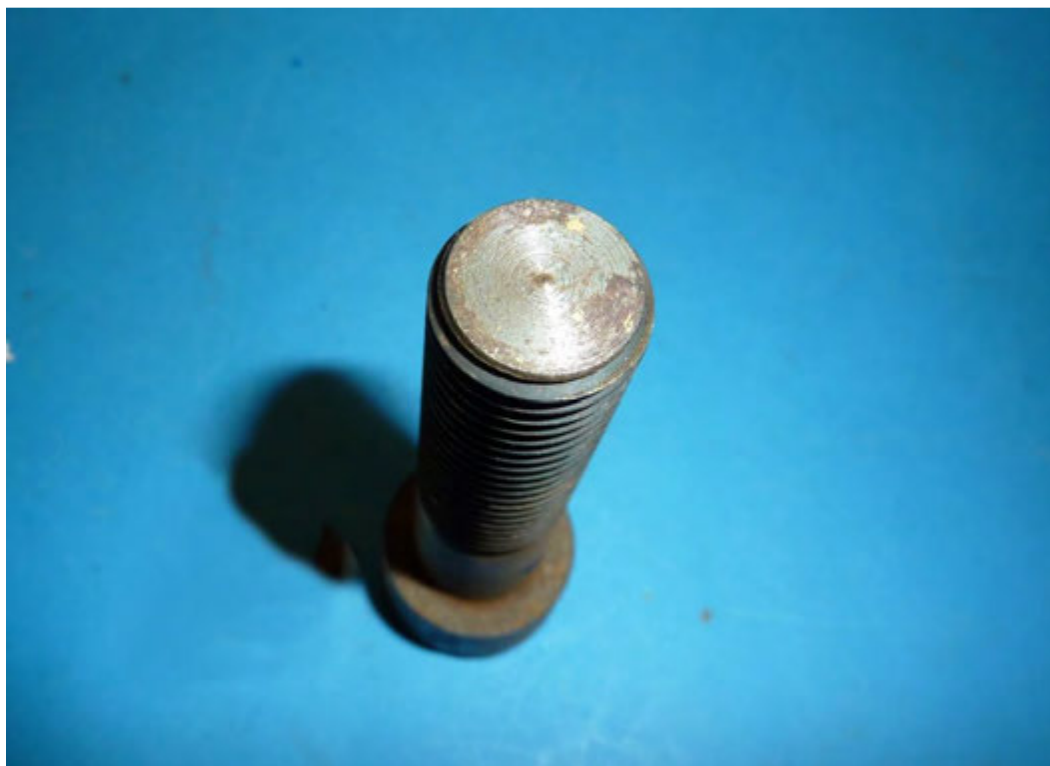
Figure 10: Second un-fractured bolt, showing evidence of prior plating at its threaded end.

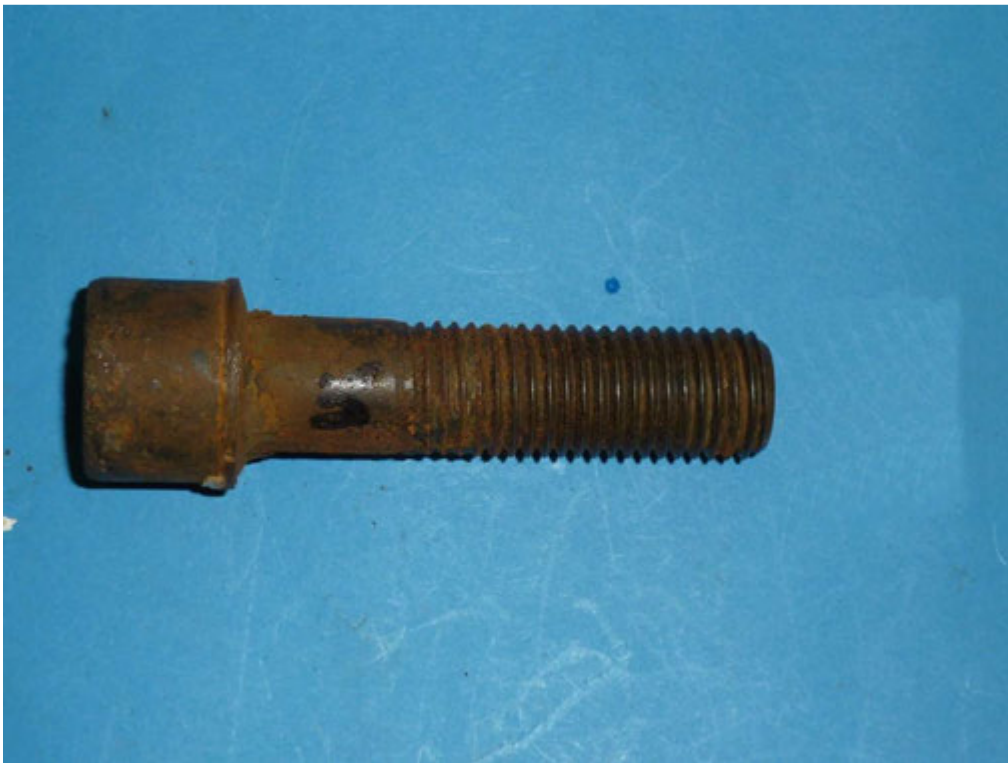
Figure 11: Un-fractured bolt showing external corrosion.

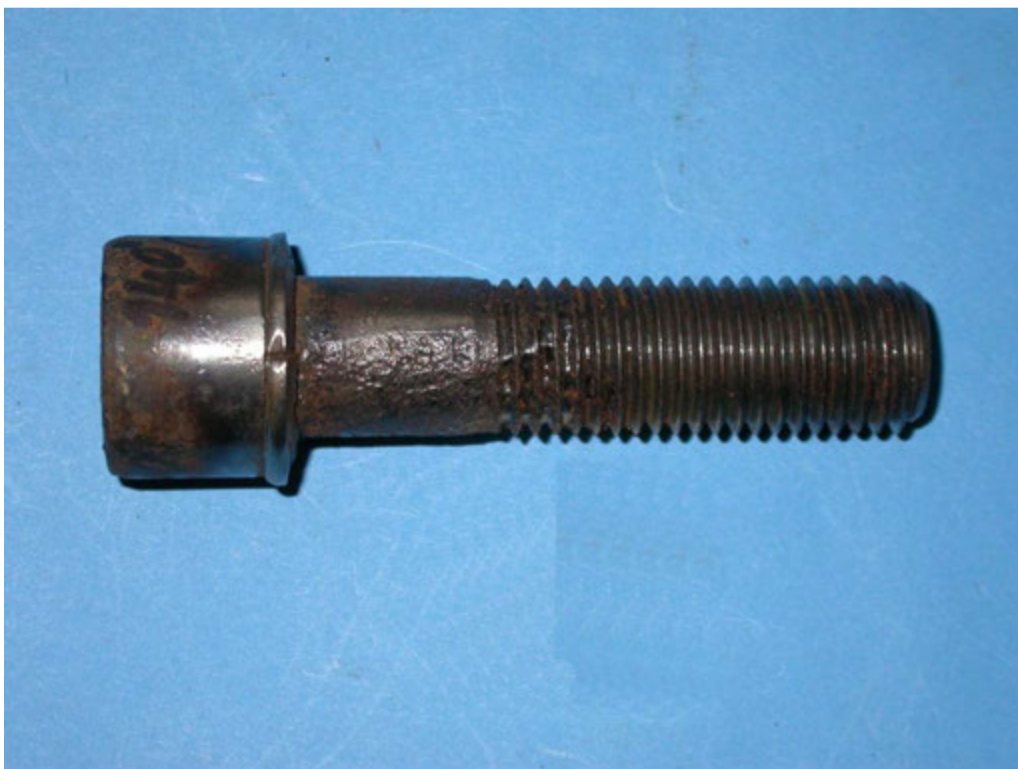
- 7.7** The unfractured bolt set also exhibited evidence of significant general rusting and local pitting corrosion, which had consumed the protective plating in all but limited regions of some threaded ends.

Figure 12: Un-fractured bolt, shown after cleaning and exhibiting evidence of local pitting corrosion.

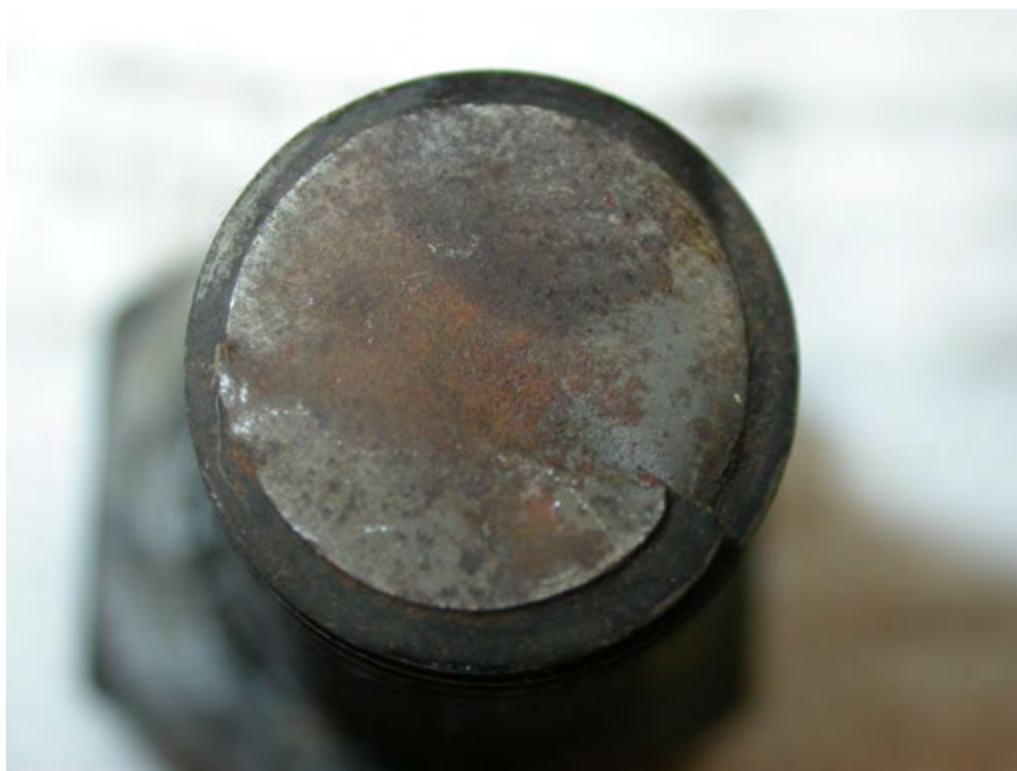
Like the two samples received originally, the larger sample set also exhibited fractures that appeared to be of two generally different kinds (Figures 13 to 21 inclusive). Ten fracture halves exhibited what appeared to be fatigue fractures (Figures 13 to 17 inclusive) and four exhibited what appeared to be largely ductile shear type fractures (Figures 18 to 21 inclusive). The fracture surfaces in both classes of fracture exhibited variable degrees of post fracture surface rusting (Figures 13, 14, 15, 18 and 19), which suggested that some of the fractures may have been of some age and could have pre-dated the current casualty.

Figure 13: Threaded bolt half exhibiting fatigue like fracture and showing light rusting of the fracture surface.

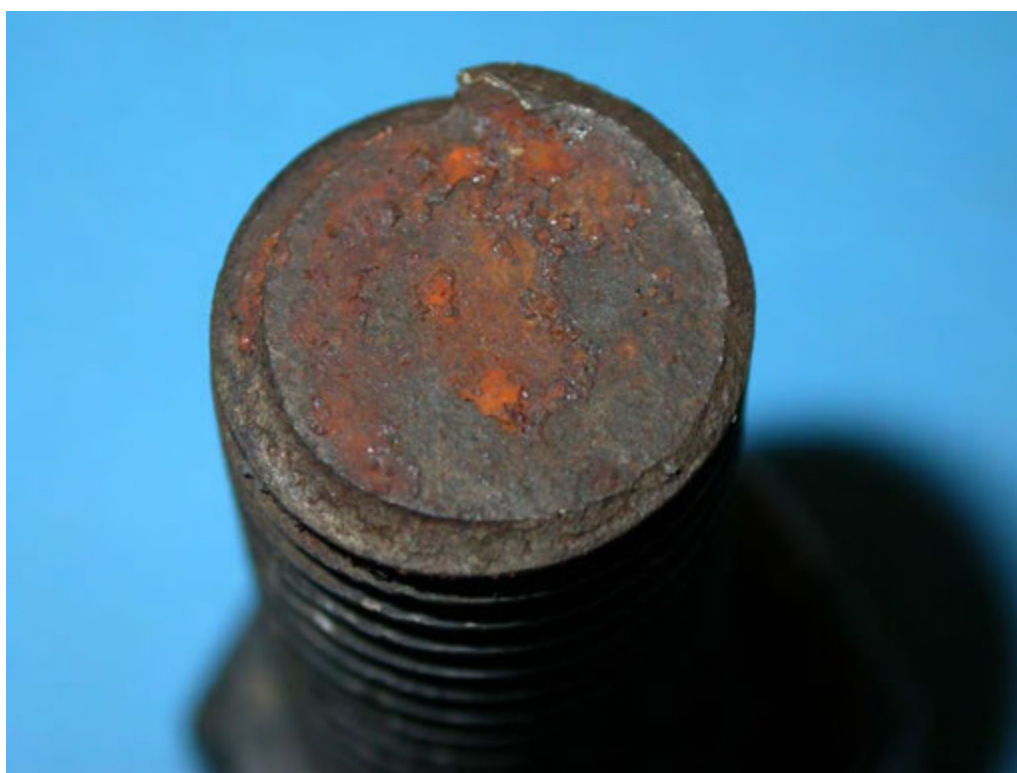
Figure 14: Threaded bolt half exhibiting fatigue like fracture and showing moderate rusting of the fracture surface.

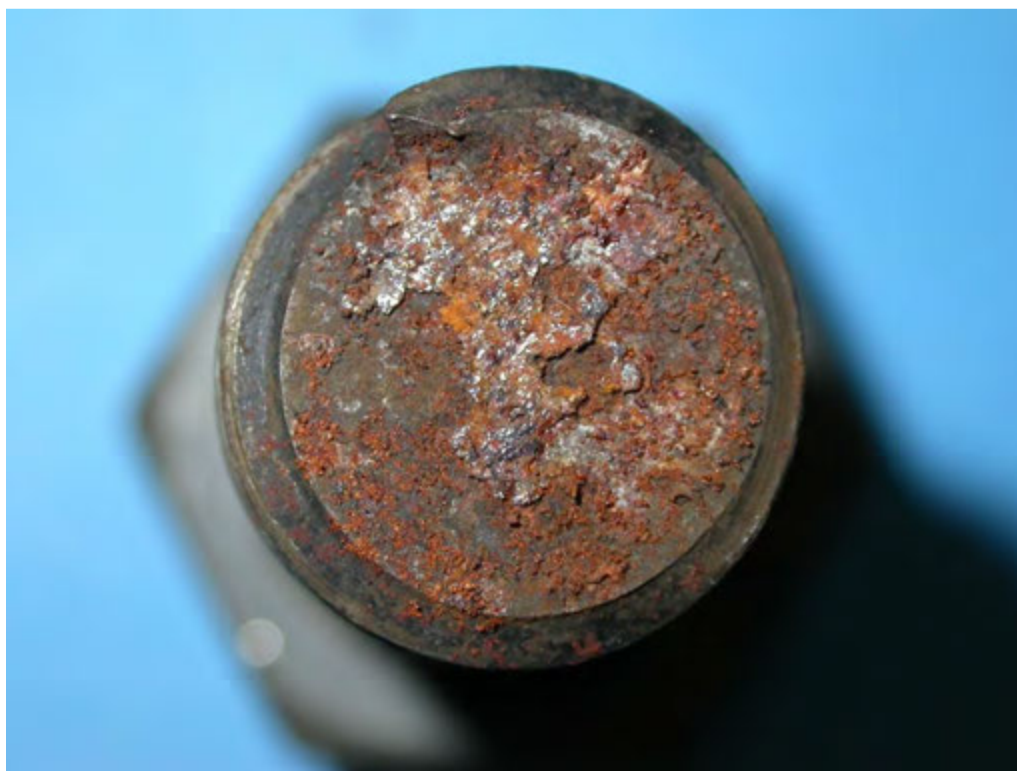
Figure 15: Threaded bolt half exhibiting fatigue like fracture and showing heavy rusting of the fracture surface.

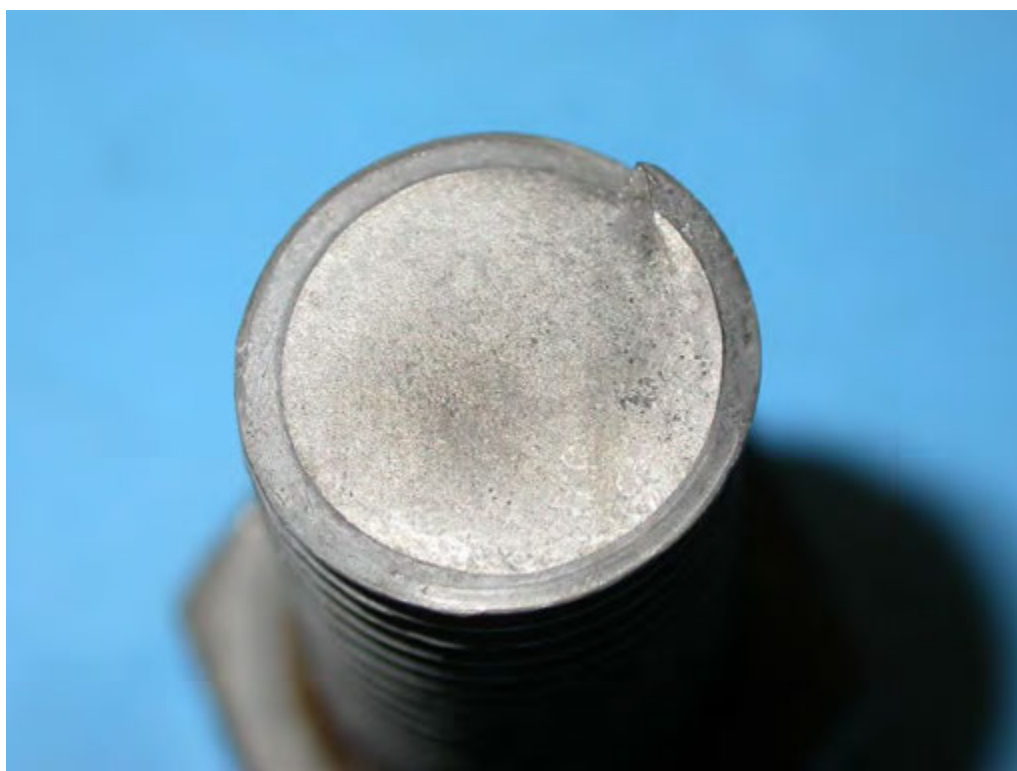
The samples exhibiting fractures that were orientated 90° to the bolts principal axis (Figures 16 and 17) exhibited features consistent with fatigue cracking over most of the fracture surface and only very small terminal ductile shear regions were apparent (Figures 22 to 32).

Figure 16: Threaded bolt half exhibiting fatigue like fracture, shown after cleaning in Clarke solution.

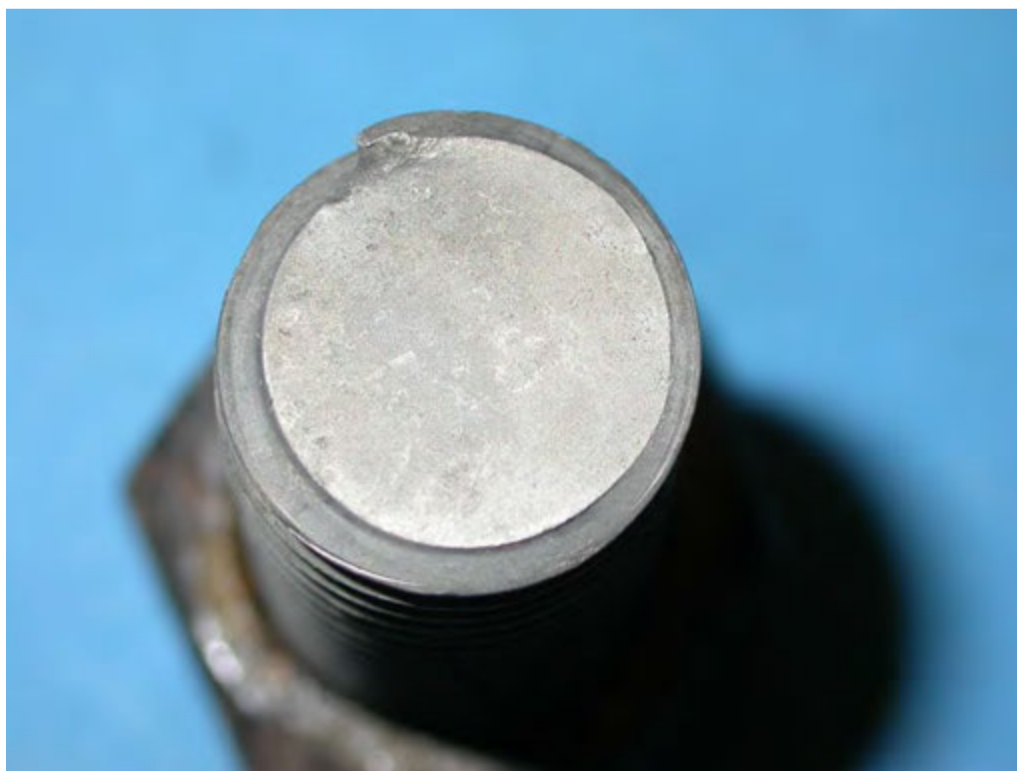
Figure 17: Second threaded bolt half exhibiting fatigue like fracture, shown after cleaning in Clarke solution.

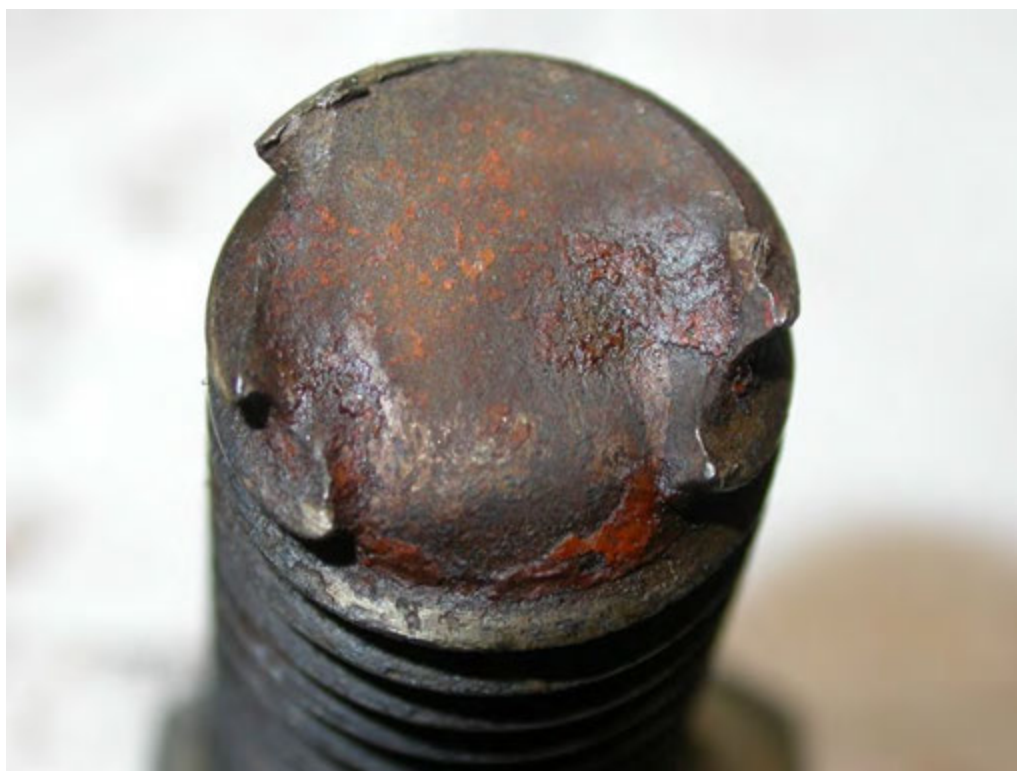
Figure 18: Threaded bolt half exhibiting 45° shear like fracture and showing moderate rusting.

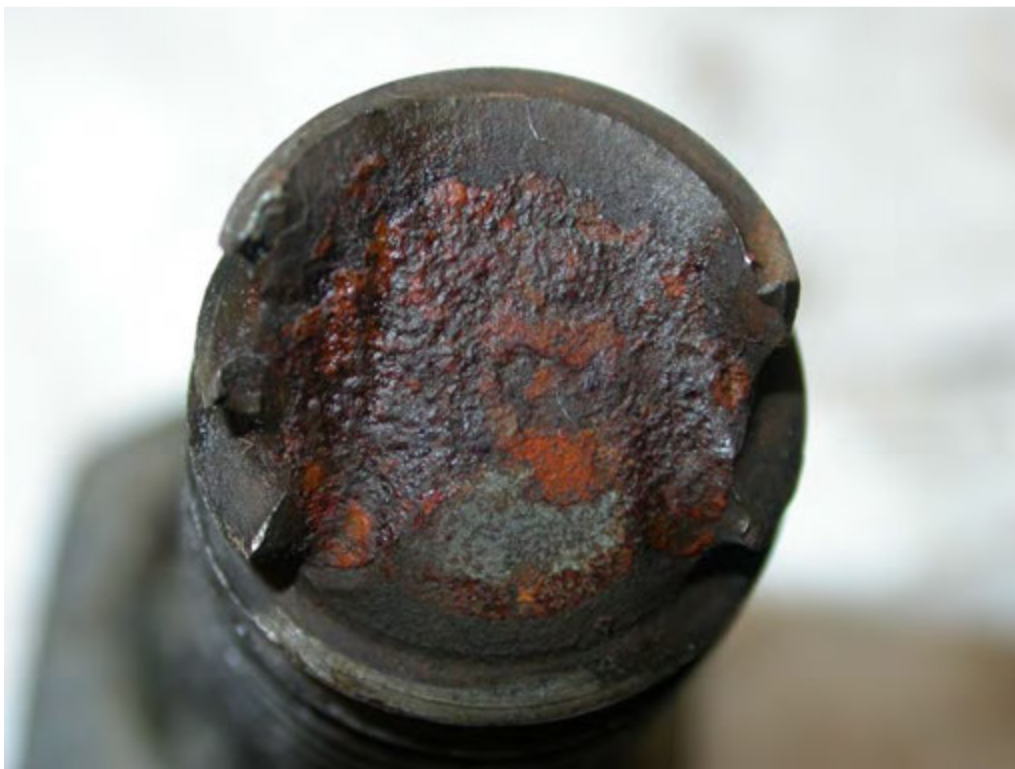
Figure 19: Second threaded bolt half exhibiting 45° shear like fracture and showing moderate rusting.

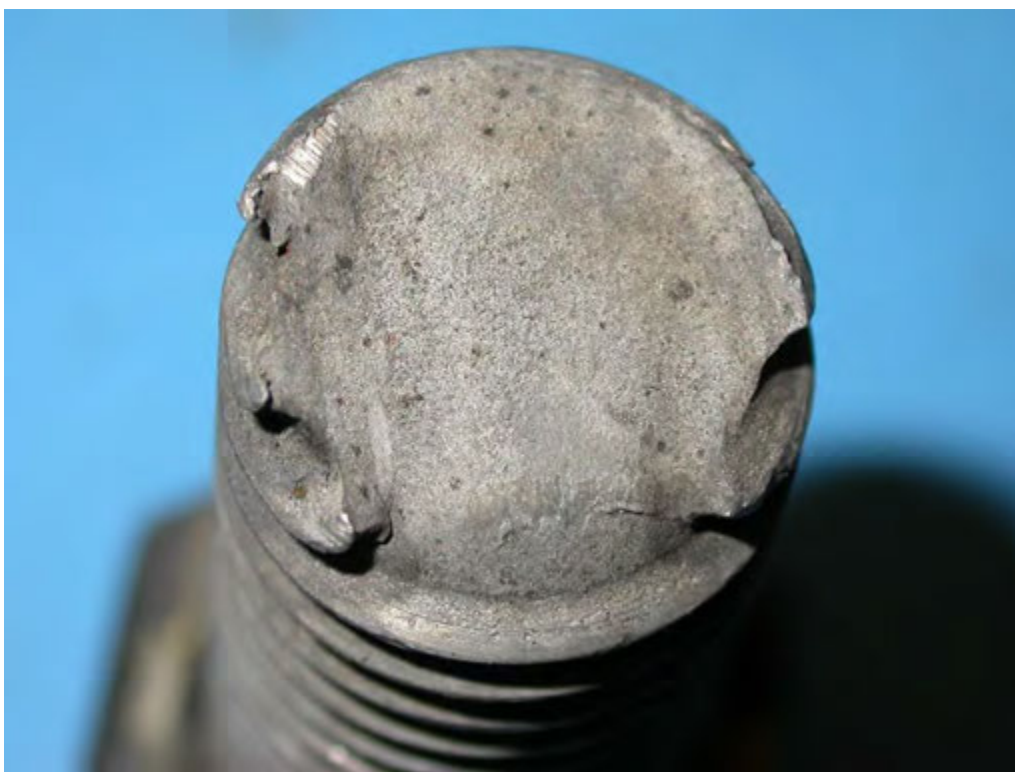
The samples exhibiting fractures at 45° to the bolts principal axis (Figures 20 and 21) exhibited features consistent with ductile shear type fracture (Figures 33 to 40). Some fractures in this population also exhibited evidence of some possible prior fatigue cracking.

Figure 20: Threaded bolt half exhibiting 45° shear like fracture, shown after cleaning in Clarke solution.

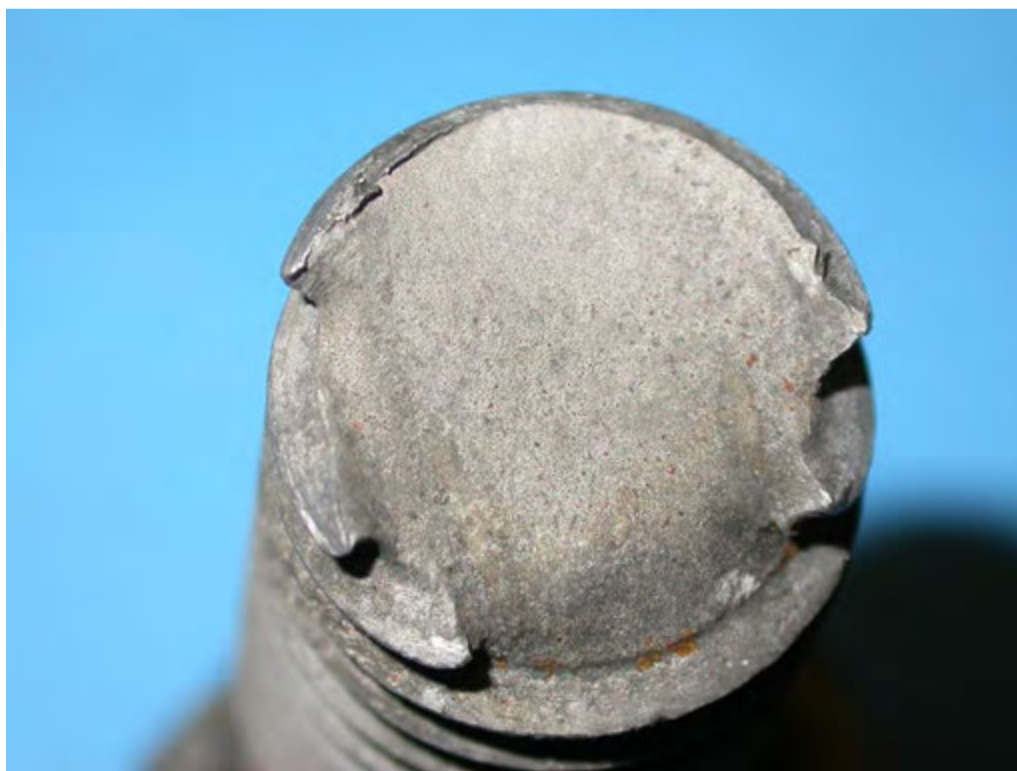
Figure 21: Second threaded bolt half exhibiting 45° shear like fracture, shown after cleaning in Clarke solution.

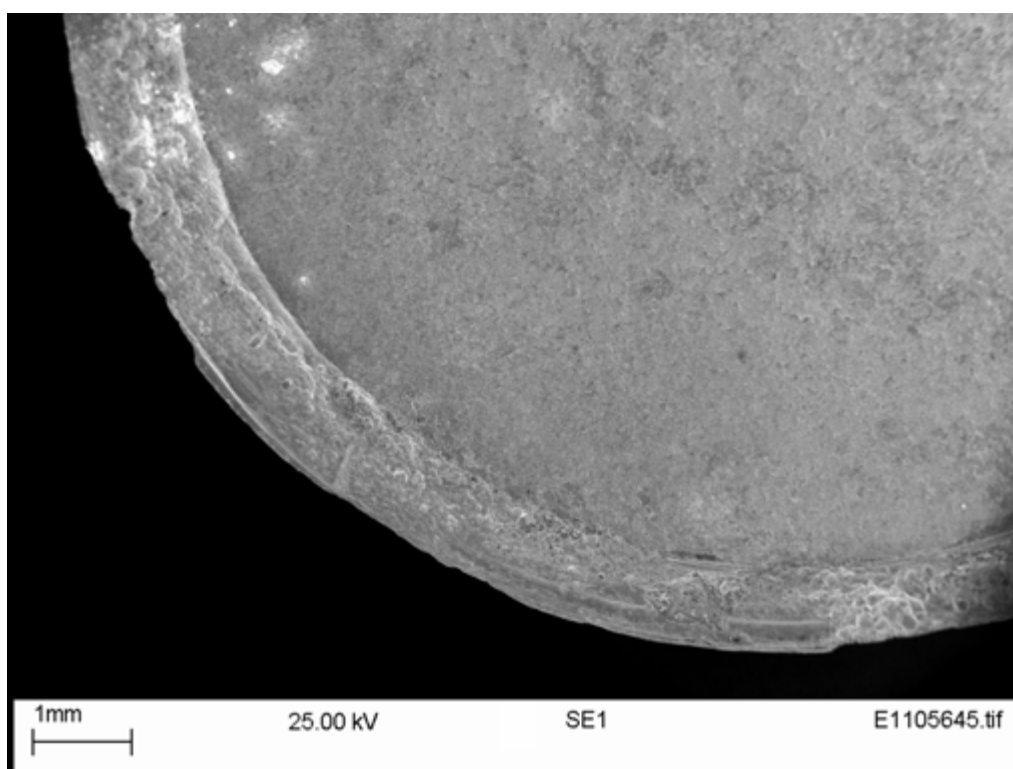
Figure 22: SEM fractograph, showing crack origin region in one of the fracture halves exhibiting fatigue fracture.

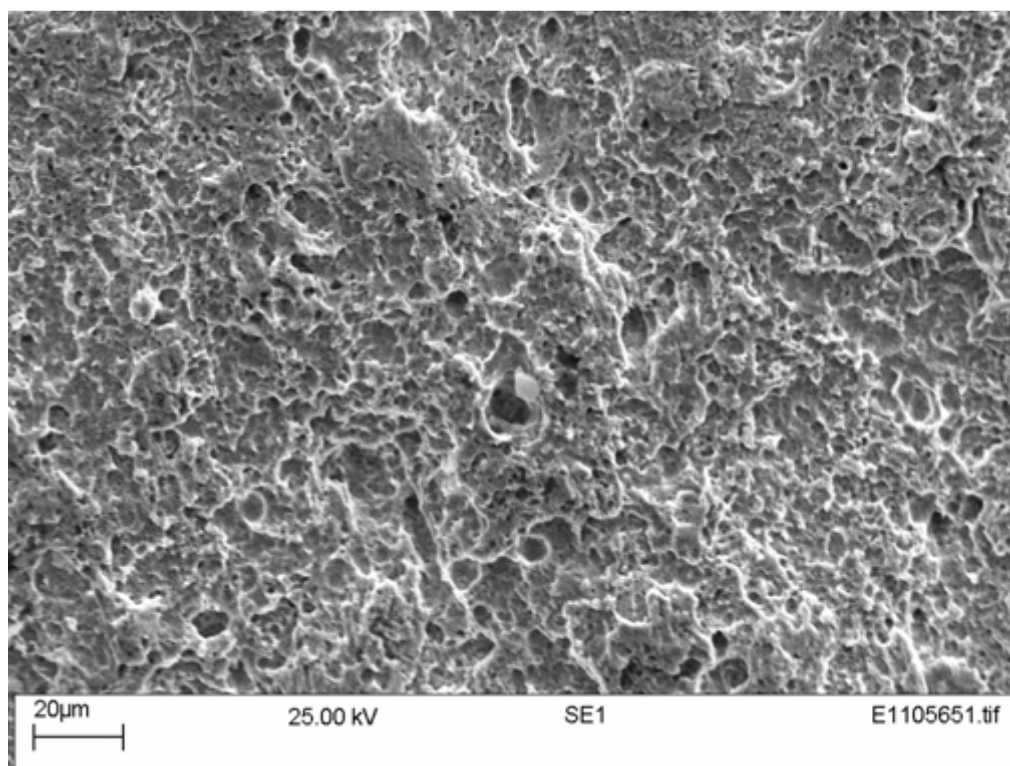
Figure 23: SEM fractograph, showing detail of figure 22 and fractography consistent with fatigue cracking.

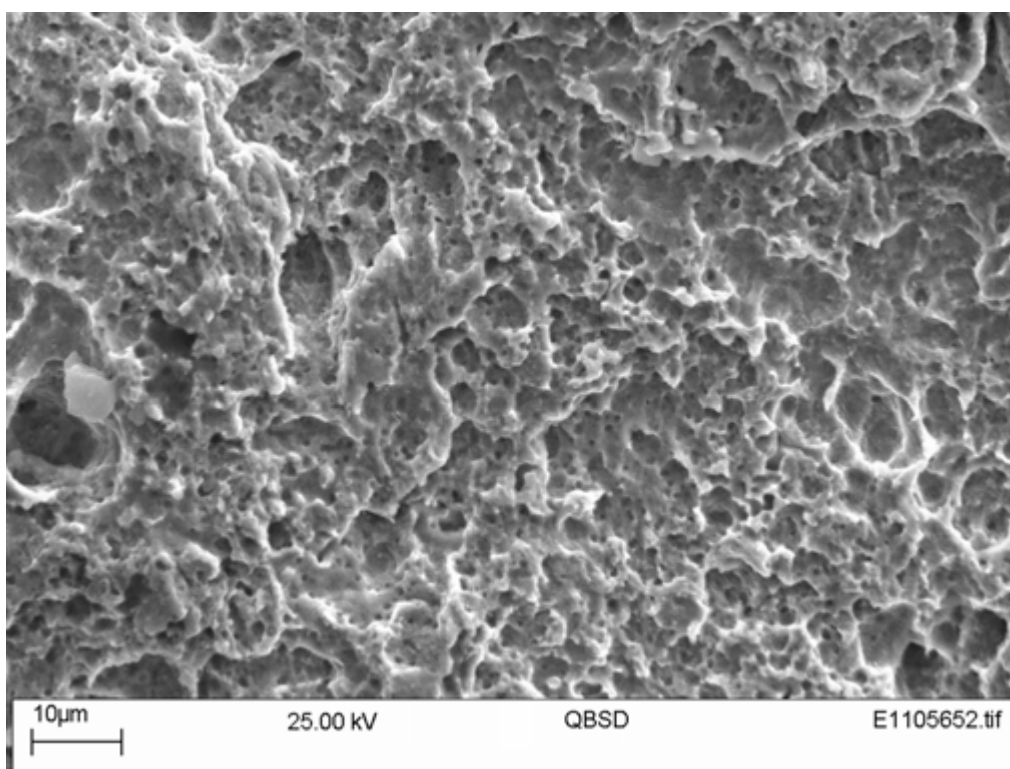
Figure 24: As above.

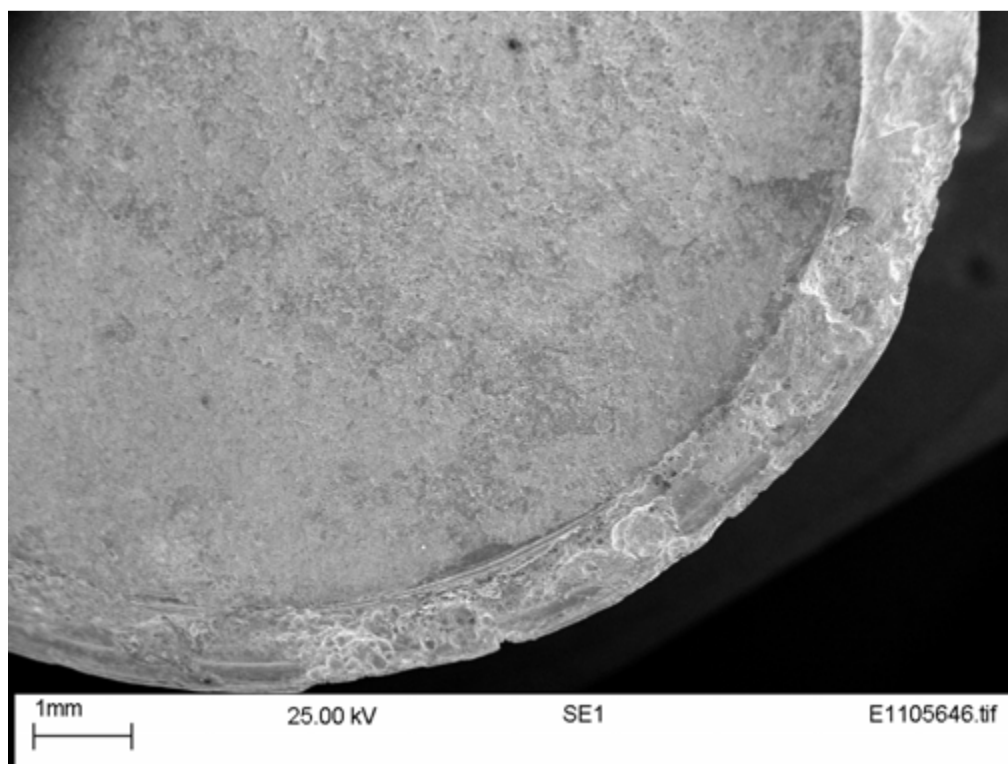
Figure 25: SEM fractograph, showing terminal fracture region of a fatigue cracked bolt.

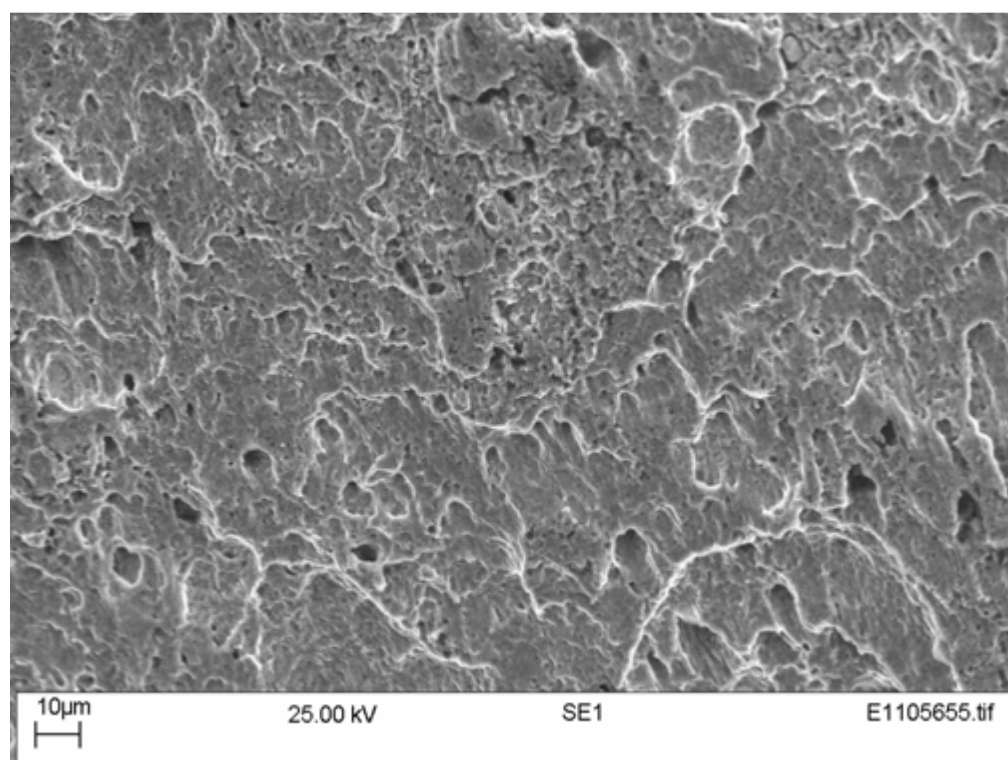
Figure 26: SEM fractograph, showing detail of figure 25 and fractography consistent with high ductility shear fracture.

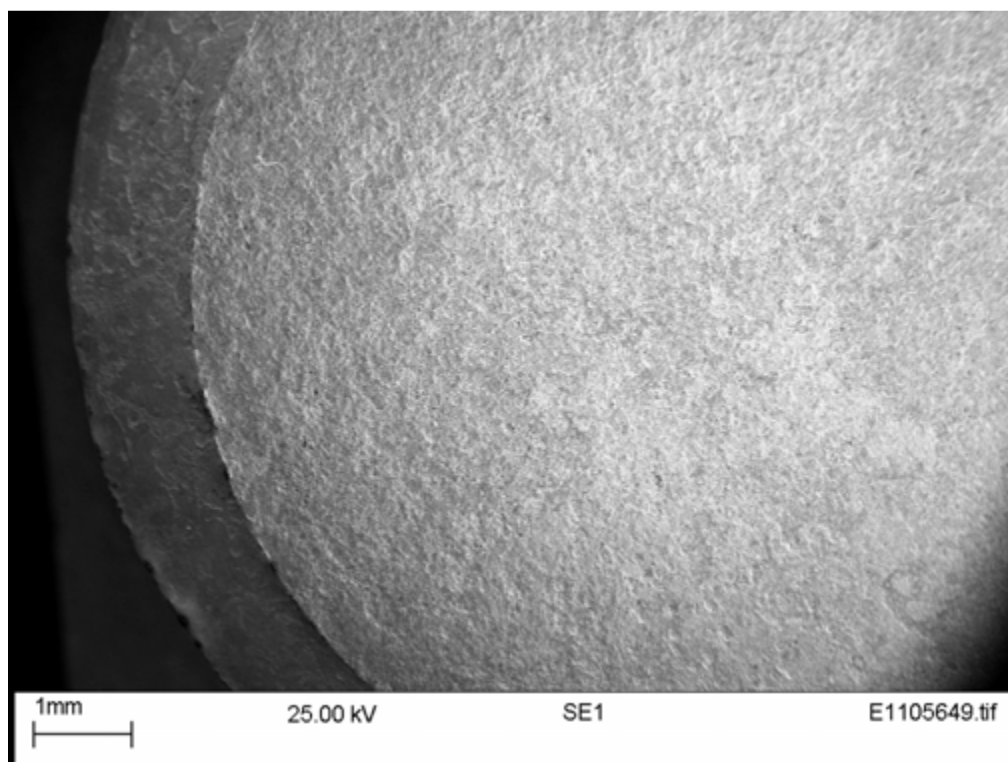
Figure 27: SEM fractograph, showing crack origin region of a second fracture half exhibiting fatigue fracture.
