Laboratory examination and failure analysis of the gantry crane wheel securing bolts

THE TEST HOUSE (CAMBRIDGE) LTD. JOB AND REPORT REFERENCE: T11285

LABORATORY EXAMINATION AND FAILURE ANALYSIS OF M16 GANTRY CRANE WHEEL SECURING BOLTS FROM THE VESSEL BLUE NOTE

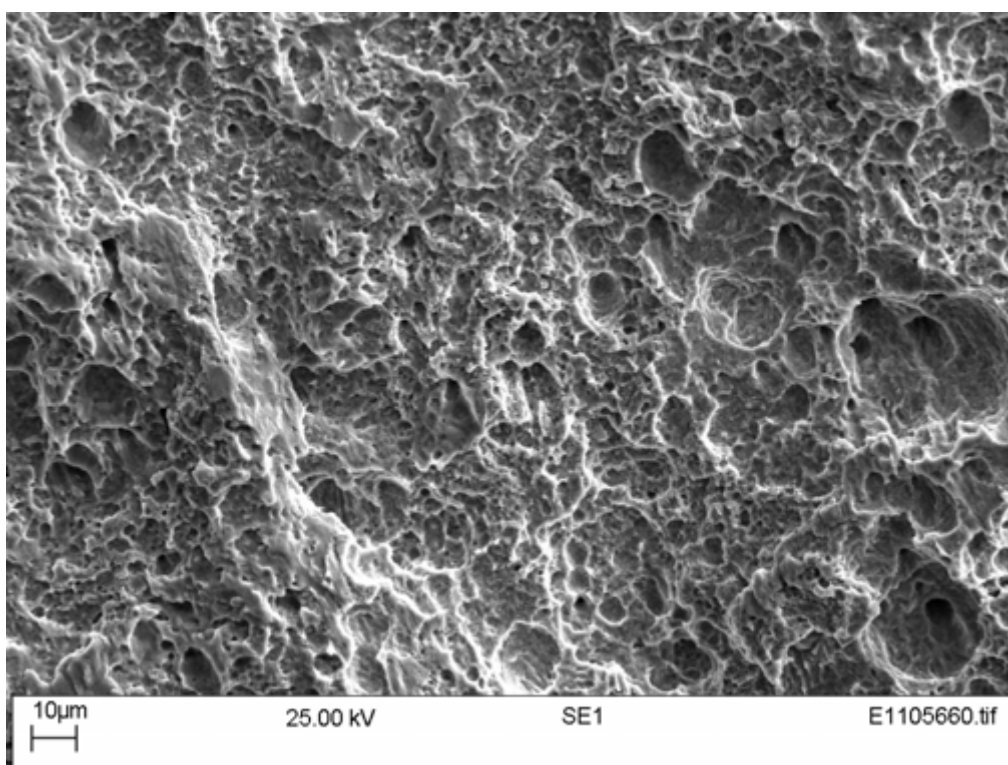
Figure 28: SEM fractograph, showing detail of figure 27 and fractography consistent with fatigue cracking.

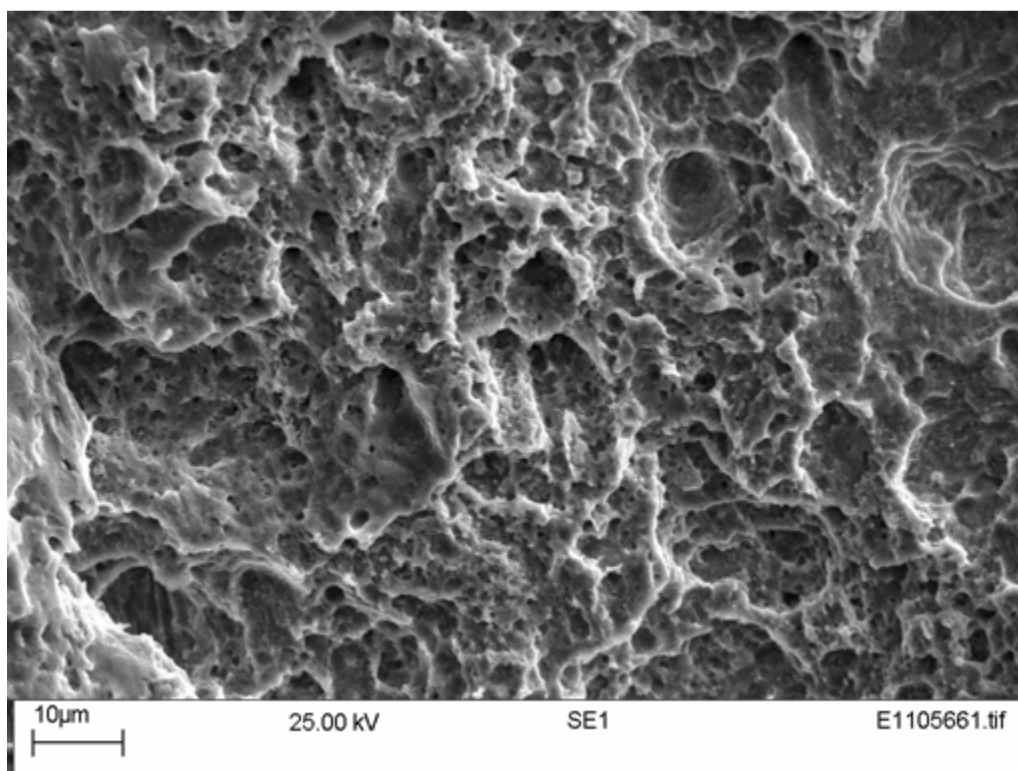
Figure 29: As figure 28.

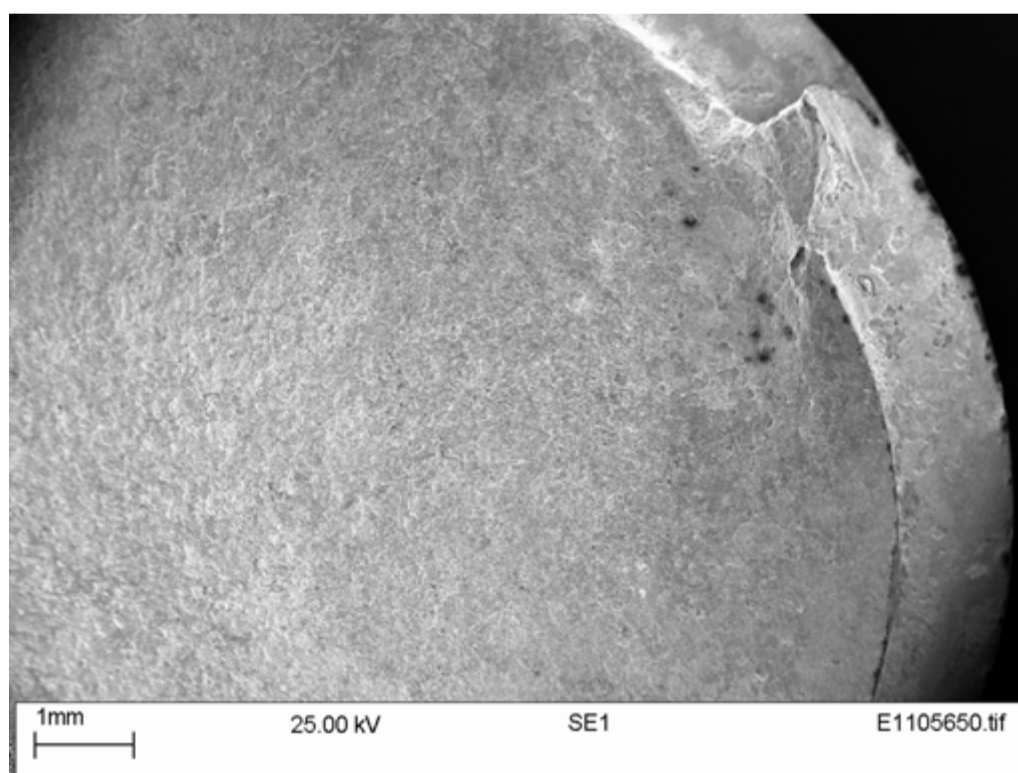
Figure 30: SEM fractograph, showing terminal fracture region of a fatigue cracked bolt.

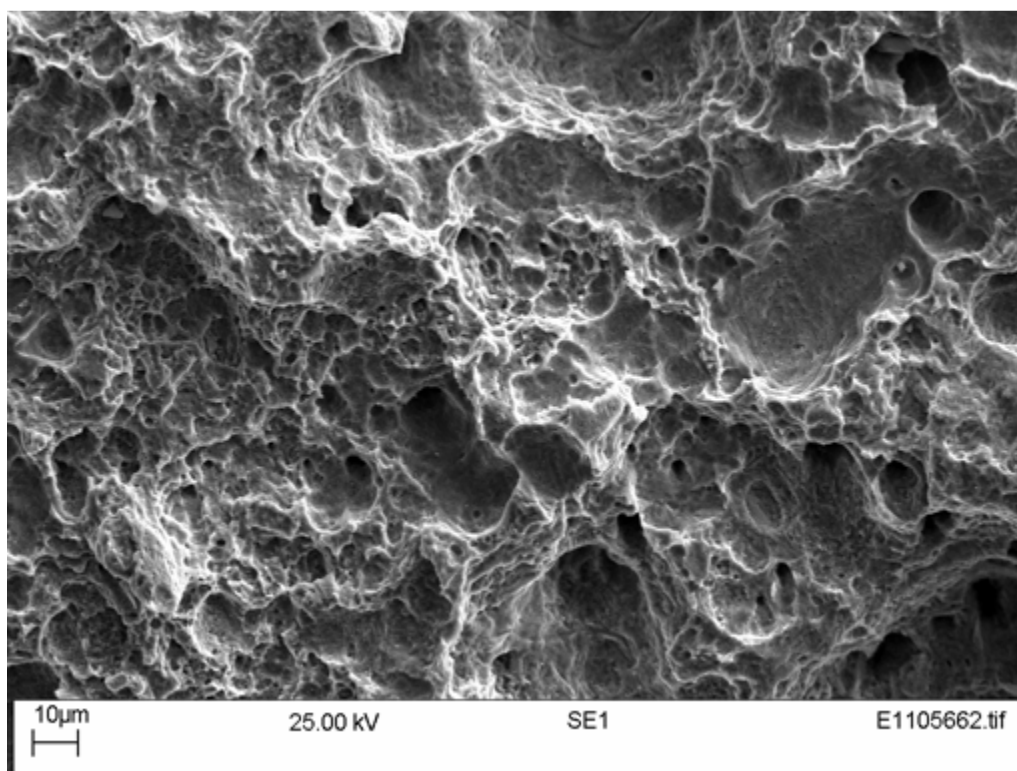
Figure 31: SEM fractograph, showing detail of figure 30 and fractography consistent with ductile microvoid coalescence type terminal fracture.

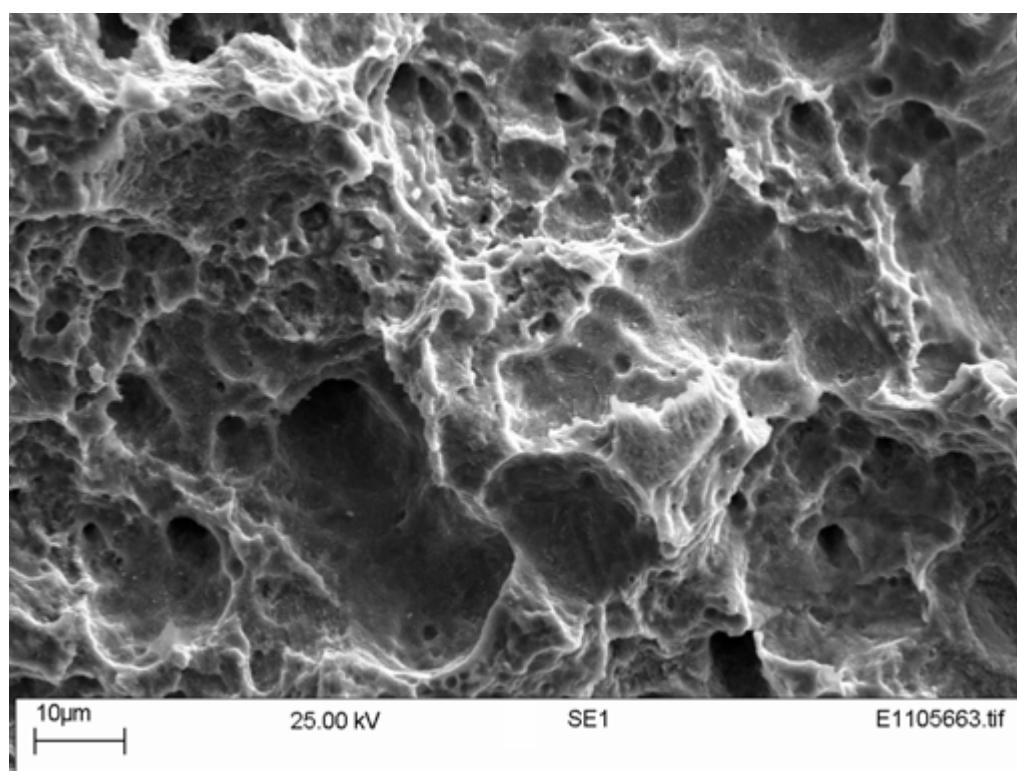
Figure 32: As above.

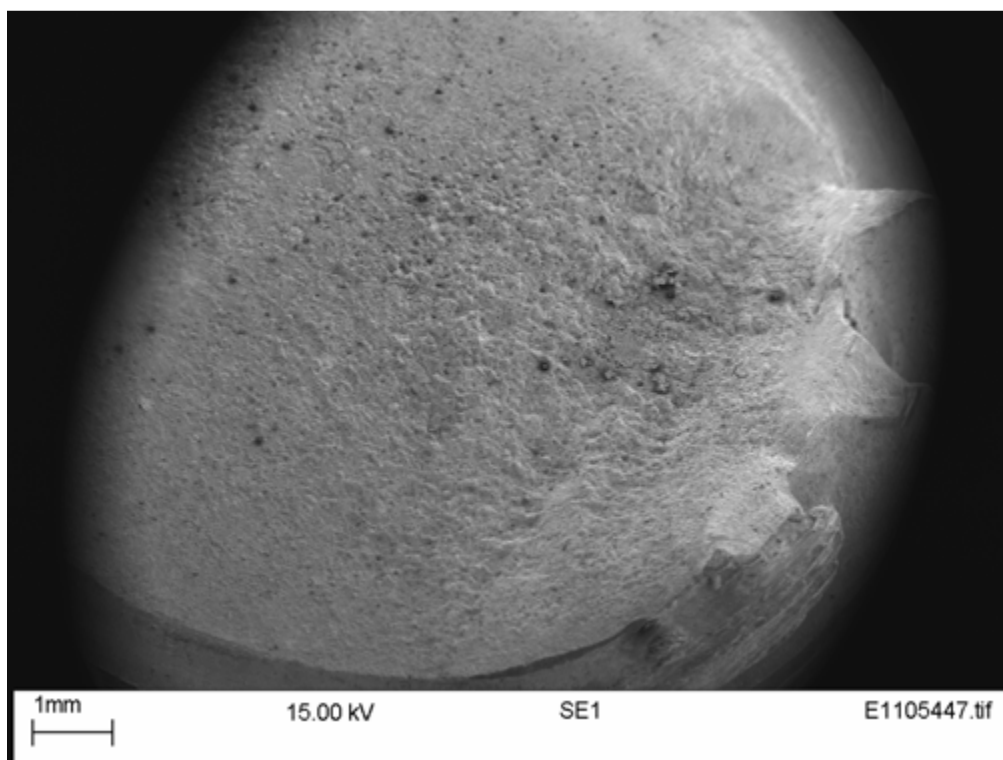
Figure 33: SEM fractograph, showing fracture origin region of a sample from the 45° shear like fracture.

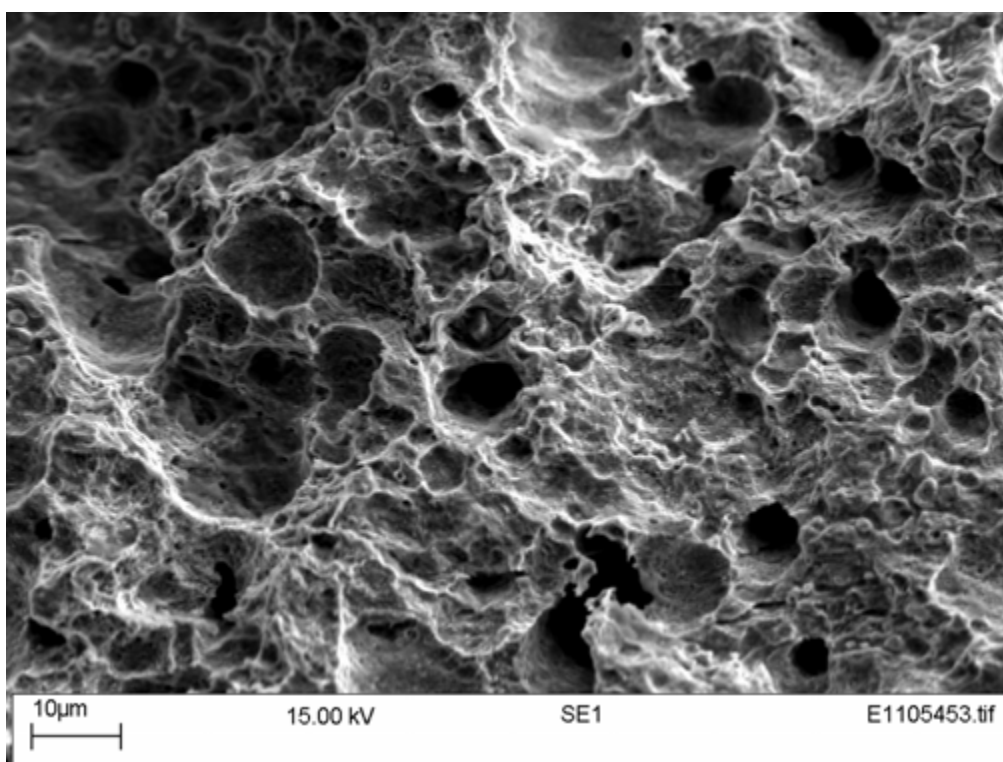
Figure 34: SEM fractograph, showing detail of figure 33 and fractography consistent with ductile microvoid coalescence type fracture.

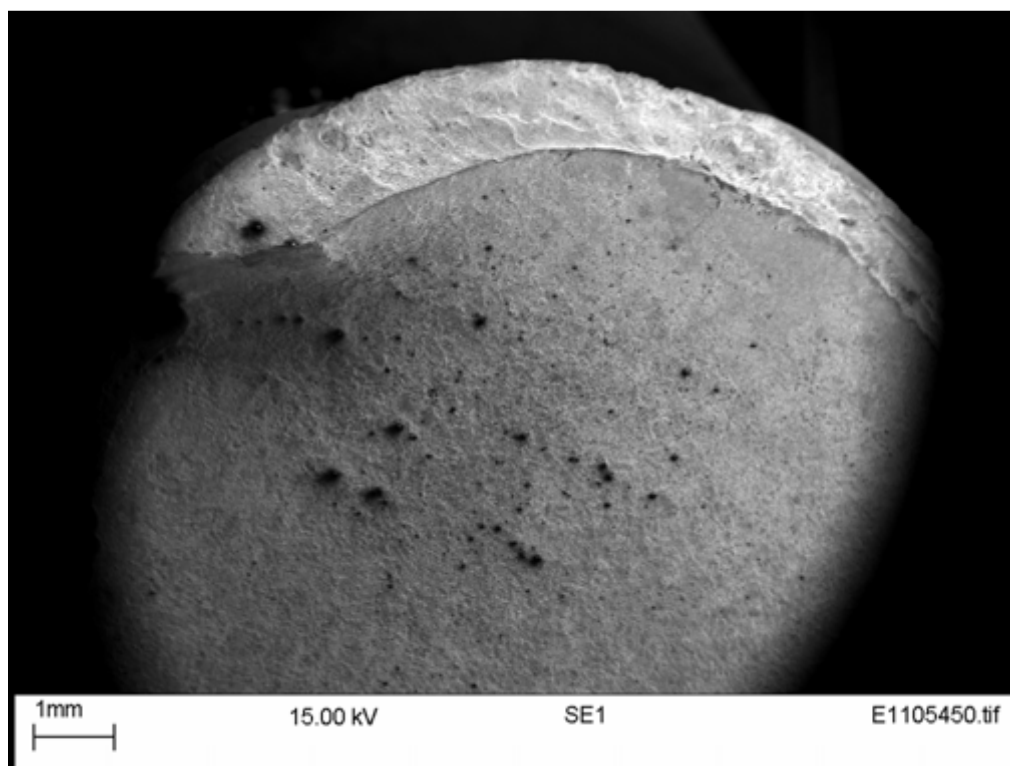
Figure 35: SEM fractograph, showing terminal fracture region of a 45° shear like fracture.

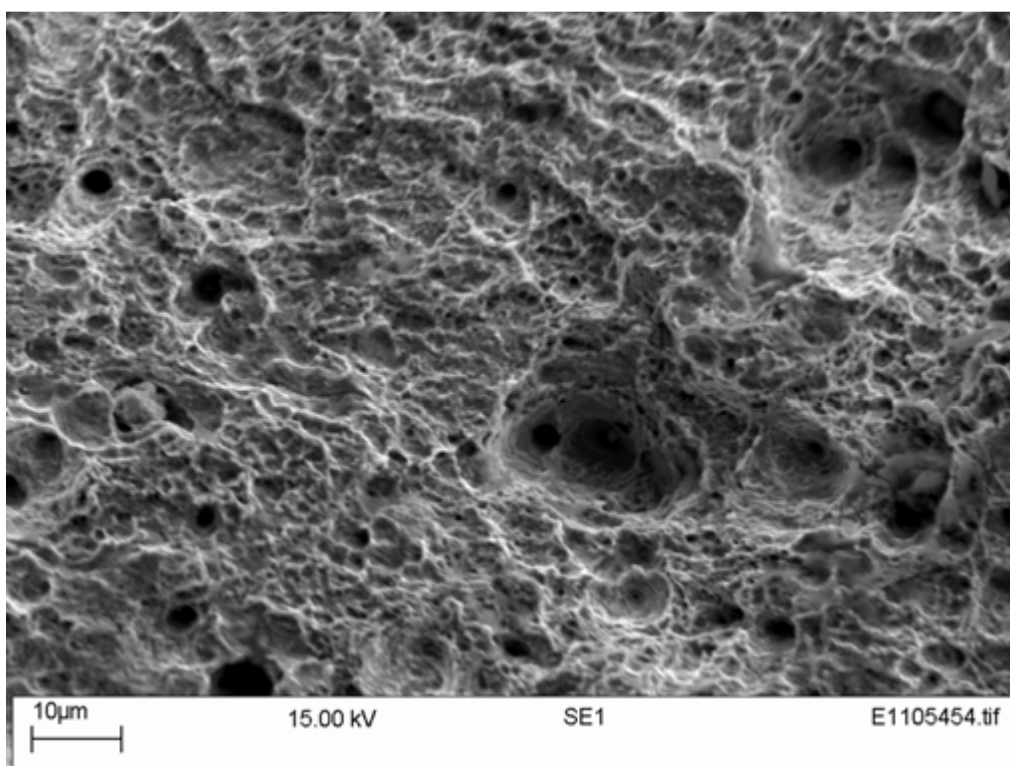
Figure 36: SEM fractograph, showing detail of figure 35 and fractography consistent with ductile microvoid coalescence type fracture.

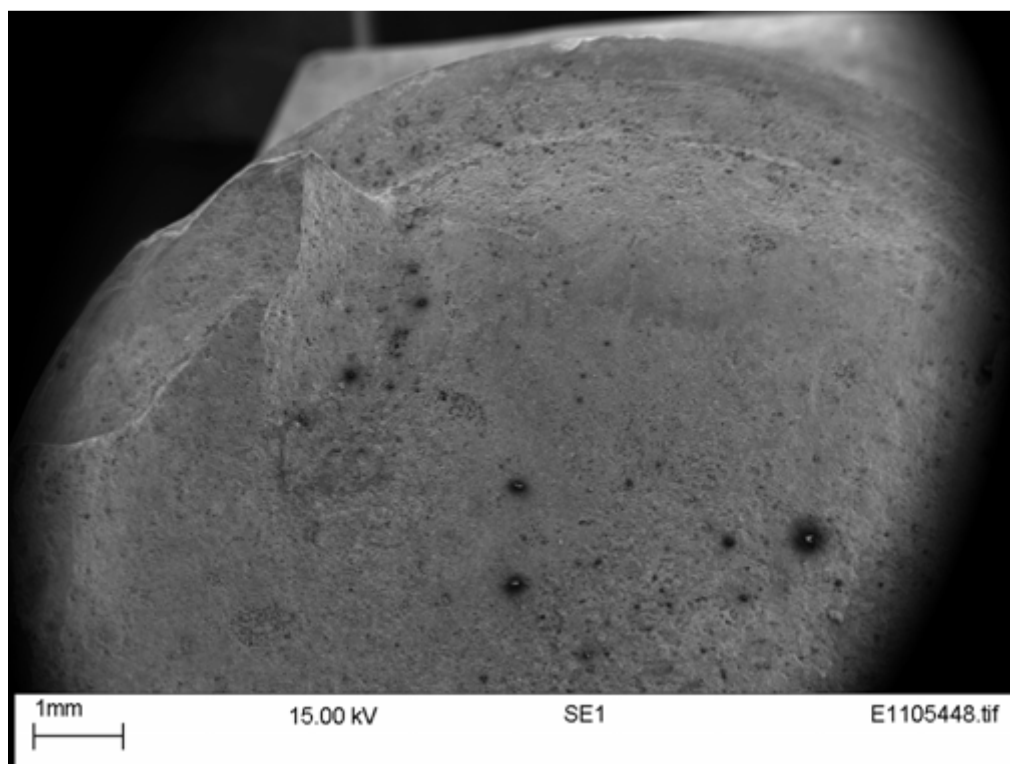
Figure 37: SEM fractograph, showing fracture origin region of a second 45° shear like fracture.

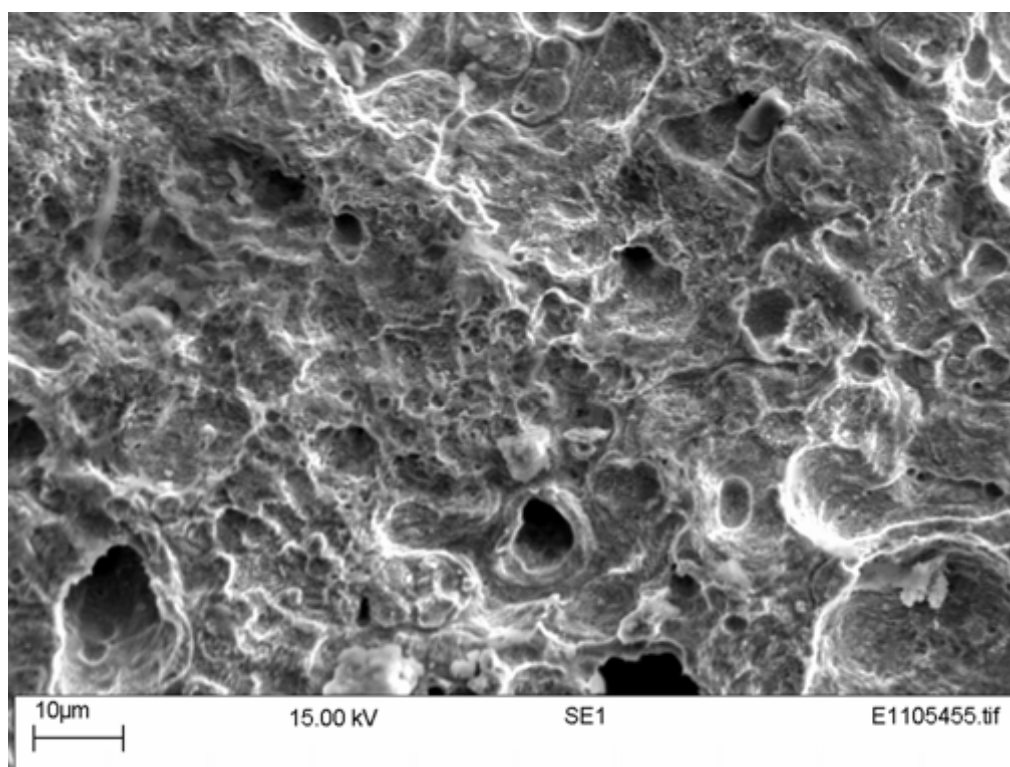
Figure 38: SEM fractograph, showing detail of figure 37 and fractography consistent with corrosion damaged ductile microvoid coalescence type fracture.

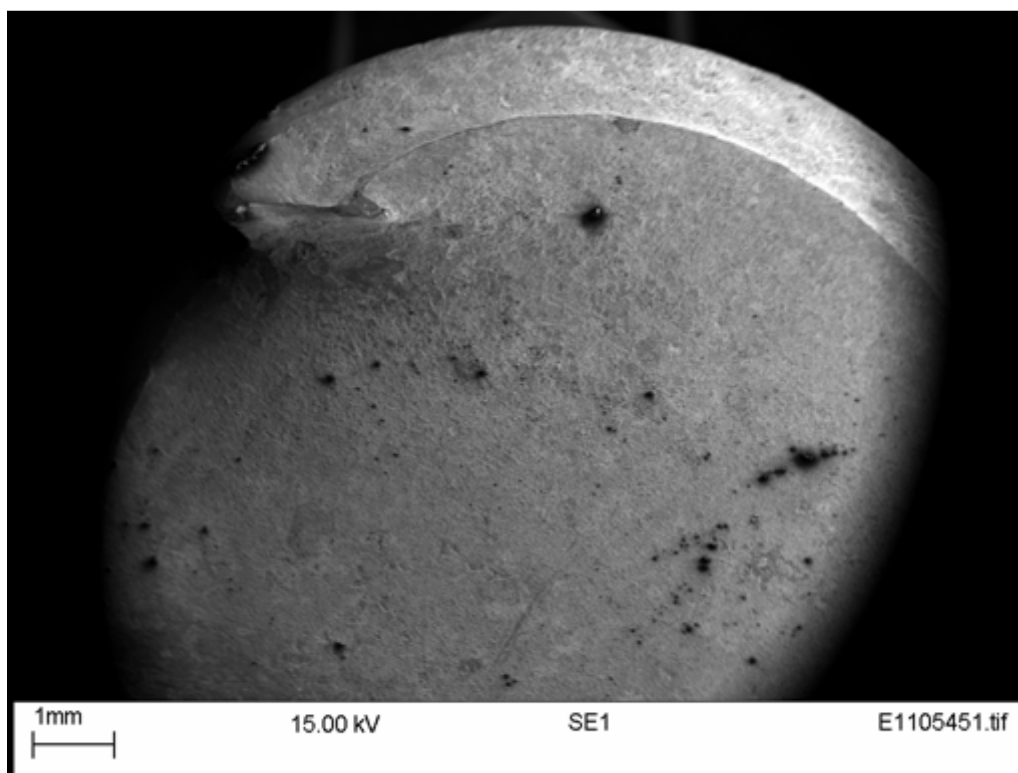
Figure 39: SEM fractograph, showing terminal fracture region of a 45° shear like fracture.

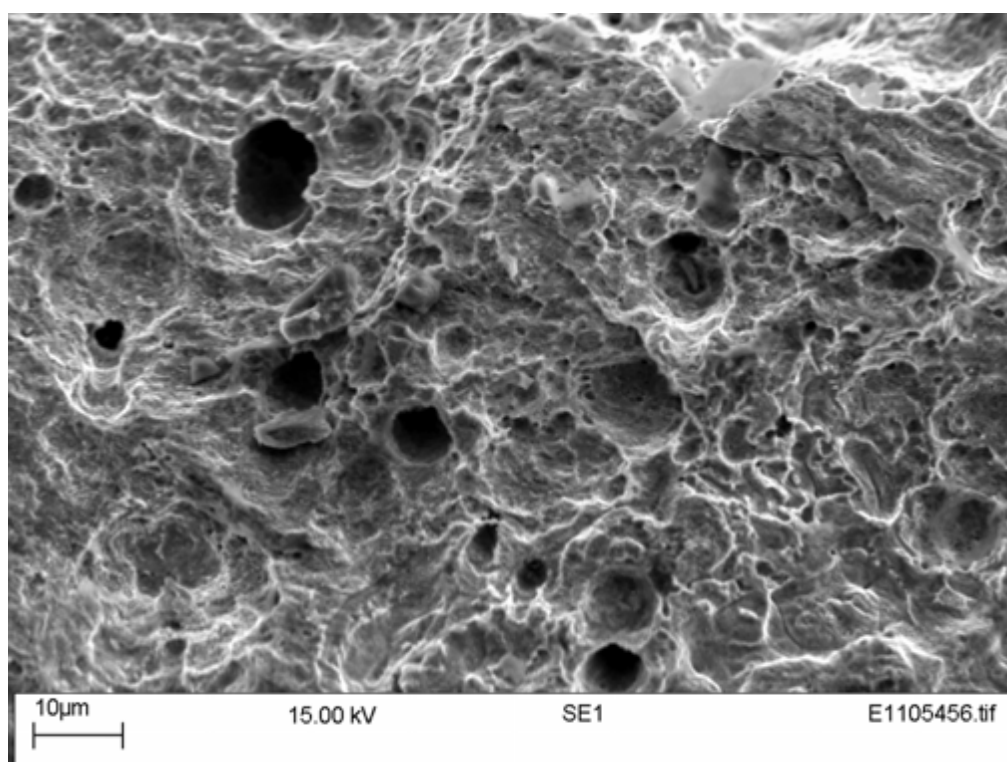
Figure 40: SEM fractograph, showing detail of figure 39 and fractography consistent with ductile microvoid coalescence type fracture.

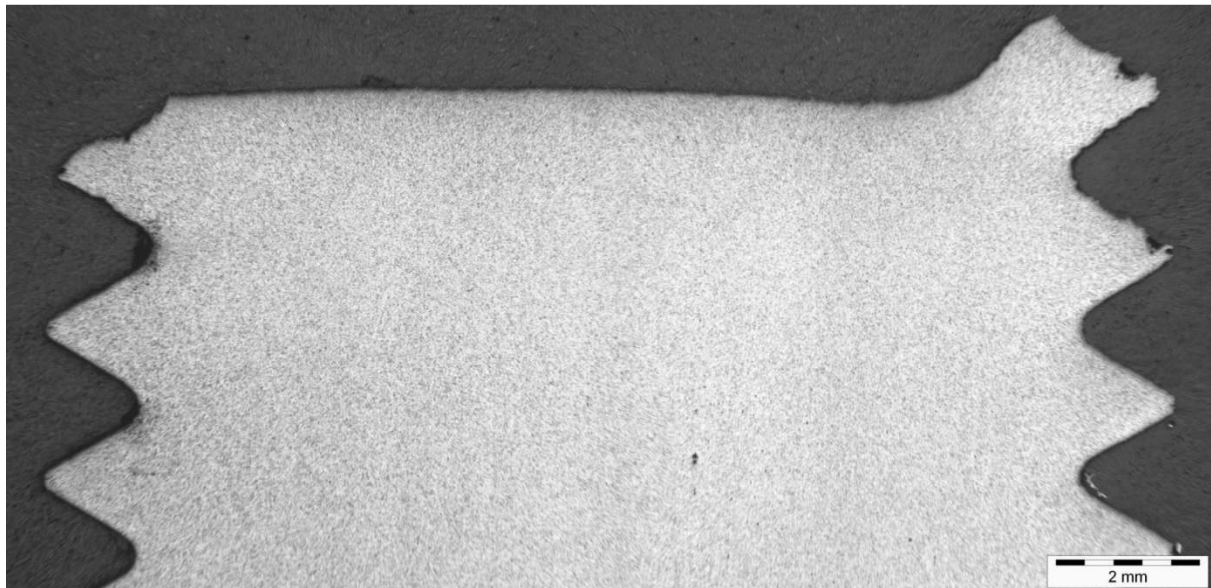
The first specimen removed from a bolt that had fracture at 90° to the principal axis of the bolt was seen to largely comprise strain free fatigue type cracking (Figures 41, 42 and 43). The fatigue crack had initiated in a thread root that appeared to be free from pre-existing material or manufacturing defects (Figure 41) and no secondary cracking was apparent in adjacent thread roots. The bolt had been manufactured by thread rolling rather than screw cutting and clear evidence of thread rolling intrusions was apparent in the thread tips (Figure 44). The bolts residual microstructure was consistent with it having been subjected to a quench and temper type heat treatment after thread rolling (Figure 45).

Figure 41: Micrograph (original image captured at X12.5), specimen etched in Nital. Longitudinal section through fatigue fractured bolt, showing crack origin (top left of field) and terminal fracture region (top right of field).

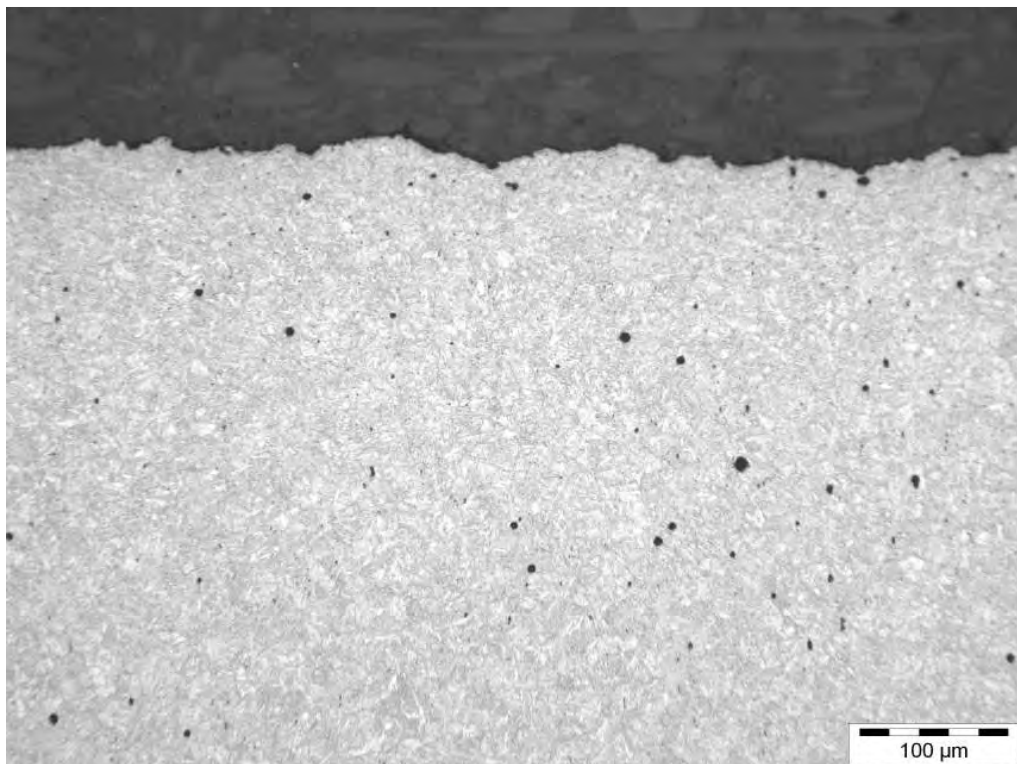
Figure 42: Micrograph (original image captured at X200), specimen etched in Nital. Detail of the crack origin region of figure 41, showing strain free fracture edge consistent with fatigue cracking.

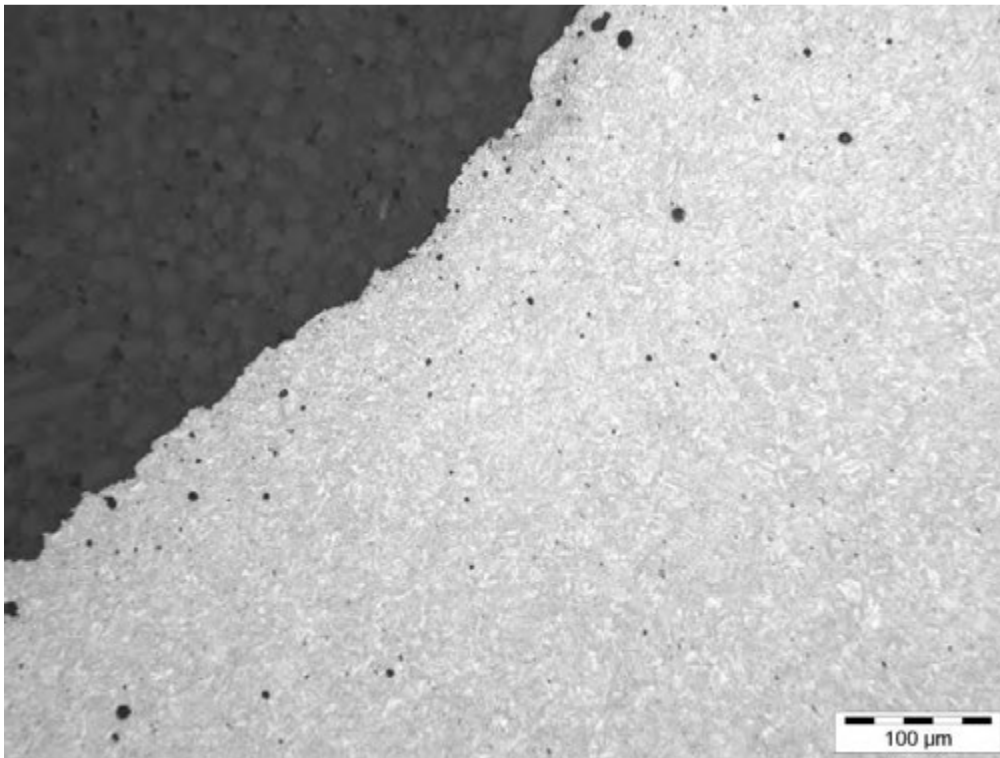
Figure 43: Micrograph (original image captured at X200), specimen etched in Nital. Detail of the terminal fracture region of figure 41 which again appeared consistent with fatigue cracking.

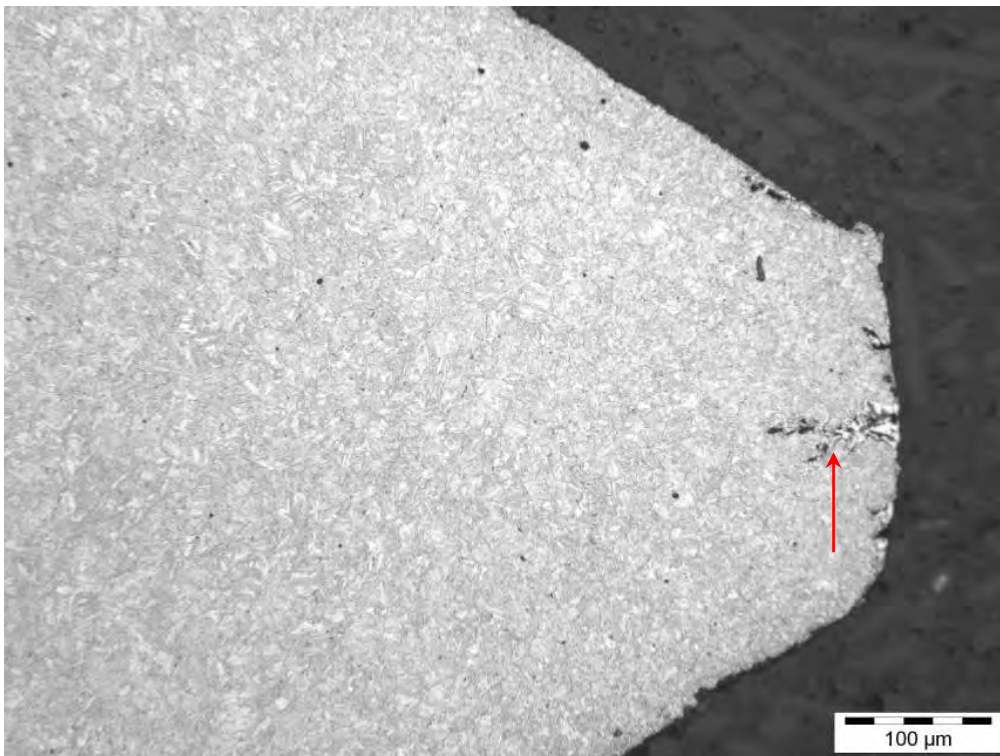
Figure 44: Micrograph (original image captured at X200), specimen etched in Nital. Detail of thread rolling intrusion (arrowed) in fatigue fractured bolt, which confirmed that the bolt had been thread rolled rather than screw cut and heat treated after threading.

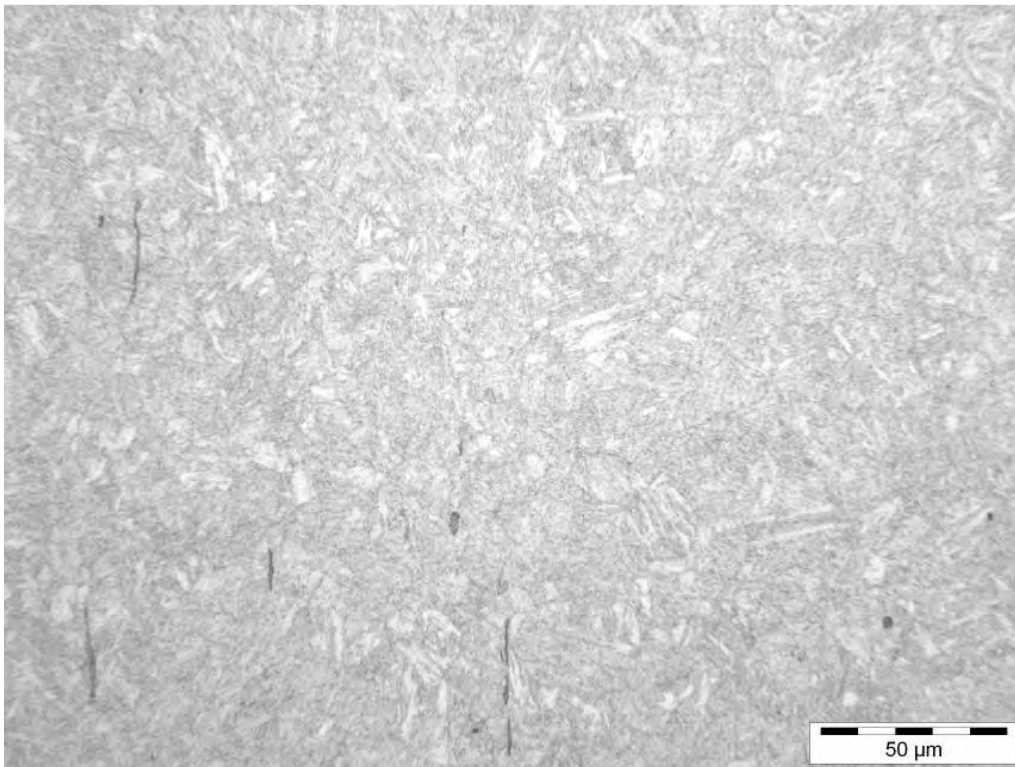
Figure 45: Micrograph (original image captured at X500), specimen etched in Nital. Longitudinal section through fatigue cracked bolt, showing a microstructure consistent with the bolt having received a quench and temper type through hardening heat treatment.

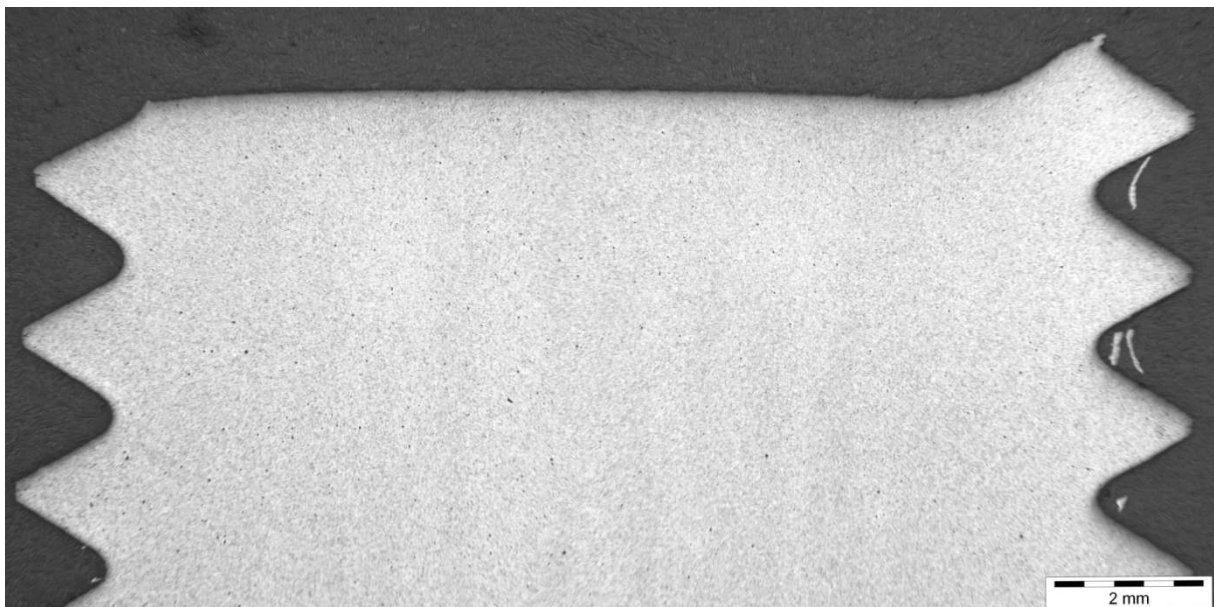
The specimen removed from a second bolt that had fractured at 90° to the principal axis of the bolt also exhibited features consistent with strain free fatigue cracking over most of the bolts cross section (Figures 46 and 47). In this case, however, there was clear evidence of a small region of ductile shear type fracture in the terminal fracture region (Figures 48 and 49). The fatigue crack had again initiated in a thread root that appeared to be free from pre-existing material or manufacturing defects (Figure 46) and there was no evidence of secondary cracking in the adjacent thread roots. The bolt had again been produced by thread rolling and had entered service in a quench and tempered heat treatment condition.

Figure 46: Micrograph (original image captured at X12.5), specimen etched in Nital. Longitudinal section through a second fatigue fractured bolt, showing crack origin (top left of field) and terminal fracture region (top right of field).

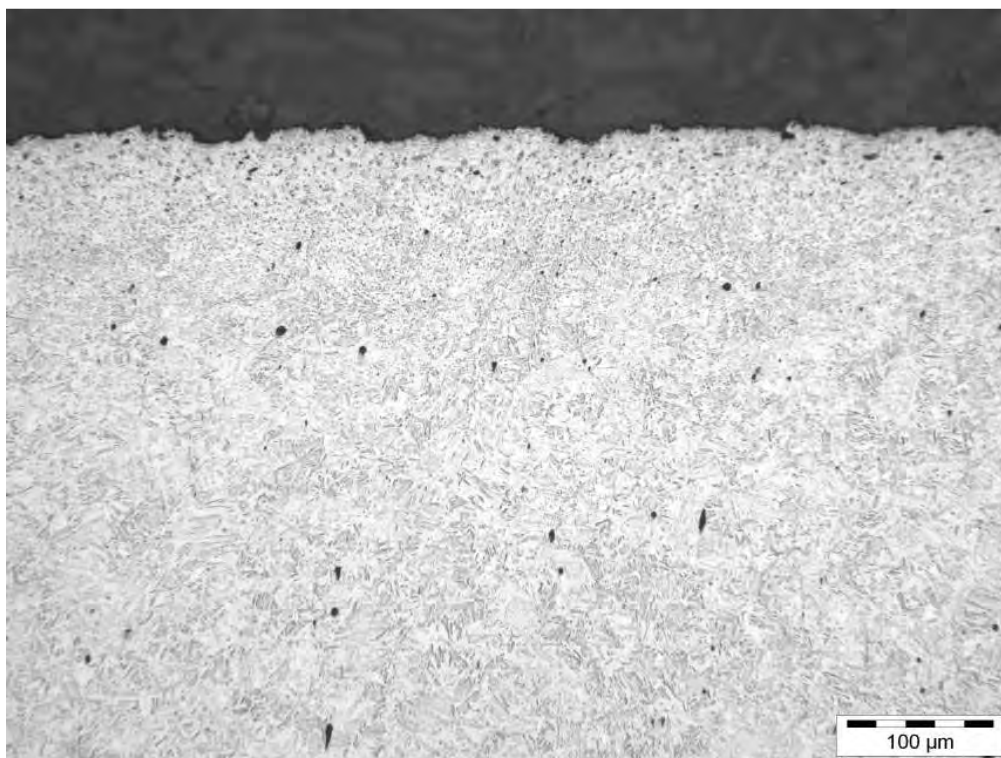
Figure 47: Micrograph (original image captured at X200), specimen etched in Nital.
Detail of the crack origin region of figure 46, showing strain free fracture edge
consistent with fatigue cracking.

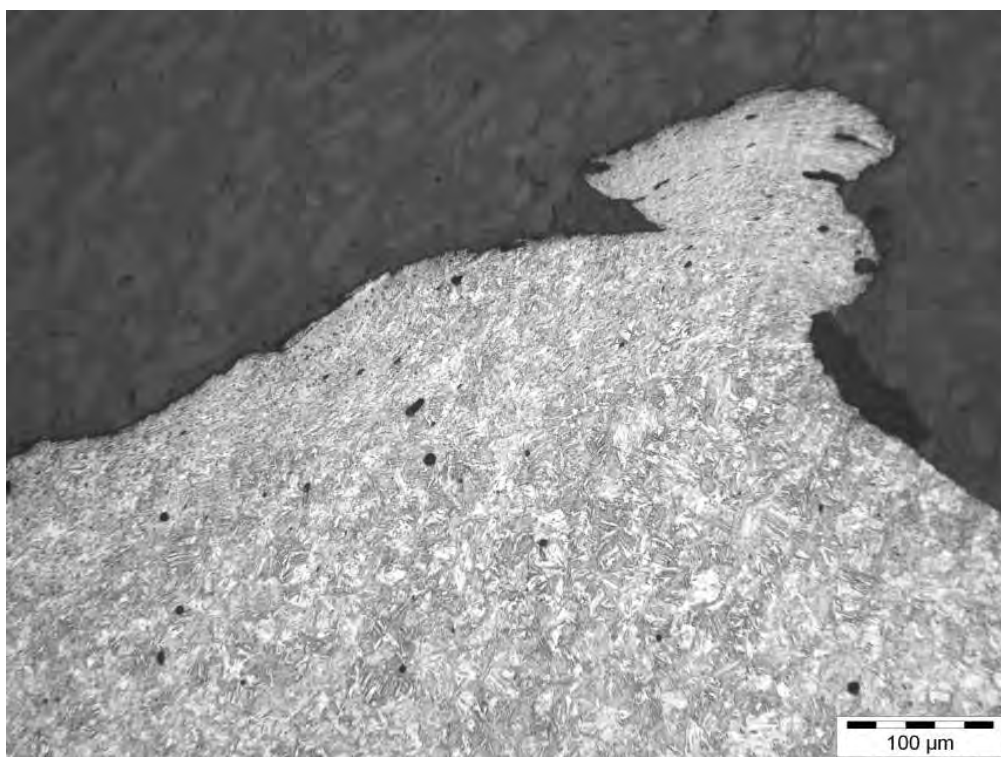
Figure 48: Micrograph (original image captured at X200), specimen etched in Nital.
Detail of the terminal fracture region of figure 46 and showing evidence of ductile
terminal overload type fracture.

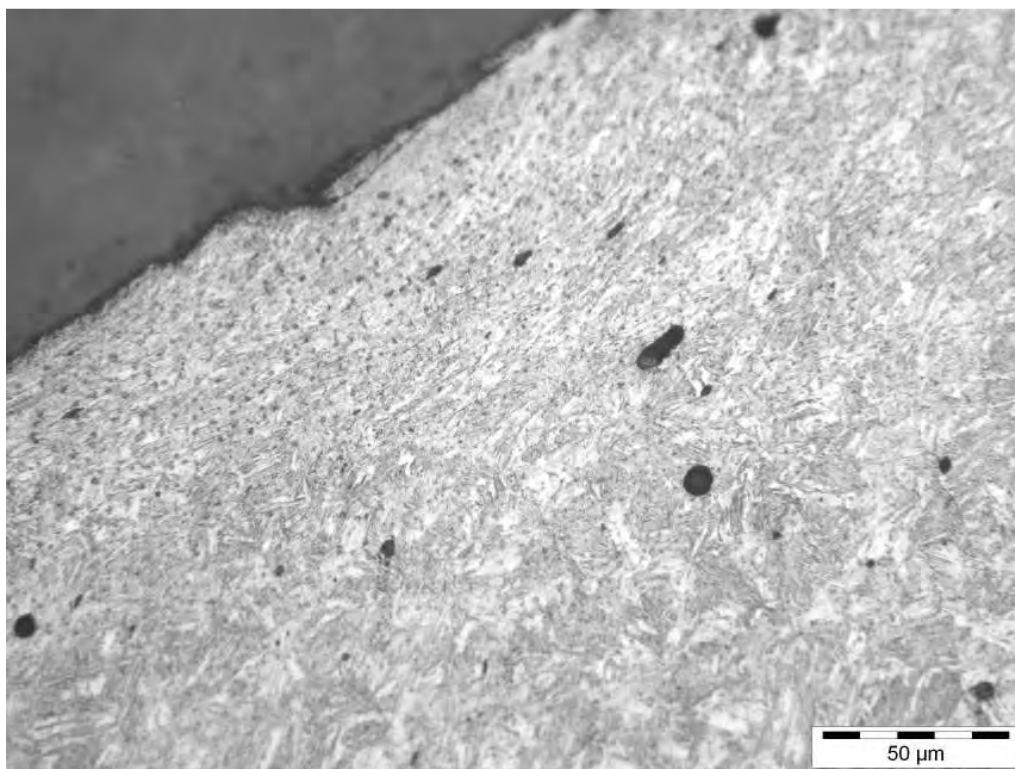
Figure 49: Micrograph (original image captured at X500), specimen etched in Nital.
Detail of figure 48.

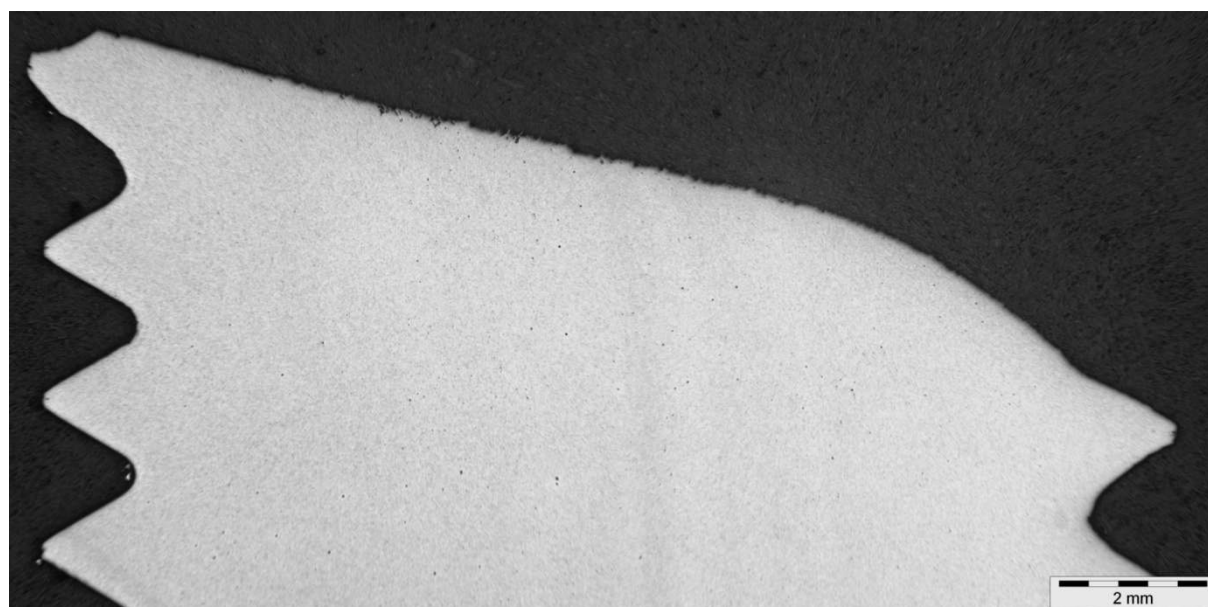
The specimen removed from a bolt exhibiting fracture at 45° to its principal axis was confirmed to exhibit largely ductile shear type fracture (Figures 50 and 51) and the bolt was seen to have expended very significant levels of ductility in the fracture process (Figure 51). The fracture surface exhibited evidence of quite extensive and deep pitting corrosion, which in turn suggested that this could be an old fracture. The bolt had again been produced by thread rolling (Figure

Figure 50: Micrograph (original image captured at X12.5), specimen etched in Nital.
Longitudinal section through a 45° shear type fracture.

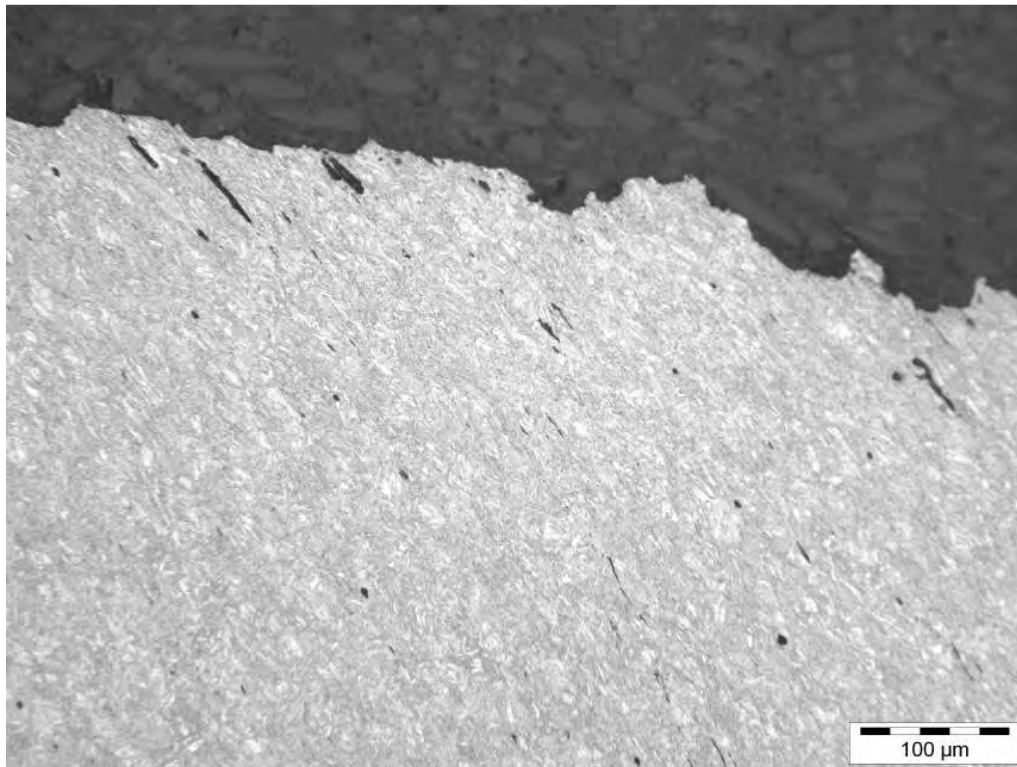
Figure 51: Micrograph (original image captured at X200), specimen etched in Nital. Detail of figure 50, showing features consistent with ductile shear type fracture.

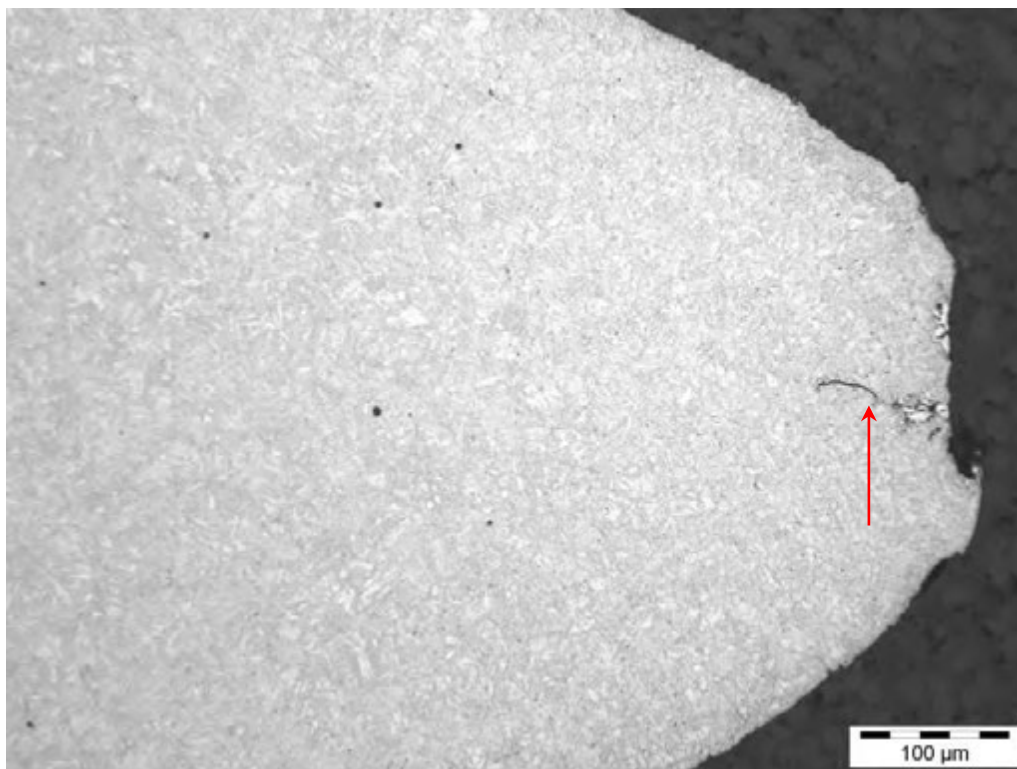
Figure 52: Micrograph (original image captured at X200), specimen etched in Nital. Detail of thread rolling intrusion (arrowed) in shear fractured bolt, which confirmed that the bolt had been thread rolled rather than screw cut and heat treated after threading.

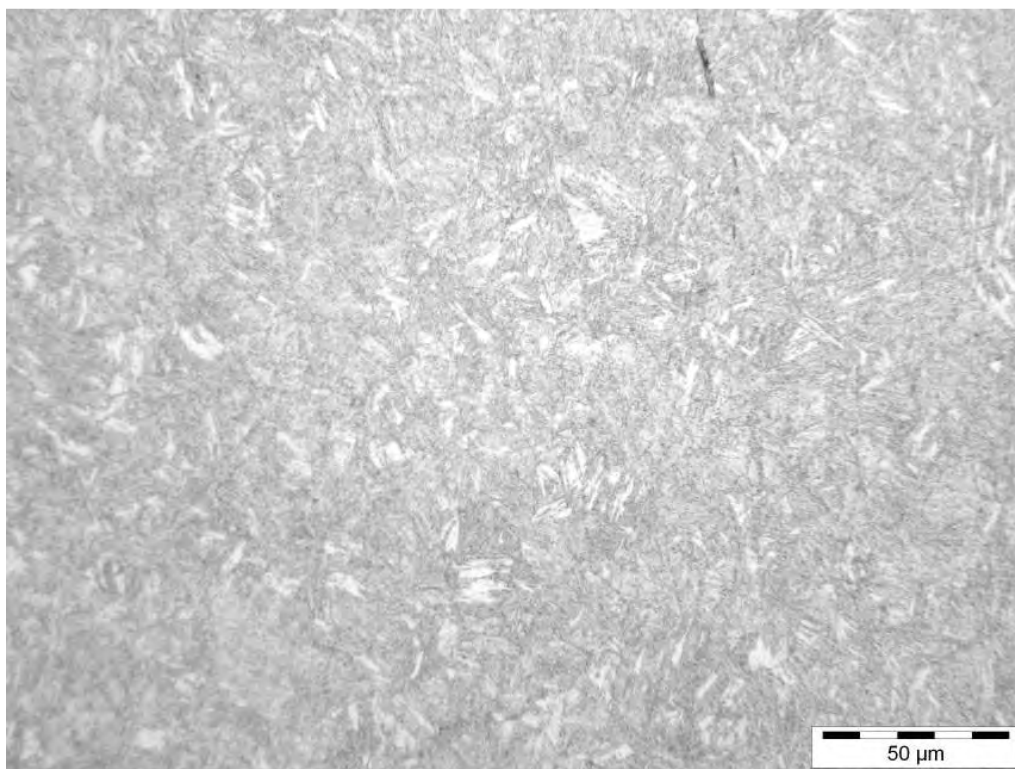
Figure 53: Micrograph (original image captured at X500), specimen etched in Nital. Longitudinal section through 45° shear type fracture, showing a microstructure consistent with the bolt having received a quench and temper type through hardening heat treatment.

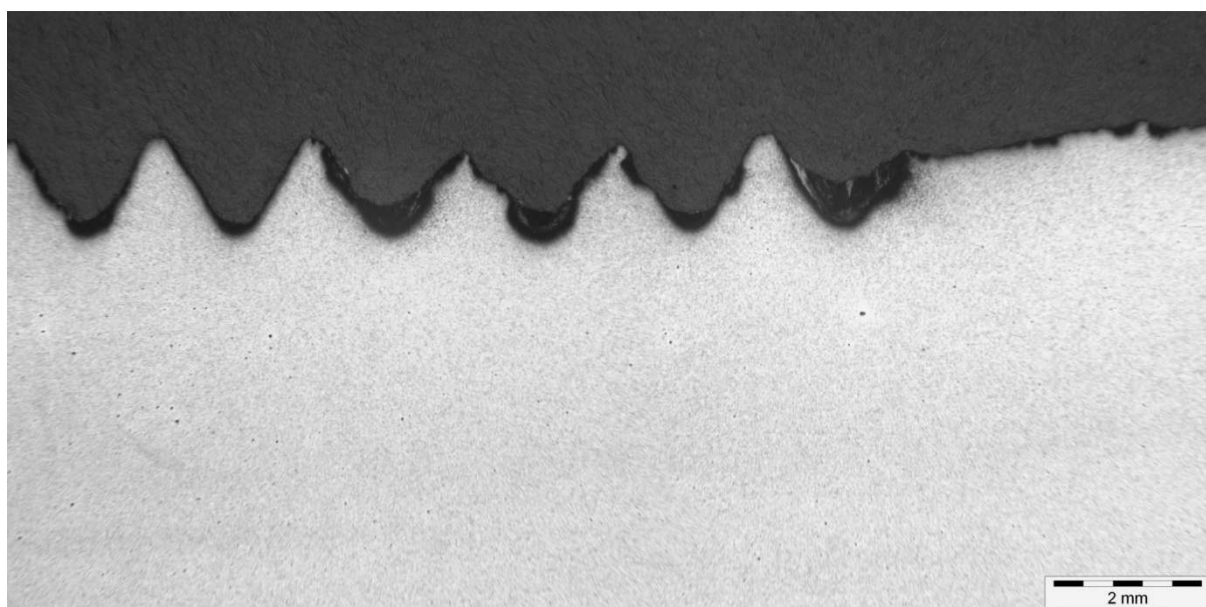
The specimens removed from two unfractured bolts confirmed both to be totally free from cracking. One of the bolts did, however, exhibit evidence of quite extensive local pitting corrosion (Figures 54, 55 and 56). Like other bolts examined in detail, both had been produced by thread rolling and had received a satisfactory post threading quench and temper type through hardening heat treatment.

Figure 54: Micrograph (original image captured at X12.5), specimen etched in Nital. Longitudinal section from an un-fractured bolt, showing corrosion of the plain shank and threads.
