Laboratory examination and failure analysis of the gantry crane wheel securing bolts

THE TEST HOUSE (CAMBRIDGE) LTD. JOB AND REPORT REFERENCE: T11285

LABORATORY EXAMINATION AND FAILURE ANALYSIS OF M16 GANTRY CRANE WHEEL SECURING BOLTS FROM THE VESSEL BLUE NOTE

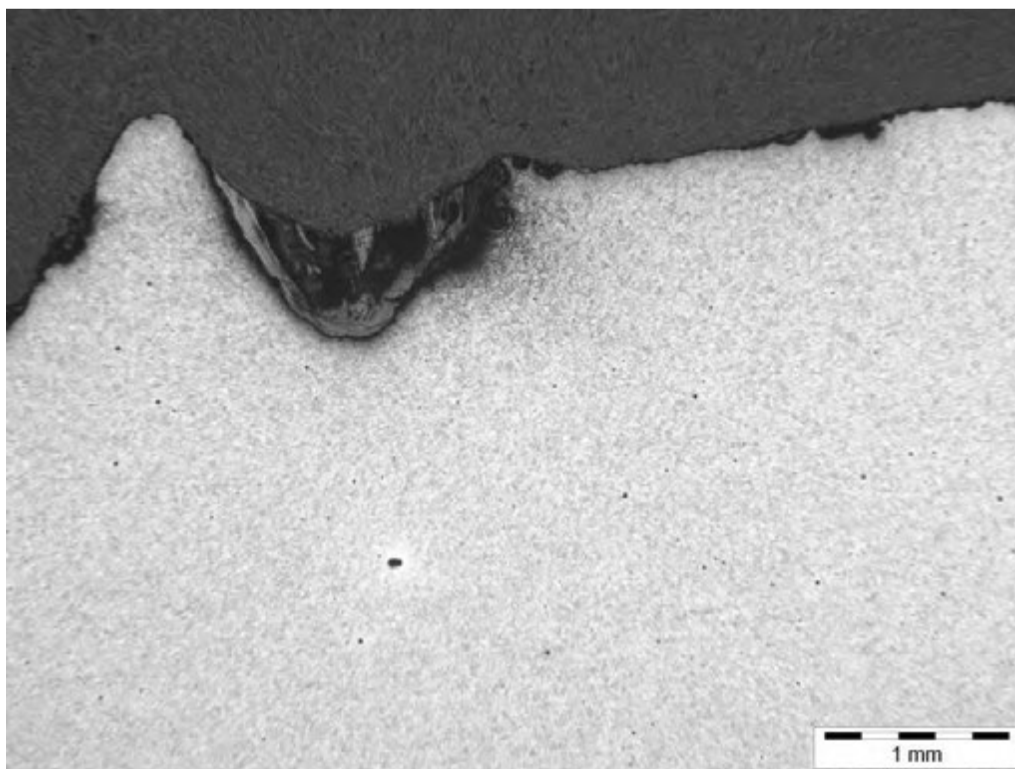
Figure 55: Micrograph (original image captured at X25), specimen etched in Nital. Detail of the corrosion damage shown in figure 54.

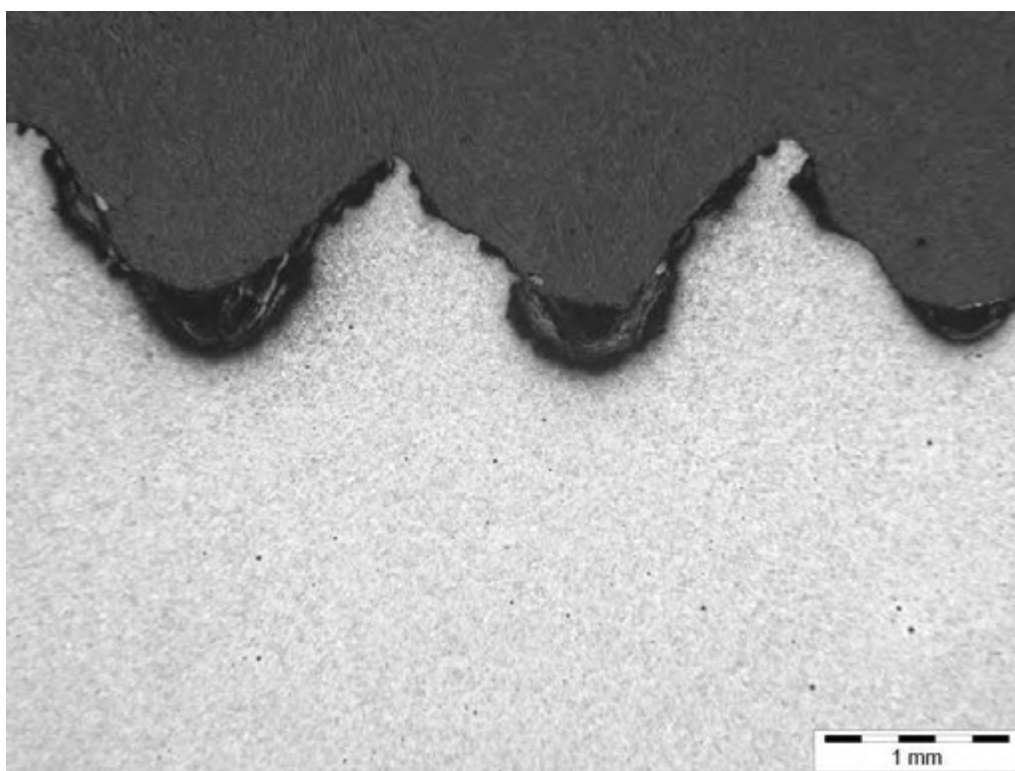
Figure 56: Micrograph (original image captured at X25), specimen etched in Nital. Further detail of the corrosion damage shown in figure 54.
