Report on the investigation of the
failure of the controllable pitch propeller of the cargo ship

Saffier

resulting in heavy contact with a berthed tug
in Immingham harbour

25 June 2011

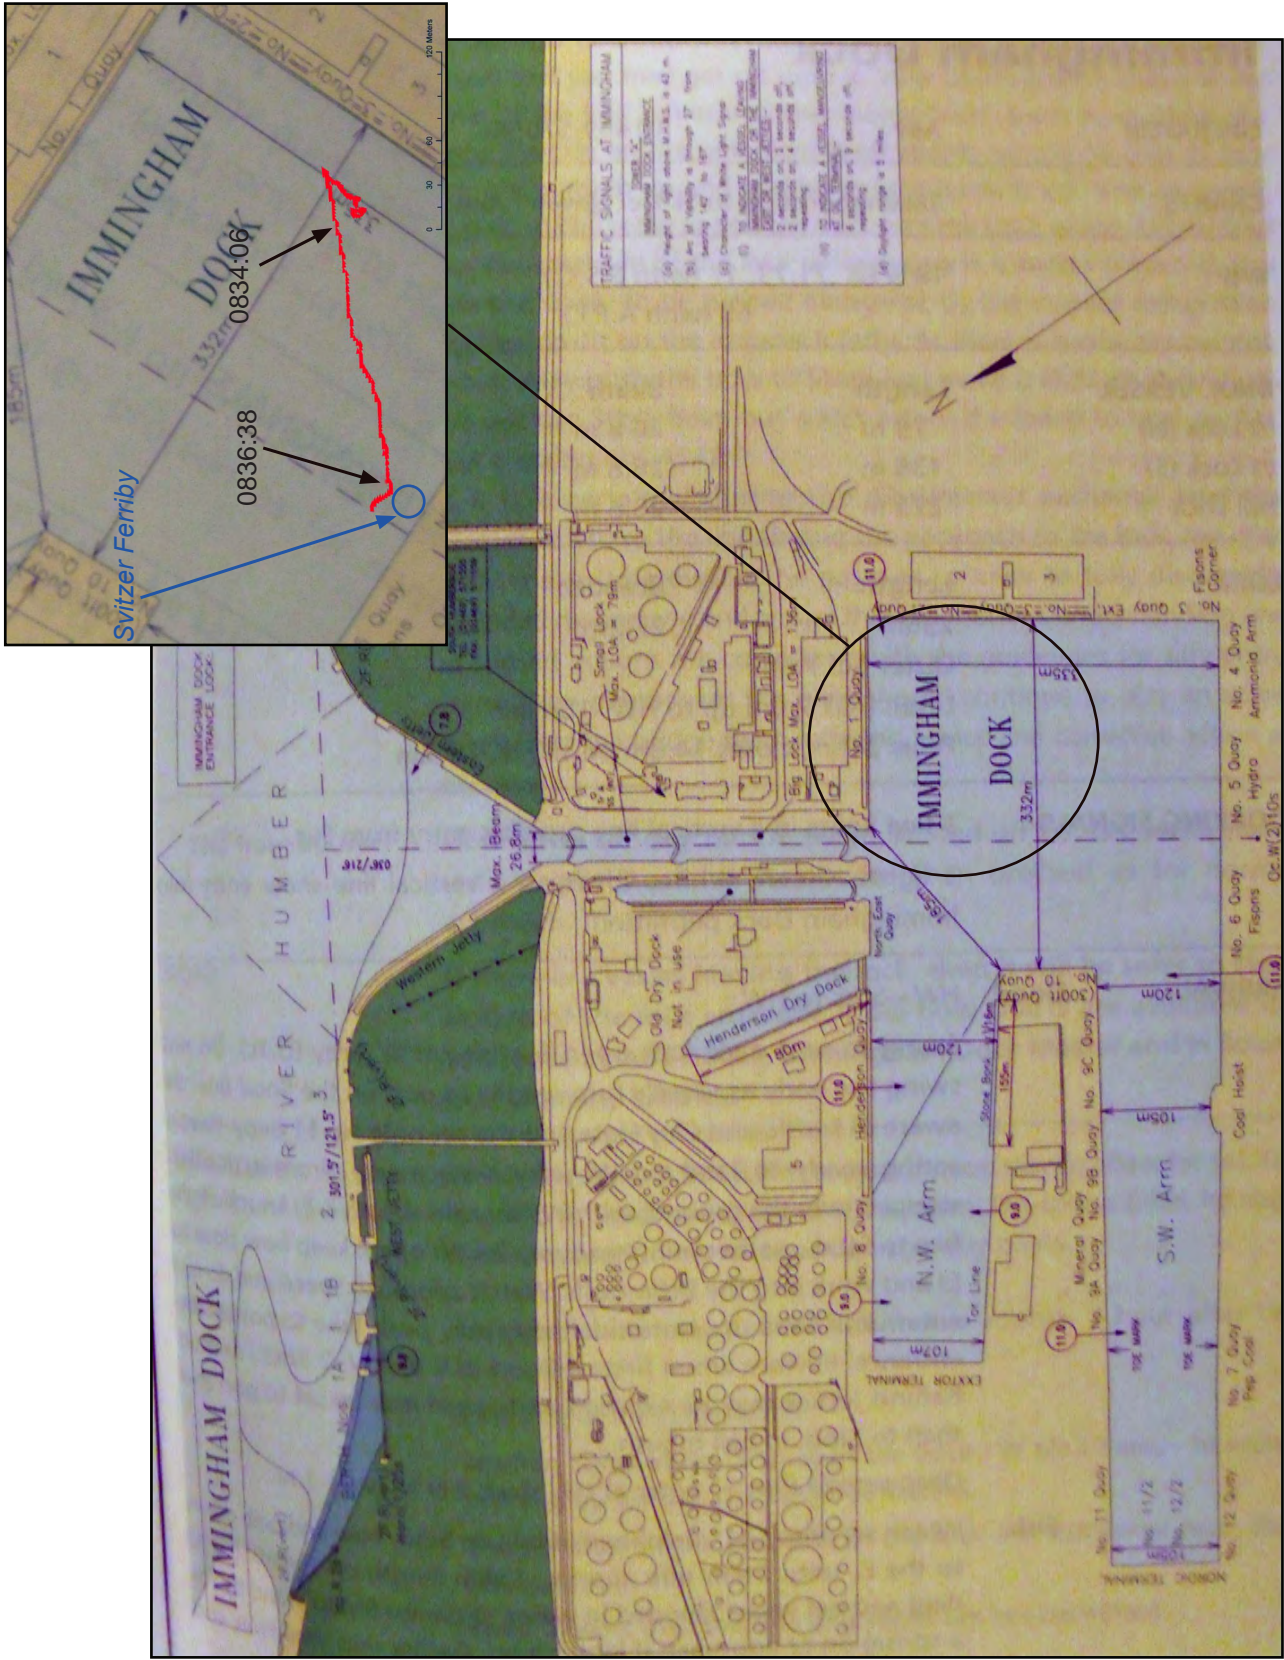
Figure 1: Immingham harbour (Inset: movement of Saffier during the incident)

On the forecastle, the chief officer relayed the closing distances between *Saffier*'s bow and *Valiant* at frequent intervals. At 0832:39, when the closest point of approach was less than 10m, the master moved the bridge lever for propeller pitch control to 'half astern'. Within a few seconds, noticing that the forward motion had not been fully arrested, he put the lever to 'full astern'. As the vessel picked up speed astern, he pulled the bridge lever back to a very slight pitch astern. The pitch indicator continued to display 100% astern and did not appear to respond to the pitch reduction command.

Time	Demand [%]	Response [%]	Speed (knots)
0832:18	61 AHD	65 AHD	0.3 AHD
0832:39	49 AST	77 AST	0.7 AHD
0832:43	64 AST	104 AST	0.7 AHD
0832:57	97 AST	154 AST	0.3 AHD
0833:25	6 AST	80 AST	1.2 AST
0833:28	36 AST	57AST	1.3 AST
0833:37	72 AST	124 AST	1.6 AST
0833:41	113 AST	142 AST	1.7 AST
0833:47	50 AST	148 AST	2.0 AST
0833:54	132 AST	156 AST	2.2 AST
0834:06	118 AST	157 AST	2.6 AST

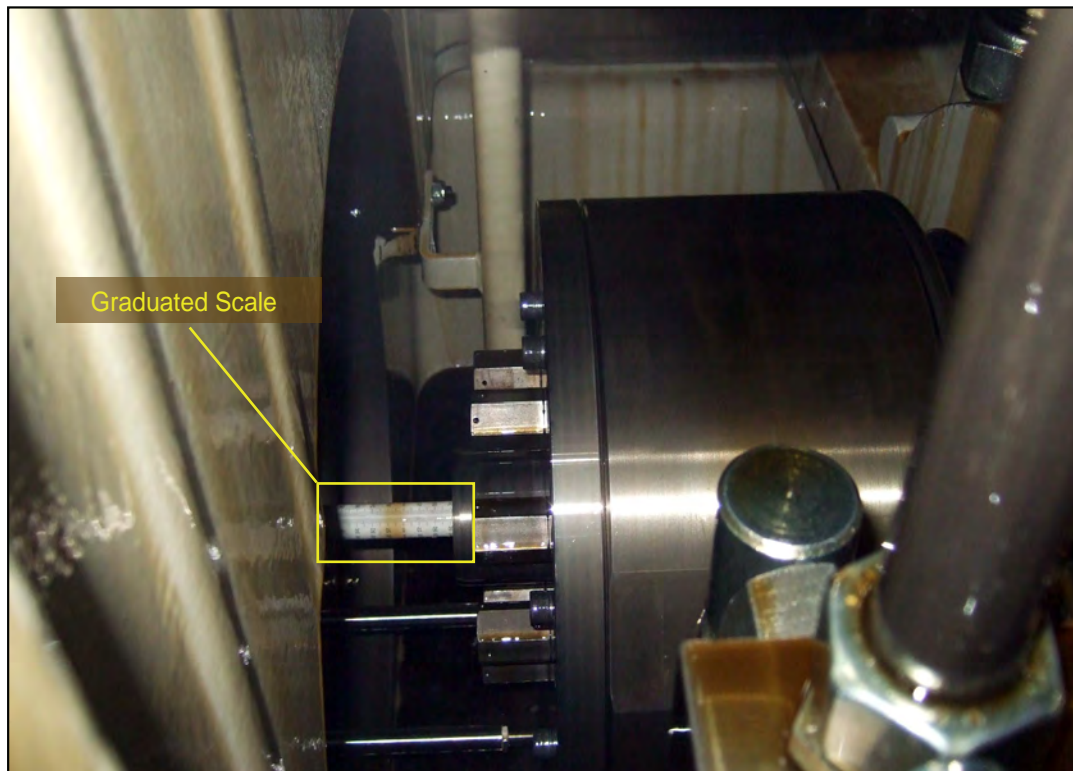
Figure 4: Graduated scale indicated CPP servo travel

The physical travel of the propeller blade servo actuating mechanism could be measured on a graduated scale which was accessed by opening an inspection window on the gearcase. The nominal position on the graduated scale for full ahead pitch was 52mm aft of the zero position and the position for full astern pitch was 40mm forward of zero position (**Figure 4**).

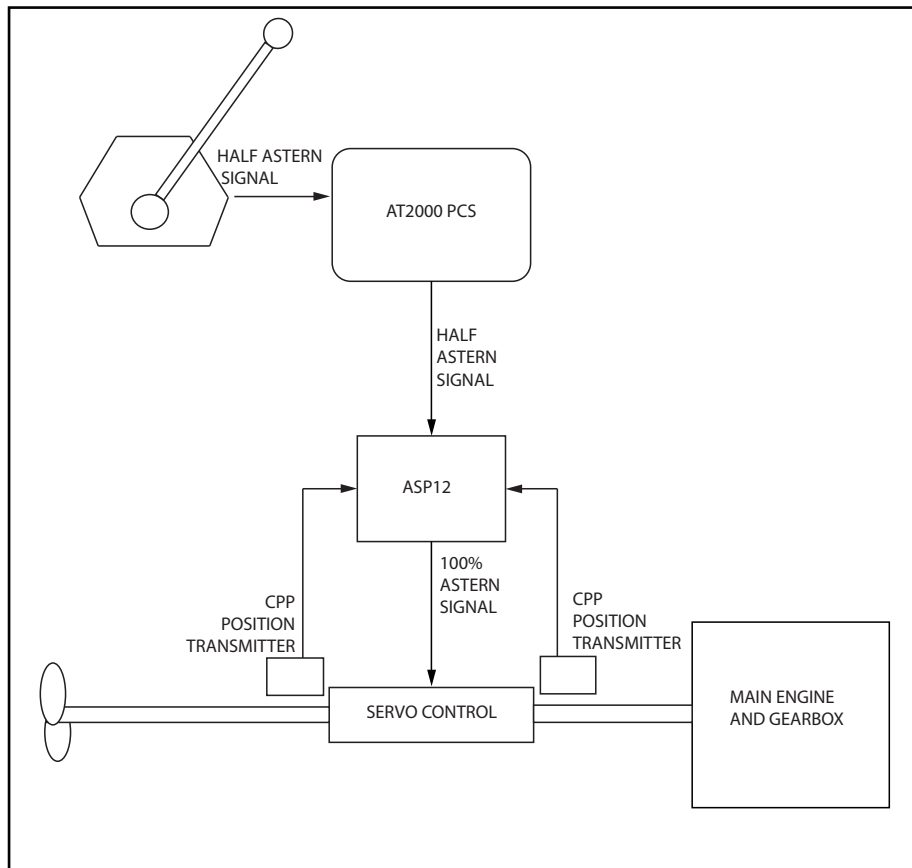
Figure 11: Half astern demand translated to full astern by AT2000 PCS

This resulted in the AT2000 PCS calibrating itself incorrectly, causing the propeller pitch to reach the designed 'full astern' position prematurely, when the pitch lever was in the 'half astern' position. When the setting of potentiometer P4 was reduced, both the ahead and astern pitch responses were found to be correct.

It was conclusively demonstrated from the tests conducted on the simulator at MAN's Frederikshavn facility that the mismatch between astern pitch demand and response was caused by the incorrect adjustment of potentiometer P4, representing the astern pitch feedback. While the ahead pitch feedback adjustment was set in a methodical way in order to load the engine correctly, there was no opportunity to adjust the astern pitch feedback as the propeller pitch response was not verified in the full astern position. Unfortunately, the service engineers' approximate setting of potentiometer P4 resulted in a feedback current of 9.75mA, which equated to an astern pitch of 155%.

6. A mismatch between the amount of astern pitch demand and response was caused by the incorrect adjustment of potentiometer P4 in the ASP12 unit. This resulted in the incorrect calibration of the control system with the net effect that, when 100% astern pitch was demanded, the propeller blades were driven to 155% astern. [2.4.1]

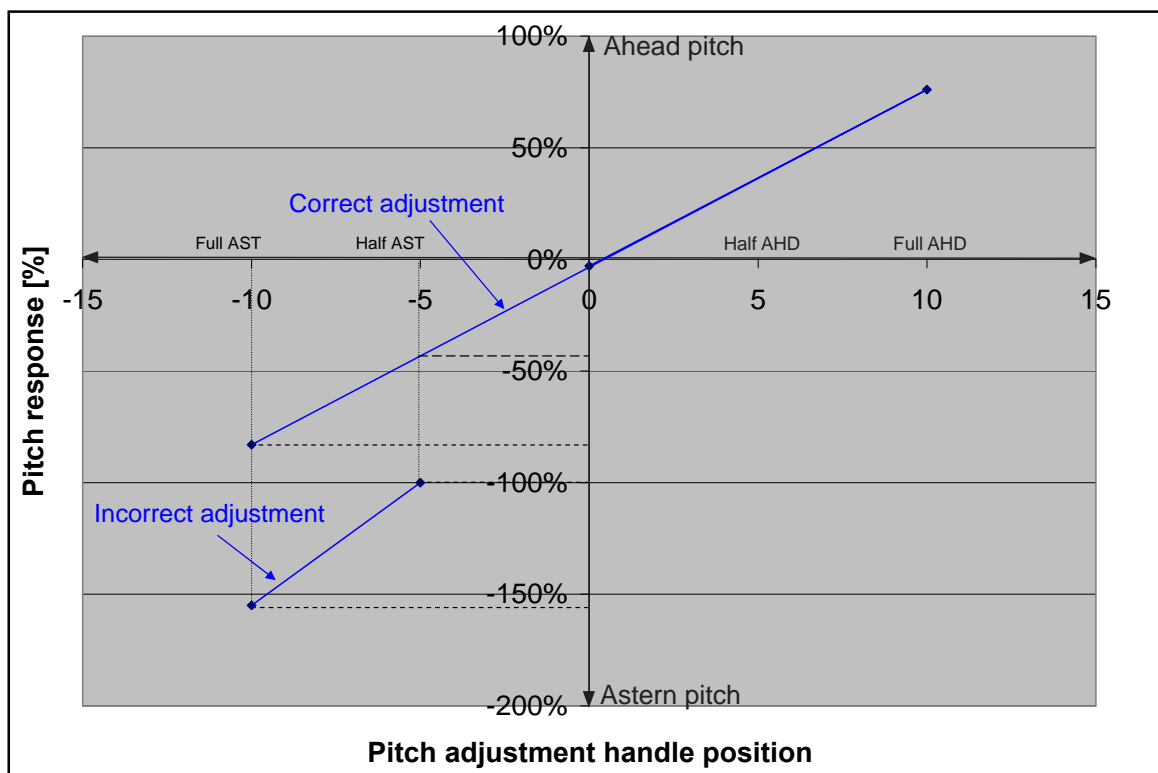
Figure 12: CPP behaviour with correct and incorrect adjustments demonstrating how the pitch supplied could significantly exceed pitch demanded due to incorrect adjustment

The anomalies caused by the incorrect astern pitch control adjustment manifested themselves shortly after the vessel went back into service. The timed tests carried out on board followed the instructions from MAN staff and clearly indicated that the average response time for pitch reduction from 70% astern to zero was approximately four times greater than for a similar amount of ahead pitch reduction. The discrepancy was apparent when both the central and portable control consoles were used. Even though this information was relayed back to MAN staff, it is disappointing that it did not trigger a more detailed technical inquiry from their side. It is particularly concerning that MAN staff dismissed the results of the timed tests as being 'normal'.
