## Fatal man overboard **FV ABOUT TIME** off Pembrokeshire 14 June 2011

### SUMMARY

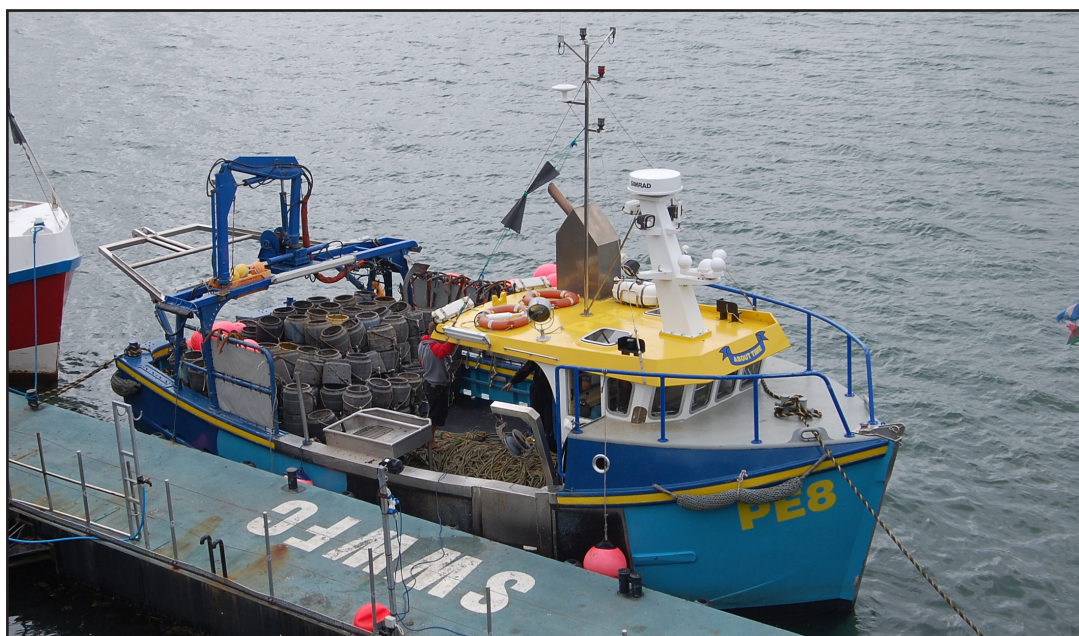
**Figure 1:** *About Time* - showing arrangement of whelk pots and ropes at time of accident

*About Time* (Figure 1) was an 11.9m UK-registered potting vessel, owned and operated by her skipper. The crew also consisted of two Latvian deckhands, one of whom was Māris Ozoliņš, the deceased. All three crewmen were share fishermen who lived on board the vessel. The vessel normally stayed alongside in port, or occasionally at anchor overnight and undertook fishing during the day.

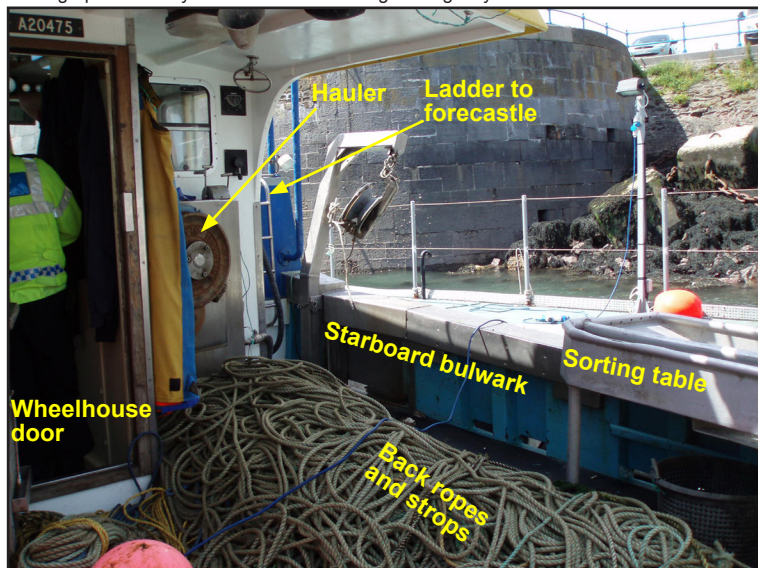
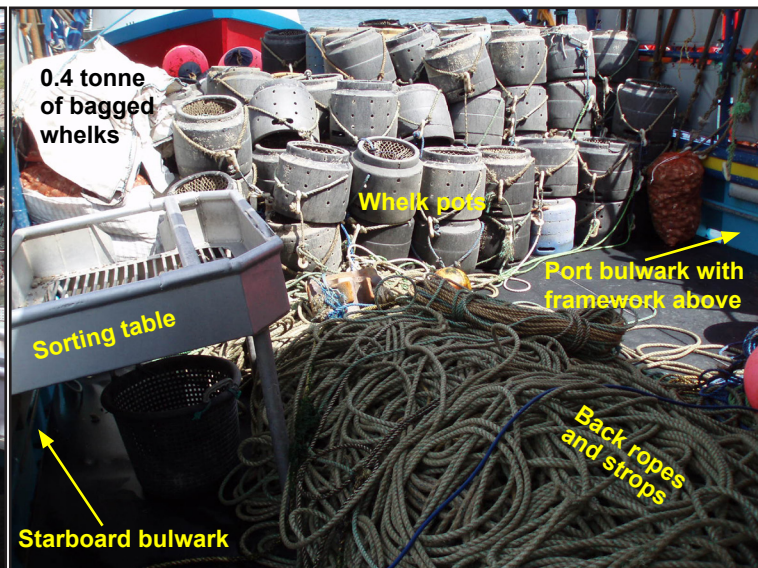
The pots were piled up at the aft end of the working deck, with the ropes left in a pile near the hauler on the starboard side of the deck (Figures 3 and 4). It was not unusual for the vessel to have this amount of gear on deck. As the height of tide was going to prevent the immediate landing of the pots at Milford Haven, the skipper decided he would shoot the three strings, unbaited, in a sheltered location within the estuary. He then intended to head back out to the fishing grounds to recover the remaining three strings and return to port. Once the fishing gear had been landed in Milford Haven, the skipper planned to take *About Time* to Dorset, picking up the three strings in the estuary en route.

**Figure 3:** View looking forward to starboard

**Figure 4:** View looking aft to port

The most significant hazard on *About Time*'s deck was the large pile of back ropes on the starboard side by the hauler that created a slip and trip hazard. The back ropes also had the effect of reducing the height of the bulwark in that area. The vessel's slight list to starboard further increased the risk of anyone falling overboard when standing on top of the ropes. Consequently, the most probable cause of Māris's loss appears to have been him slipping or tripping while on the starboard side of the deck (other boundary areas of the vessel were well protected), either as he was relieving himself or as he was moving towards the wheelhouse ladder, which led to him falling over the low bulwark.

- The most probable cause of Māris falling overboard was a slip or trip while on the starboard side of the deck. The presence of a large pile of rope in this area increased the risk of this occurring and reduced the effective height of the bulwark.

- 2012/105** Refer to the available industry best practice guidance and review the risk assessment for *About Time* and any other vessels he may own, to identify measures to improve onboard safety by:
- Identifying the hazards posed during the transportation of fishing gear on deck and ensuring the effective segregation of the crew from the gear;
  - Ensuring the use of appropriate footwear at all times;
  - Evaluating the hazards posed by low bulwarks;
  - Appraising the use of personal flotation devices (PFDs) and personal locator beacons (PLBs);
  - Ensuring all crew have completed the mandatory safety training courses.

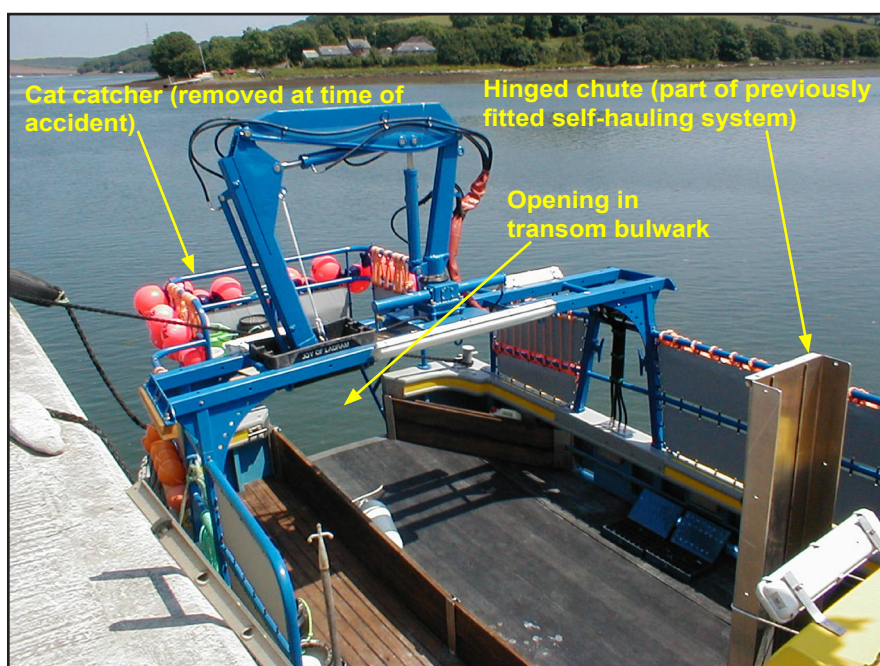
In 2005, the vessel's previous owner had installed a self-hauling system on the starboard side (**Figure 5**) which incorporated an area to segregate the crew from the fishing gear. This system was removed when the previous owner changed fishing mode to trawling for scientific research purposes. Although the current owner reverted to dedicated potting, he did not reinstate the self-hauling system or segregation area.

**Figure 5:** View looking aft showing previously fitted self-hauling system and segregated working area in 2005

There were no means available to easily segregate the ropes from the crew working on or moving around the deck. The vessel's layout, with a forward engine room, meant there was no convenient means of creating a below-deck rope store. The vessel's previous owner had incorporated a segregated working area on the starboard side as part of a self-hauling system, but had later removed this. Although this would not have eradicated the problem of a large amount of rope on deck, the segregation would have provided a safe walkway adjacent to the bulwark and a physical barrier between the crew and the gear during hauling and shooting operations.
