Report on the investigation of the  
collision between the rigid inflatable boat

***Morfil***

and the passenger vessel

***Sun Clipper***

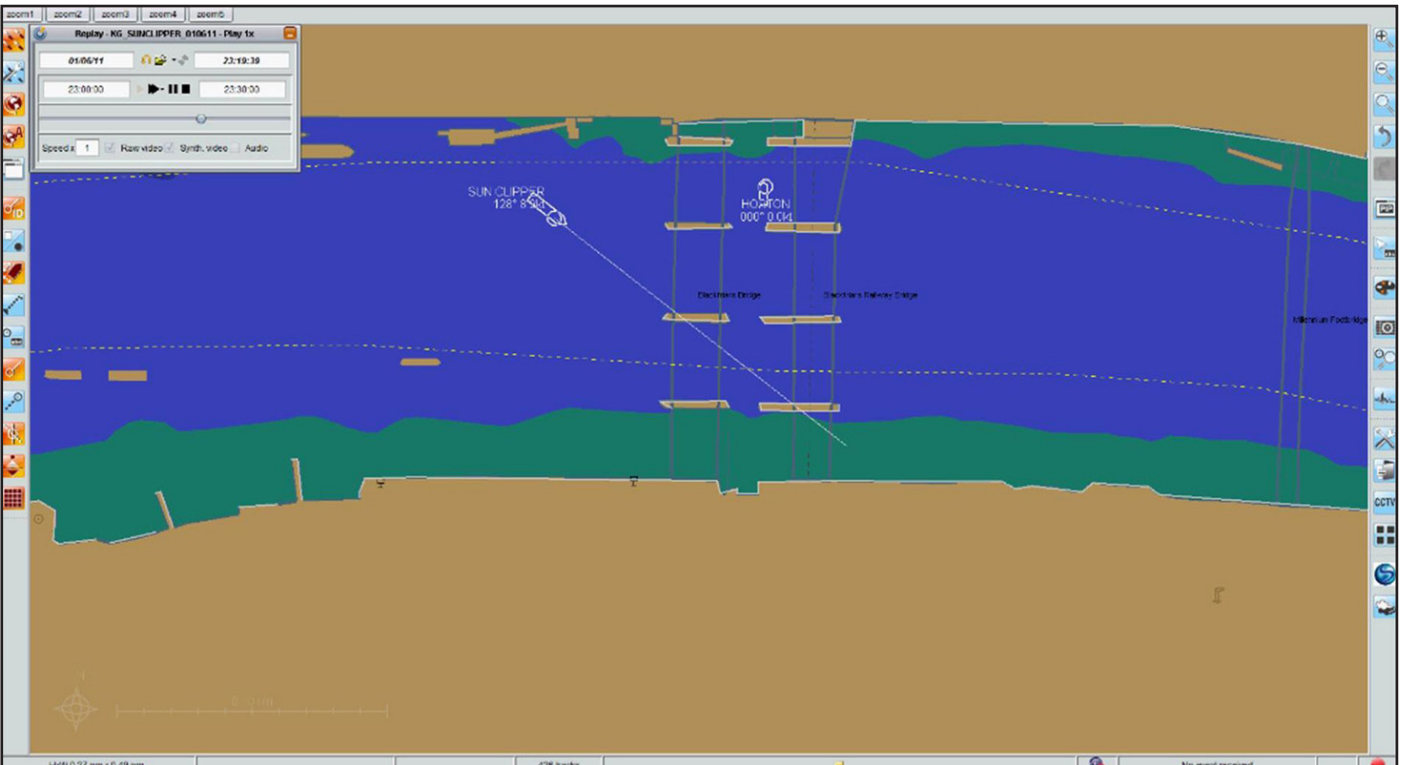
Figure 4: Thames AIS still - Sun Clipper departing berth

*Sun Clipper's* master checked the Thames Automatic Identification System (AIS) display<sup>2</sup> to see if any larger vessels were to the east of the Blackfriars bridges and travelling upstream. No vessels were detected in a position to cause concern, so the master manoeuvred *Sun Clipper* towards No.3 arch of the Blackfriars Road Bridge (**Figure 4**). The mate then joined the master on the bridge.

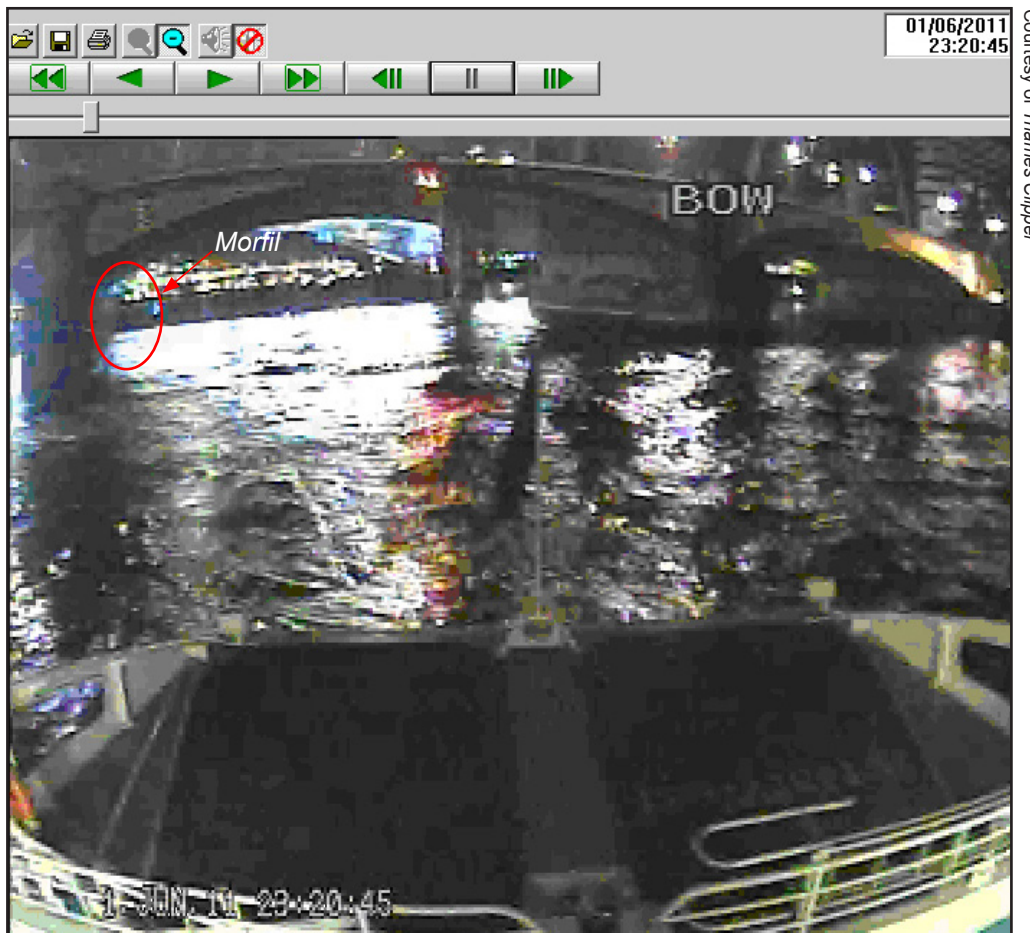
**Figure 5:** CCTV still - first sighting of *Morfil*

*Sun Clipper* was approaching No.3 arch at a speed over the ground of 8 knots when the master and mate noticed a small vessel off the port bow, later identified as *Morfil*, heading towards them (**Figure 5**). The RIB was also heading for No.3 arch but from the opposite side. The master and mate saw that *Morfil* was on the plane and estimated that she was travelling faster than 30 knots. *Sun Clipper's* master immediately realised that a collision was imminent, and reduced the engine throttles to zero.

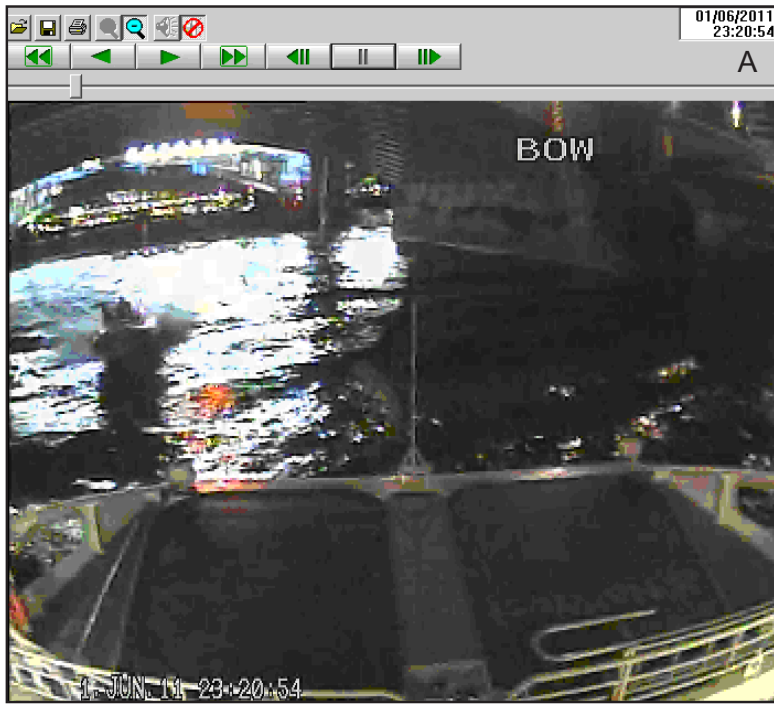
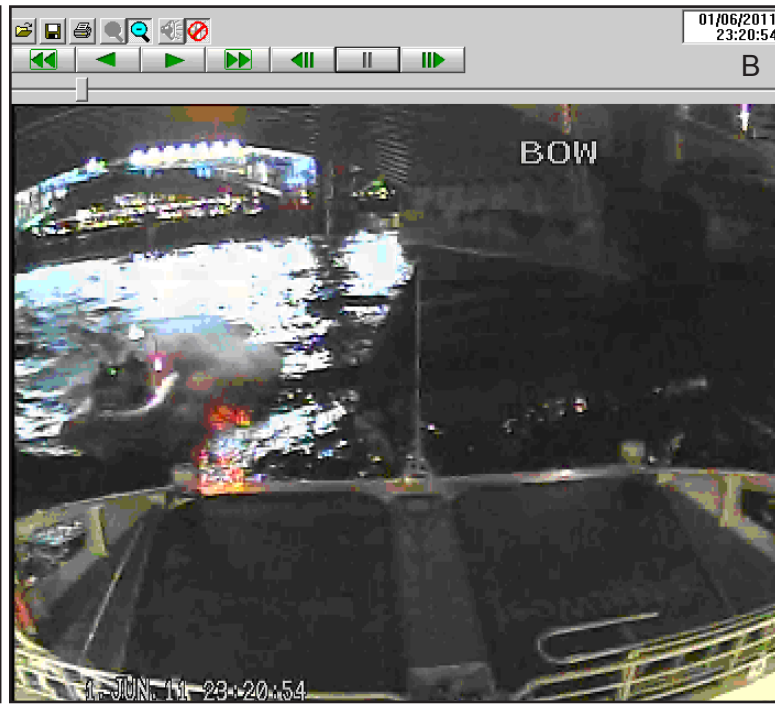
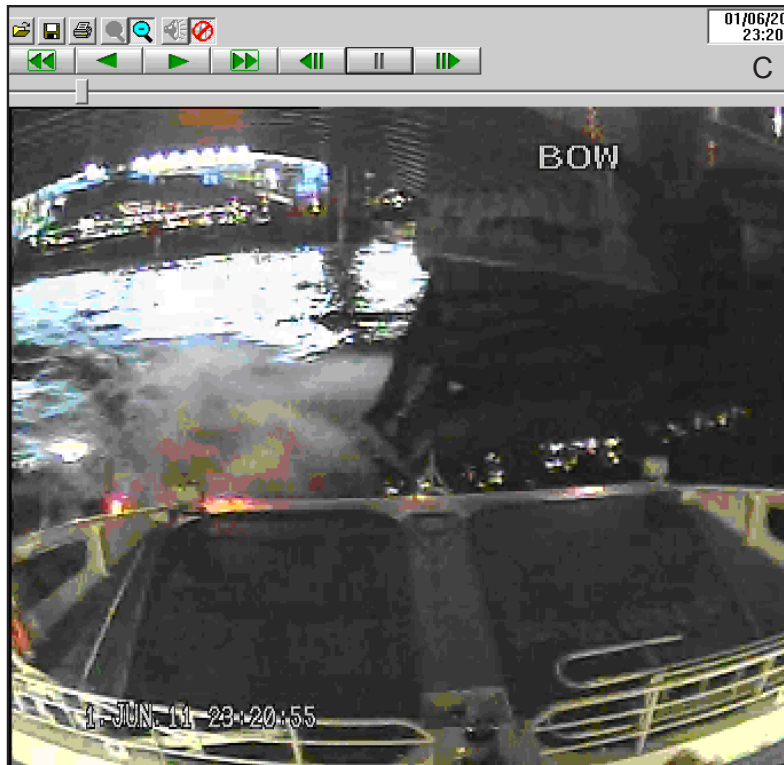
Figures 6a to c: CCTV still - *Morfil's* swerve to starboard

Moments later, *Morfil's* coxswain saw *Sun Clipper* directly ahead, and turned the steering wheel to port and then to starboard (**Figures 6a to 6c**). This action caused the RIB to swerve violently. Seconds later, at 2321, *Morfil* collided with *Sun Clipper's* port bow and both the RIB's occupants were thrown overboard.

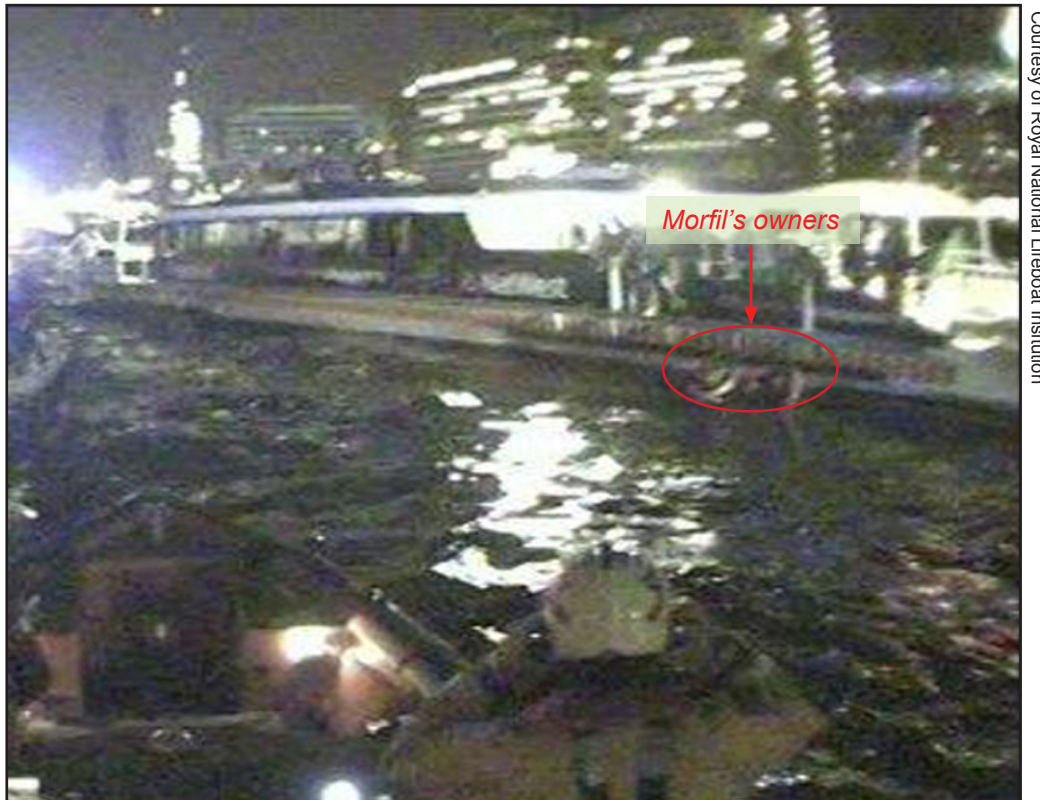
**Figure 7:** CCTV still - *Morfil's* owners at stern of *Sun Clipper*

with *Sun Clipper* for a second time, this time amidships on her port side. *Morfil* then passed close to her two owners in the water before turning towards the road bridge, where the RIB grounded and stopped under No.1 arch.

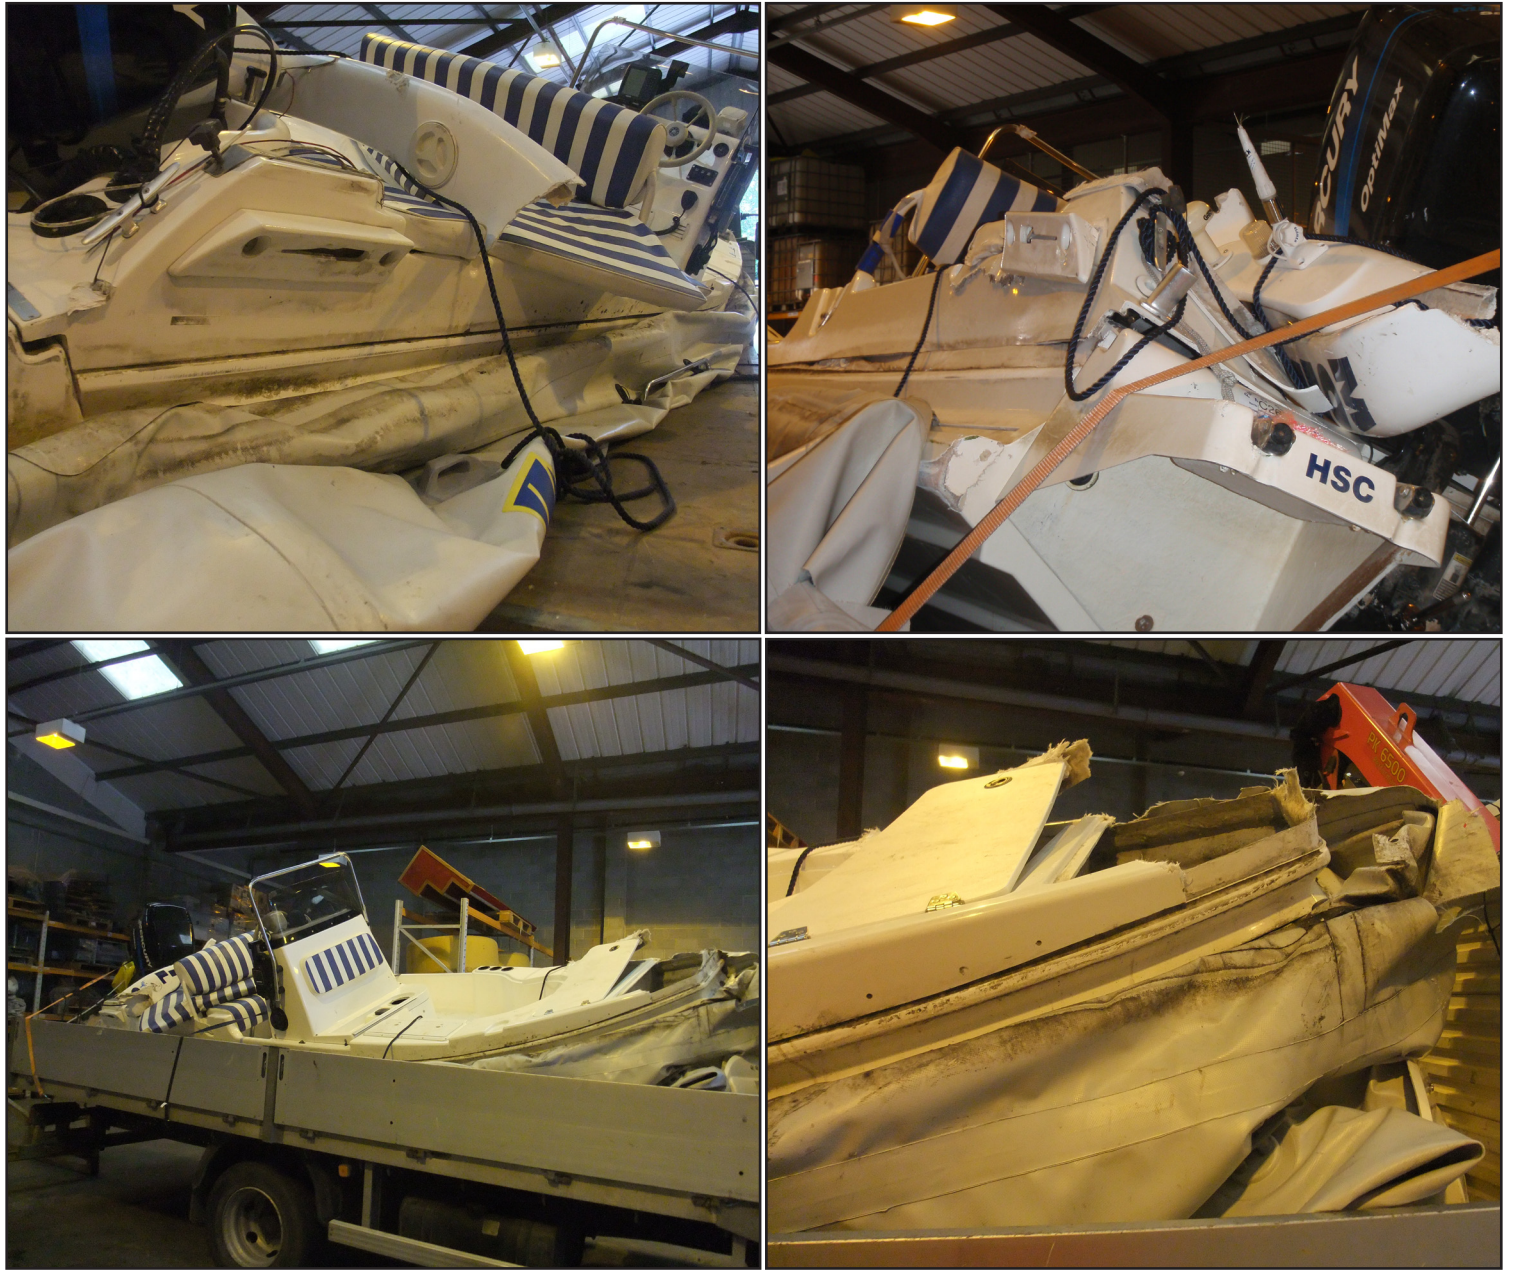
**Figure 8:** *Morfil* - damage

*Morfil* suffered extensive damage (**Figure 8**) and was a constructive total loss. *Sun Clipper* suffered only superficial damage to her fendering.
