Report on the investigation of
the electrical blackout and subsequent
grounding of the feeder container vessel

Clonlee

on the River Tyne, England

16 March 2011

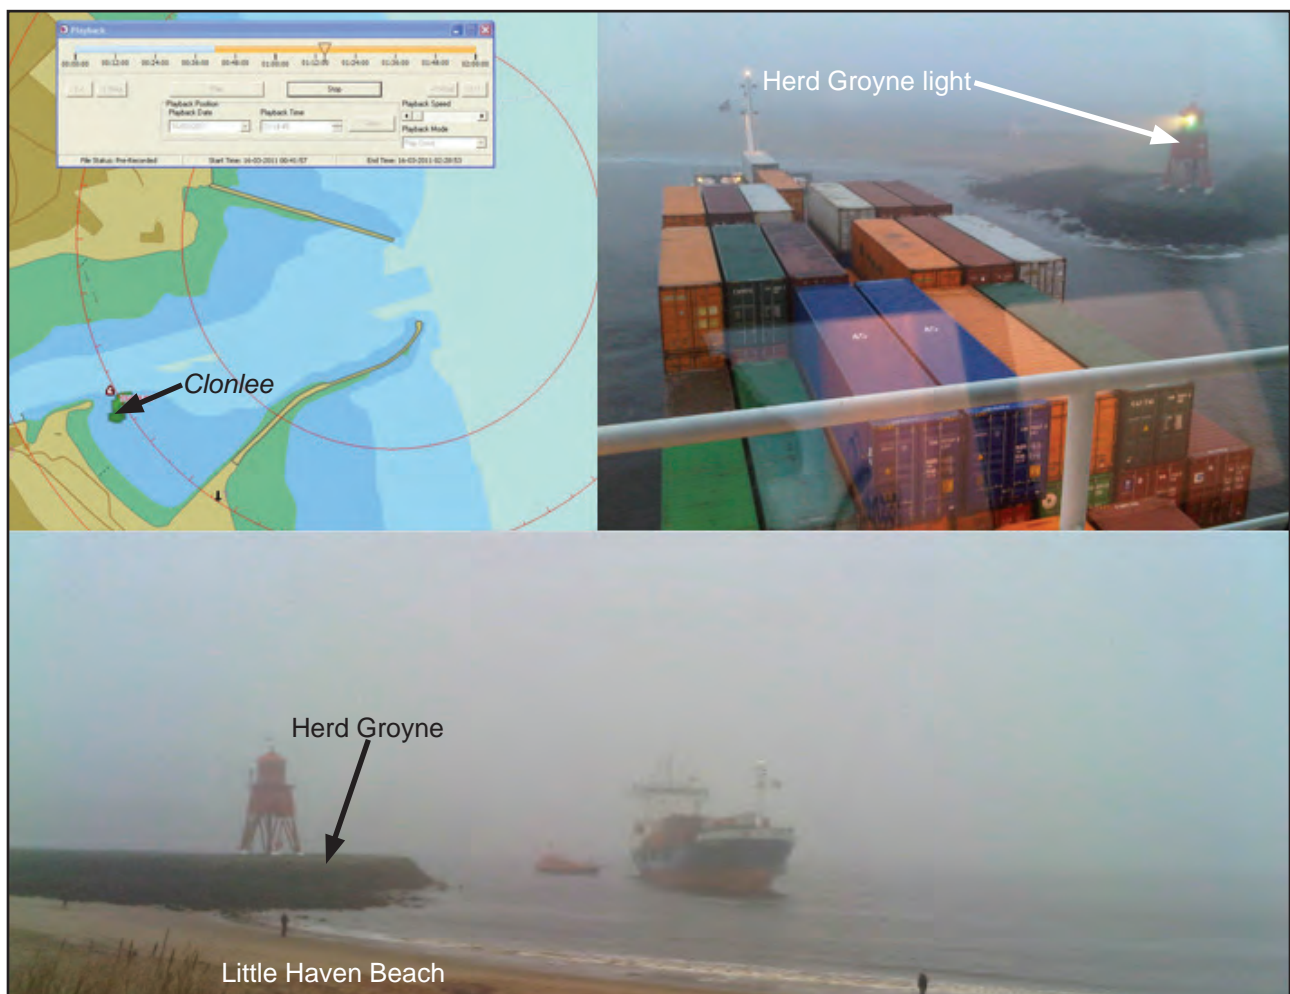
Figure 8: *Clonlee* aground on Little Haven beach

The master put the rudder hard-over to port to steer *Clonlee* away from the rocky groyne and, at 0113, the vessel grounded on the sand of Little Haven beach at South Shields (**Figure 8**). The master immediately informed VTS that his vessel was aground and requested the assistance of a tug. The VTS duty officer alerted the harbourmaster (HM) and suspended all ship movements within the port limits.

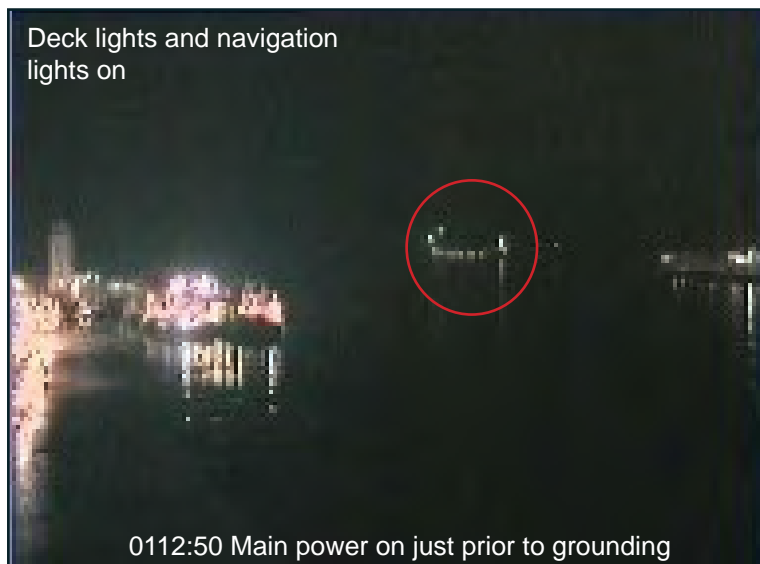
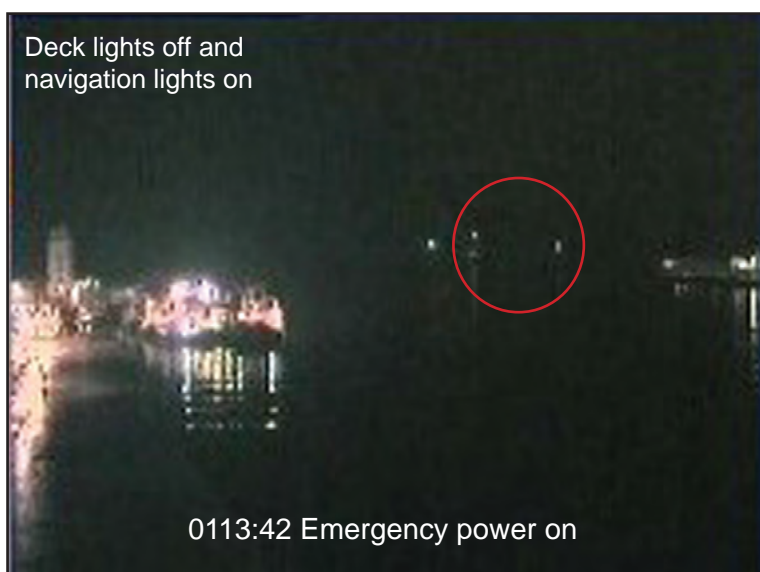
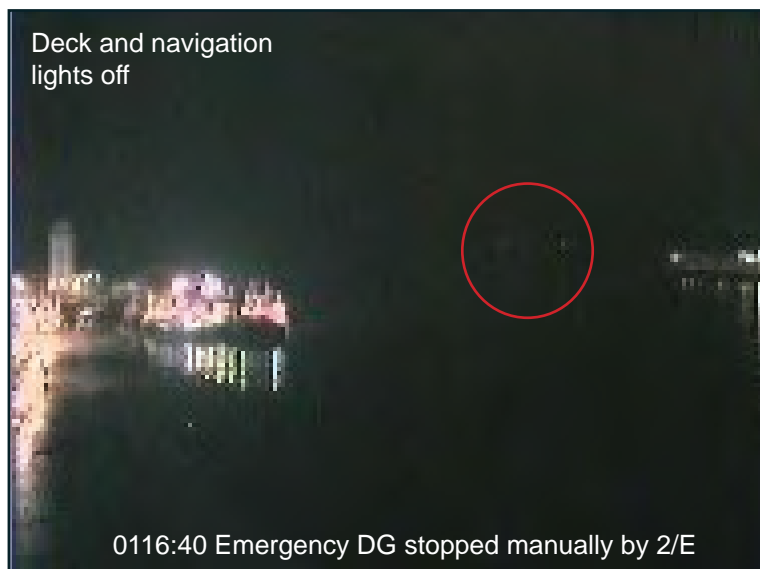
Figure 9: Third blackout as *Clonlee* runs aground

Clonlee's engineers had restored the main electrical power for a second time just as the vessel grounded (**Figure 9**), but again, after about 30 seconds, she blacked out. At 0116, the engineers manually stopped the emergency generator and attempted to restore power by operating the switchboard in its manual mode.

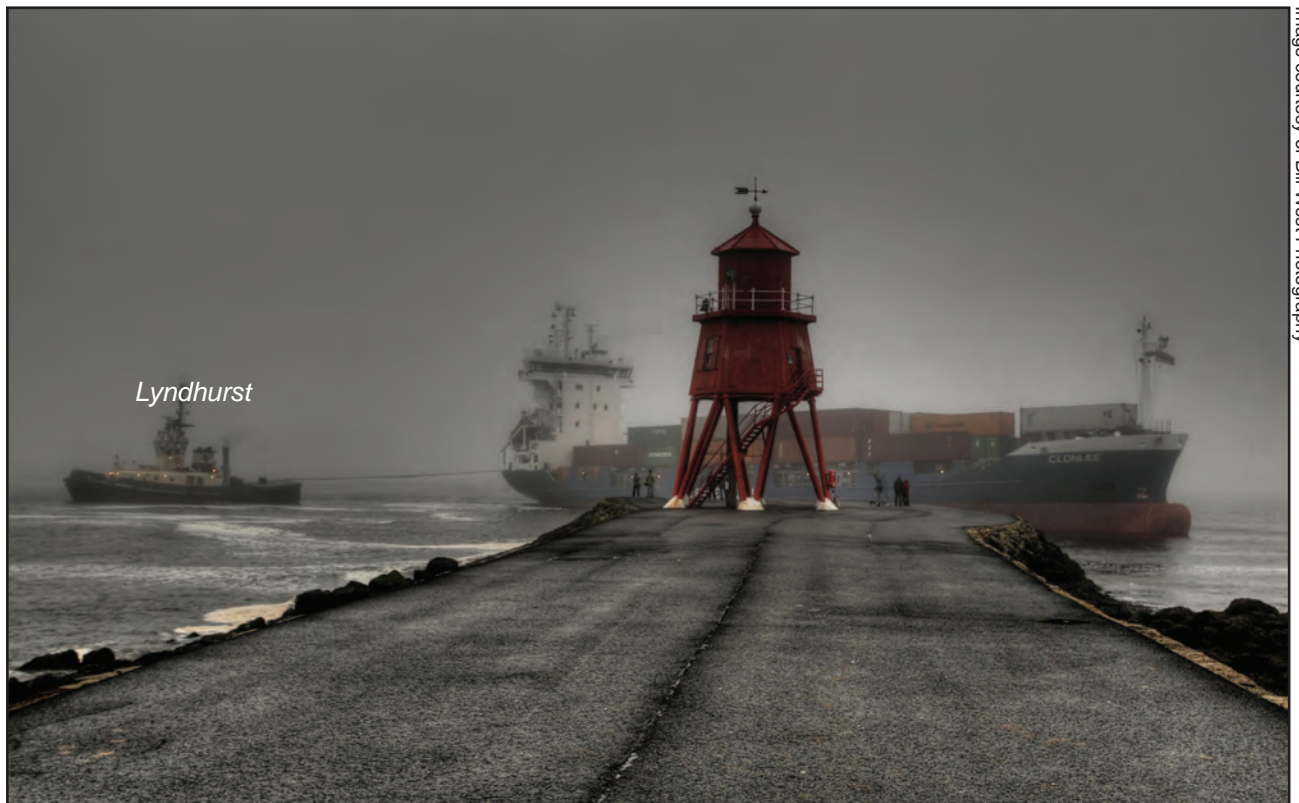
Figure 10: Refloating of *Clonlee* at 1000 on the rising tide

At 0800, the chief officer began to pump out the forward ballast tanks. An hour and 45 minutes later, with deballasting completed and a second tug in attendance, *Clonlee's* heading started to slowly drift to port. The tugs were advised that the vessel was about to refloat and *Lyndhurst* was asked to pull minimum weight astern (**Figure 10**). At 1000, *Clonlee* refloated and started to move slowly astern.

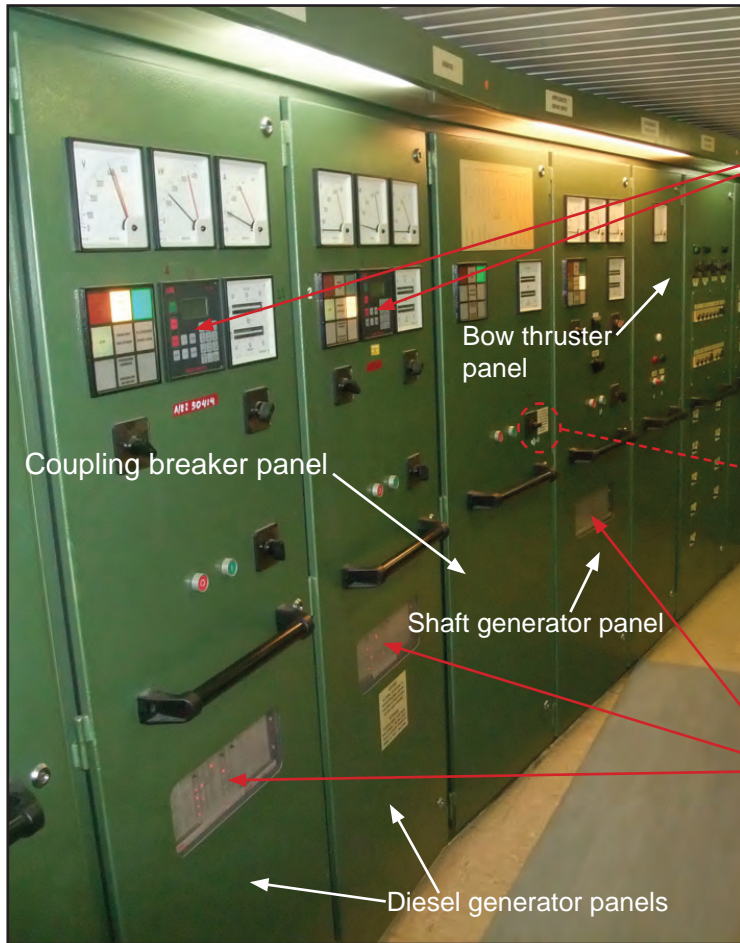
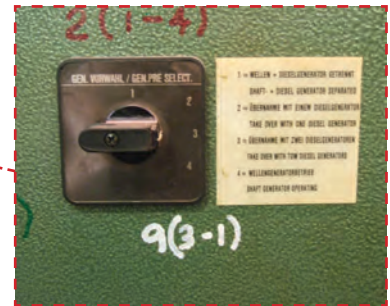
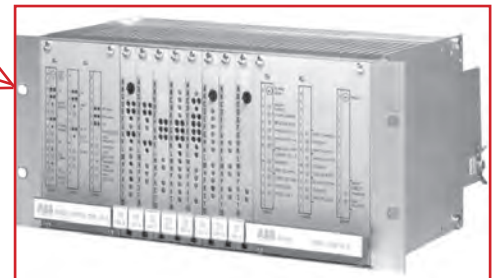
Figure 15: Switchboard protection and control devices

Following the blackout, the engineers reset the trips on the front of the Synpol panels (**Figure 15**) and then attempted to recover the main power supply with the DGs in their automatic mode and with the generator pre-selection switch set to position 3. After their first two attempts to restore power failed, the 2/E went to the poop deck and switched the emergency generator to its manual mode and stopped it. This resulted in the loss of electrical power to the ship's emergency circuits. The engineers then attempted to operate the main switchboard manually. They made several unsuccessful attempts to restore power from this blacked out condition before returning the emergency generator to its automatic mode. After each blackout the engineers recalled having to reset the DGs' high frequency trips.

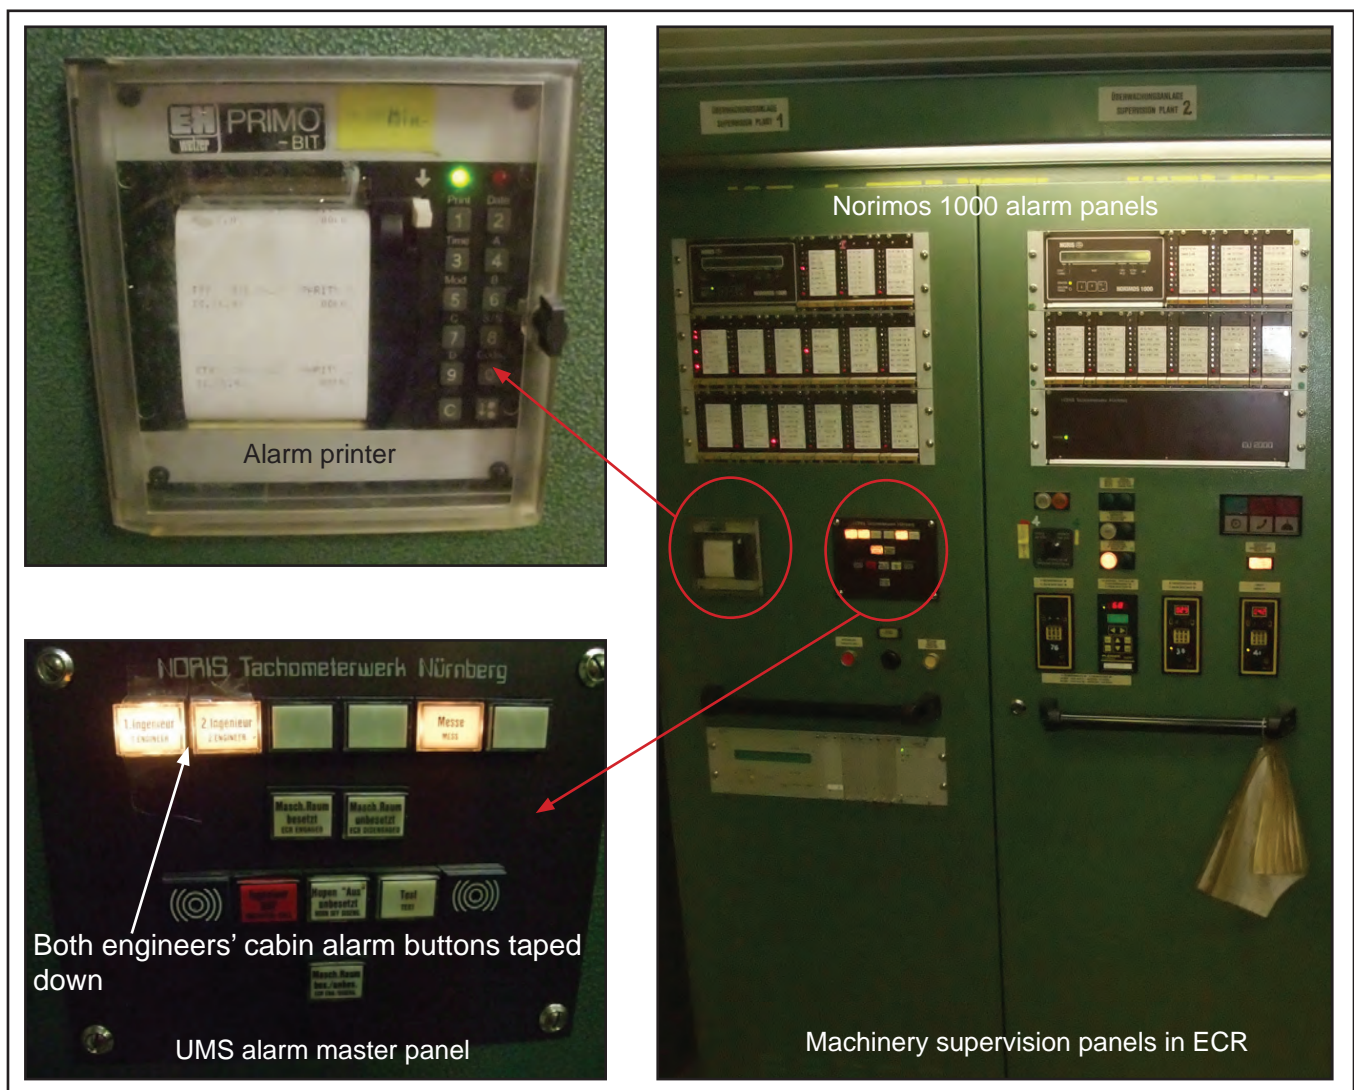
Figure 17: Noris machinery supervision system

The alarm on the SMA48 navigation panel activated on the bridge 20 seconds before the blackout. The alarm was silenced on the bridge but its activation was not recorded.

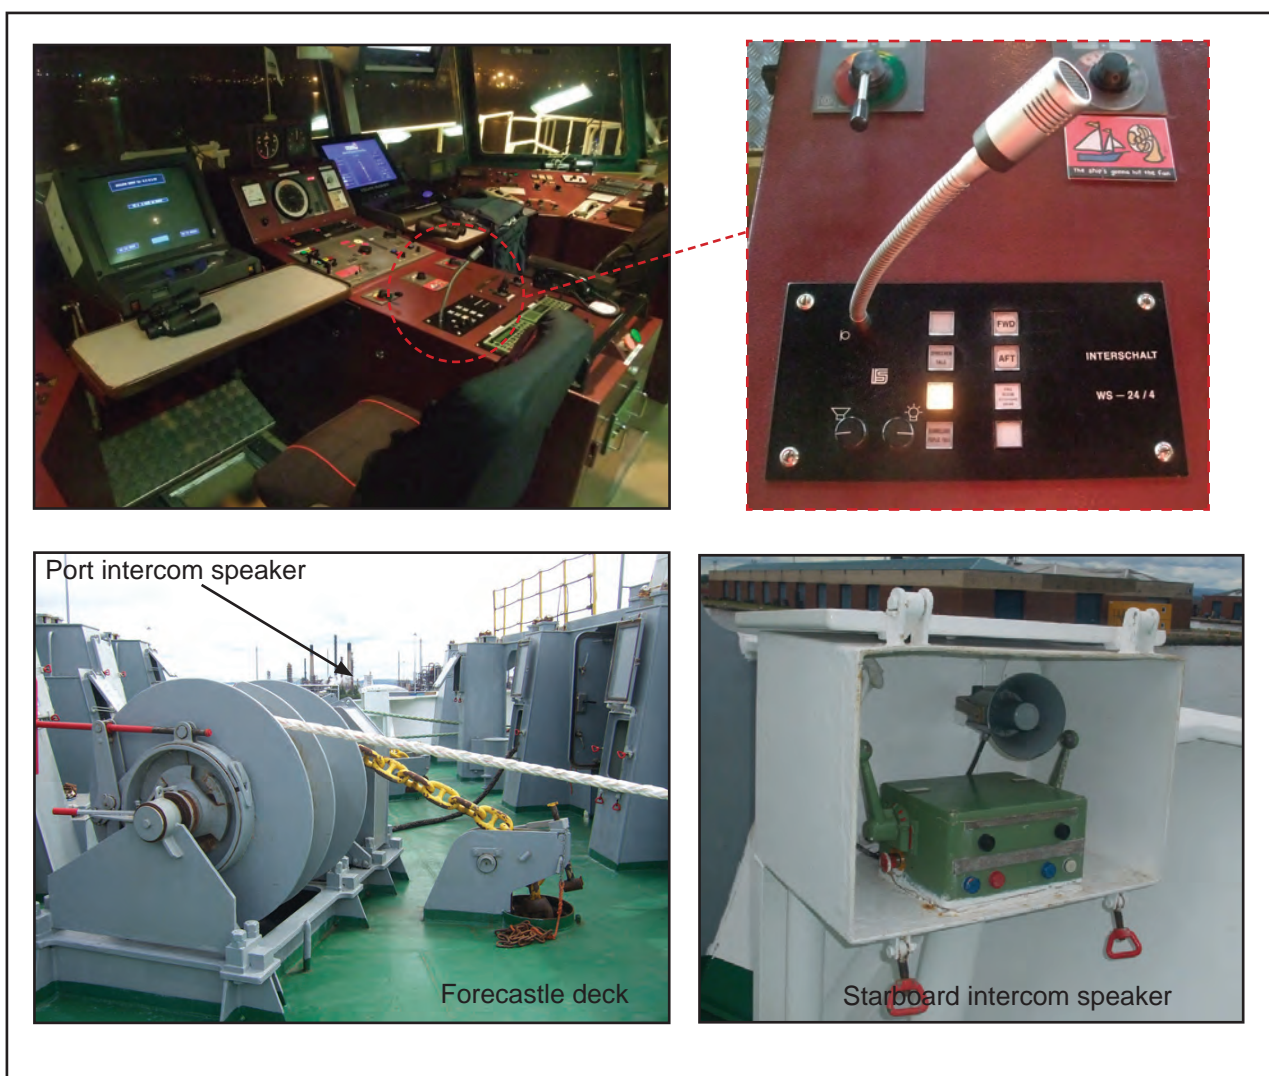
Figure 18: Internal intercom

The internal intercom provided the primary means of communication between the bridge and the deck mooring stations. However, the intercom was not used during the vessel's approach to the Tyne, or to relay messages to the forecastle after the blackout.

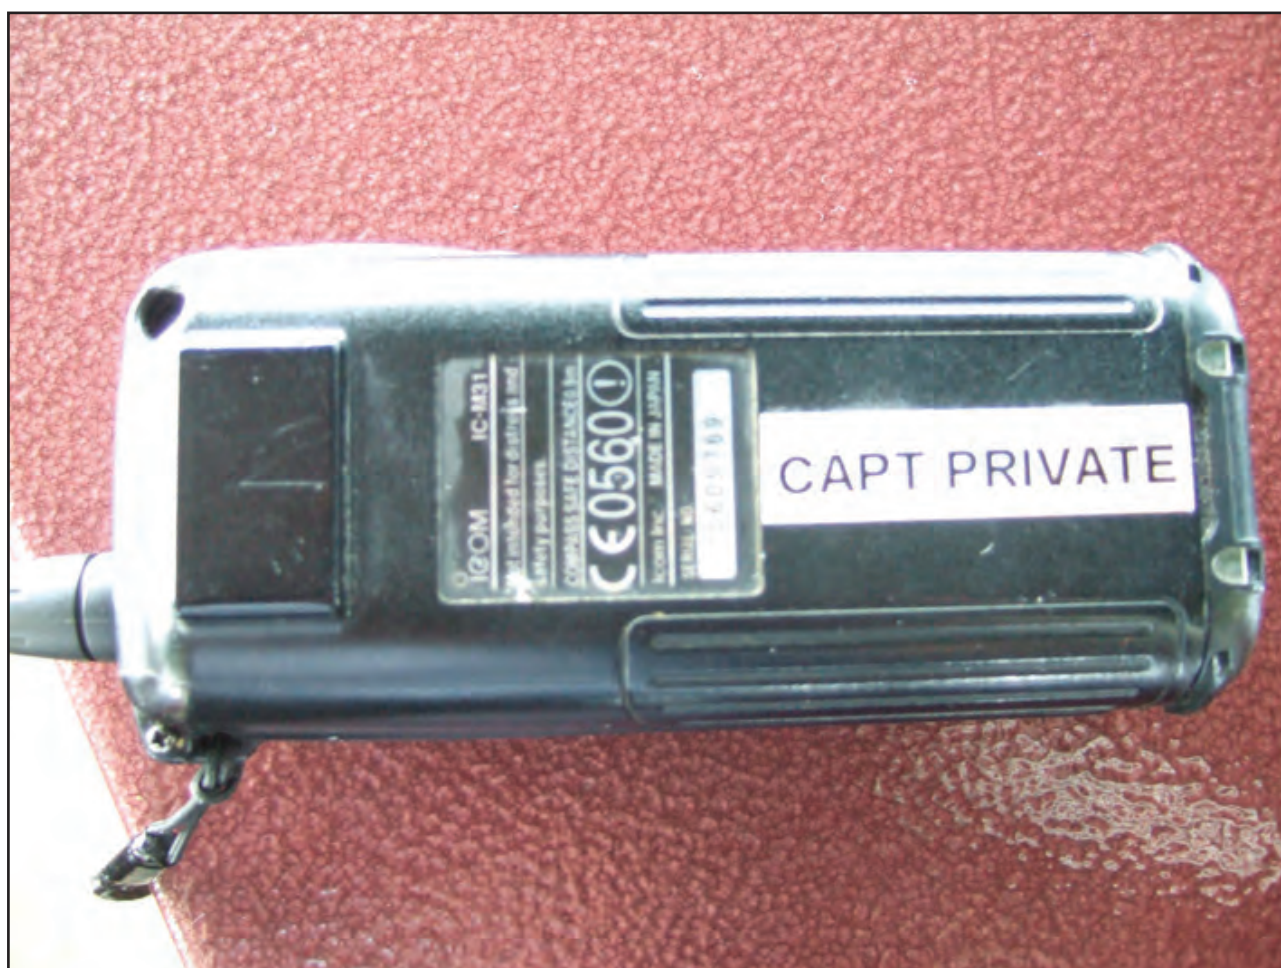
Figure 19: Master's hand-held radio

At the time of the blackout, the master's radio was in his cabin. The 2/O used his radio to relay the master's post-blackout orders to the deck crew. The 2/O and the AB communicated with each other on working channel 8 in their native Filipino language.

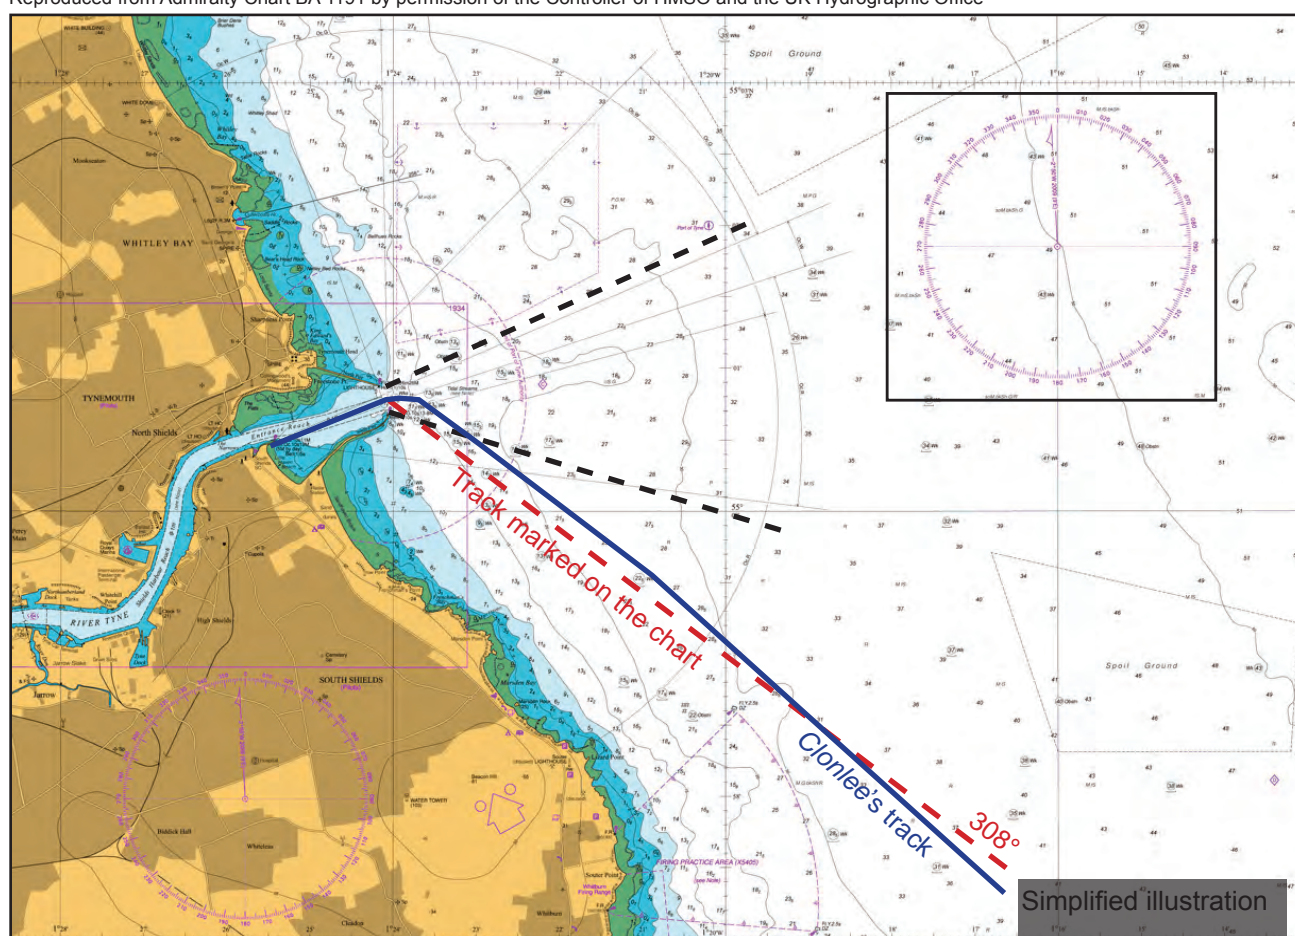
Figure 22: *Clonlee*’s approach to the River Tyne

The master took the con of his vessel for her arrival at the River Tyne when *Clonlee* was just over 3 miles SE of the breakwater entrance. He did not follow the track marked on his chart as he headed north-west towards the harbour entrance (**Figure 22**).

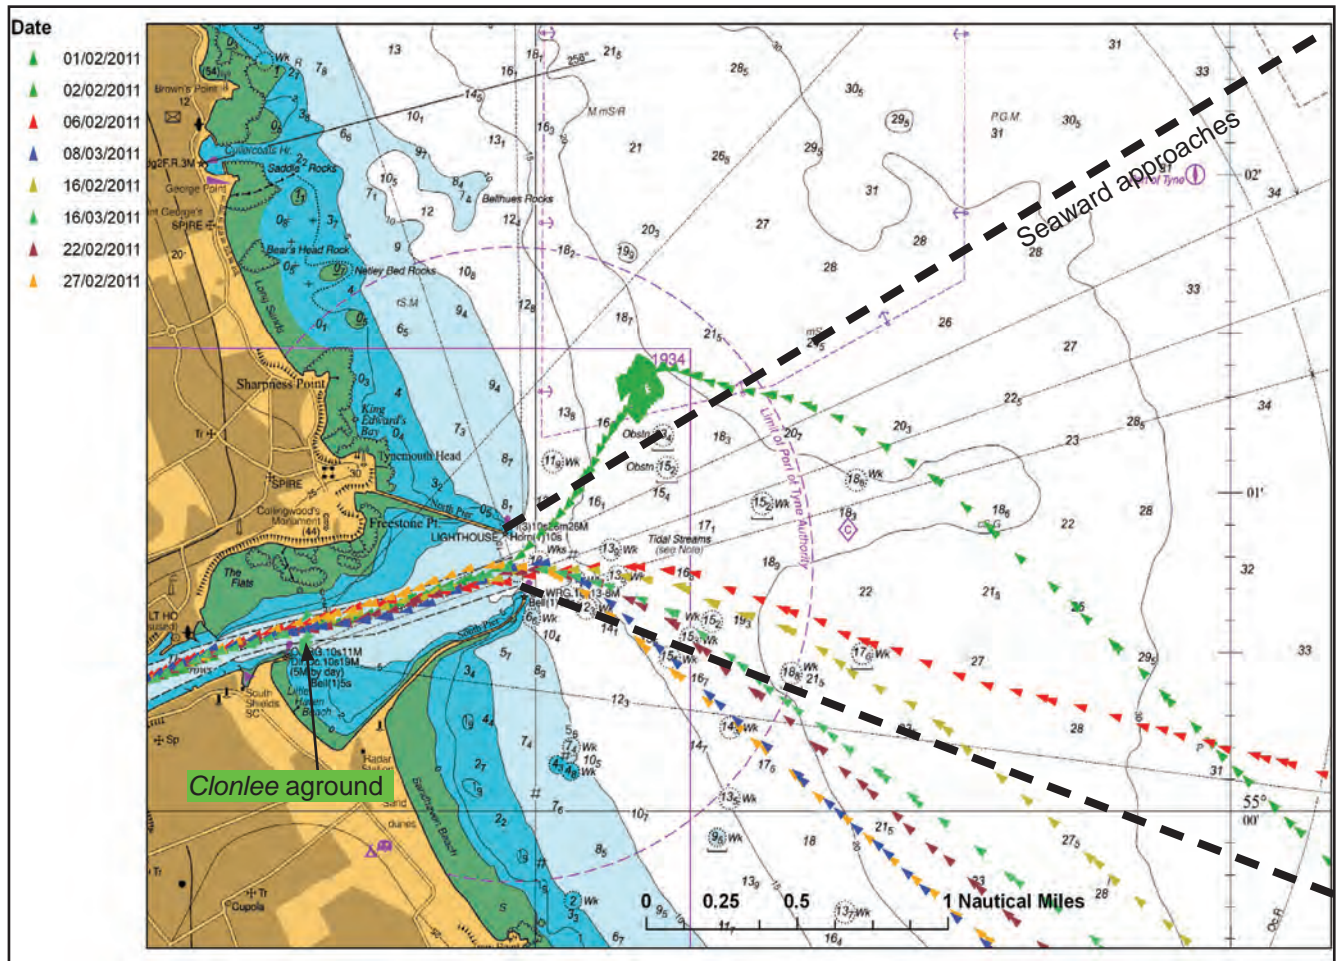
Figure 23: *Clonlee's* approaches to the River Tyne during the two month period immediately prior to the accident

A review of *Clonlee's* previous approaches to the River Tyne from the south during the 2-month period prior to the accident (**Figure 23**) identified that this manoeuvre was not an isolated occurrence, but was common practice. It was clearly apparent that the repetitive nature of the vessel's operations had led to the bridge team adopting a complacent approach to passage planning and basic navigational practices.
