Report on the investigation of
the collision between the container ship

Cosco Hong Kong

Zhe Ling Yu Yun 135

resulting in the loss of 11 lives

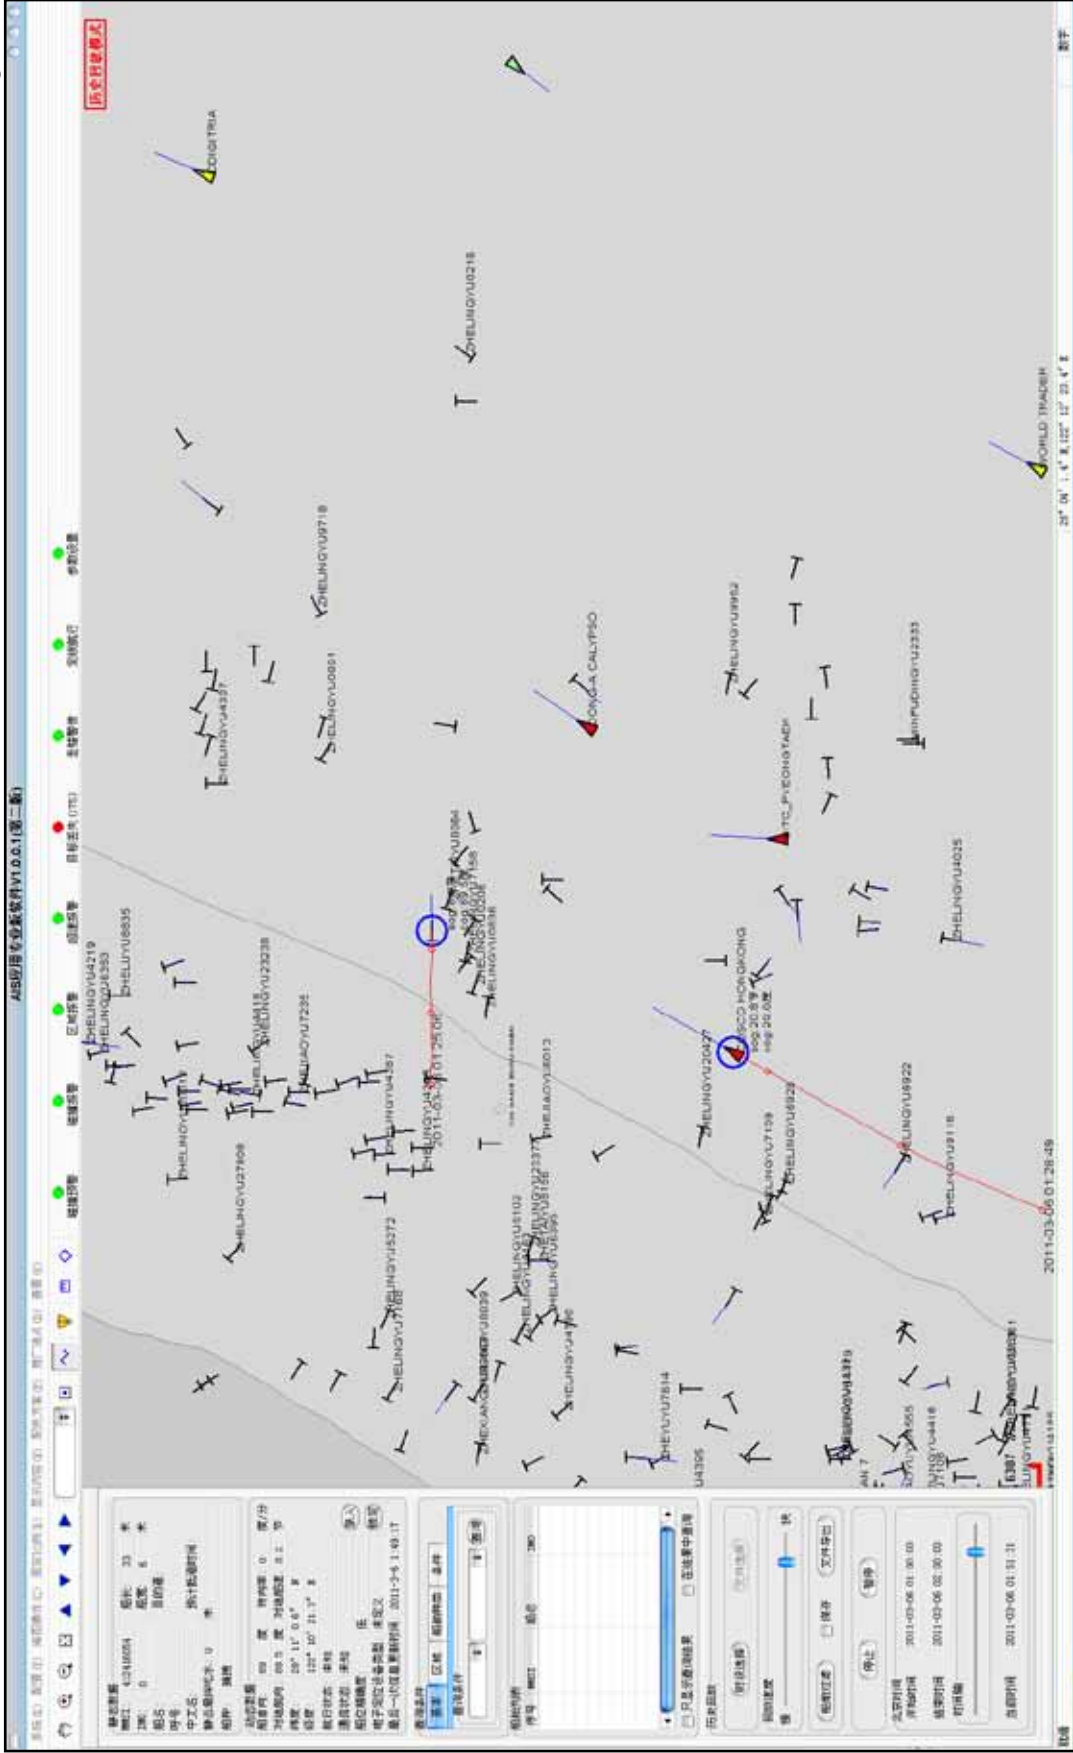
Figure 2

AIS screen-shot at 0149

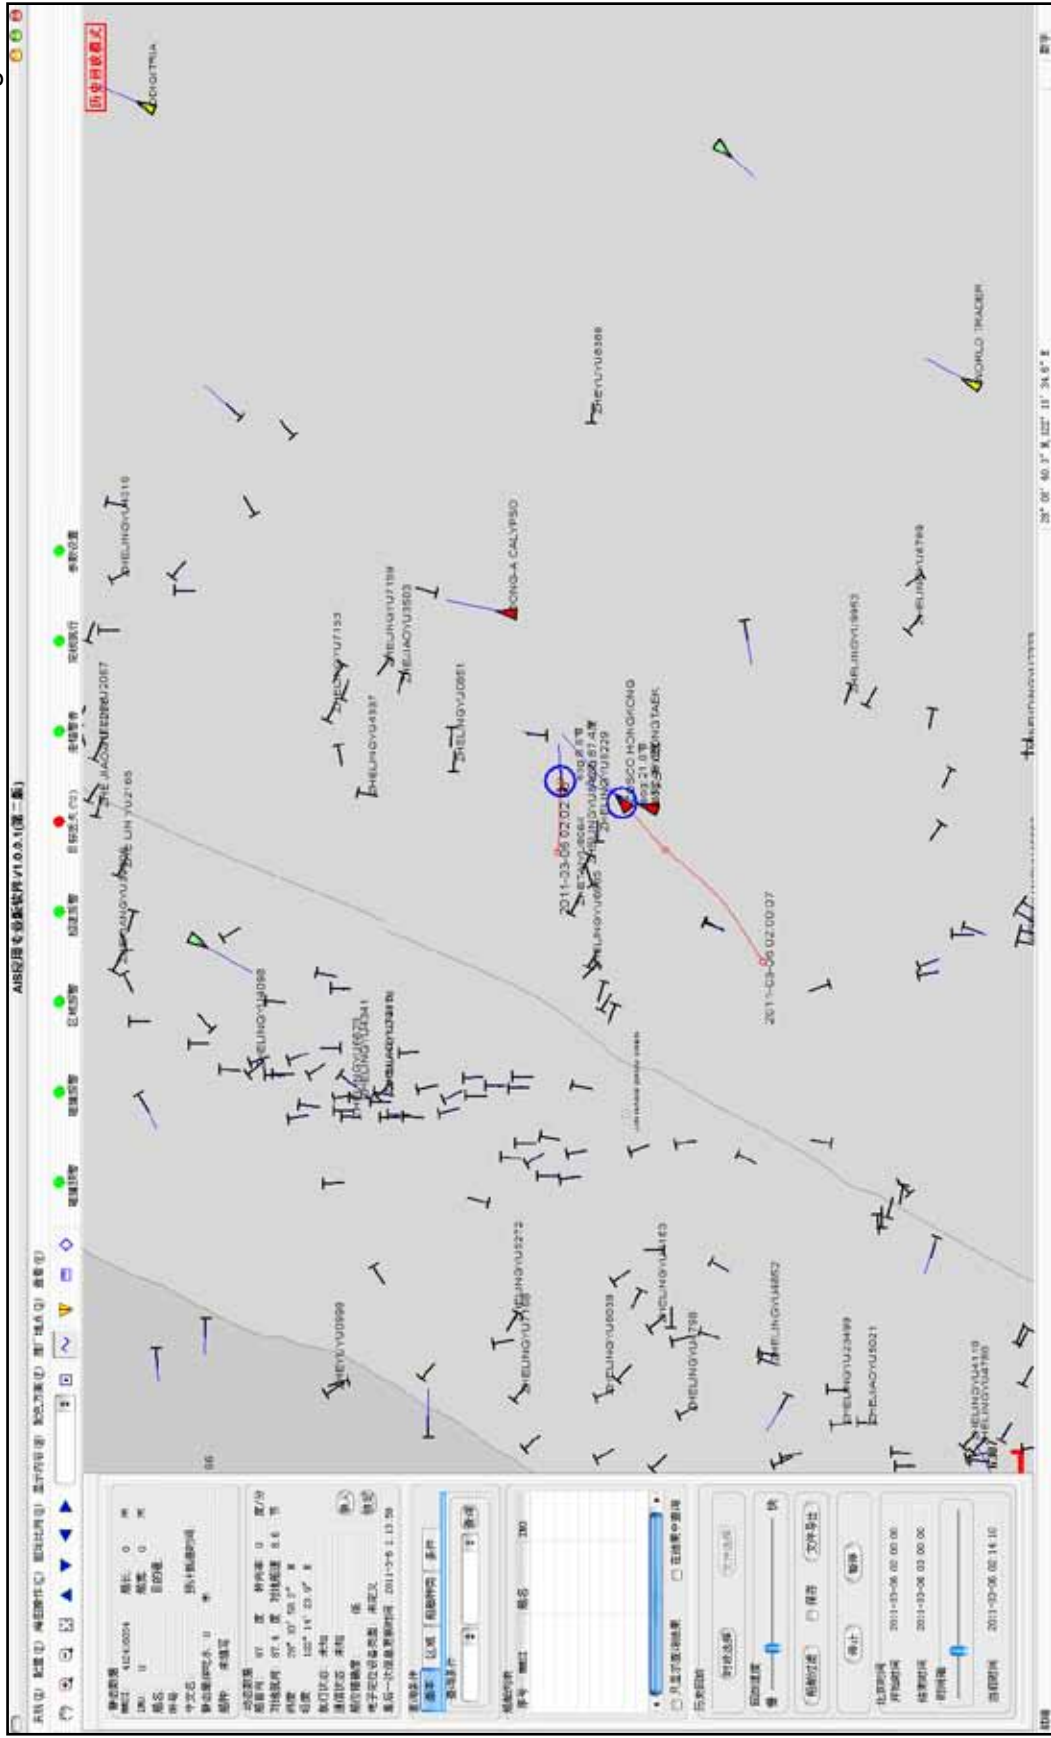
Figure 5

AIS screen-shot at 0214

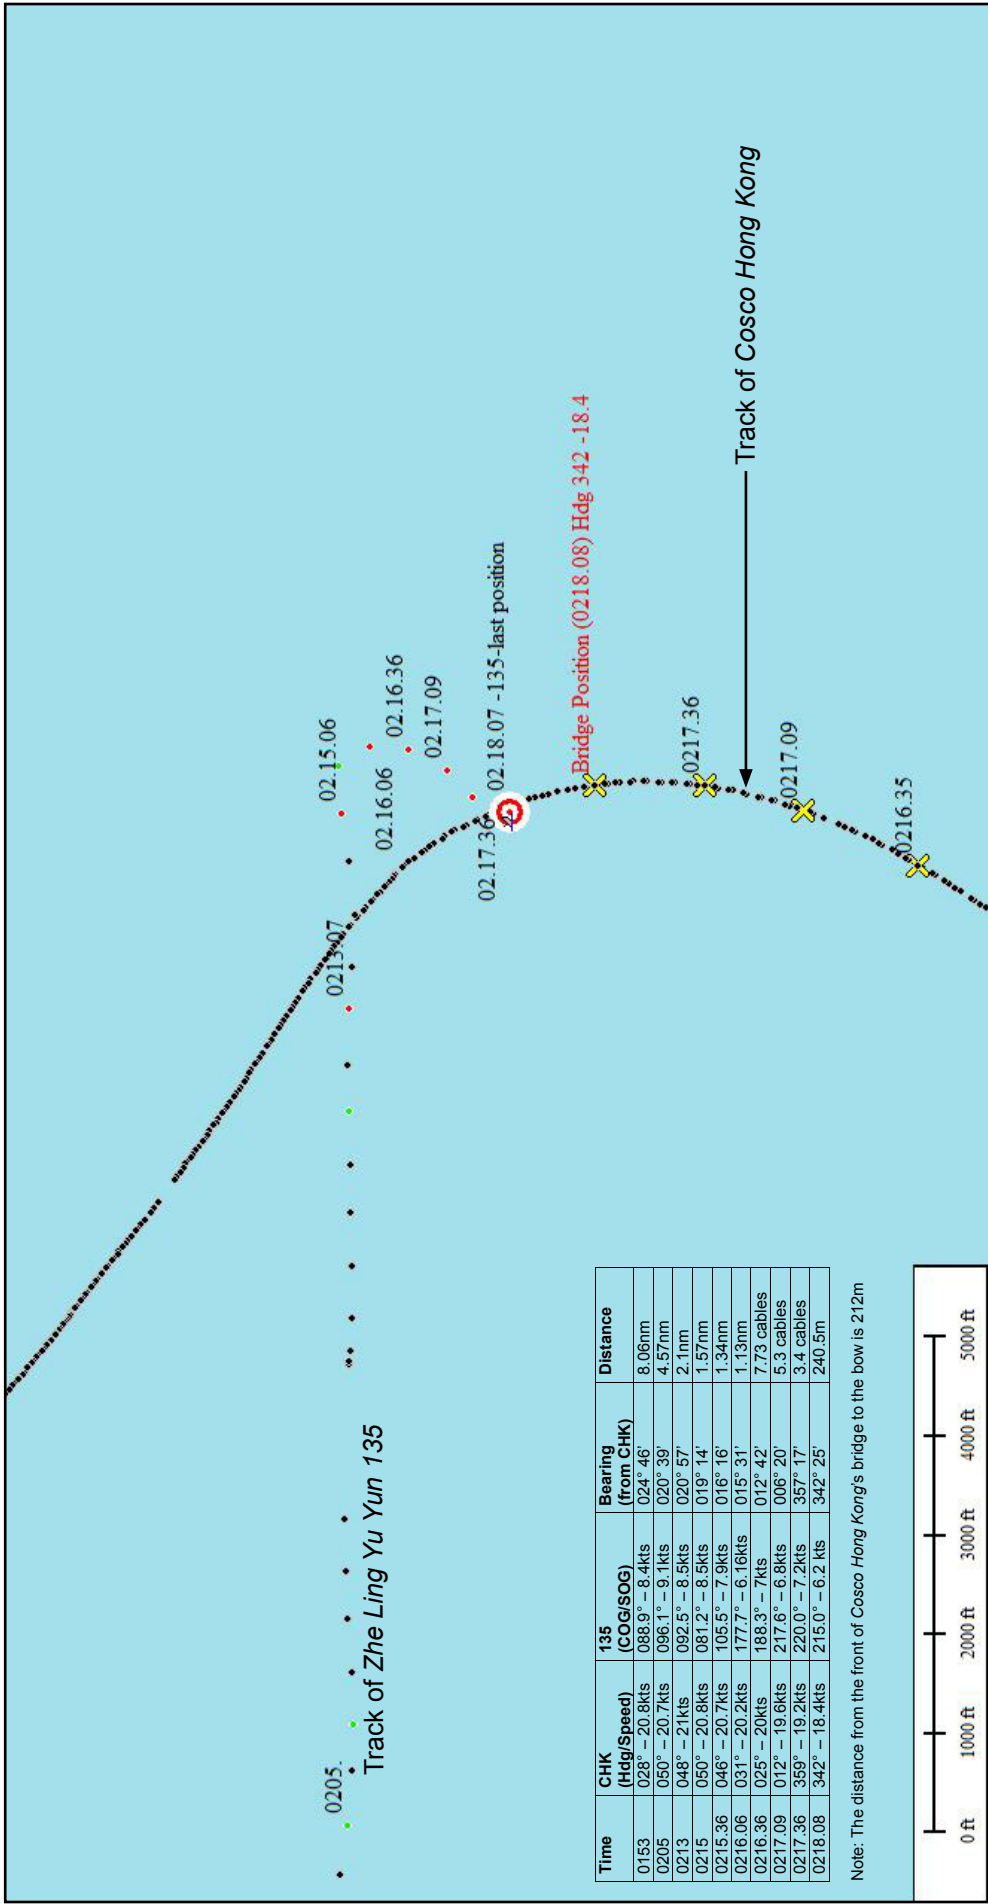
Figure 7 shows the reconstruction of the ground tracks of *Cosco Hong Kong* and *Zhe Ling Yu Yun 135* based on SVDR and AIS information respectively. From the reconstruction, it has been determined that *Cosco Hong Kong*'s bow struck *Zhe Ling Yu Yun 135* seconds after the fish transporter's last AIS transmission at 0218.07 when *Cosco Hong Kong*'s heading was passing through 342° and her speed was 18.4kts.

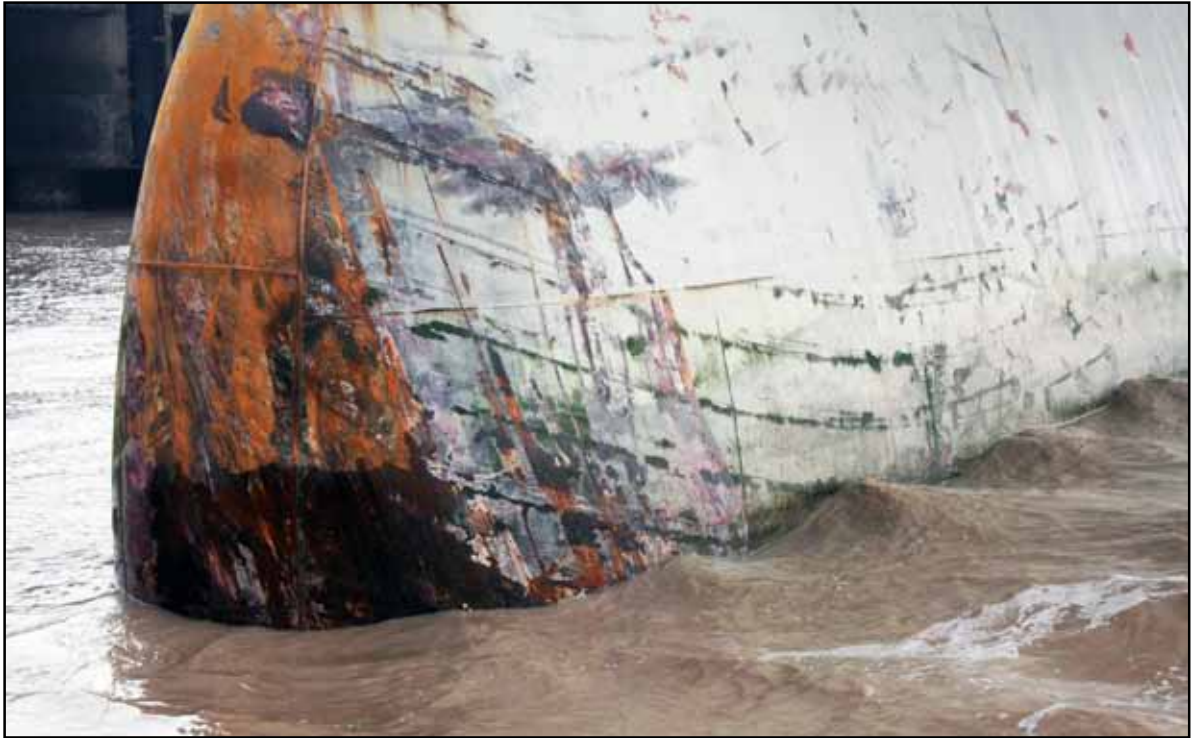
Figure 8

Review of AIS information by the Taizhou MRCC indicated that the vessel's position had last been transmitted at 0218 when very close to *Cosco Hong Kong*. At 0100 on 7 March 2011, the Maritime Safety Administration People's Republic of China (MSA) contacted *Cosco Hong Kong* through the vessel's commercial agent and instructed the master to save the information on the vessel's voyage data recorder (VDR). This action was taken by the master about 10 minutes later. Subsequent inspection of *Cosco Hong Kong's* hull identified paint damage and paint marks on her bulbous bow (**Figure 8**).

Marks on *Cosco Hong Kong's* bulbous bow

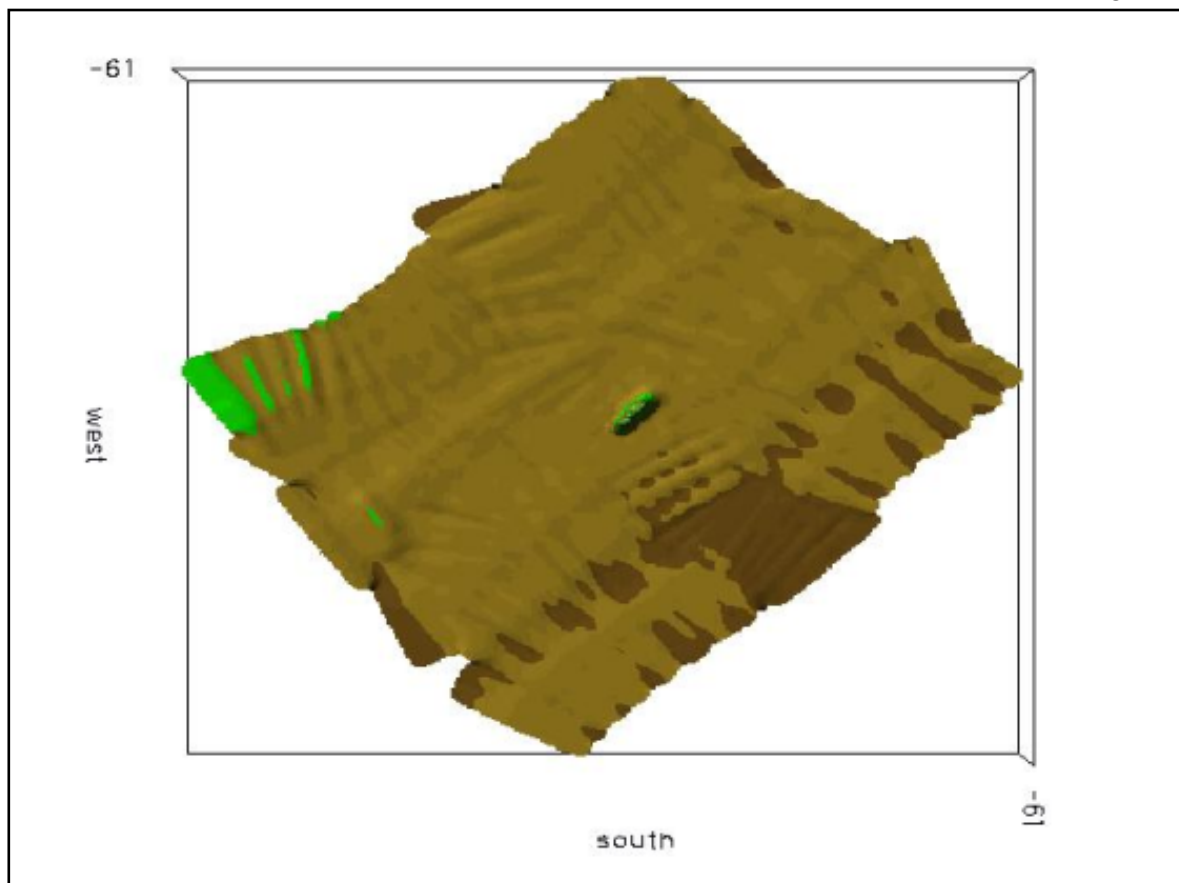
Side-scan sonar image of the wreck of *Zhe Ling Yu Yun 135*

The wreck of *Zhe Ling Yu Yun 135* lies only 30m from the position where the vessel last transmitted on AIS, which was at 0218.07, seconds before the collision. The fish transporter's contact with the container ship's bulbous bow at a closing speed in excess of 20kts would undoubtedly have resulted in catastrophic damage to the fish transporter. Given the position of the wreck, together with the lack of any radar or visual evidence of her being afloat after the collision, and the absence of any calls for assistance on VHF radio, it can only be concluded that *Zhe Ling Yu Yun 135* sank almost immediately after being struck. Consequently, as many of her crew would probably have been asleep in the vessel's accommodation, only the crew who were in the wheelhouse would have had any chance of escaping.
