Collision between **MV BOXFORD** and **FV ADMIRAL BLAKE** 29nm south of Start Point, English Channel 11 February 2011

SUMMARY

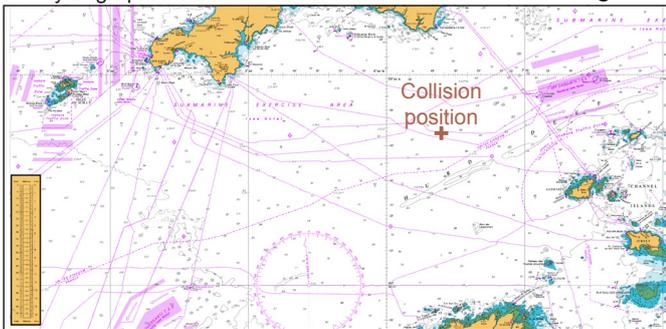
Figure 3

Extract of chart BA 2675 showing position of collision

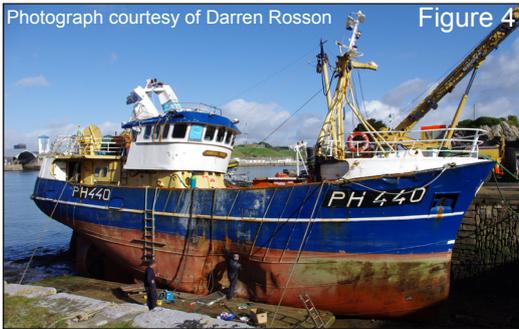
Admiral Blake was severely damaged in the collision and began taking water in the fish hold and storage tanks through a split in her hull plating. Although her pumps were initially able to cope with the water ingress, she later took an additional pump on board from a lifeboat. Further damage included the distortion and buckling of the starboard bulwark, the demolition of the main mast, aerials and lights, and the bending or removal of several deck vents and pipes (**Figures 4 and 5**). *Admiral Blake* was towed to her home port of Plymouth, England by one of the RNLI lifeboats.

Admiral Blake - damage to starboard hull

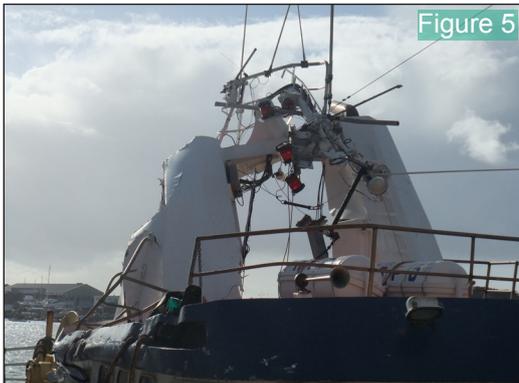
Admiral Blake - damage to main mast

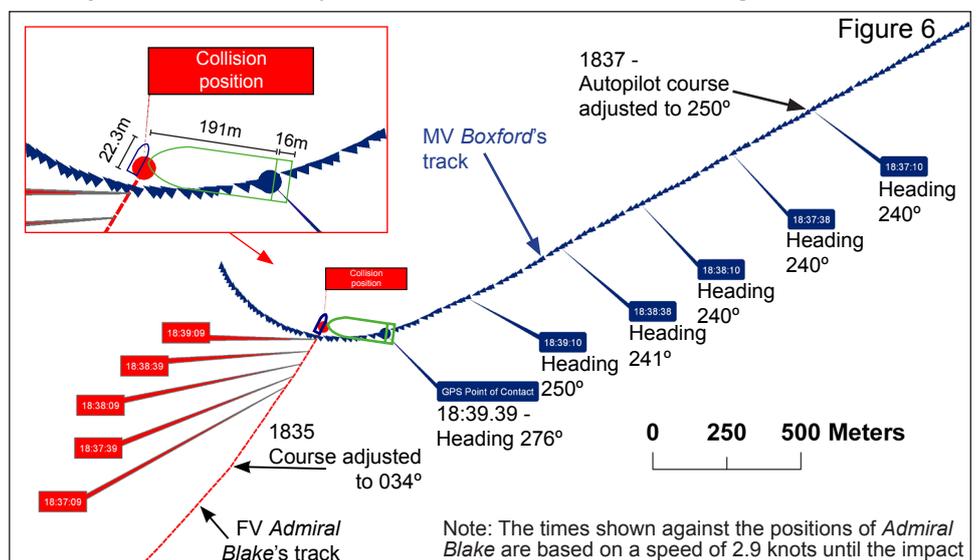
GPS reconstruction of the ground tracks of vessels

approximately 1837, *Admiral Blake* passed ahead of *Boxford* at a distance of about 1nm. If both vessels had then maintained their courses, *Admiral Blake*'s closest point of approach (CPA) to *Boxford* would have been about 3 cables on the container ship's starboard side. The collision directly resulted from *Boxford*'s alterations of course to starboard from 1837 onwards.

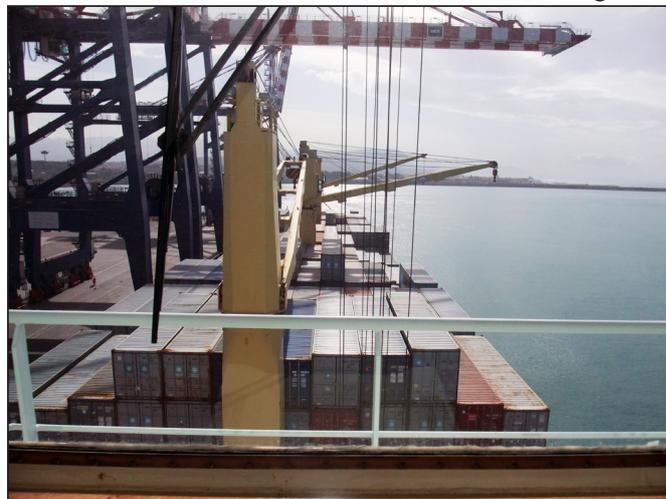
Figure 7

movement in the moderate sea and 4-5m swell, the variable visibility, and the view ahead being partially obstructed by the uprights of the vessel's deck cranes (**Figures 1 and 7**). It is also possible that the inexperienced cadet only reported the light to the master when he could see it clearly.

MV *Boxford*'s view ahead partially obstructed by the uprights of the deck cranes

- The collision occurred because of an alteration of course by *Boxford* directly towards *Admiral Blake* when the vessels were only 2 cables apart.
- The bridge team on *Boxford* first sighted *Admiral Blake* when the vessels were only about 1nm apart probably due to the prevailing visibility and sea conditions, and the partial obstruction of the view ahead by the uprights of the vessel's cranes.
