Report on the investigation of the fatality
of a rescue boat crewman on board

Tombarra

at Berth 3, Royal Portbury Docks,

Part B - The weight of the rescue boat

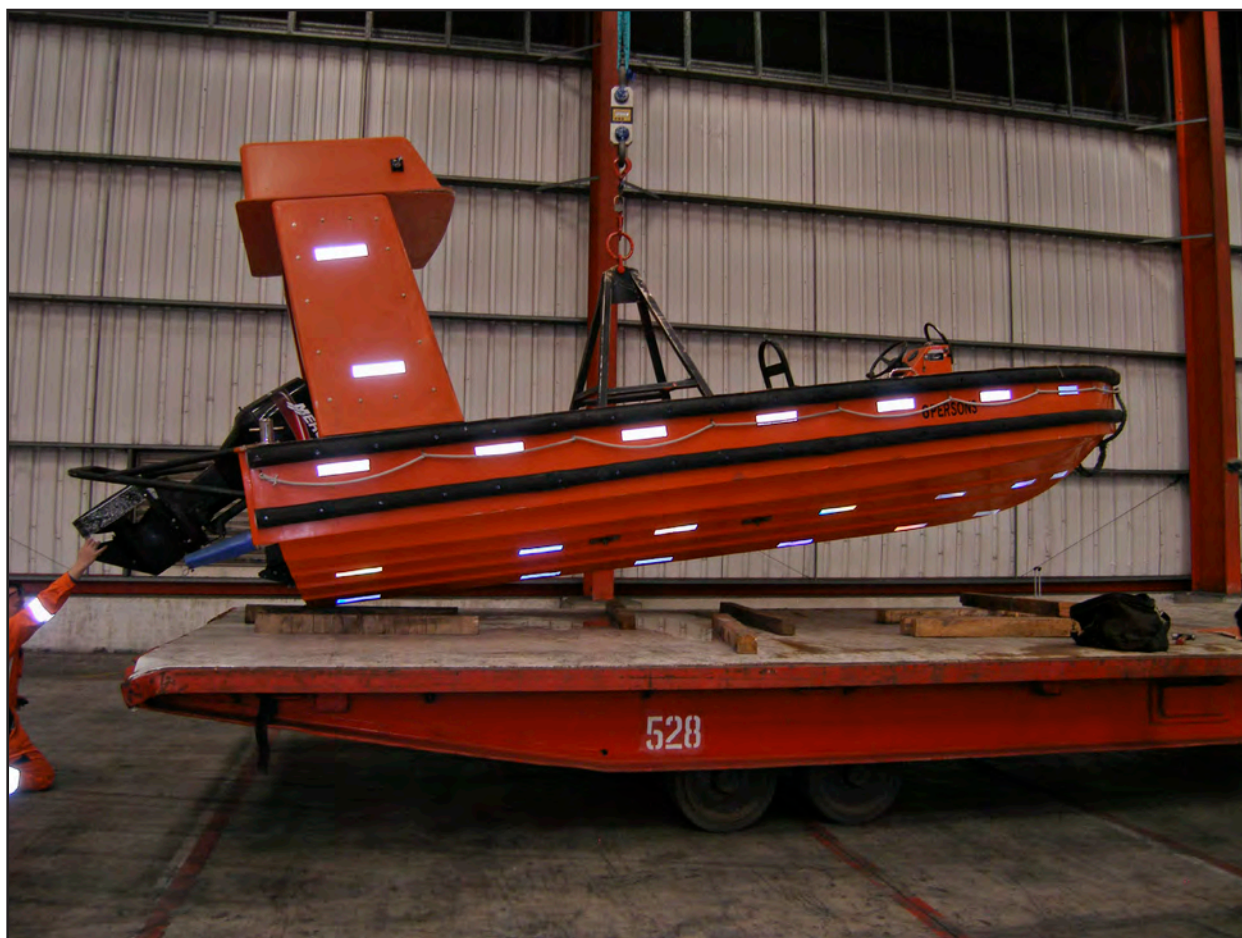
Figure 1: Rescue boat when weighed

Although the weight of the boat exceeded the Safe Working Load (SWL) of the davit, the weight of the boat did not contribute substantially to the failure of the fall wire (see **MAIB report 19A/2012 – Part A**). However, the higher than expected weight of the rescue boat, and the results from inspections of the buoyancy spaces within the boat's hull, prompted Wilhelmsen Lines Car Carriers Ltd (WLCCL), *Tombarra's* ship manager, to weigh other rescue boats in its fleet. It became quickly evident that other WHFRB 6.50 rescue boats were also overweight and that further investigation was warranted.

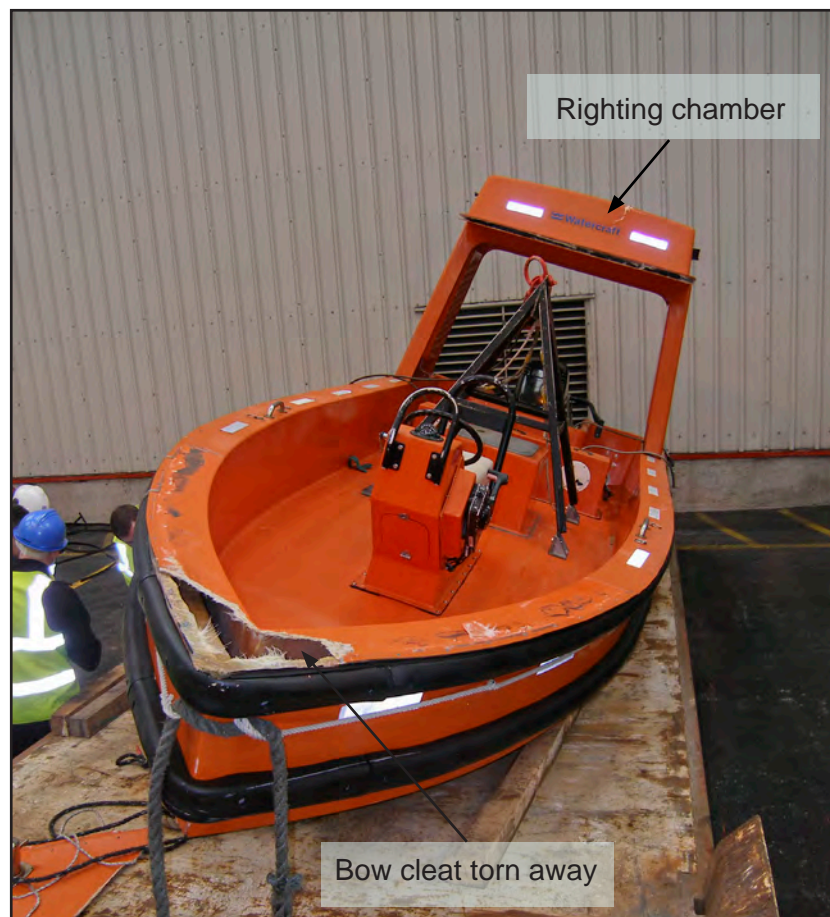
Initial inspection indicated that the damage to the boat caused by its fall and subsequent recovery from the water was relatively minor, and included: the separation of the forward seam of the buoyant righting chamber and fracture of its upper surface (**Figure 2**); a section of the glass reinforced plastic (GRP) surrounding the bow cleat had been torn away (**Figure 2**); and several joint rivets at the gunwale port side joint of the righting chamber frame had failed (**Figure 3**). A previous hull repair was also evident (**Figure 4**).

Figure 2: Damage to buoyant righting chamber and bow

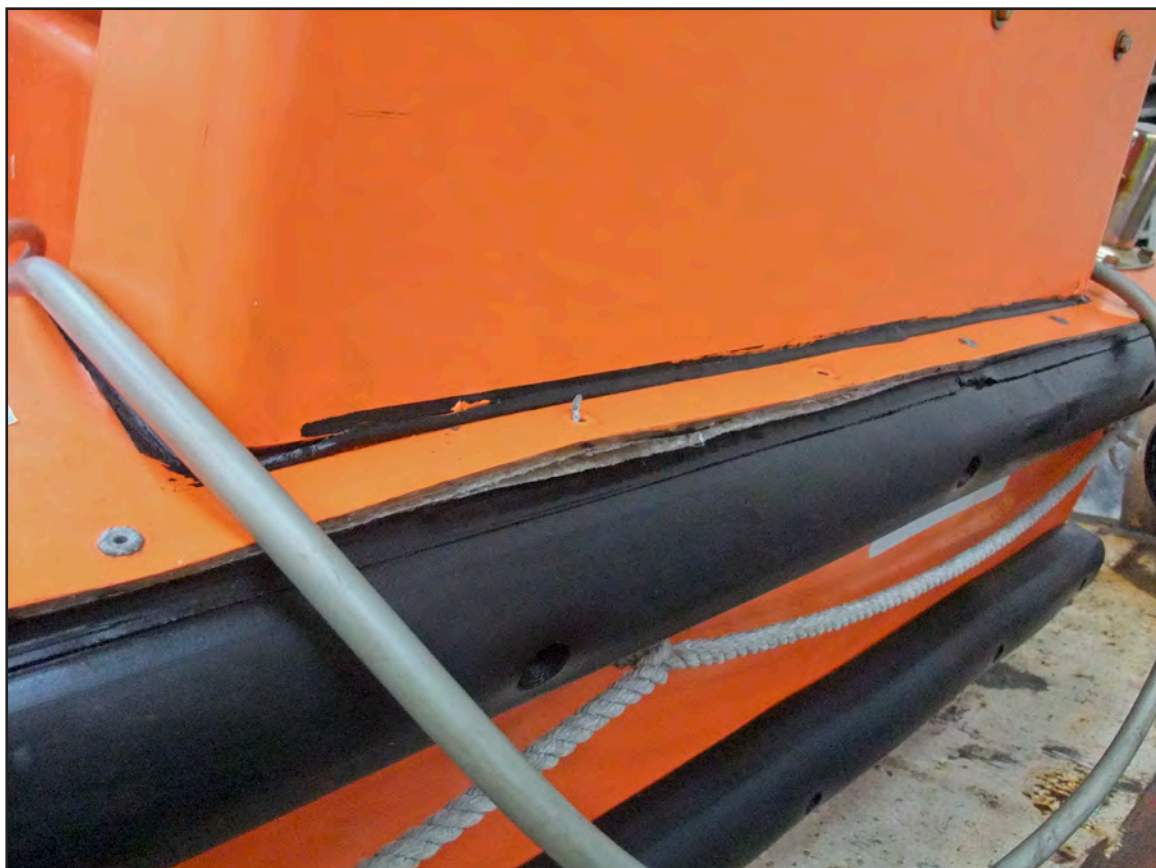
Figure 3: Failure of rivets on port gunwale

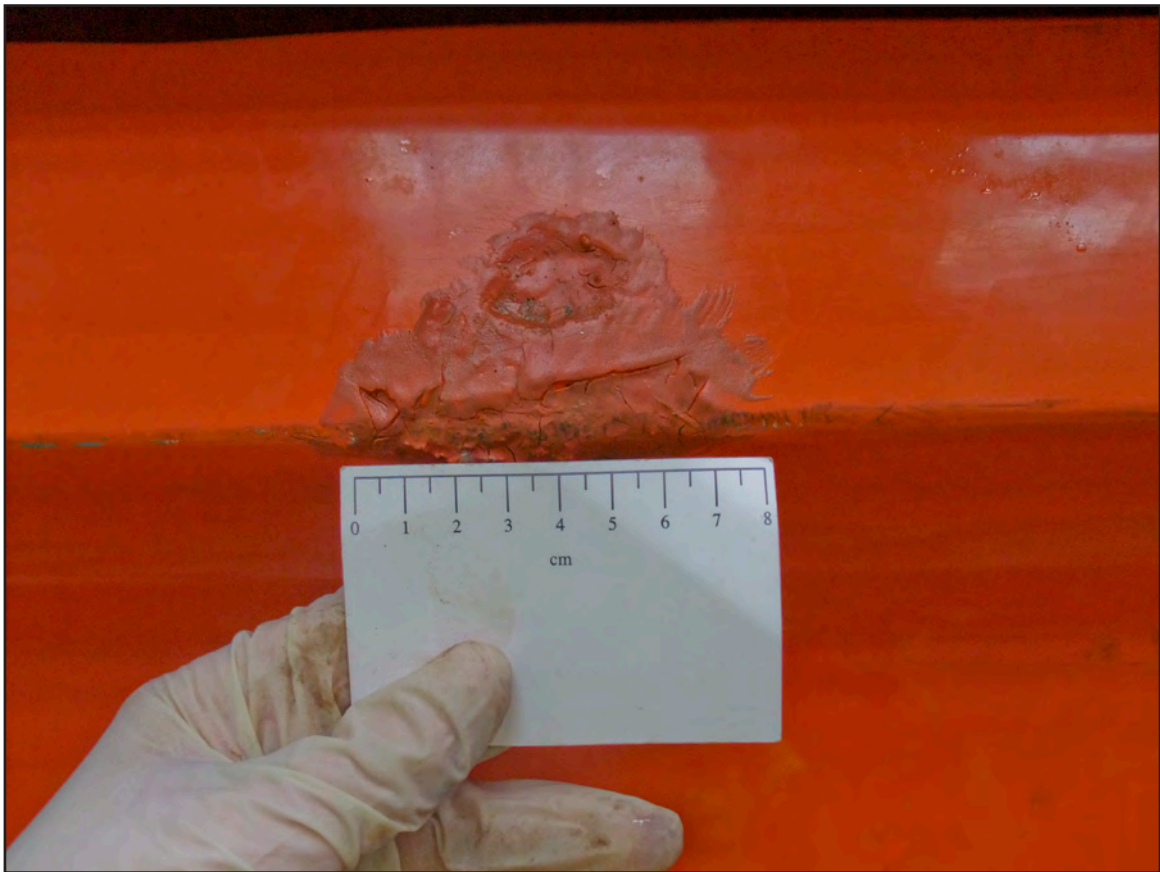
Figure 4: Hull damage repair

The starboard side of the hull was found repaired in a bad manner and osmosis had appeared. This could also be a possible area of water penetration in all compartments.

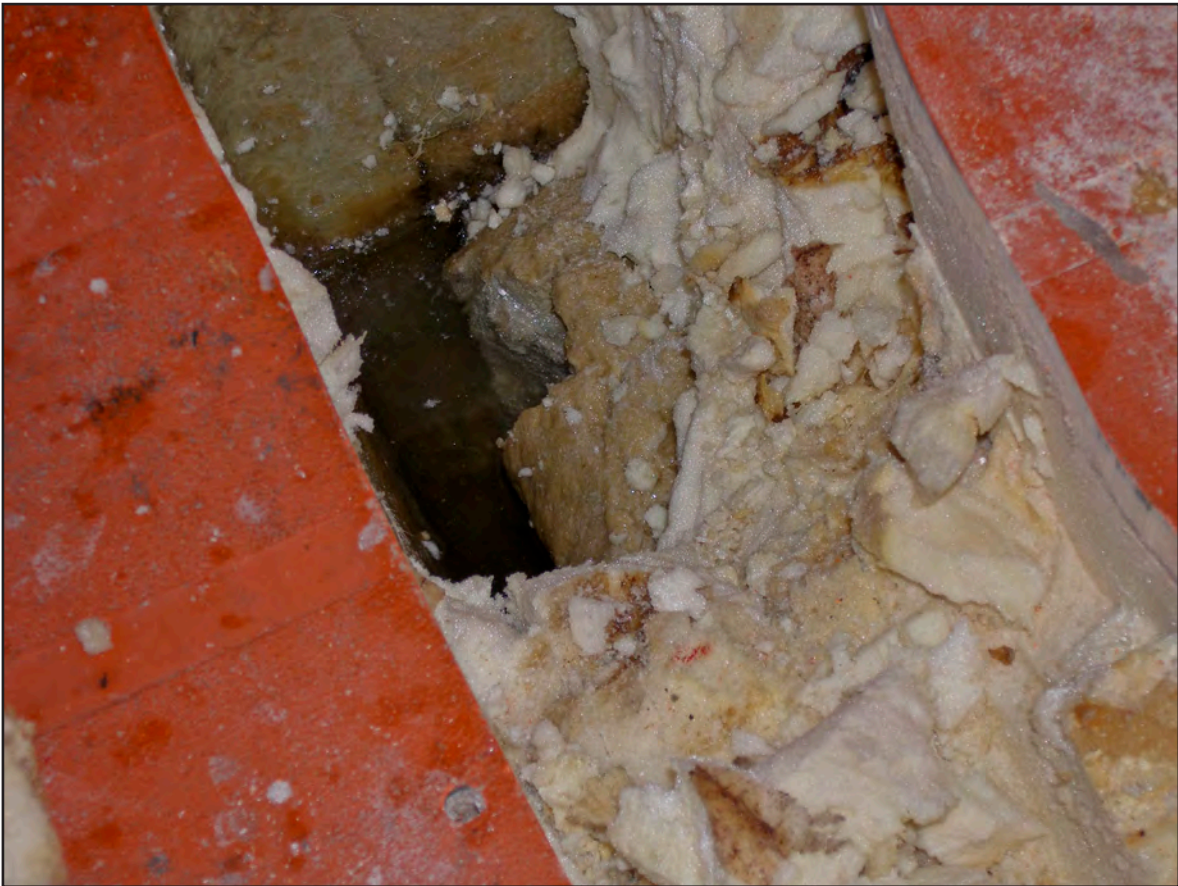
Sections of the deck were cut open in three locations (forward, midships and aft). The mid position, aft of the lifting frame, was found to contain voids, free water, and what appeared to be degraded or poorly made PU foam in the lower part of the foam buoyancy space (**Figures 10 and 11**). The gap between the stiffener and the underside of the deck was clearly visible (**Figure 11**). The buoyancy spaces opened forward and aft were in a similar condition, but not to the same degree. Fifteen holes were drilled into the hull's hollow stiffeners and water drained from 14 of them (**Figure 12**). NWH's inspection report (**Annex A**) identified several possible routes, other than the damaged areas, through which water could have entered the hull. These included:

Figure 10: Free water in buoyancy space

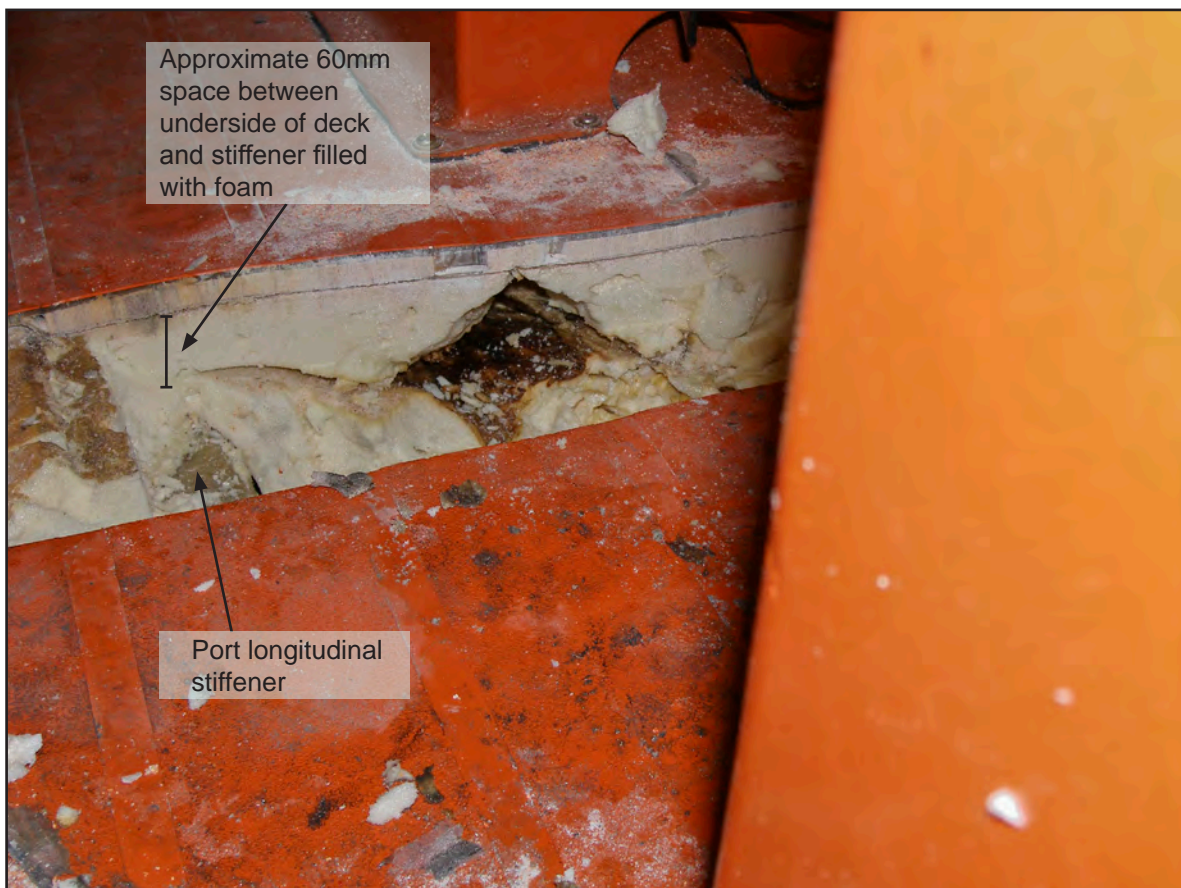
Figure 11: Degraded foam and void

Bayer's analysis of the foam from *Tombarra's* rescue boat indicated that the lower layer of the foam, which was darker and more brittle than the upper layer, had been poorly mixed and also possibly contained a higher proportion of Polymeric Methylene Diphenylene Isocyanate (PMDI) than recommended⁴. As a result, the darker foam had a high proportion of open cells, that had allowed water to penetrate the foam. However, the characteristics of the darker foam were considered to result from processing errors rather than from the foam coming into contact with water. In support of its conclusion, Bayer produced two foam samples for reference (**Figures 16 and 17**). Both samples were made using the correct ratio of constituents, but were mixed at different speeds. One sample, which was considered by the manufacturer to be representative of the quality expected, was mixed at a speed of 2500rpm, and the other at 150rpm. The appearance and feel of the sample mixed at the lower speed was similar to the samples removed from the lower hull of the rescue boat, while the samples mixed at the higher speed were similar to the foam found in the upper section of the boat.

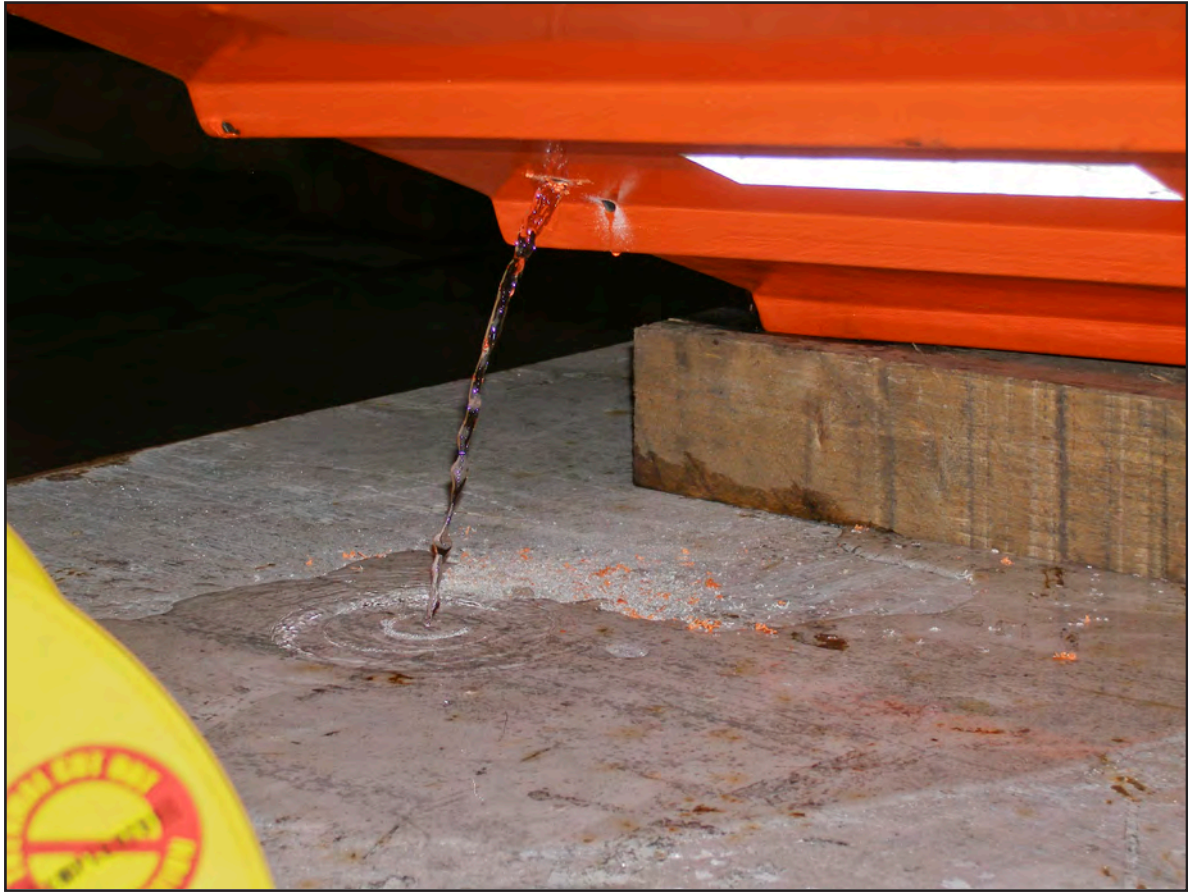
Figure 12: Water draining from drilled hole

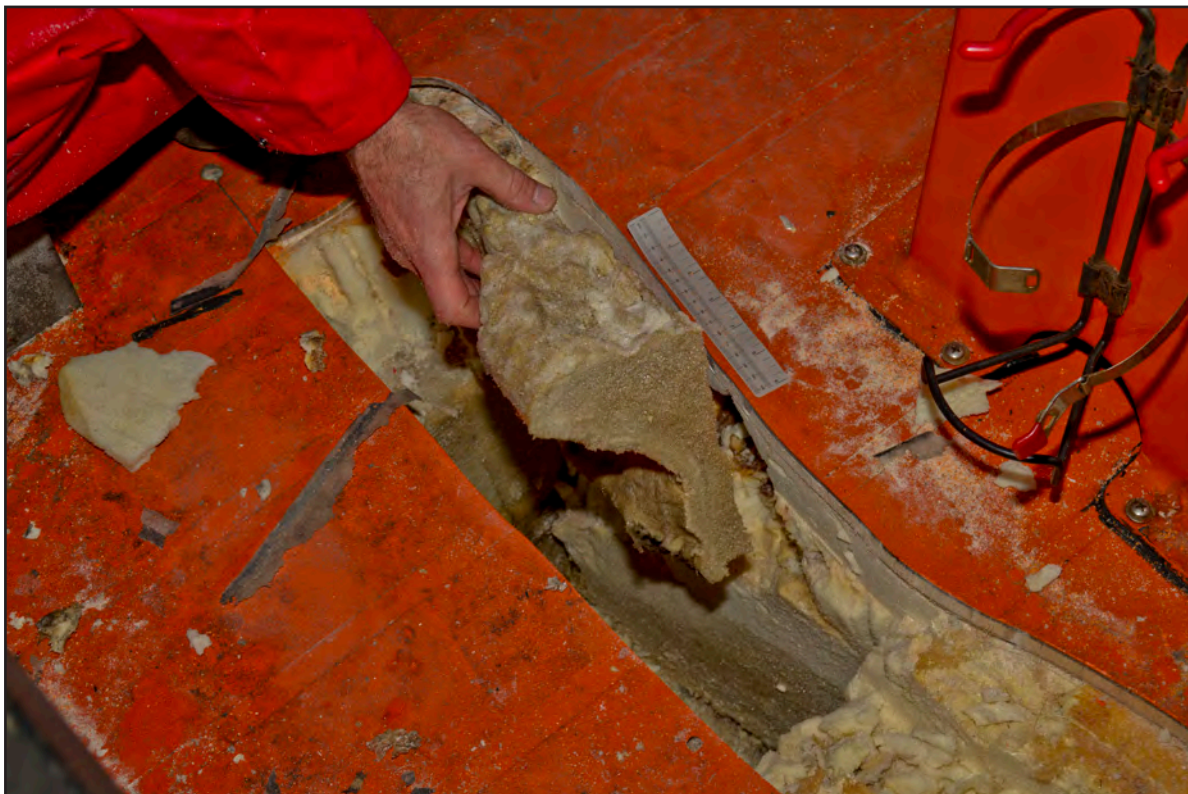
Figure 13: Void within foam

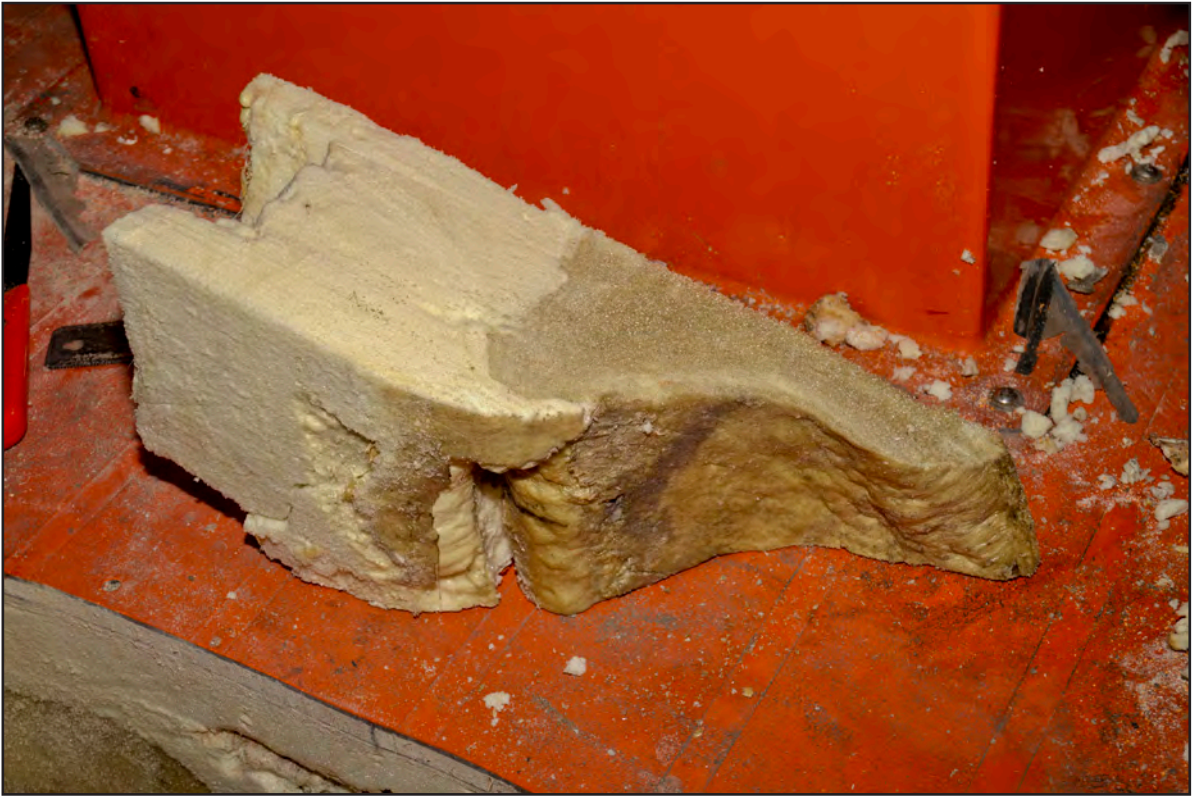
Figure 14: Demarcation line through foam

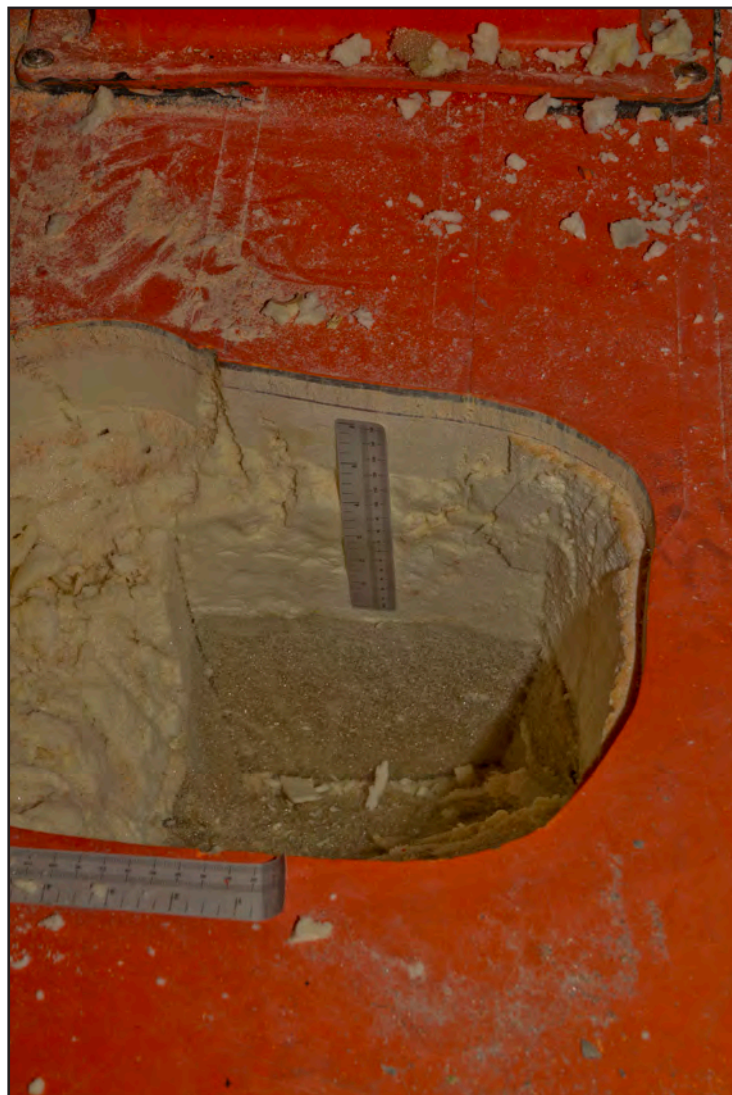
Figure 15: Foam demarcation - forward opening

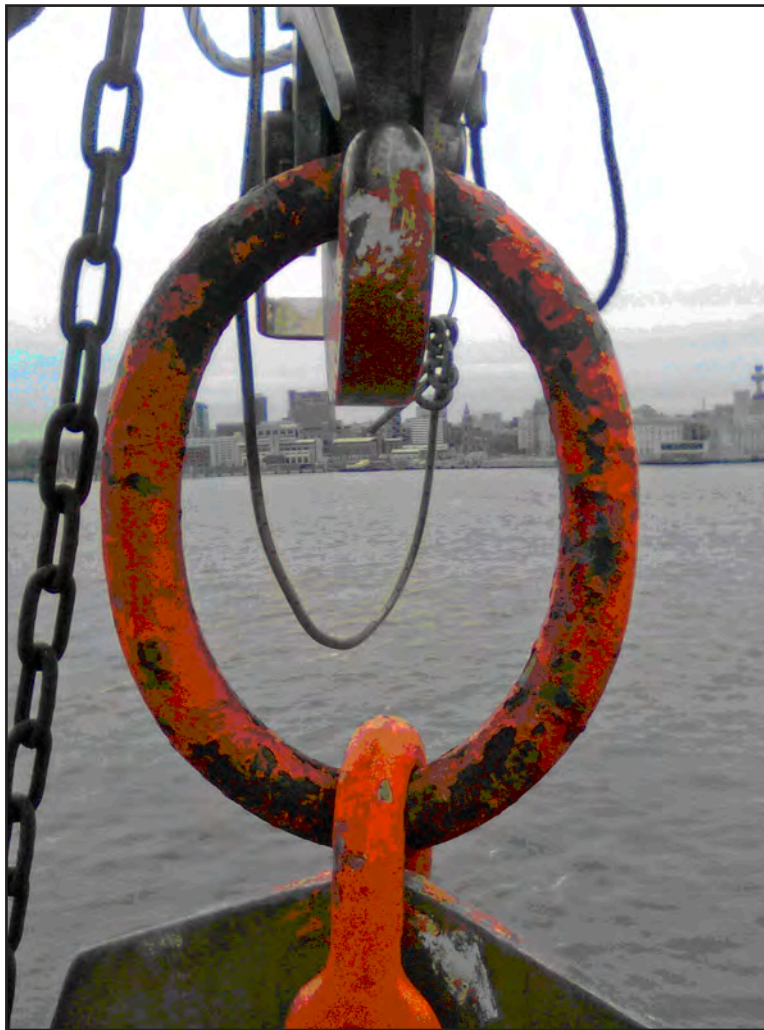
Figure 18: Stretched lifting ring

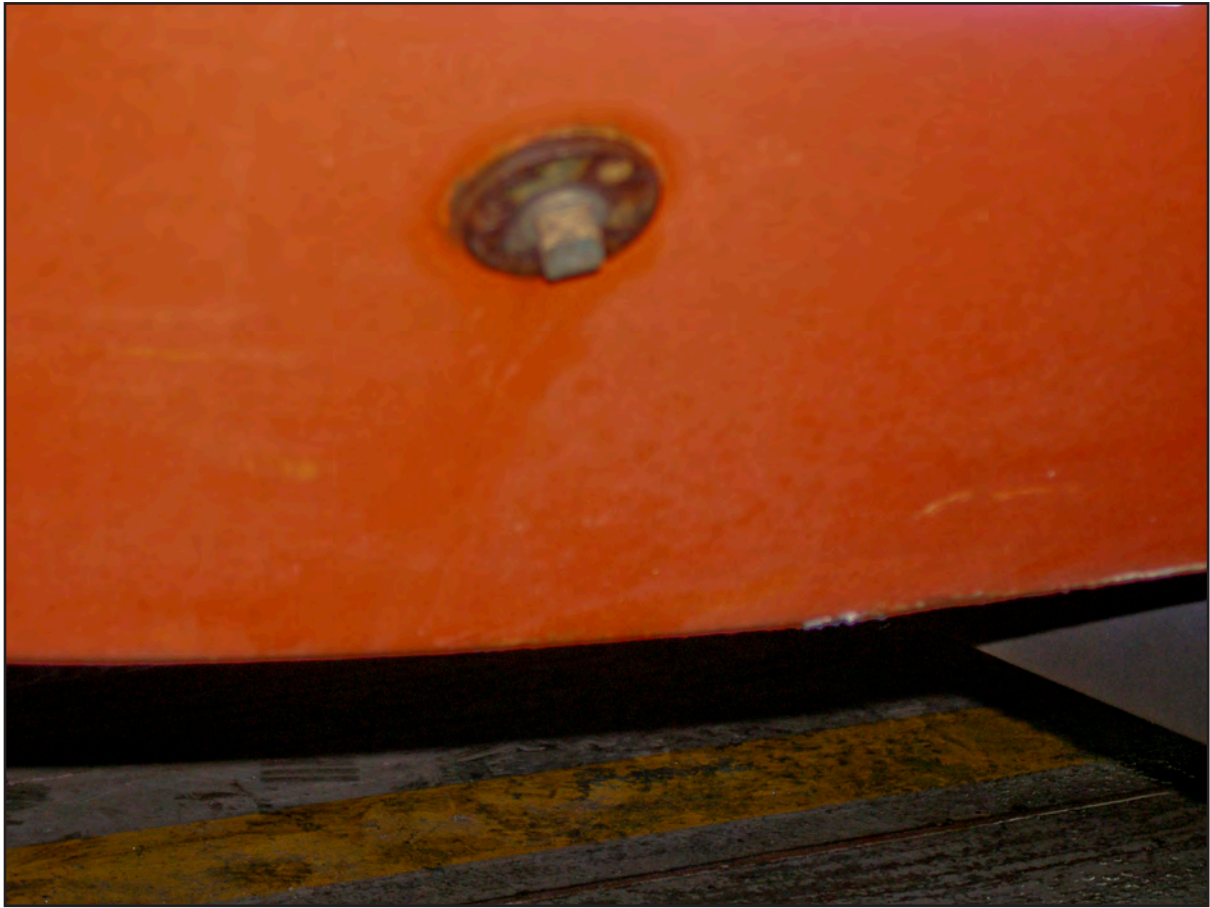
The MOB 17 FRB was manufactured by USH and was supplied to the ship in 1997. The boat had a history of water ingress in its foam buoyancy spaces. In 2006, the extent of the water ingress resulted in unapproved repairs being carried out that included the fitting of an inspection hatch to the deck and two drain plugs to the forward part of the hull (**Figure 25**).

Figure 25: Hull drain plug

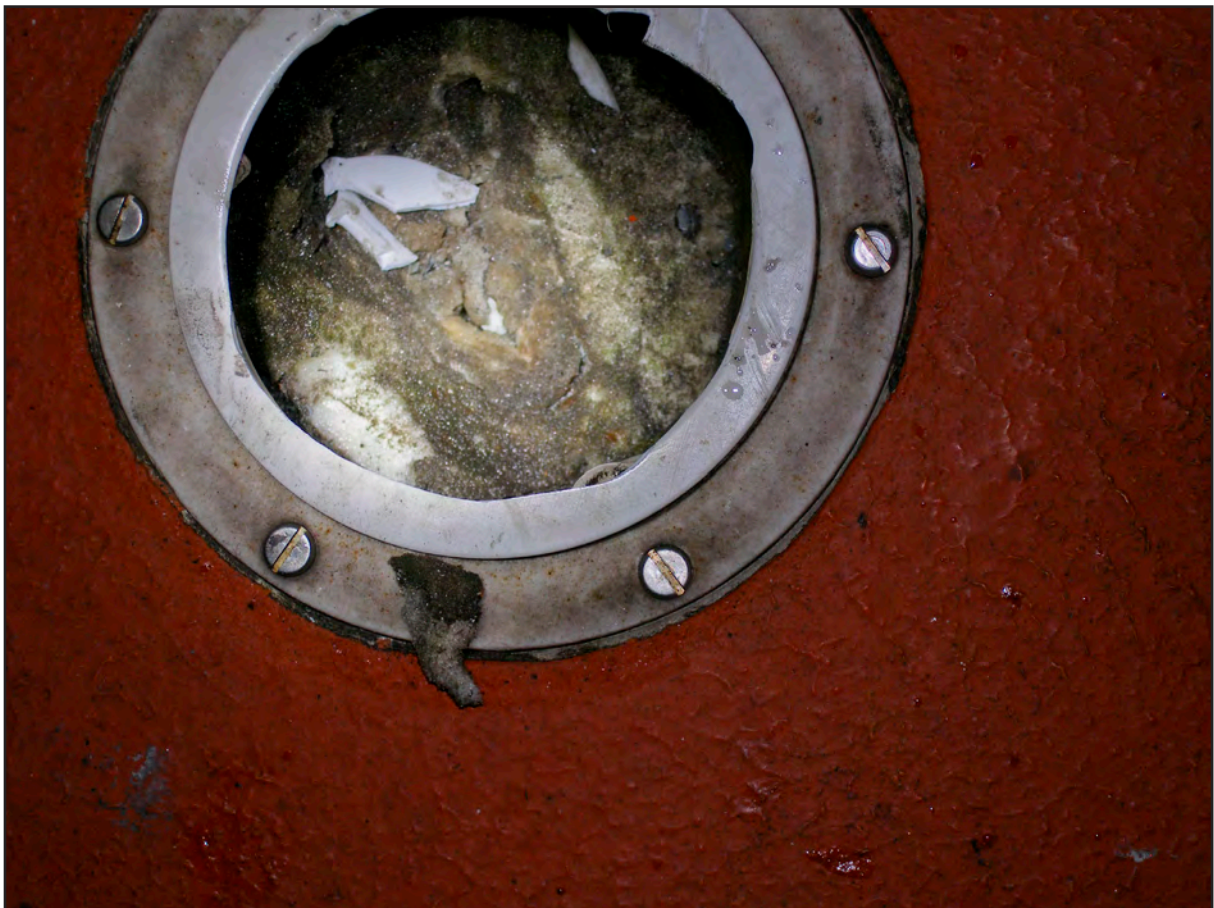
After the accident, one plug and the inspection hatch were opened and a considerable amount of water flowed out from the plug, while the foam below the hatch was found to be saturated and easily compressed (**Figure 26**).

Figure 26: Inspection hatch and saturated foam

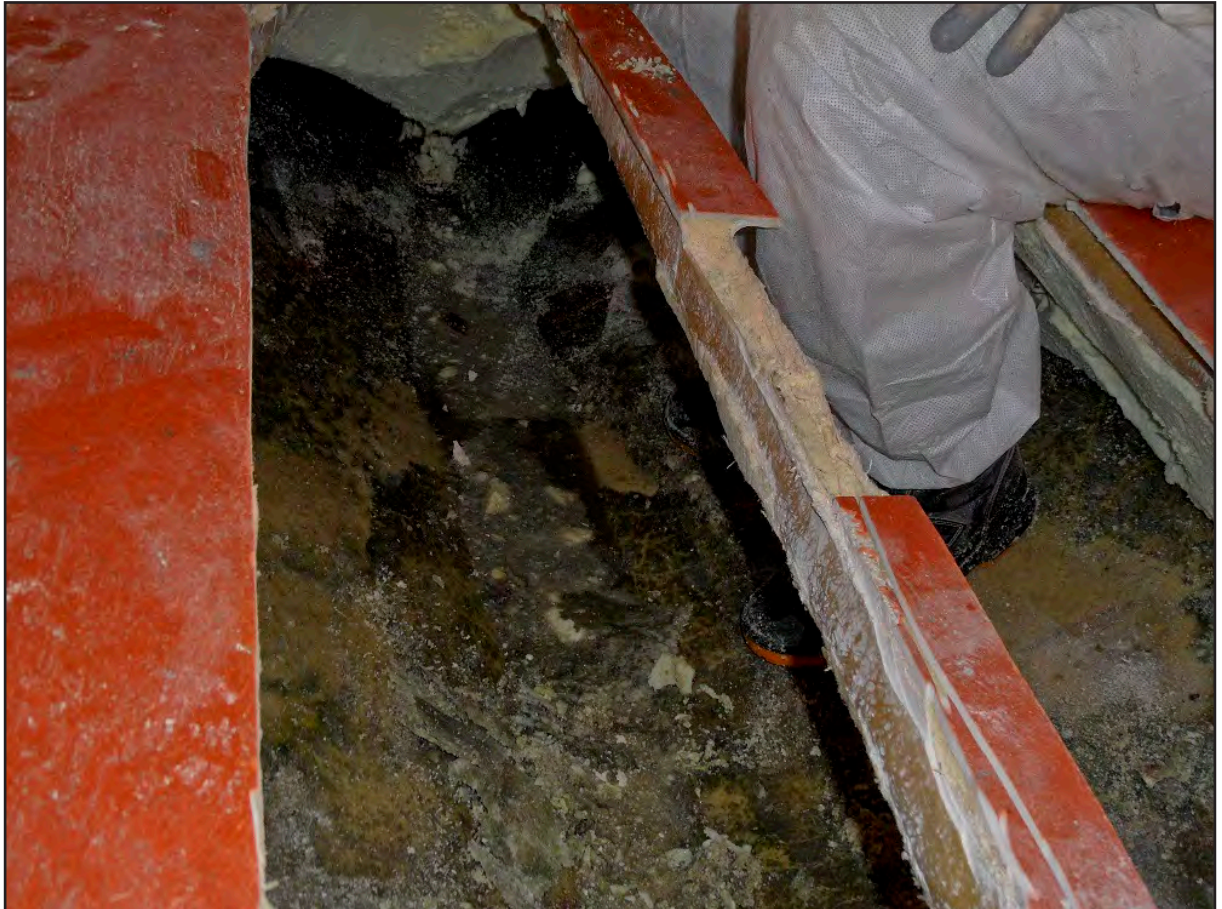
The boat weighed 1050kg, an increase of over 300kg from when it was new. The boat was overhauled by Schat-Harding UK which found that water appeared to have remained in the lower part of the hull, possibly for some considerable time, causing a black discolouration at the foam/hull interface (**Figure 27**). The foam had also delaminated from the hull.

Figure 27: Inner hull discolouration

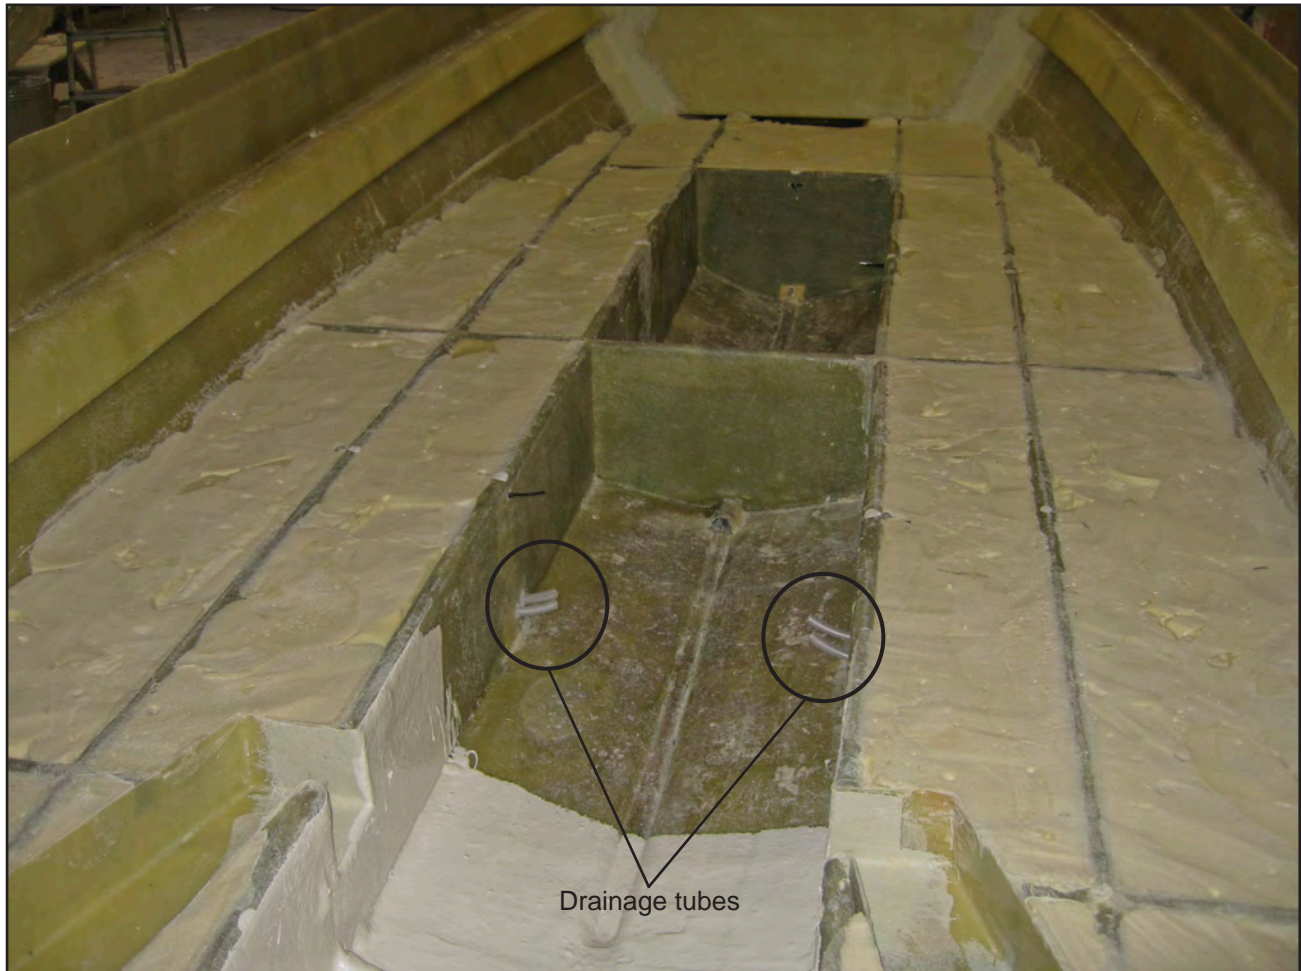
Figure 28: Buoyancy space drainage

The manufacturer recognised that poor quality foam had the potential to develop void spaces and to delaminate from the inner surfaces of the boat's hull. In addition, the manufacturer realised that it was unlikely that its boats would remain watertight throughout their lifetime. Consequently, it re-designed the buoyancy spaces of its boats to allow pre-moulded foam blocks to be fitted where possible, and to add drainage channels from the foam spaces into the inner-keel, which was kept empty. These measures were aimed at ensuring that any water that did enter the hull space could be drained out. **(Figure 28).**
