COMMENTARY AND OPINION IN RESPECT OF INSPECTIONS AND TESTS COMPLETED ON A BROKEN FAST RECOVERY CRAFT HOIST ROPE FROM THE CAR CARRIER VESSEL MV TOMBARRA

KPR report

MV Tombarra

Following an incident on the MV Tombarra on Monday 7th Feb 2011 where a winch system continued to operate when it should have activated a limit switch and been electrically disabled, ERA RFA department have been asked to assess the limit switch which appears to have failed to operate correctly.

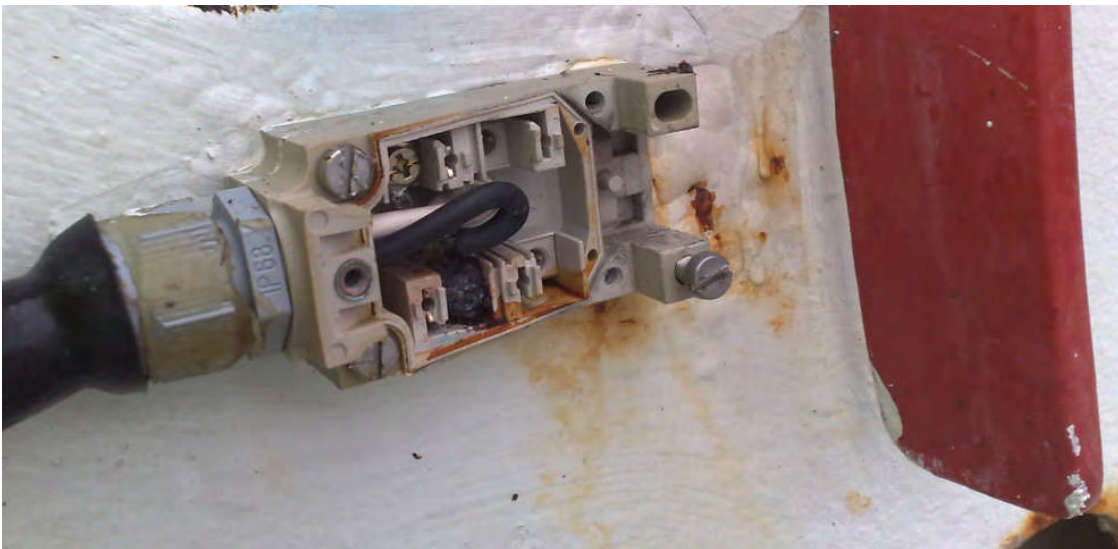
5.9.1 Main Body

Four fixing locations are provided on the proximity sensor to secure it to the davit. Of these four fixings the back two fixings had screws in them done up tight. The top front fixing was missing; the bottom front fixing was partially undone but was tight due to rusting. The 2 secure fixings were sufficient to hold the sensor in place.

I unscrewed and removed the front cover of the switch this is also where the sensor is actually housed. Upon removing the cover I noticed that there had been water ingress, at the bottom of the sensor there was brown rust marks where water had been and the lower electrical connection was badly corroded. There were also signs of corrosion on one of the two pins on the sensor. There was no sign of water still being present.

Proximity sensor body showing signs that there had been water ingress; the bottom electrical connection was badly corroded. This photo also shows 1 fixing screw missing and 1 fixing screw not driven home fully.

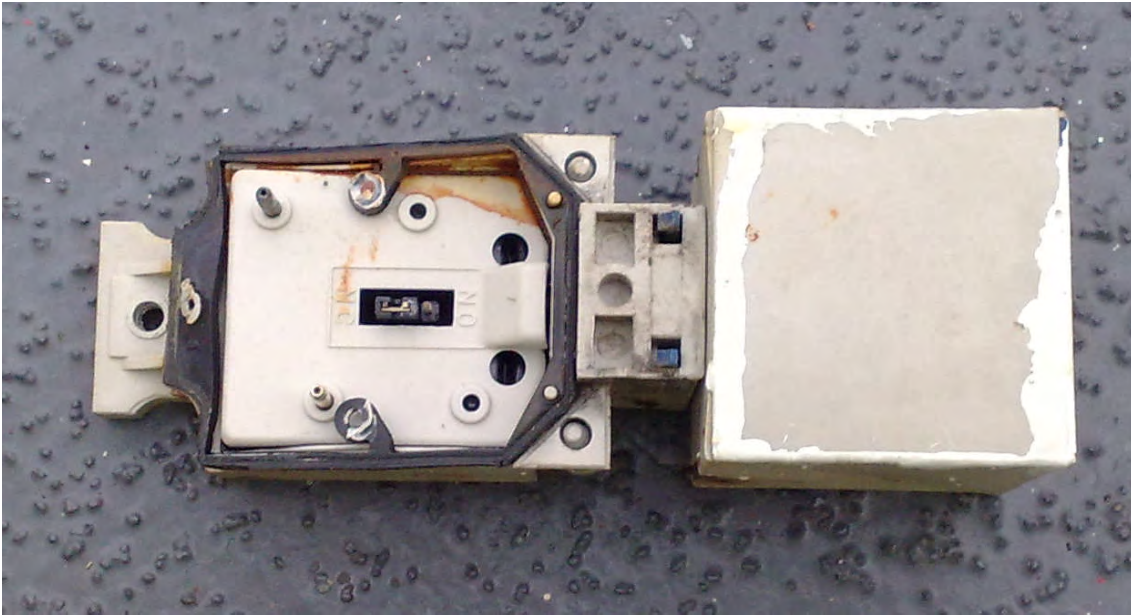
5.9.2 Head

This photo shows the underneath of the proximity sensor head. Again there are signs that there had been water ingress. The gasket looks to be intact, perhaps slight damage at the top left hand corner, this would be the bottom left corner when in place.

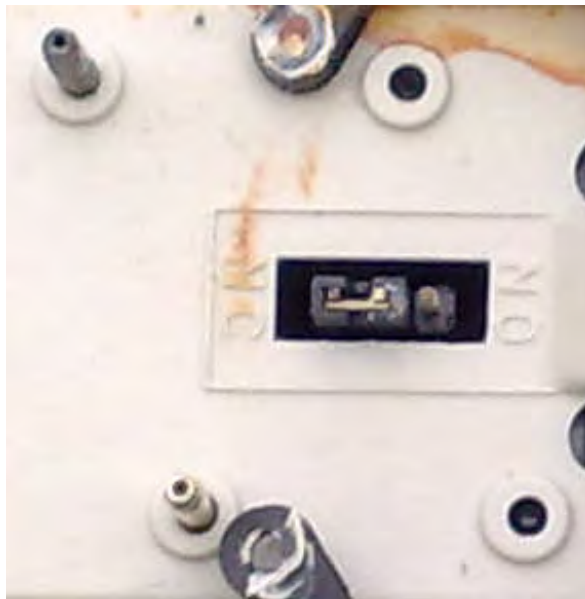
5.9.3 Programming Jumper

A close up of the NO/NC mode jumper, showing that the proximity sensor is in the normally closed mode. Slight corrosion can be seen on the upper pin, lower when in place.

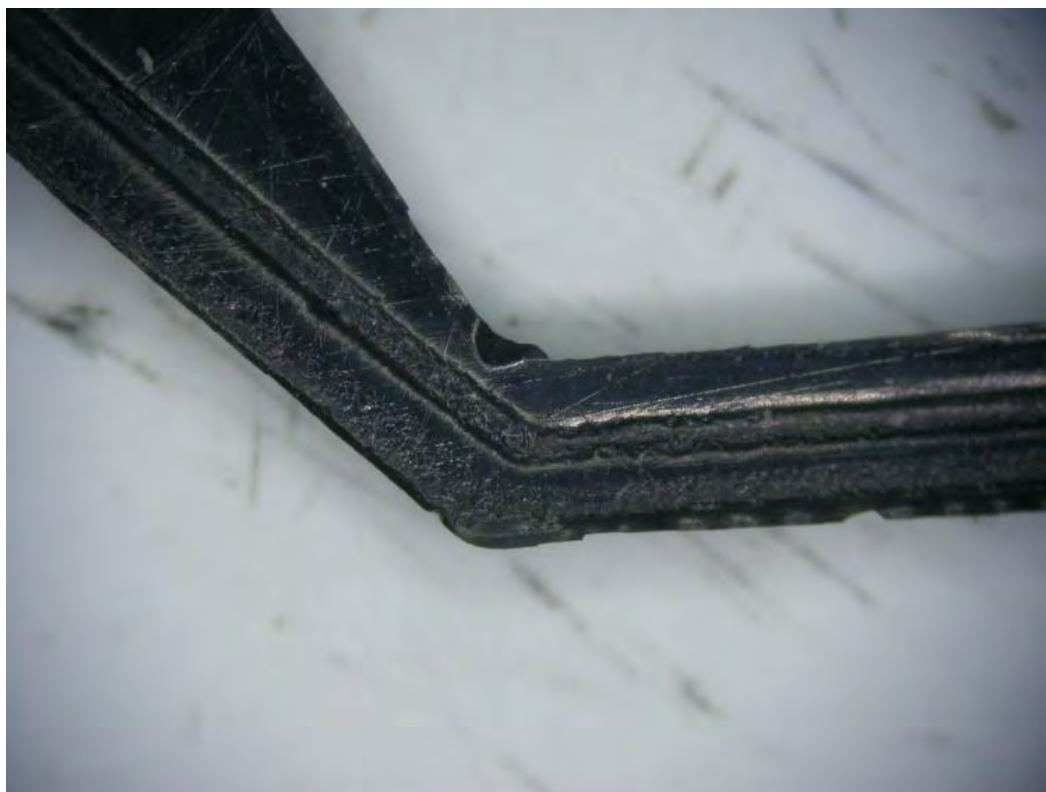
Figure 3: sample #1 rubber gasket seal

Looking at the rubber seal there is clear evidence of deterioration. The seal is beginning to split and the rubber is beginning to harden / perish. There is no evidence of water ingress into this unit – see Figure 6: Inside sample #2 , but the quality of the seal is considered to be compromised. See Figure 4: sample #2 rubber gasket seal, and compare with an un used and presumably younger example in Figure 3: sample #1 rubber gasket seal.

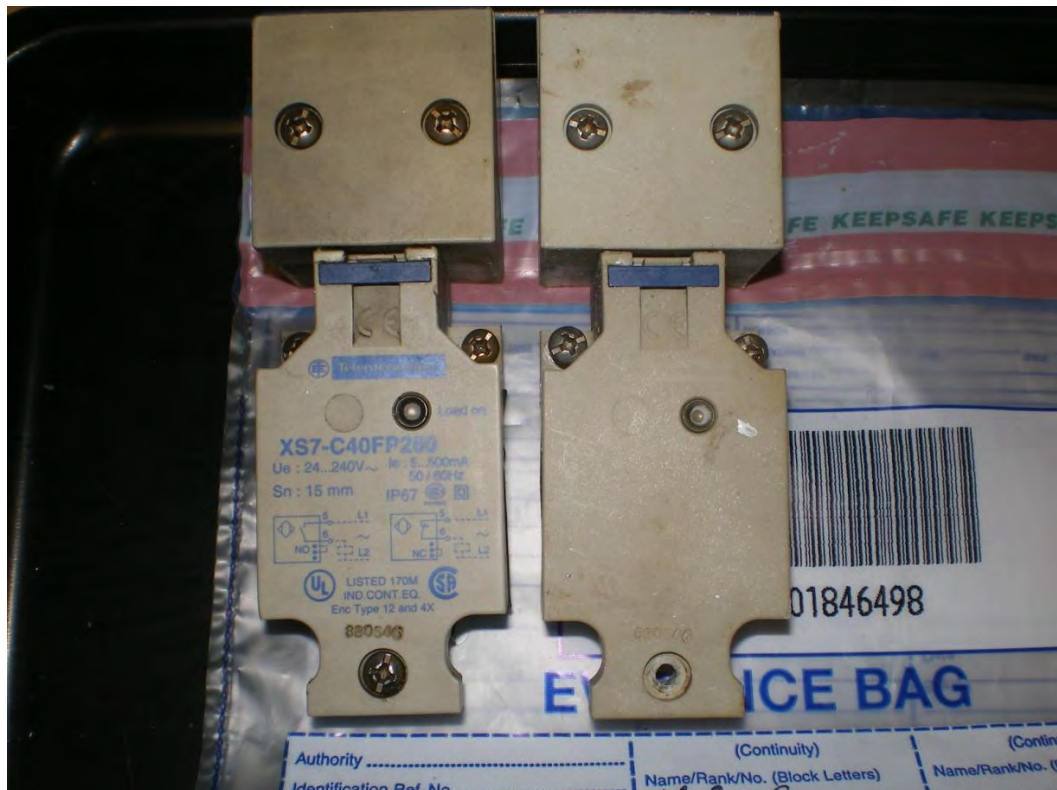
Figure 7: printing loss comparing samples #2 and #3

The unit retained the printed details on the outside surface of the case (it may be significant that the failed sample #3 did not retain this printing).

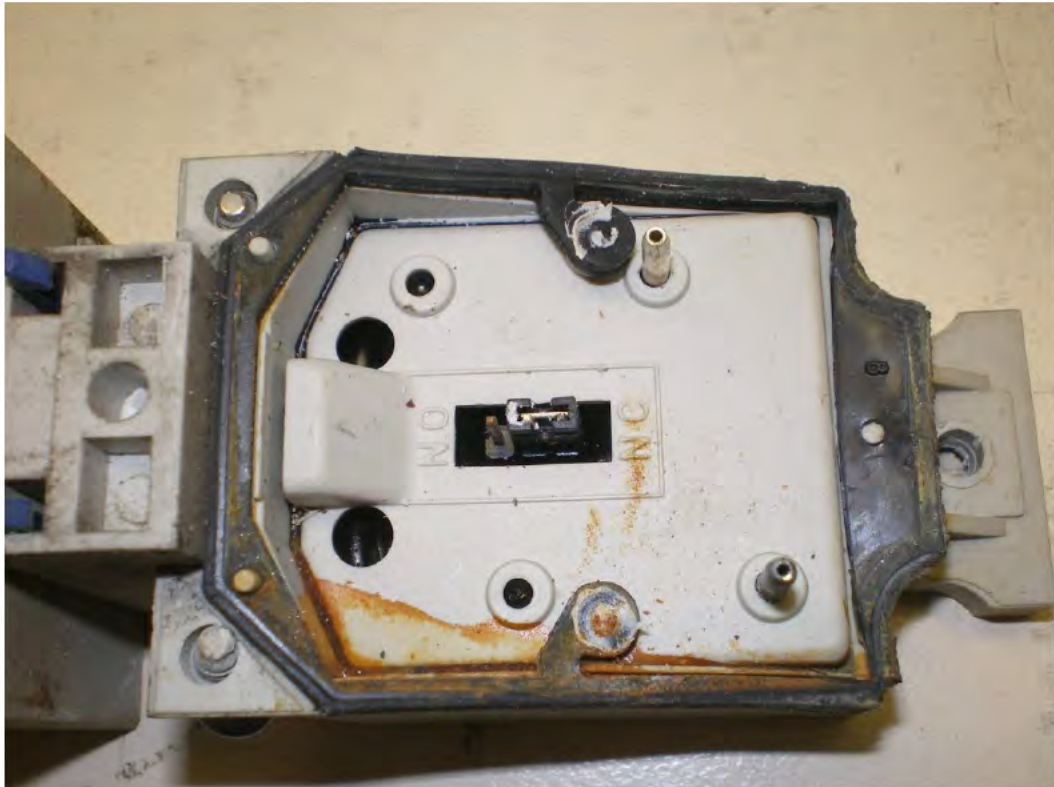
Figure 9: Inside sample #3 cavity – electronics section

This type of electrical failure is consistent with a semiconductor failure in a solid state switch. It is therefore necessary to disassemble the electronics section of the device and remove the epoxy potting which encases the circuitry.

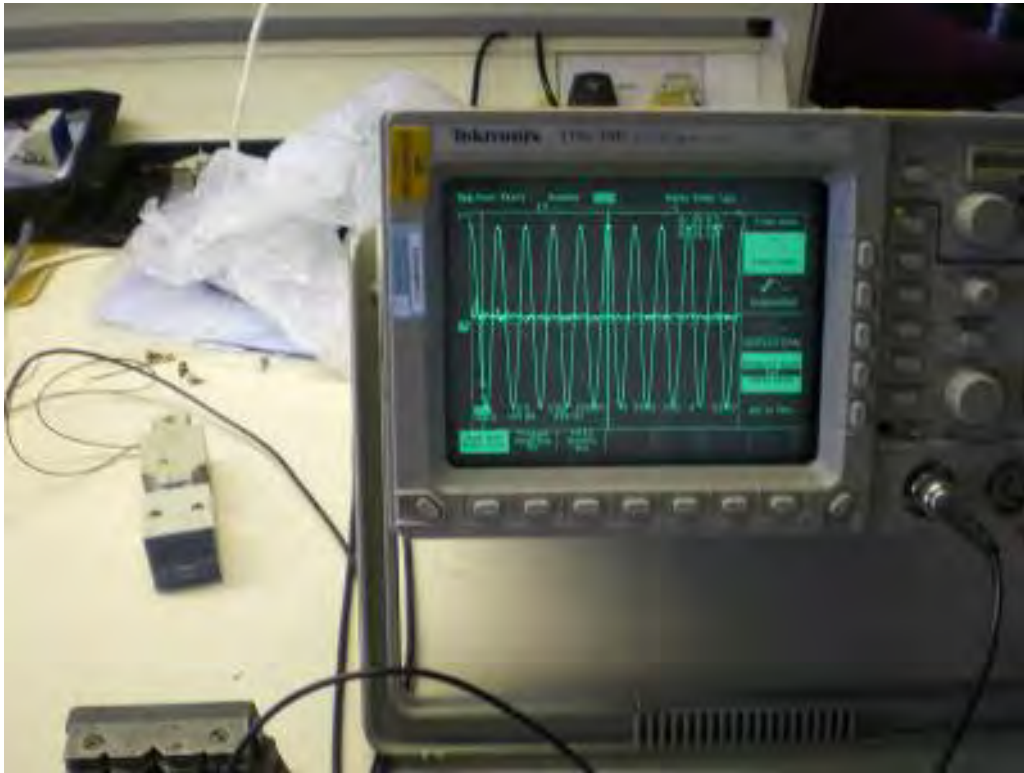
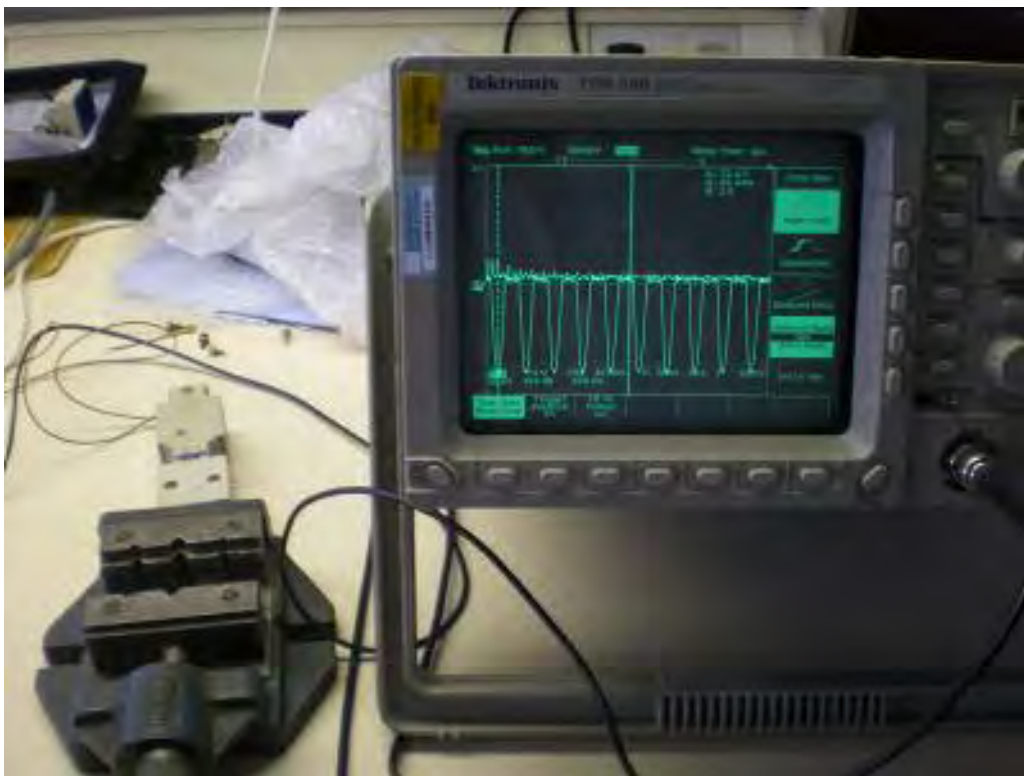
The scope trace showed that the failure was indeed a half wave failure: i.e. the negative part of the mains failed to switch off. See Figure 1. This test took place with the failed switch unit mounted into the 'socket' of the new unit. The 'socket' of the failed unit was thereby positively eliminated from suspicion.

**Figure 1: Failed Limit switch with load lamp connected along with monitor oscilloscope:
above: metal mass away from switch – power full on
below: metal mass close to switch – negative voltage fails to switch off.**

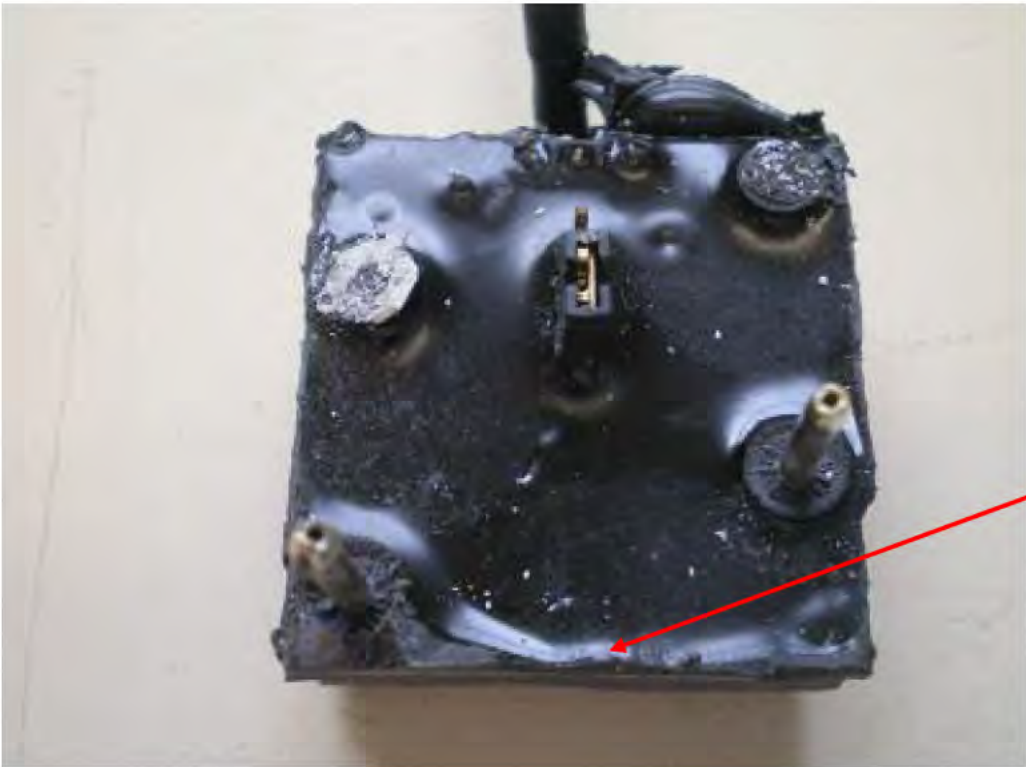
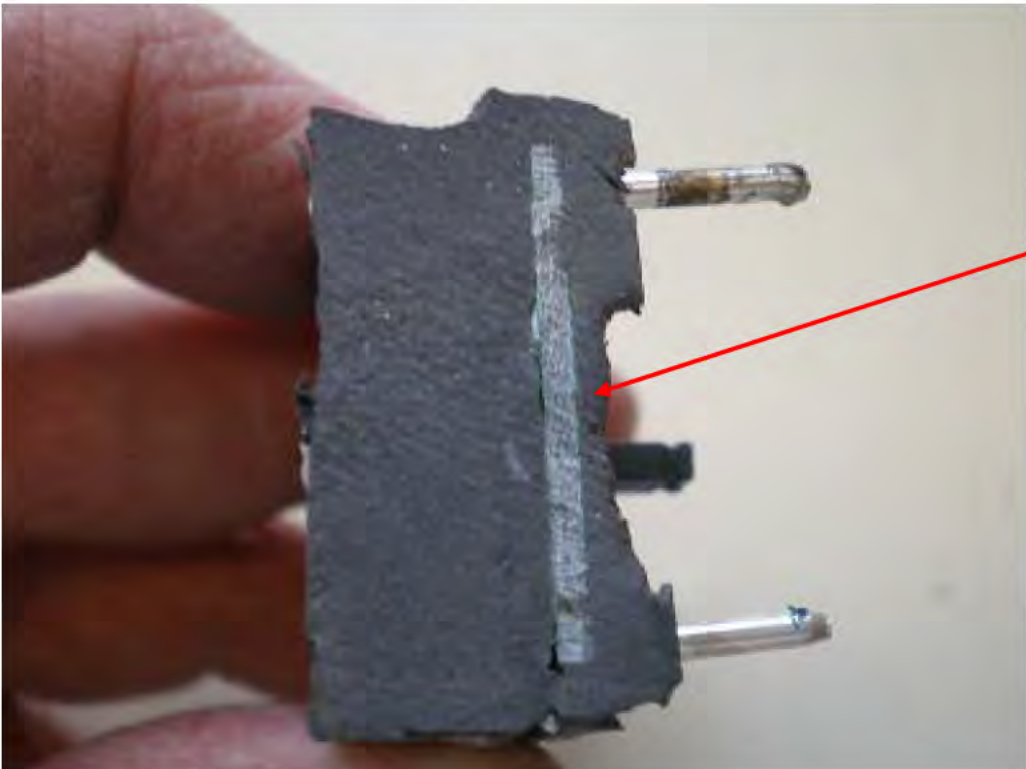
Figure 4:
Failed unit - partially decapsulated,
showing the region where the pcb was subsequently found damaged.
No encapsulation damage or fault is evident.

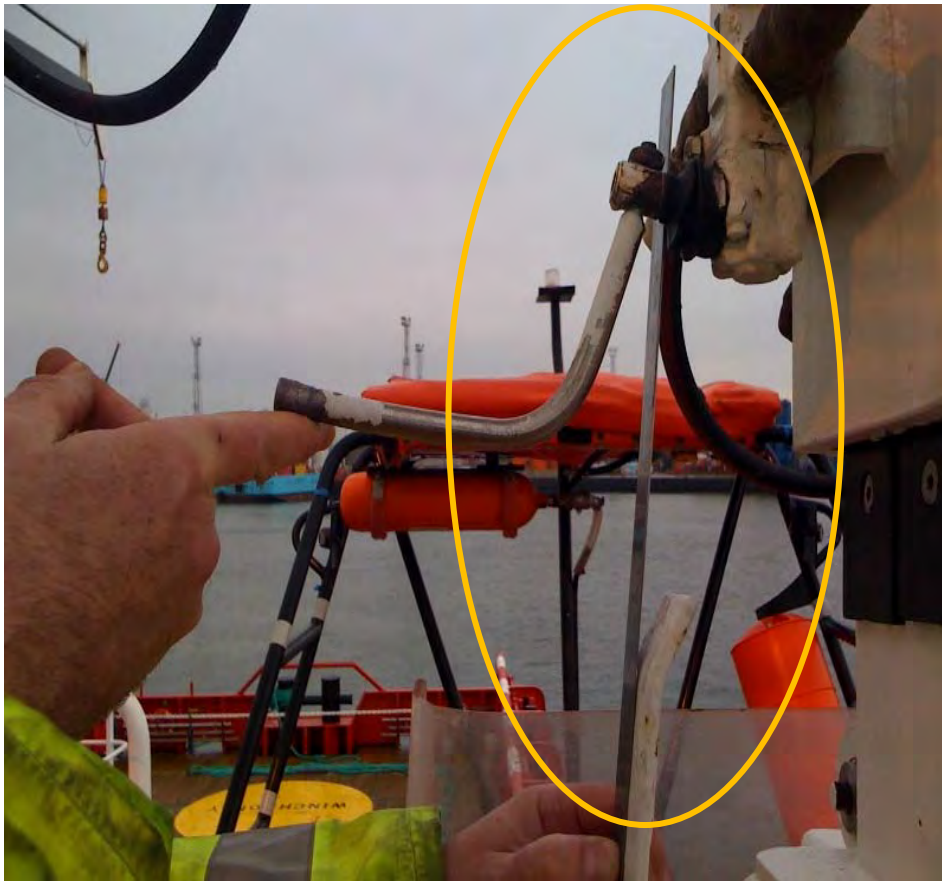
Photo 1 (Limit switch in activation position)

The Docking Head limit switch did not work (photo 1). It was wrongly positioned and it did not stop the docking head being lifted further (photo 2). The strain applied to the wire was too high. As a result, full hydraulic pressure was applied to the davit wire, well above the breaking strain, and the wire almost parted.

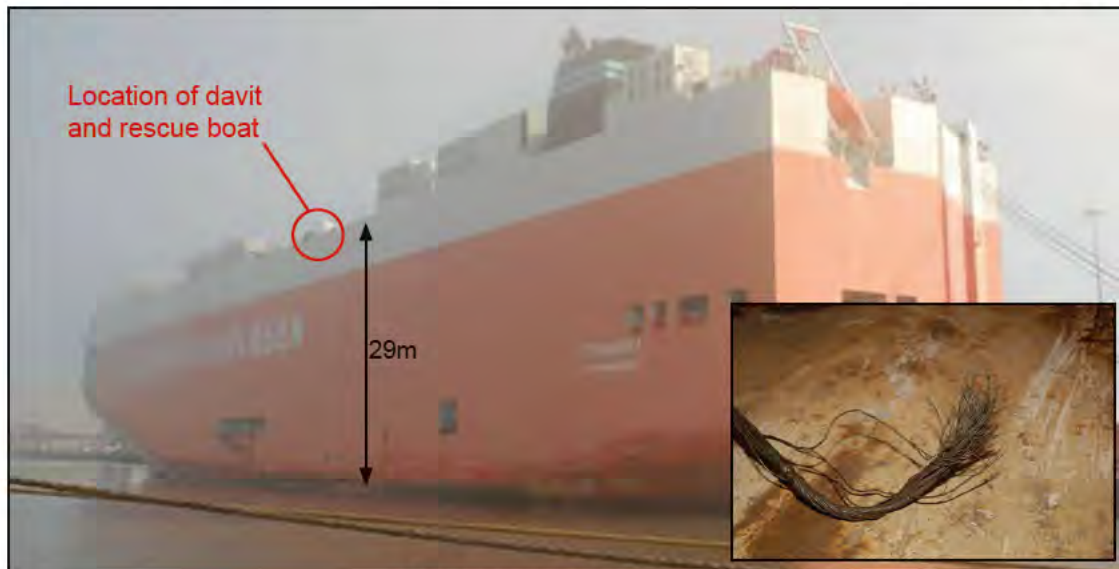
Figure 1

Vessel and parted fall wire

The fall wire was observed to be in good condition and when tested after the accident it achieved a breaking load of 137kN. The wire parted near the lower most davit sheave as the rescue boat reached its stowed position and the winch was still hoisting under power. Although the winch motor was rated with a nominal pull of 50kN, the maximum pull that it was capable of exerting when trying to overcome the increased resistance in the system during the final stages of hoisting would have rapidly exceeded the breaking load of the wire. The proximity switch, which should have prevented this situation from occurring, was tested in situ and was found to be defective.

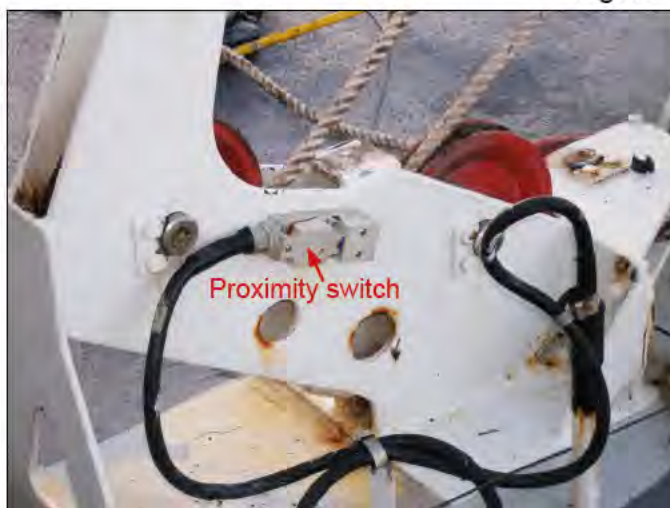
Figure 3

The winch was operated by a control panel sited forward of the davit. The boat was hoisted using the buttons on the control panel until the davit was near the stowed position. It was then intended that hoisting be completed manually by the use of a winch handle adjacent to the winch motor. To prevent the inadvertent operation of the winch when the rescue boat was in its stowed position, an inductive proximity sensor/switch (Telemechanique XS7-C40FP260) was fitted on the davit (**Figure 3**). The switch was intended to cut off power to the winch when the davit closed to within approximately 12mm of the sensor.

Proximity switch on davit

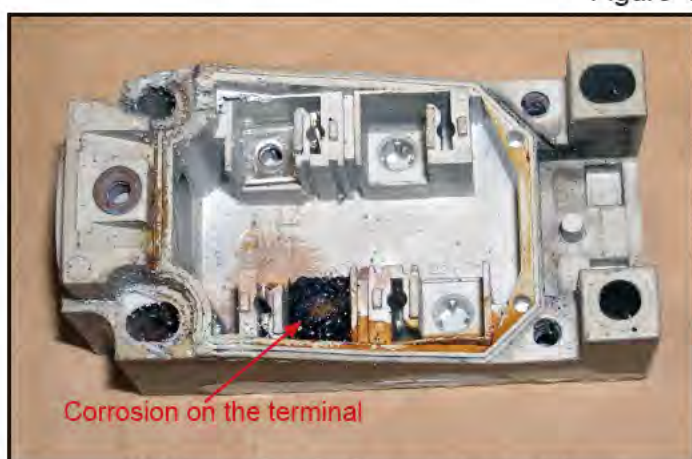
Figure 4

Corrosion on the terminal

Water ingress into proximity switch

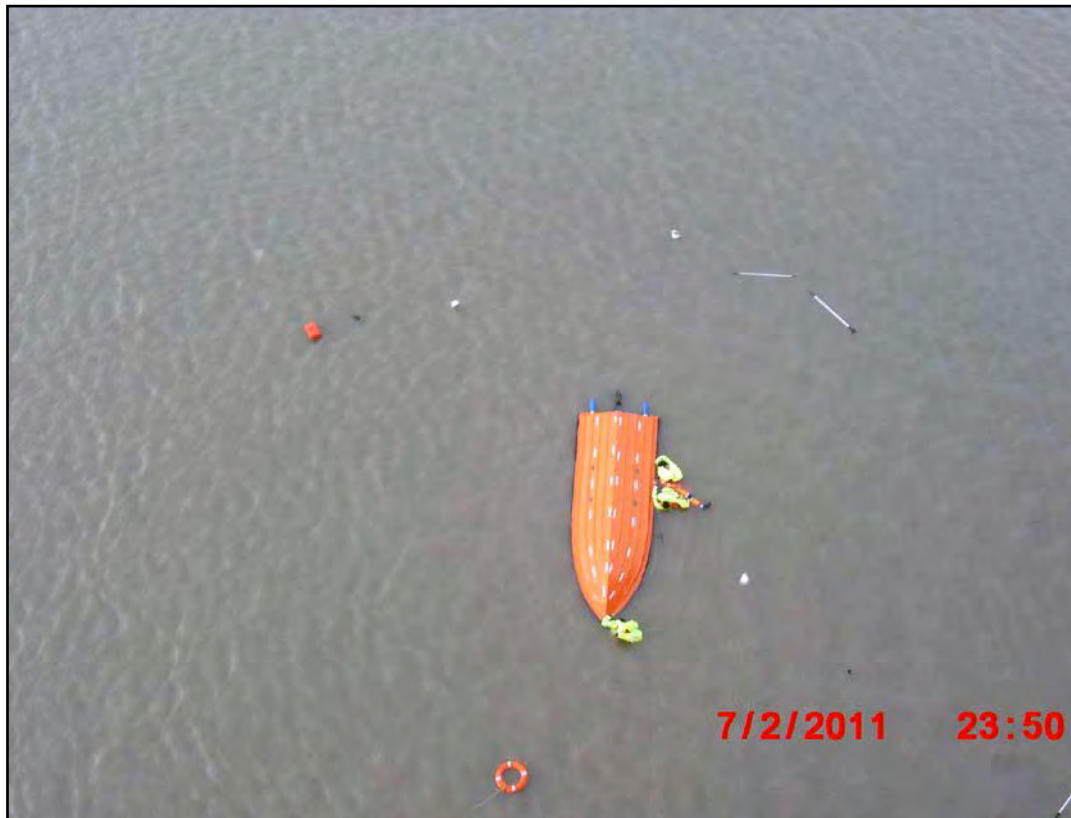
Figure 1: The rescue boat and crew after the fall wire failure

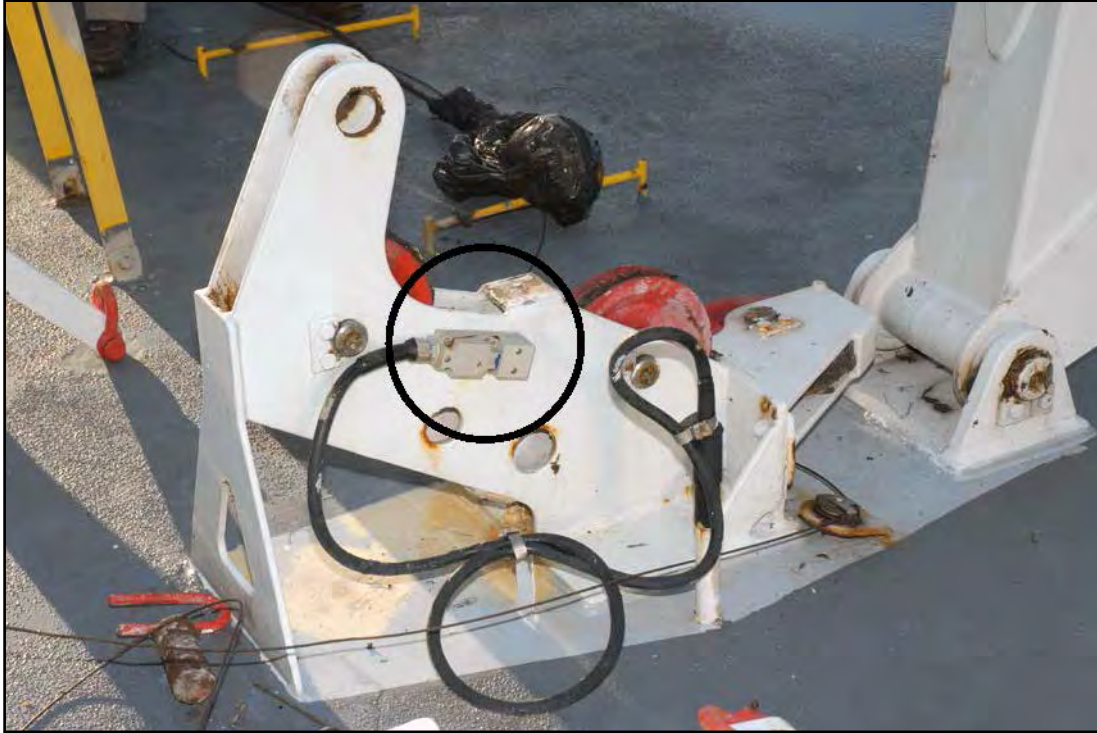
The davit proximity switch (**Figure 2**) did not operate due to a short circuit of its printed circuit board. The short circuit had been caused by either moisture ingress or by transient power surges.

Figure 2: Proximity switch on davit (circled)
