## FV KAREN

### Grounding at the Entrance to Ardglass Harbour, County Down, Northern Ireland 3 January 2011

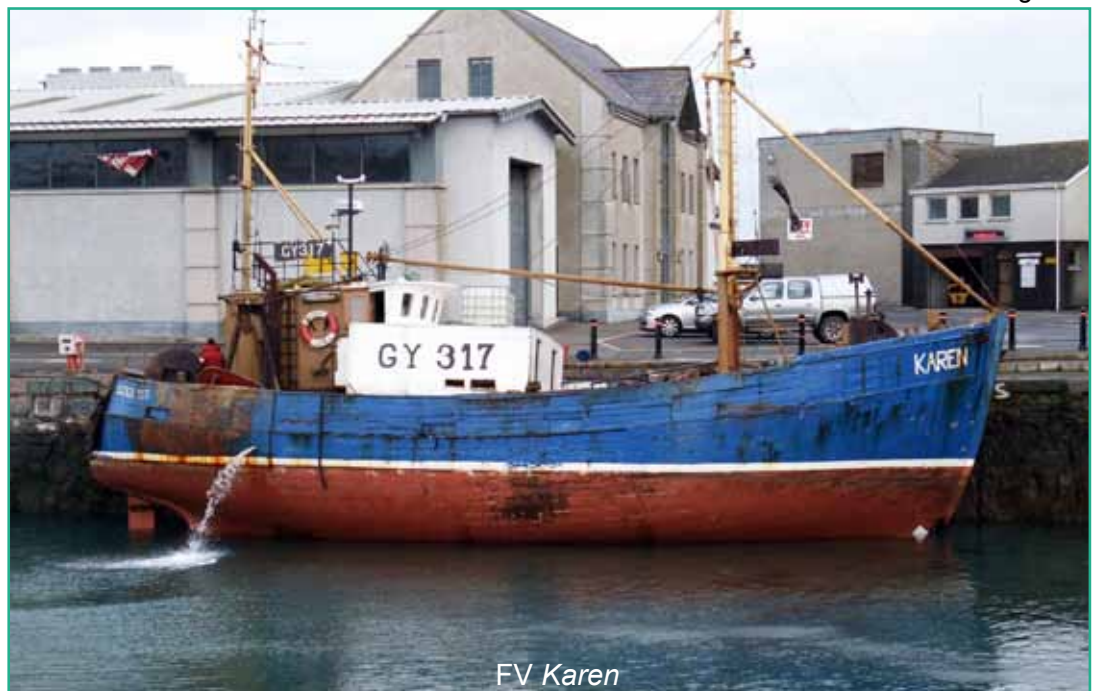
Figure 1

FV Karen

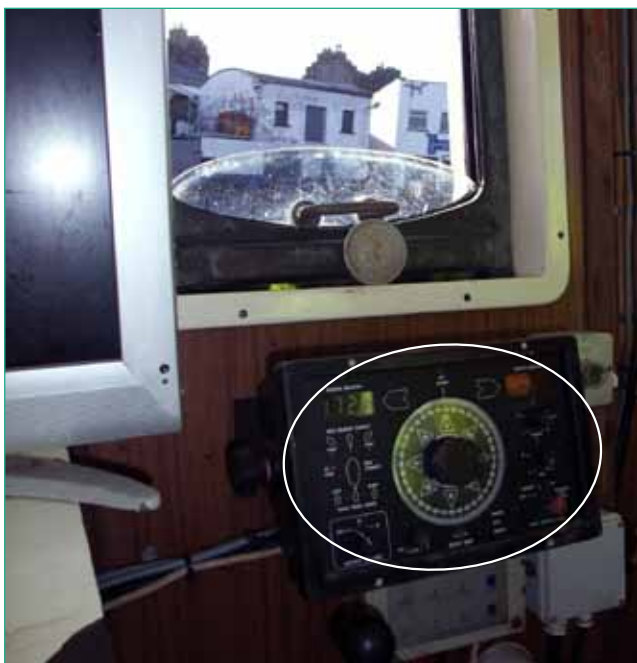
Figure 2

During the latter stages of the passage, the skipper reportedly opened and leaned out of the wheelhouse starboard window, which was positioned directly above the autopilot (**Figure 2**), to speak with a crewman on deck. At about 1755, the vessel grounded on the northern side of Ardglass Harbour. The impact caused the crewman to fall onto a rail, resulting in bruising to his ribs. There were no other injuries. The skipper's estimated grounding position and other key navigational marks are shown in **Figure 3**.

Position of autopilot in relation to the wheelhouse starboard window

the vessel had grounded closer to the harbour. There was no evidence to support a suggestion that the autopilot might have been inadvertently adjusted to starboard just prior to the grounding when the skipper reportedly leaned out of the wheelhouse starboard window to speak with a crewman on deck.

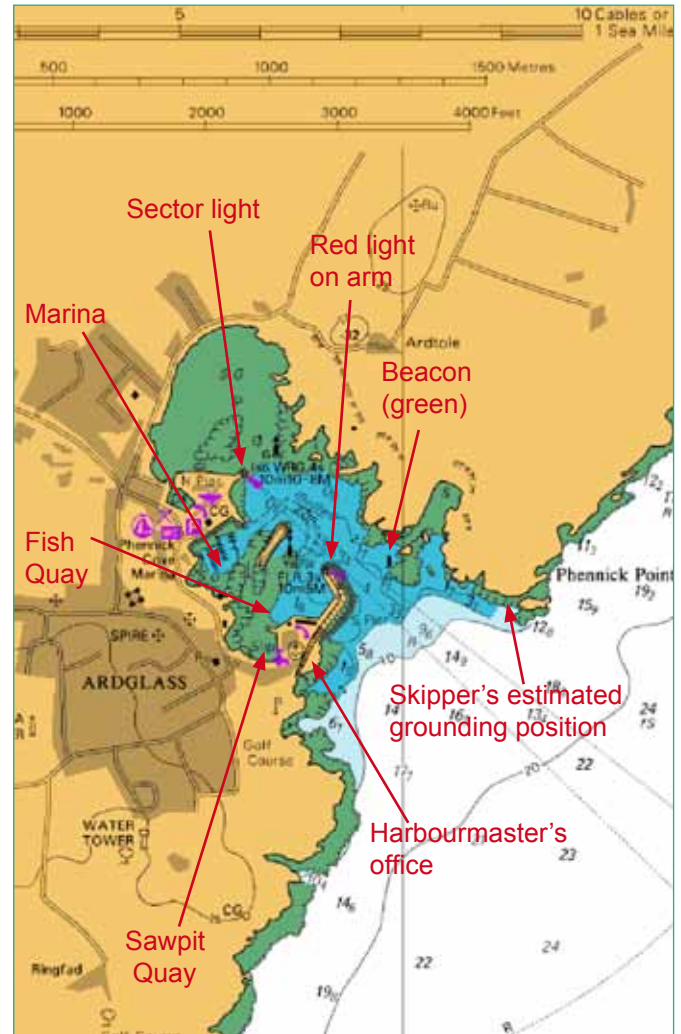
Figure 3

Skipper's estimated grounding position and key navigational marks

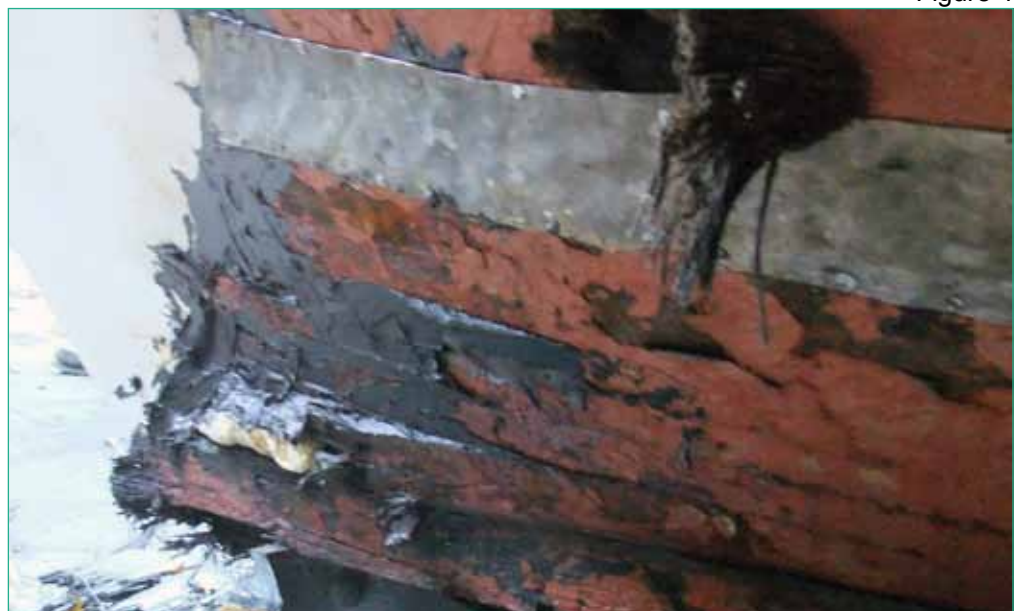
Figure 4

Damage to the vessel was limited to the foot of the stem post (**figure 4**), where some planking had also sprung causing the caulking to become displaced. There was also abrasion damage to the hull on both sides at the turn of bilge.

Stem post damage

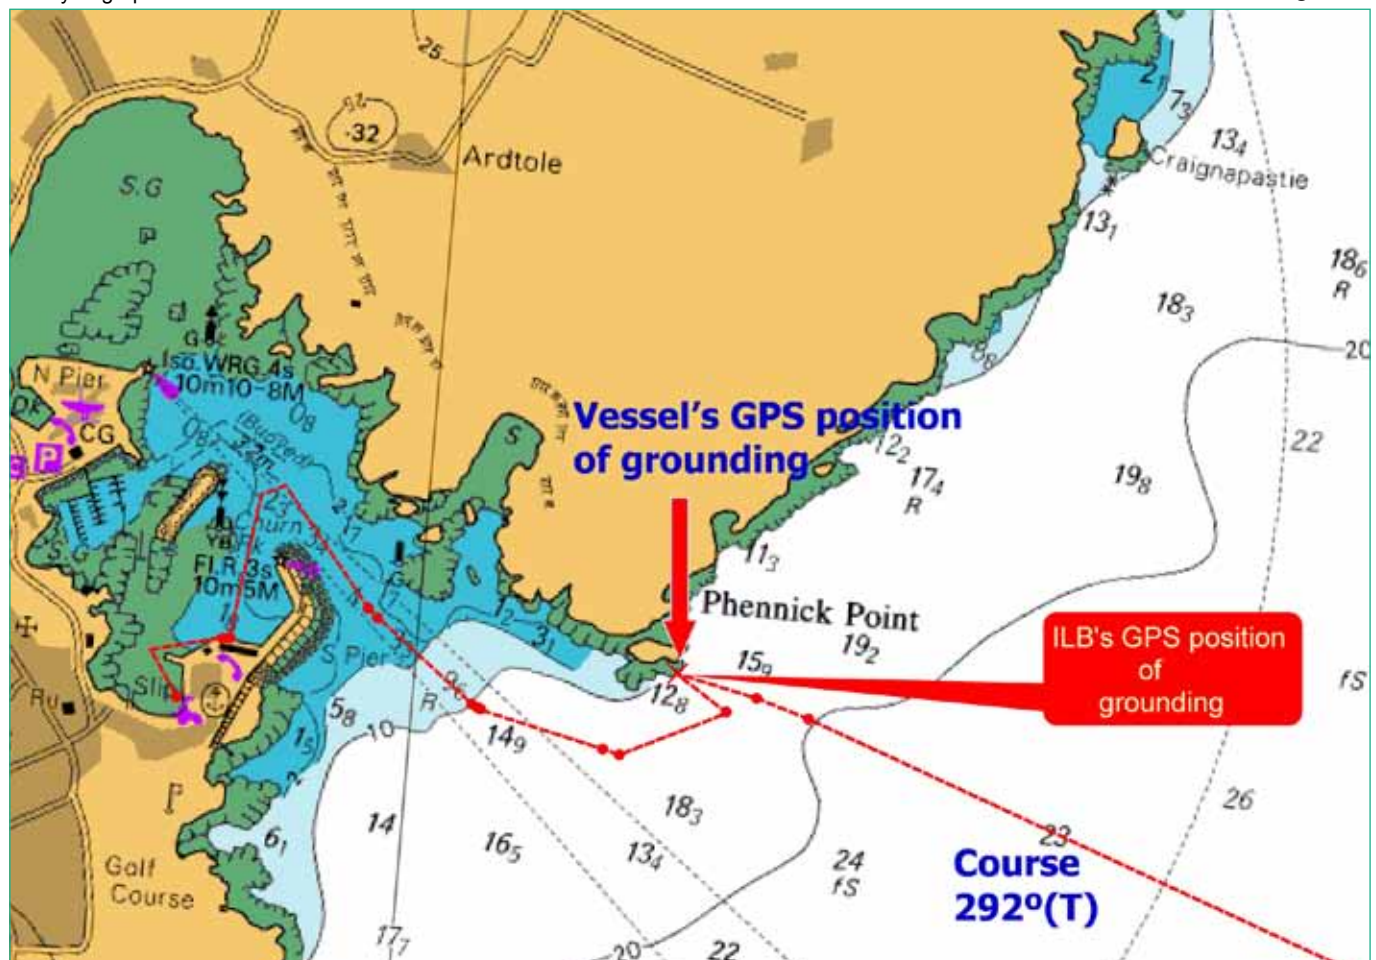
Figure 5

Data downloaded from *Karen's* GPS unit confirmed that she was making a generally steady course of 292°(T) until grounding at Phennick Point in position 54°15.613'N, 005°35.693'W (Figure 5). The grounding position was confirmed from the ILB's GPS, though the skipper estimated

GPS track and grounding position
