FATAL MAN OVERBOARD FROM JOANNA

Alongside in Glasgow, Scotland,
13 December 2010

**Marine Accident Investigation Branch
June 2011**

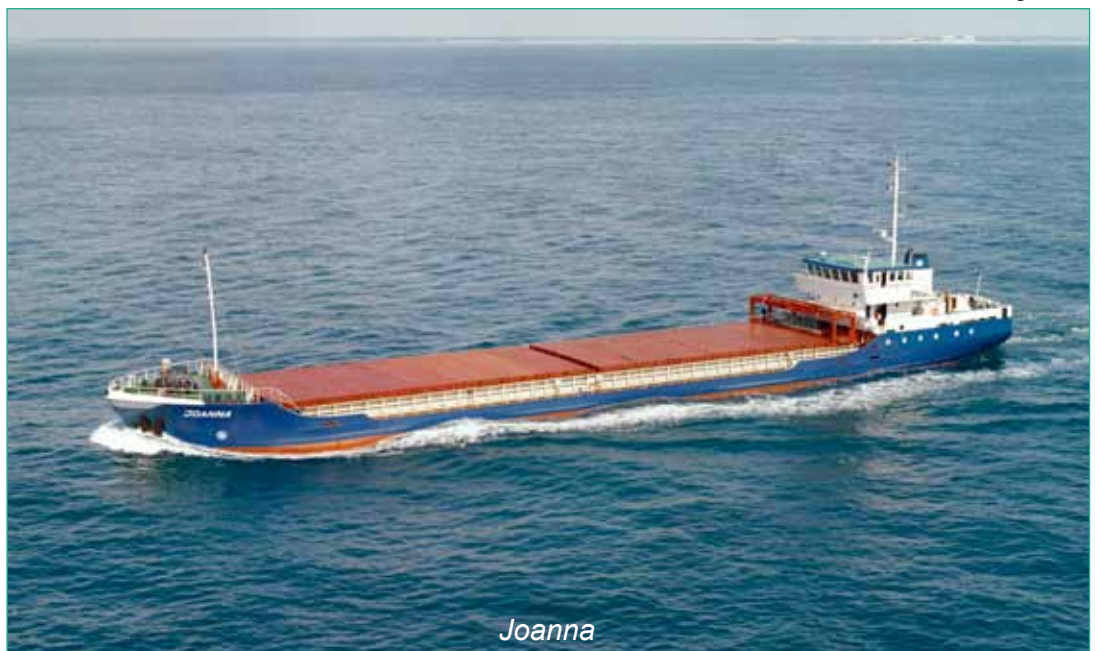
Figure 1

Joanna

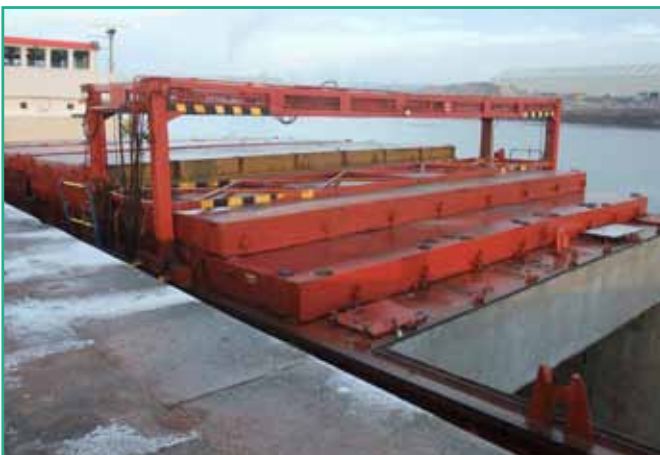
Figure 2

Joanna's single hold was fitted with 14 hatch covers that were moved using a straddle lift (**Figure 2**). The lift was fitted at build and spanned

the width of the cargo hold. It was operated by the bosun from its starboard platform, assisted by an AB on its port platform.

- Implemented a drug and alcohol policy.
- Reviewed its key shipboard operations which now include the opening and closing of hatches.
- Provided written procedures for the operation of the straddle lift.
- Completed risk assessments to improve the safety of operations on board its vessels
- Provided two safety harnesses and two working lifejackets on board *Joanna*.

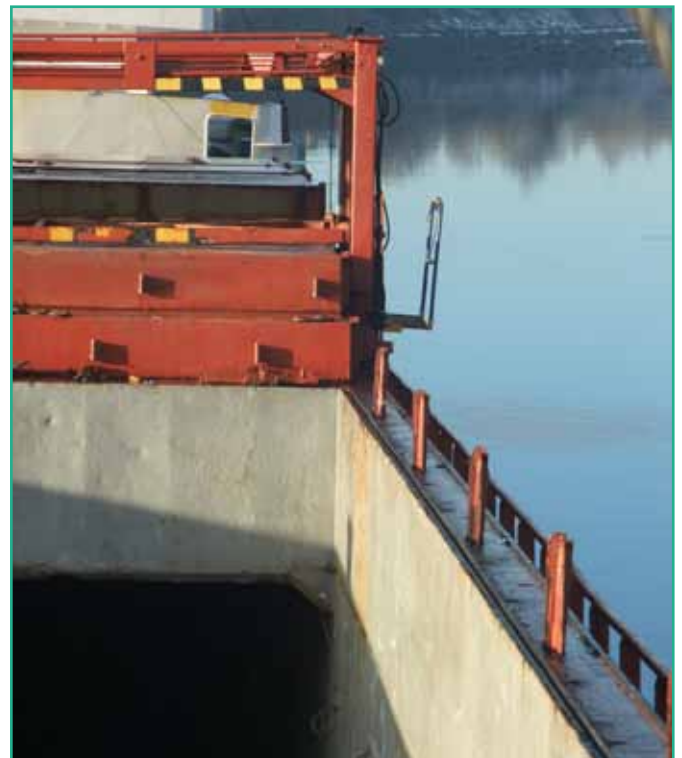
Figure 3

The platforms (**Figure 3**) were 1.65m above the deck and were 0.39m deep. Each platform was fitted with a guardrail on its outboard side, but no protection was fitted at the fore and aft ends. A number of hand/foot supports were fitted to the aft uprights of the lift, the lowest of which was 1.9m above the deck. The distance between the deck guardrail and the hatch coaming was 0.5m and the uppermost guardrail was 1m above the deck and 3.6m above the waterline.

The crew were also exposed to the risk of falling when standing on the platforms due to the absence of any guardrails or similar protection at the platforms' fore and aft ends. Although the distance

to the deck below was only 1.65m, this was still sufficient for the potential consequences of any fall from the platforms to be serious.

- The crew working on the lift platforms were exposed to the risk of falling because the fore and aft ends of the platforms were not provided with guardrails or similar means of protection.

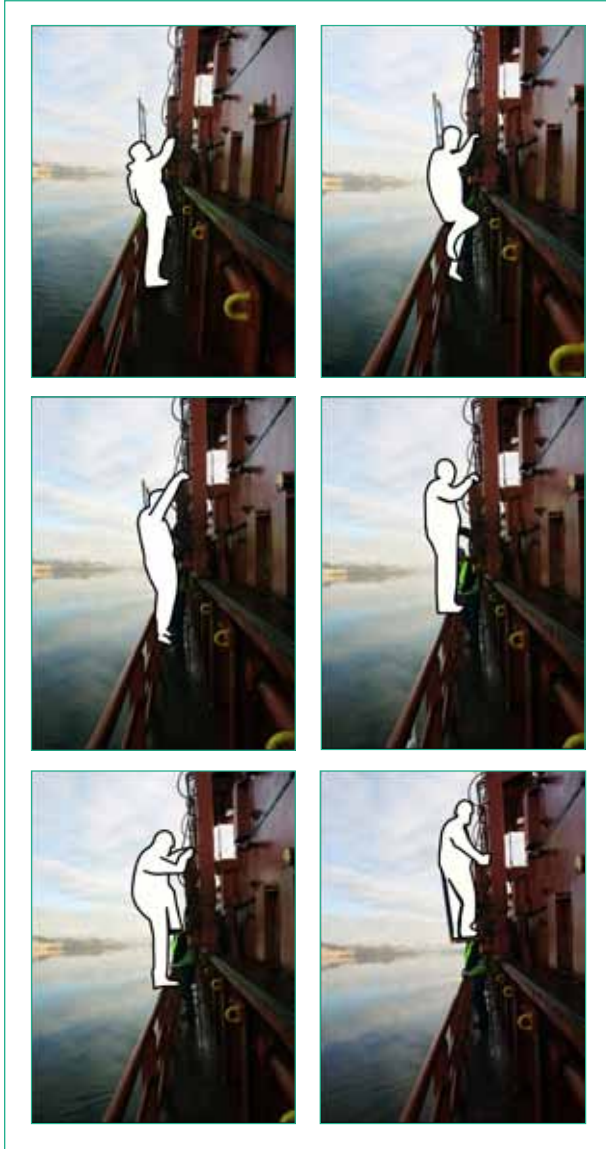
Figure 4

The crew usually accessed the platforms either by climbing up from the main deck or via the hatch covers. **Figure 4** shows the method usually adopted by the crew to reach the platform from the main deck. The crew climbed up the guardrails while facing the straddle lift and holding on to the hand/foot supports on the aft upright. When on the top guardrail, the crew would step across to the platform. To approach the platforms from the hatch covers, the crew either had to duck under the lift's main beam or swing outboard of the aft upright using the hand/foot supports provided.

The use of the guardrails to climb to the straddle lift's operating platforms was clearly dangerous, as the area beneath the lift was confined, and over balancing or slipping could easily result in a person falling on to the deck or overboard. In this case, the risk of falling was significantly increased as Stanislaw was almost 2.5 times over the limit for alcohol for professional seafarers who are on duty, as detailed in the Railways and Transport Act 2003. While it is noted that the effects of alcohol vary between individuals, they are generally considered to impair motor co-ordination, slow down reaction times, and reduce peripheral and night vision. Alcohol can also increase a person's confidence levels, frequently resulting in a person being more likely to take risks. In addition to Stanislaw's potential impairment through alcohol, the soles of his wellington boots were almost totally bare of tread and his leather gloves had been smoothed through use. Consequently, neither the wellington boots nor the gloves would have provided much grip, particularly on the wet or icy metal surfaces of the guardrails and hand-holds when stepping from the top guardrail to the straddle platform.

The routes used by the crew to get on to the platforms on the ends of the straddle lift were inherently unsafe because they exposed the crew to the risk of falling from height. The UK's Merchant Shipping (Safe Movement on Board Ship) Regulations which applied to *Joanna* when she was alongside in Glasgow, require an employer and master to '*ensure that safe means of access is provided and maintained to any place on the ship to which a person may be expected to go*'.

Without a dedicated ladder or similar means of access, any slip or loss of balance, either when climbing the ship side guardrails or when moving on to the platform from the hatch covers, had significant potential to result in a fall onto the deck, or over the ship's side to the water or quayside, and cause serious injury. It was therefore only fortuitous that similar accidents had not occurred in the past.

- Stanislaw Bania almost certainly fell into the water while trying to climb on to the port operating platform on the straddle lift via the deck guardrails.

- The crew and the shore workers reacted quickly and positively, and did well to recover Stanislaw from the water in difficult circumstances.
- The access routes used by the crew to get on to the platforms on the ends of the straddle lift were inherently unsafe.

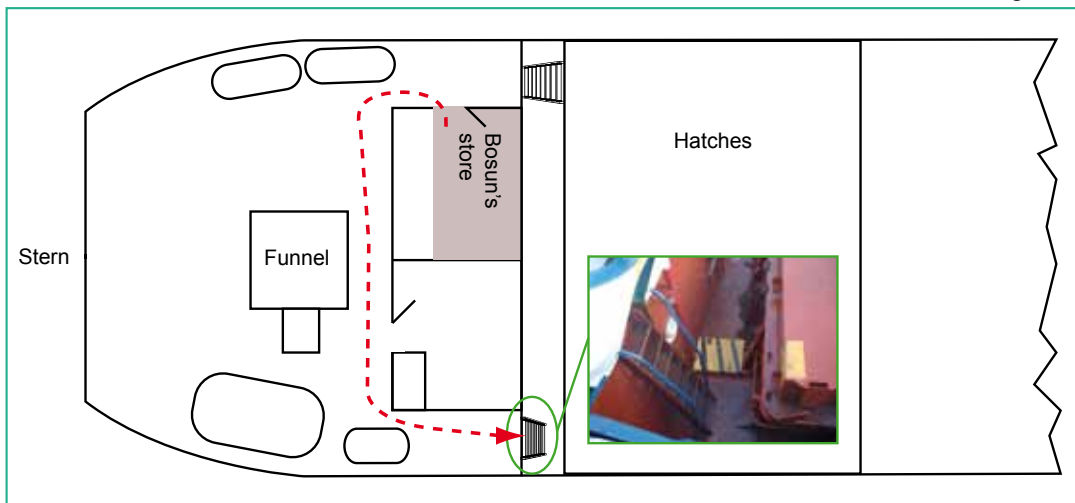
Figure 5

Cargo operations were completed at 1745, and the chief officer instructed the bosun and Stanislaw to “close the hatches”. The two ratings left the bosun’s store and went to the ladder providing access to the main deck on the starboard side (**Figure 5**). The bosun then went down the ladder and made his way along the starboard side of the main deck towards the straddle lift which was stowed amidships. It is assumed that Stanislaw also went down the ladder to make his way towards the port platform. Using the deck guardrail as a ladder, the bosun climbed onto the straddle lift platform and waited for Stanislaw to appear on the port side.

As Stanislaw accompanied the bosun to the top of the ladder leading to the starboard side of the main deck, it is almost certain that, like the bosun, he intended to access the platform on the straddle lift from the main deck using the guardrails. The alternative would have been via the hatch covers, which were accessed by a gangway on the port side of the accommodation deck, forward of the bosun's store (**Figure 5**).

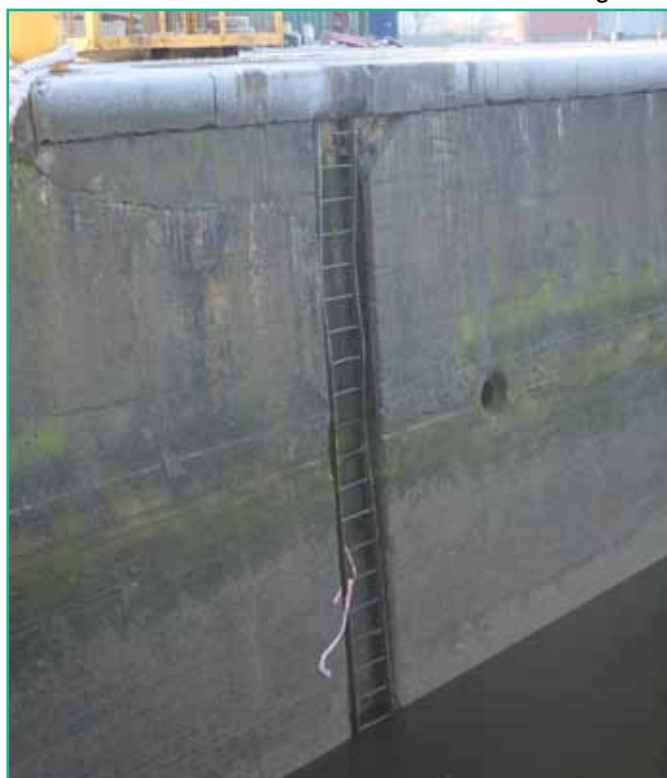
Figure 6

On the poop deck, the chief engineer and cook heard the bosun's shouts and looked over the port side of the vessel. They saw Stanislaw floating towards the stern and shouted out to him. Without delay, the chief engineer collected a lifebuoy and line. He and the cook then went on to the quayside where a ladder (**Figure 6**) was sited astern of the vessel.
