Report on the investigation of
the collision between

Two Cardiff Bay Yacht Club RIBs

resulting in injuries to three students

27 October 2010

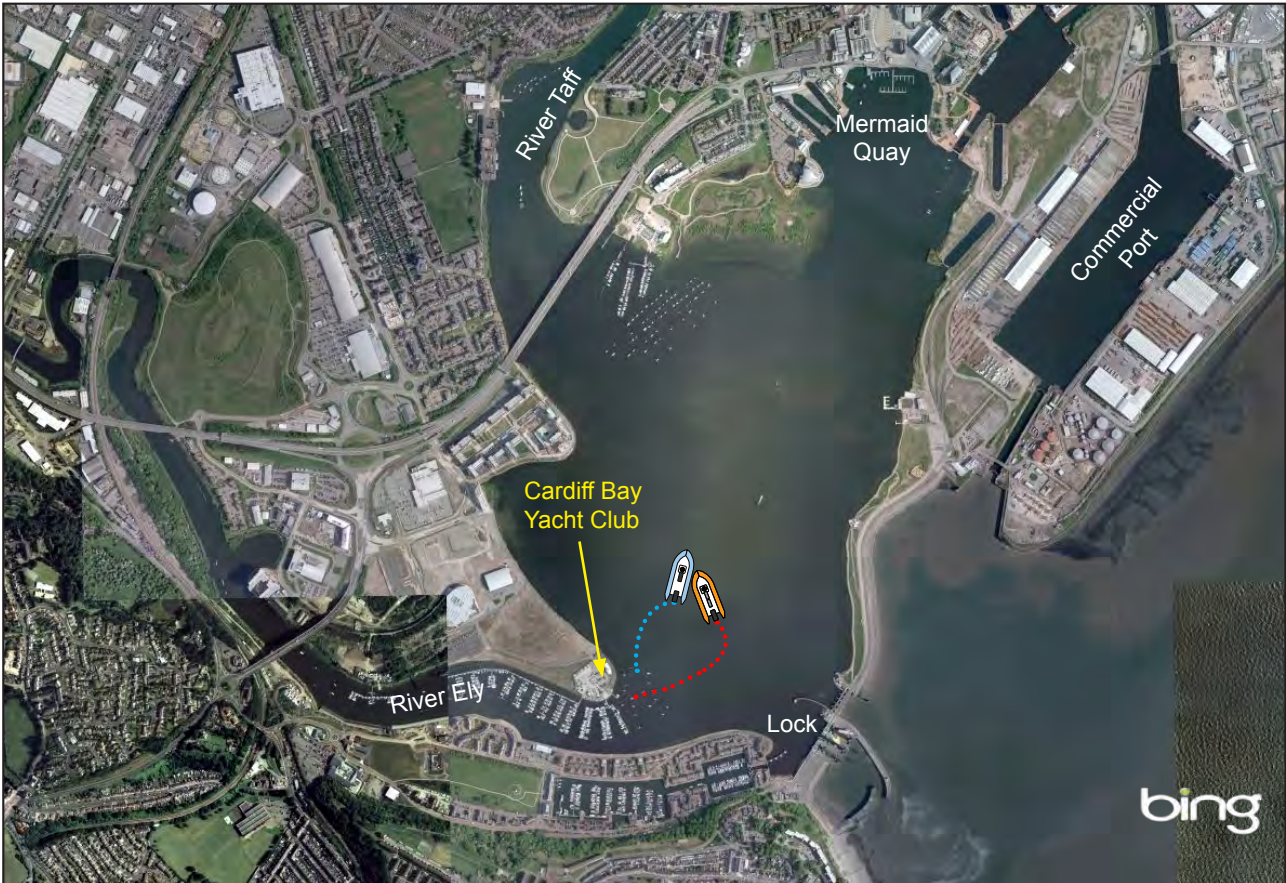
Figure 2

RIB, with its driver and six girls on board, set off to the left of the track taken by the first two RIBs. The other, an orange tubed Tornado RIB, with its driver, a house mother and four girls on board, set off to the right, passing close to moored craft on the outer edge of the moorings (**Figure 2**). The driver of this RIB soon became concerned about approaching too close to the locks, and swung the boat back to port towards the centre of the bay.

Track of the RIBs prior to the collision

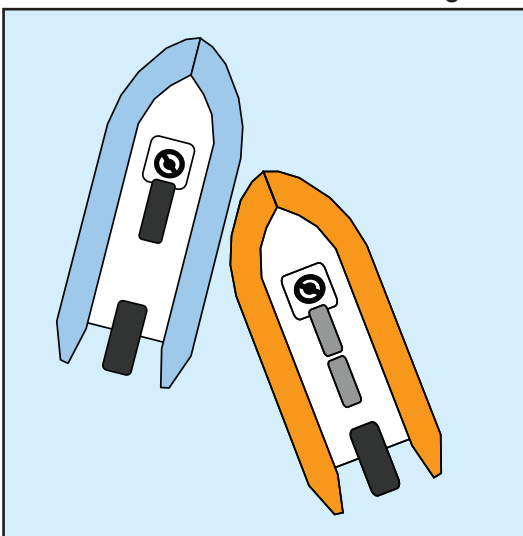
Figure 3

Angle of RIBs at time of collision

The Tornado RIB was probably heading towards the mouth of the River Taff when the driver suddenly saw the starboard side of the Ribcraft RIB very close ahead. Although the driver reduced the boat's speed and started to turn to starboard, collision could not be avoided (**Figure 3**).

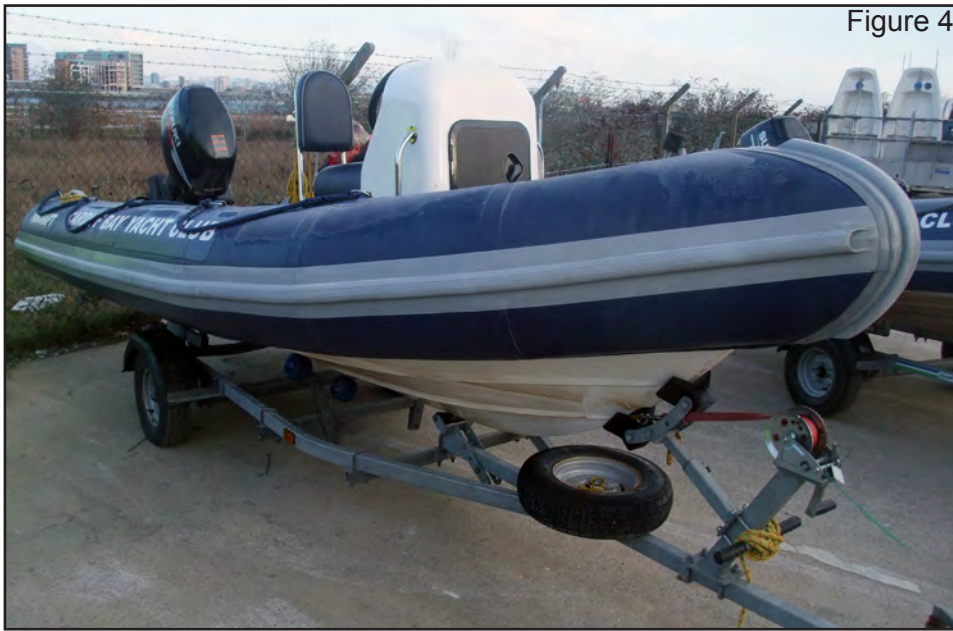
Figure 4

The boat was observed to be in very good fabric condition.

The Ribcraft RIB involved in the collision

The Ribcraft RIB was fitted with one seat for the driver while at the time of the accident there were 7 persons in the boat, one more than the maximum recommended on the builder's plate. The other boat involved in the collision had two seats but was carrying six persons.

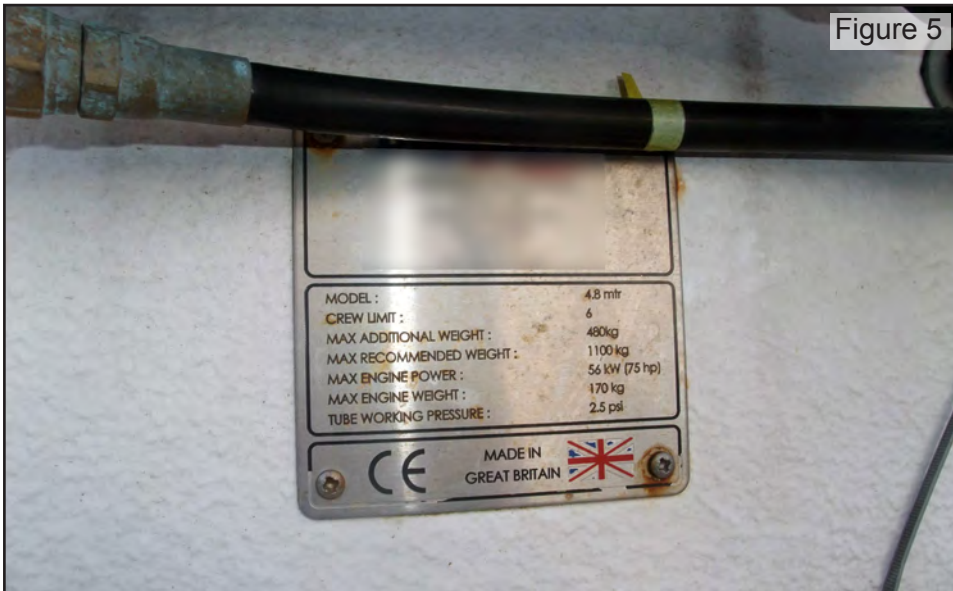
Figure 5

The builder's plate (**Figure 5**) located on the transom showed that the boat's manufacturers recommended that the RIB could carry up to six people while underway. At the time of the collision there were seven persons on board.

The Recreational Craft Directive plate in the Ribcraft RIB

2. The guidance issued by the RYA to its training centres following the Plas Menai accident (**Annex E**) included advice that boat passengers should, where appropriate, be provided with a seat. CBYC should ensure that the recommended maximum capacity of its boats as marked on the builder's plate is not exceeded. It should also provide guidance on the use of its boats for the carriage of persons in excess of the available seating. [2.7]

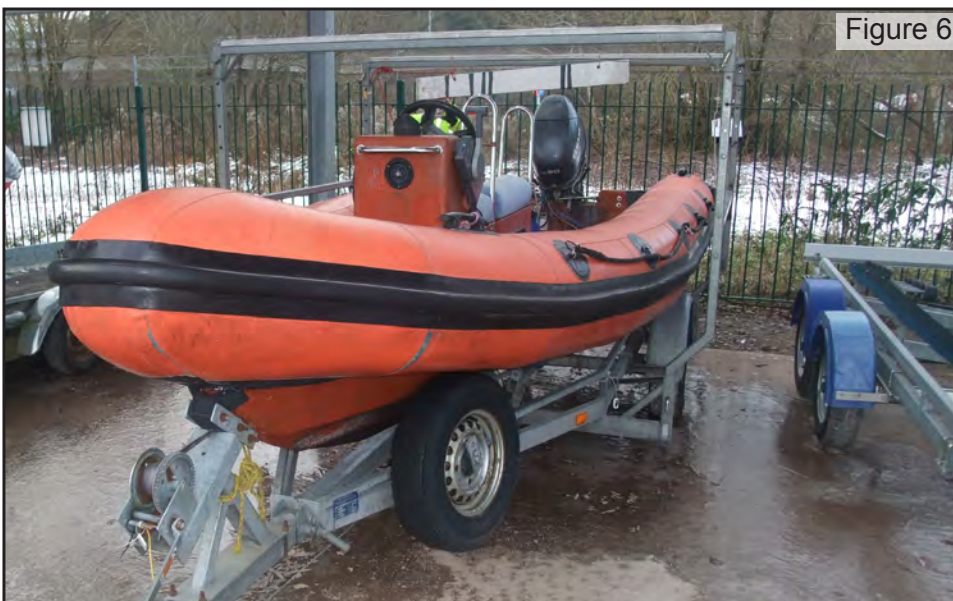
Figure 6

The Tornado RIB (**Figure 6**) was built in 1997, prior to the introduction of the Recreational Craft Directive (RCD), and no builder's plate was fitted. Fitted with orange buoyancy tubes and two jockey seats, it was powered by a 50hp engine. The boat was observed to be in a generally poor fabric condition.

The Tornado RIB involved in the collision

Although the Ribcraft RIB was in good material state, the poor fabric condition of the Tornado RIB involved in the collision reflects gaps in the care and maintenance of the safety boats belonging to CBYC, an RYA recognised training centre.

3. CBYC should review its system for the care and maintenance of club boats to ensure they are always in a good and serviceable condition. [2.10]

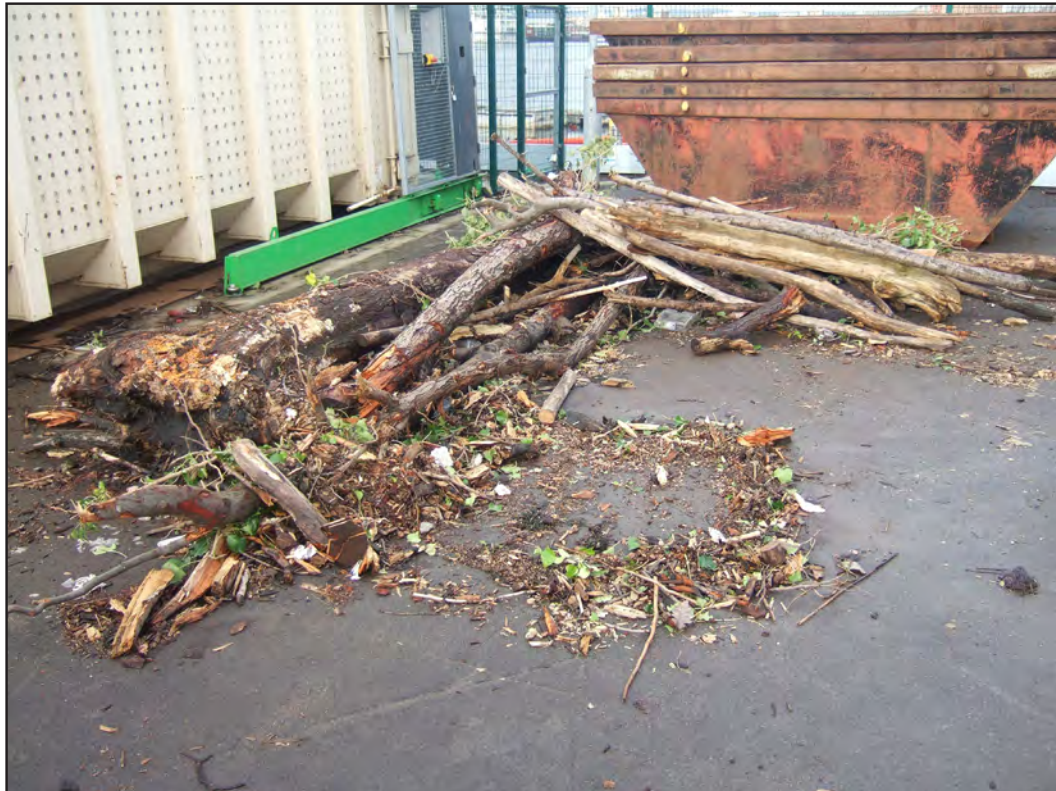
Figure 8

CHA annually removes approximately 1000 tonnes of flotsam from Cardiff Bay, consisting of a range of items from tree trunks and branches to domestic rubbish and other debris (**Figure 8**). While 80-85% of the debris is captured by booms on the rivers Taff and Ely, the remainder is blown onto the banks of the rivers or onto the shoreline of the bay and is collected from there. Semi-submerged items which pose a hazard to surface navigation, are occasionally reported in the main body of the bay and recovered by CHA debris collection vessels.

Examples of flotsam recovered from Cardiff Bay
