MV ANTONIS

Contact with Langton-Alexandra swing bridge In the Port of Liverpool 11 December 2010

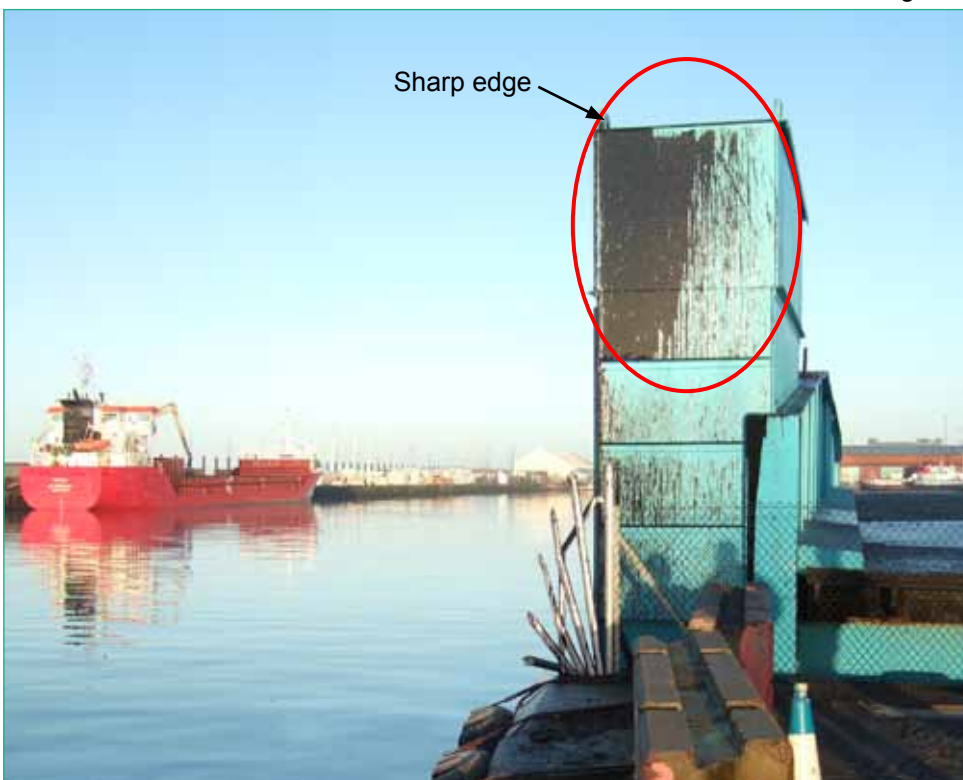
Figure 3

side of the passageway. As the vessel entered the passageway, the pilot noticed her stern drift towards the eastern wall. He ordered the third tug to 'push with full weight', which was acknowledged and implemented by the tug's master. The pilot also ordered the helm 'hard-a-port'. However, these actions did not prevent the vessel's hull from making contact with the sharp edge of a counterweight ballast tank fitted on the open and recessed swing bridge (**Figure 3**).

Swing bridge showing counterweight

completed in April 2008. To compensate for the increased length of the swing bridge, a rectangular counterweight was fitted (Figure 3). The extension to the bridge resulted in its end overhanging the northern end of the eastern wall inside Alexandra Dock when in a stowed position. This made it vulnerable to contact from passing traffic (Figure 6).

Even though the swing bridge was open and recessed, *Antonis* was able to make contact with the sharp corner of its counterweight (**Figure 3**) due to the hull overhang in the area of No 5 (P) fuel oil tank.

Prior to the accident, the port authority had not identified the counterweight as being a potential hazard to vessels using the passageway.

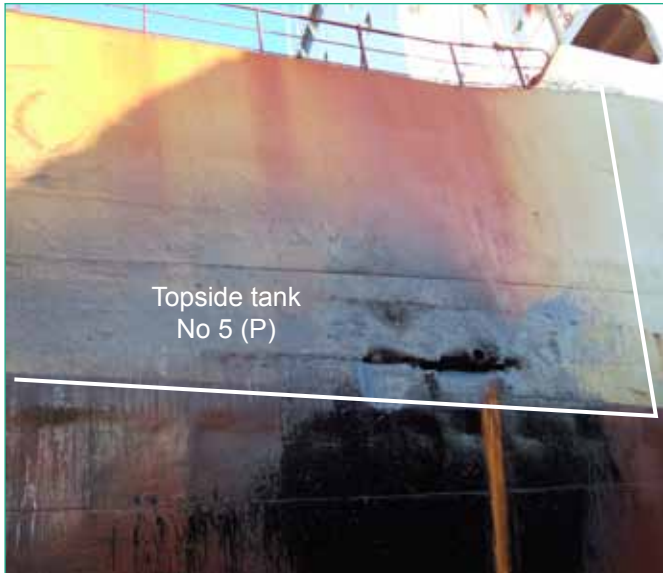
Figure 4

The contact occurred at 0428 in way of No 5 (P) topside fuel oil tank and caused a 1.5 metre gash in the vessel's side (**Figure 4**). This resulted in heavy fuel oil spilling into the dock.

1.5 meter gash

Despite efforts by the vessel's crew to stem the flow of oil, about 330 tonnes entered the dock system.

The master immediately called the engine room and ordered the chief engineer to start transferring the oil from No 5 (P) to other tanks. He also told him to pump out ballast from the port side to create a starboard list in an attempt to stop the oil flow into the dock.

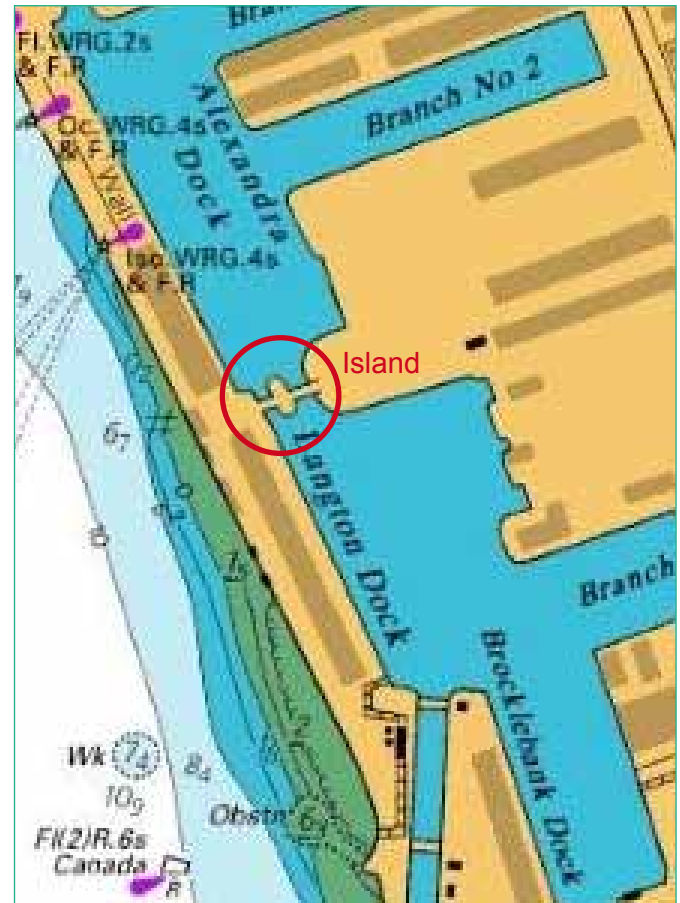
Figure 5

Work to widen the passageway from 27 to 39.46 metres (Figure 5) was completed in September 2006 when the passageway was re-opened to traffic. In April 2007, the swing bridge was lifted out to be refurbished and lengthened. This work was

Langton-Alexandra passageway

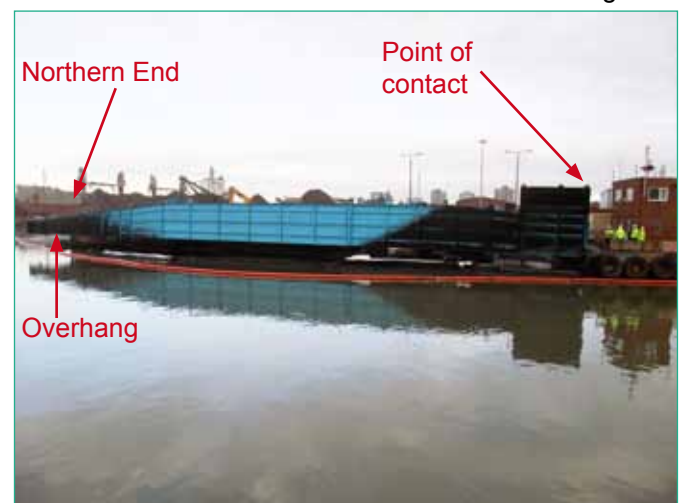
Figure 6

Langton-Alexandra passageway swing bridge

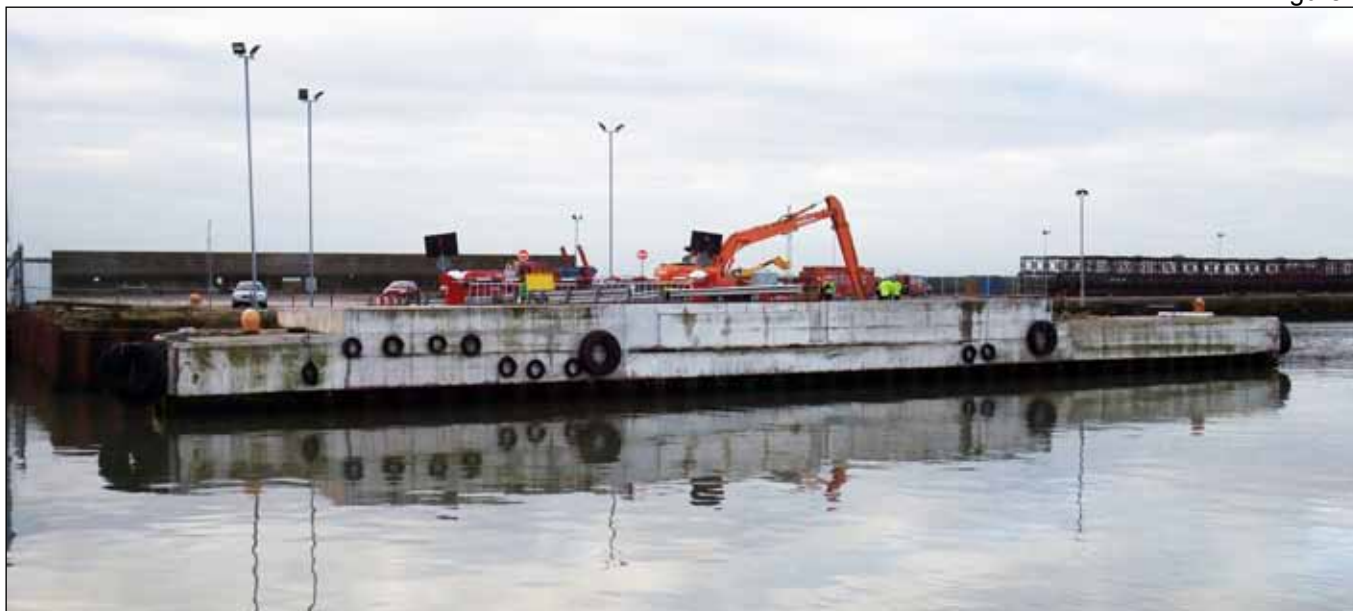
Western wall of passageway

Since the passageway was re-opened in 2006, 130 vessels of more than 100 metres in length have used it. There has been only one reported incident, in February 2008, when a south-bound vessel made contact with the north-west corner (**Figure 7**) of the passageway, resulting in an indentation to the vessel's hull above the waterline. Since April 2008, 75 vessels of more than 100 metres in length have used the passageway.

it was believed that, if vessels landed against this wall, no damage to the ship or wall would be caused. The passageway's western wall (**Figure 7**) was poorly fendered, built of concrete and more likely to cause damage if landed upon. The risk of a vessel's overhang making contact with the swing bridge counterweight had not been recognised.

- Has increased the fendering on the western wall.
- Intends to install low level indicator lights to assist in locating the waterline within the passageway.
- Intends to discuss with the tug companies possible improvements to the fendering on the south side of the eastern wall.
- Intends to improve the fendering in the passageway and protection to the bridge end.
- Intends to discuss with the pilotage services company how the use of the third tug can be optimised to enhance pilots' control of the manoeuvre through the passageway.
- Intends to complete a formal risk assessment for vessels transiting the dock system.
