Report on the investigation of
the catastrophic failure of a capacitor
in the aft harmonic filter room on board
RMS Queen Mary 2
while approaching Barcelona
23 September 2010

At 0425 on 23 September 2010, as *RMS Queen Mary 2 (QM2)* was approaching Barcelona, an explosion occurred in the vessel's aft main switchboard room. Within a few seconds, all four propulsion motors shut down, and the vessel blacked out shortly afterwards. Fortunately, the vessel was clear of navigational hazards and drifted in open sea.

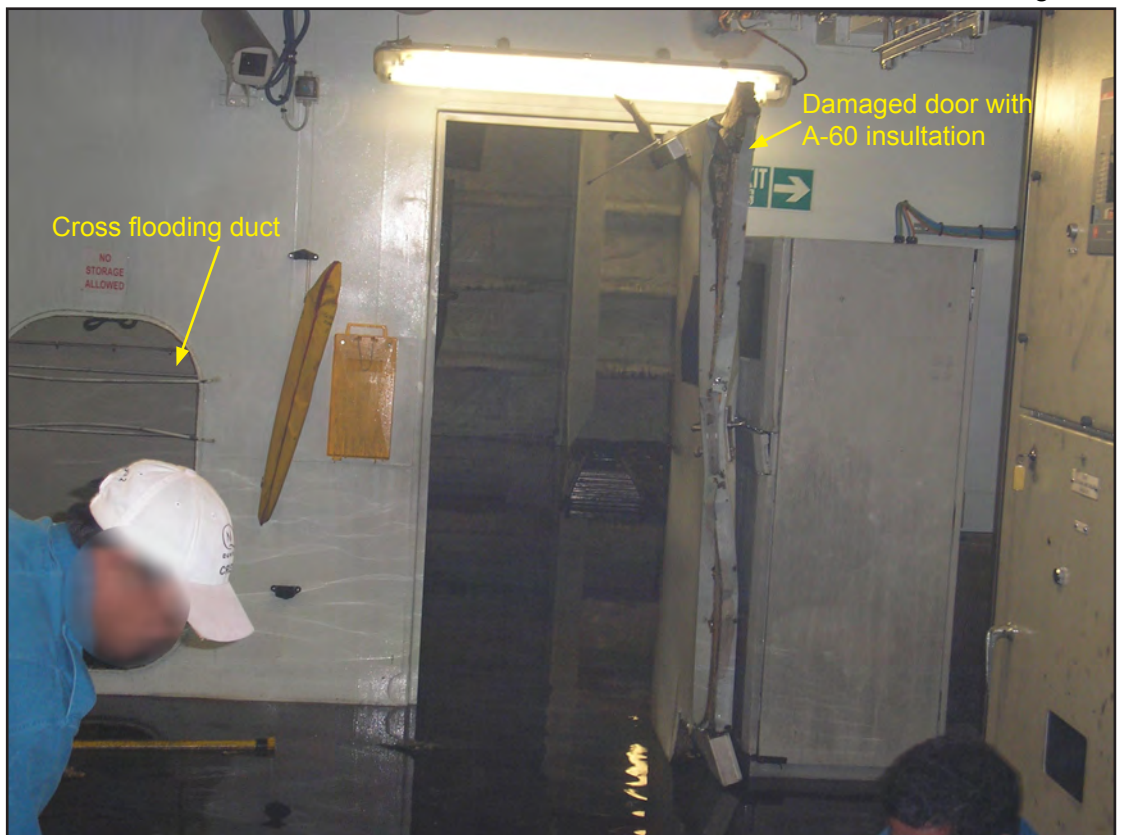
Figure 6

By 0439, the second electro-technical officer and a third engineer, both wearing breathing apparatus and carrying carbon dioxide portable fire extinguishers and a thermal imaging camera, were ready to carry out an inspection of the scene. They entered the aft MSB room and made their way into the HF room, stopping just after entering the doorway (**Figure 4**). They confirmed that the space was filled with thick black smoke; but there was no fire and, using their thermal imaging cameras, they did not detect any hot spots. Two *Hi-Fog* glass bulbs (**Figure 5**), one in the aft HF room and another in the aft MSB room had ruptured and there was approximately 10mm of water on the decks of both compartments (**Figure 6**).

Water in the aft harmonic filter and main switchboard rooms

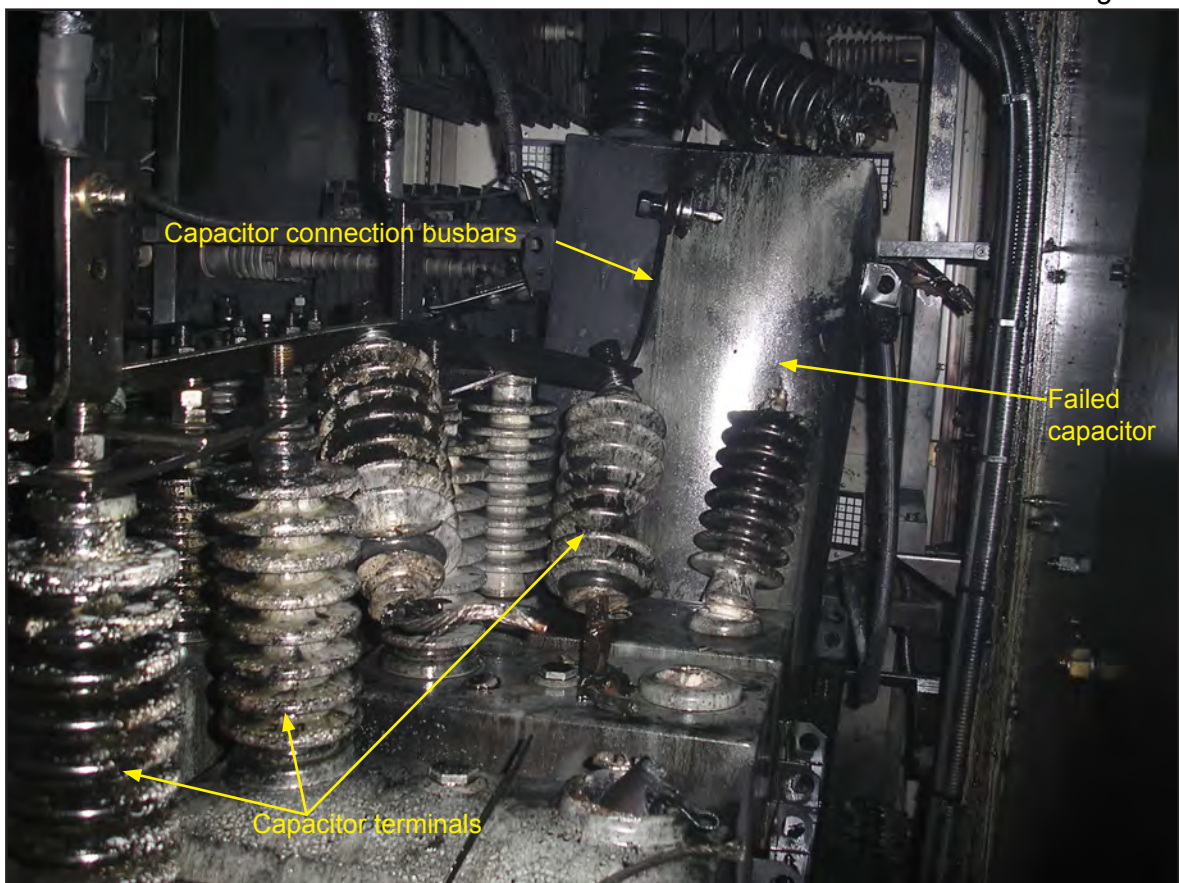
Figure 7

The explosion was triggered by deterioration in the capacitors in the aft HF. Internal arcing between the capacitor plates developed, which vaporised the dielectric medium causing the internal pressure to increase, until it caused the capacitor casing to rupture. Dielectric fluid vapour sprayed out, igniting and creating the likely conditions for an arc-flash to occur between the 11000 volt bus bars that fed power to the aft HF.

The damage in the aft HF room was extensive. Most of the occupants of the six crew cabins located directly above the aft HF room heard the noise of the blast and described the sound as a 'loud bang'. There was no damage inside their cabins. Panels on either sides of the rank 11.3 cubicle were badly distorted and covered with soot. Panels for the rank 4 cubicle were also bulged out. The floor and deckhead were covered with soot and dielectric oil was found all over the rank 11.3 HF section, including the area under the capacitors and on the inside of the top panel of the enclosure. One capacitor was found to have lifted up around 60cm from its normal position. Its bottom cover had bent outwards and blown out at its welded joint. It had wrenched itself free from its foundation bolts, breaking the connection to the capacitor elements inside. All the capacitors fitted in the same row as the failed one had suffered damage on their terminals. The casing of another capacitor was found to have bulged severely (**Figure 7** and **Figure 8**).

Failed capacitor

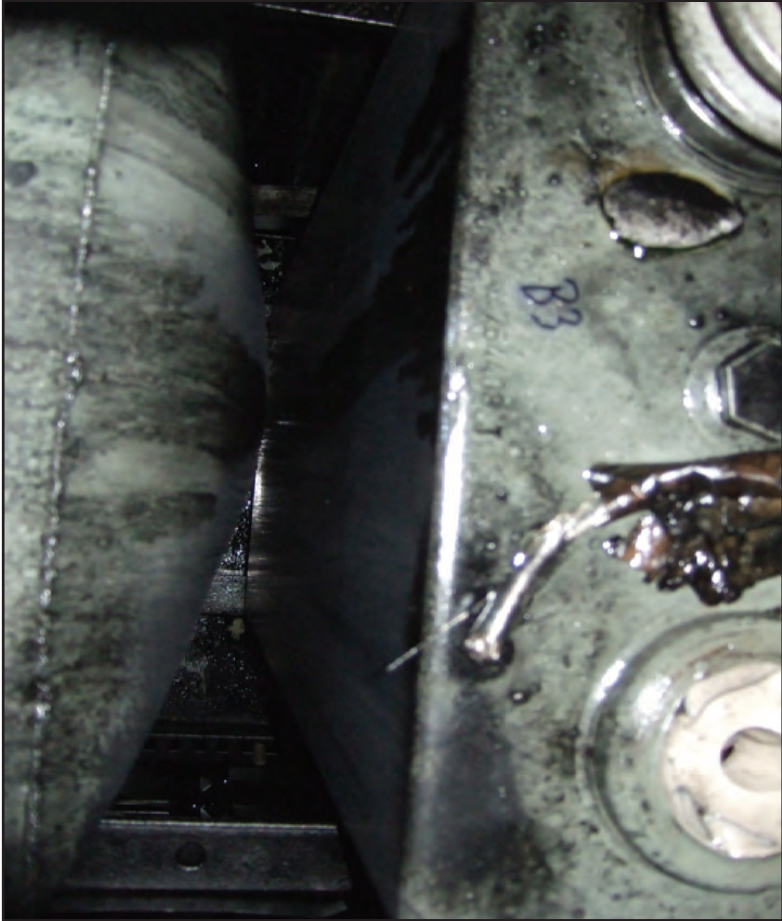
Figure 8

Top view of bulged capacitor

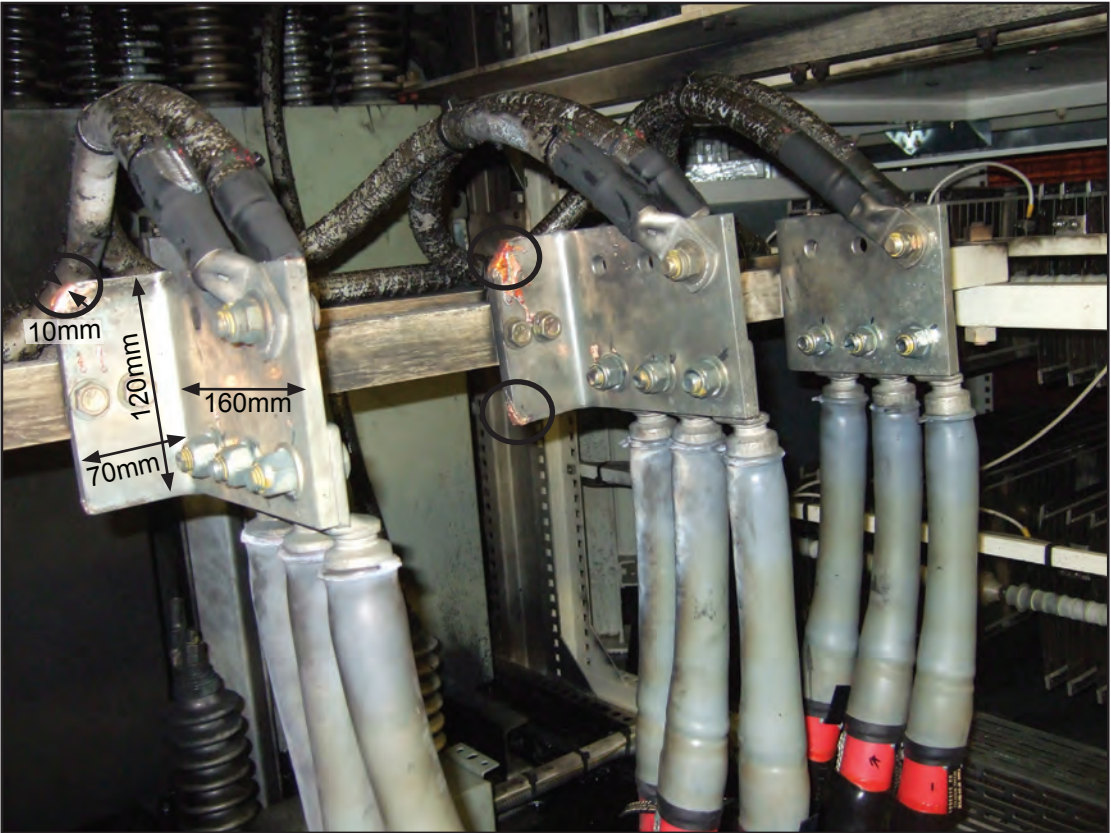
Figure 9

The 'A-60' rated steel door to the compartment was found forced out through its frame and the adjoining steel door for the MSB room was also buckled and split. A steel door at the inboard entrance to the aft MSB room and located approximately 20m away from the site of the explosion was forced off its hinges. The stiffeners on the bulkhead of the compartment were buckled and the steel cover plate on the cross-flooding duct between the HF and MSB rooms was blown out into the MSB room. The polythene covering on a fire extinguisher, which was located approximately 2m away from the failed capacitor, was found singed. The corners of all three high voltage bus bars that fed into the aft HF had been melted (**Figure 9**).

Evidence of arcing on the harmonic filter bus bars

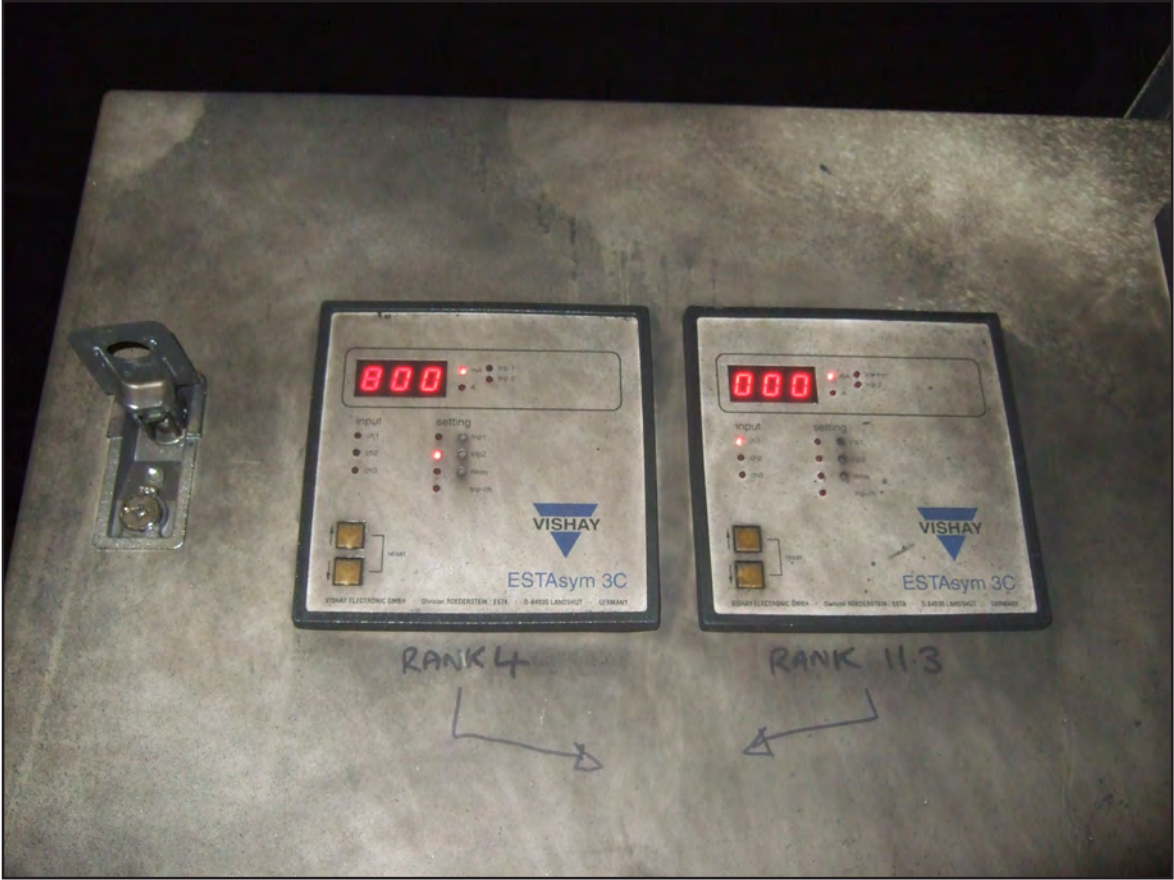
Figure 21

Immediately after the accident, the imbalance detection unit for rank 4 of the aft HF indicated 800mA and the equivalent unit on rank 11.3 (where the failure took place) showed '000' (**Figure 21**). Cooling water leakage and cooling air alarms were also provided for each rank. These alarms did not activate during the accident. An overload alarm was also provided but it was not possible to determine from the alarm records if this activated during the accident.

Current imbalance indicators in the aft harmonic filter room
