Extracts from Hawkins & Associates Ltd's report on Ignition of Hydraulic Oils by Hot Surfaces –  
C69/45210 dated 10 November 2010

MAIB Safety Flyer

### **YEOMAN BONTRUP: RADIATION HAZARD IDENTIFIED FOLLOWING A FIRE**

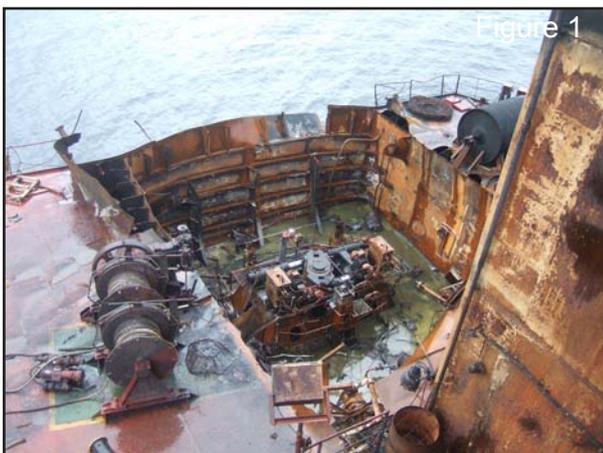
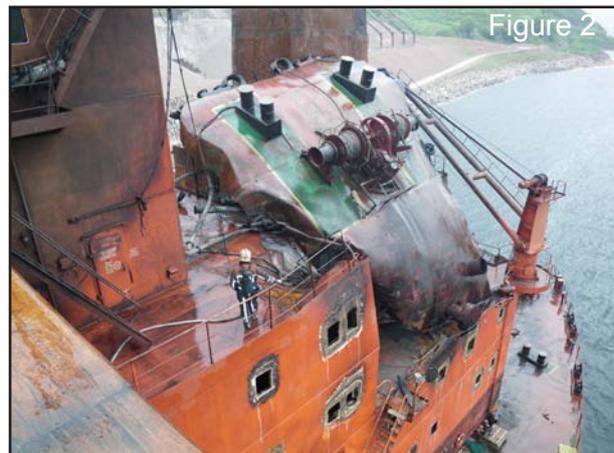
On 2 July 2010, a fire was discovered on the vertical cargo conveyor belt of the self-unloading bulk carrier *Yeoman Bontrup* while the cargo hopper was being repaired. The crew tackled the fire from the conveyor tunnels under the holds, but it quickly spread throughout the cargo handling area and into the accommodation. The fire also spread into the engine room by heat transfer through the bulkheads and via an open connecting door, and then to the steering gear compartment which contained a number of hydraulic systems as well as stocks of oils, greases, and ship's-use chemicals. There, the fire caused a large explosion that blasted the entire poop deck into the air and onto the funnel deck (**Figures 1 & 2**). Fortunately, there were only minor smoke inhalation and bruising injuries.

The fire was most likely caused by hotwork repair debris falling from the cargo hopper at the top of the tower into the flammable side curtain of the vertical conveyor belt.

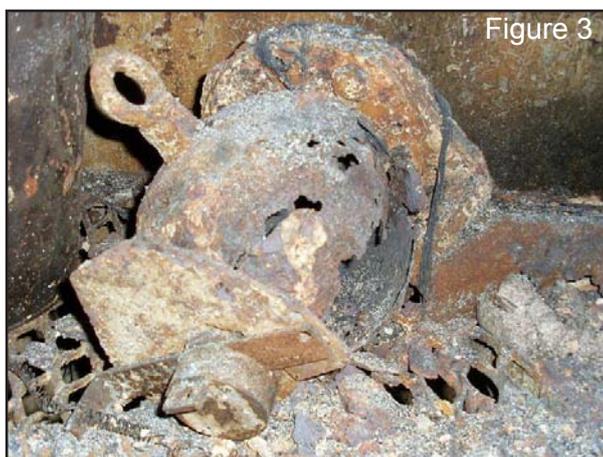
Silometer devices, containing radioactive Cobalt 60 isotopes, were fitted to the cargo hopper to detect excessive build up of cargo in the self-unloading system. The silometers had not been used for 10 years, and the outer shells of the source containers were in an extremely poor condition. However, the radioactive isotopes inside them were still active. During the fire, the lead shielding around one of the radioactive source containers melted, exposing the radioactive source container itself (**Figure 3**).

The onboard risk assessments did not include the risk of exposure to gamma ray radiation, and the Safety Management System did not provide any guidance on inspecting the silometers or safety precautions to be taken. Consequently: welding operations regularly took place in the hopper area without any precautions being taken to warn or protect the personnel involved; when the fire broke out none of the firefighters or salvors was warned of the potential hazard; and inspectors and surveyors investigating the cause of the fire were consequently exposed to low levels of radiation when they inspected the cargo hopper area. Fortunately, the source containers were not breached; had this occurred the fire could have spread radioactive particles throughout the surrounding area, generating a severe risk to health.

- Where appropriate, ship owners and managers should ensure their Safety Management Systems provide comprehensive guidance for the control, use, inspection, maintenance and disposal of radiation sources fitted to their vessels to ensure that risks of exposure to radiation are minimised.
- Such guidance should include the potential risk to health from exposure to radiation resulting from an accident such as a fire or collision.
- Emergency plans should ensure that the presence of radiation sources is brought to the attention of attending emergency services (eg. Fire and Rescue Service) so that the radiation risk is given due consideration.
