Extracts from Hawkins & Associates Ltd's report on Ignition of Hydraulic Oils by Hot Surfaces –
C69/45210 dated 10 November 2010

YEOMAN BONTRUP: RADIATION HAZARD IDENTIFIED FOLLOWING A FIRE

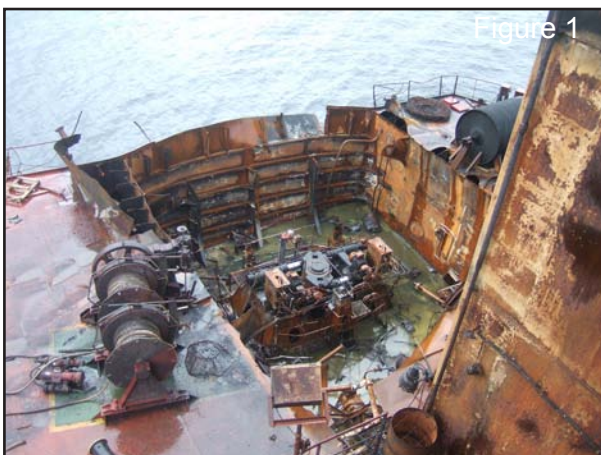
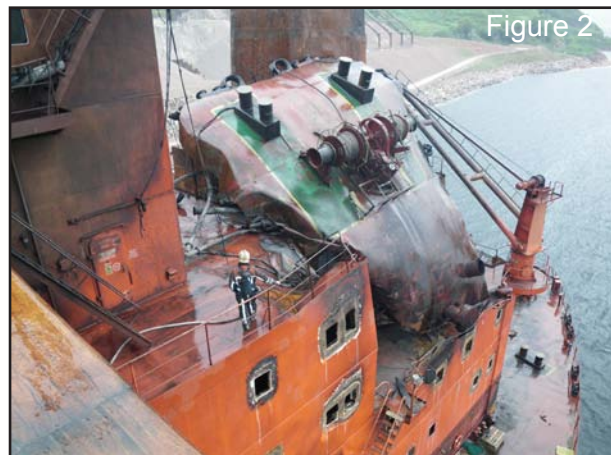
On 2 July 2010, a fire was discovered on the vertical cargo conveyor belt of the self-unloading bulk carrier *Yeoman Bontrup* while the cargo hopper was being repaired. The crew tackled the fire from the conveyor tunnels under the holds, but it quickly spread throughout the cargo handling area and into the accommodation. The fire also spread into the engine room by heat transfer through the bulkheads and via an open connecting door, and then to the steering gear compartment which contained a number of hydraulic systems as well as stocks of oils, greases, and ship's-use chemicals. There, the fire caused a large explosion that blasted the entire poop deck into the air and onto the funnel deck (**Figures 1 & 2**). Fortunately, there were only minor smoke inhalation and bruising injuries.

The fire was most likely caused by hotwork repair debris falling from the cargo hopper at the top of the tower into the flammable side curtain of the vertical conveyor belt.

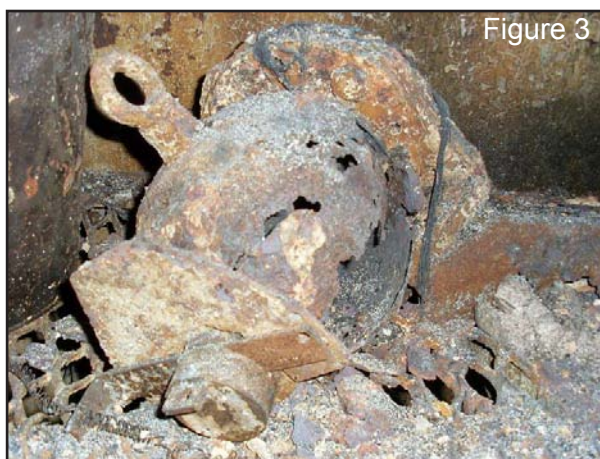
Silometer devices, containing radioactive Cobalt 60 isotopes, were fitted to the cargo hopper to detect excessive build up of cargo in the self-unloading system. The silometers had not been used for 10 years, and the outer shells of the source containers were in an extremely poor condition. However, the radioactive isotopes inside them were still active. During the fire, the lead shielding around one of the radioactive source containers melted, exposing the radioactive source container itself (**Figure 3**).

The onboard risk assessments did not include the risk of exposure to gamma ray radiation, and the Safety Management System did not provide any guidance on inspecting the silometers or safety precautions to be taken. Consequently: welding operations regularly took place in the hopper area without any precautions being taken to warn or protect the personnel involved; when the fire broke out none of the firefighters or salvors was warned of the potential hazard; and inspectors and surveyors investigating the cause of the fire were consequently exposed to low levels of radiation when they inspected the cargo hopper area. Fortunately, the source containers were not breached; had this occurred the fire could have spread radioactive particles throughout the surrounding area, generating a severe risk to health.

- Where appropriate, ship owners and managers should ensure their Safety Management Systems provide comprehensive guidance for the control, use, inspection, maintenance and disposal of radiation sources fitted to their vessels to ensure that risks of exposure to radiation are minimised.
- Such guidance should include the potential risk to health from exposure to radiation resulting from an accident such as a fire or collision.
- Emergency plans should ensure that the presence of radiation sources is brought to the attention of attending emergency services (eg. Fire and Rescue Service) so that the radiation risk is given due consideration.
