Report on the investigation of
the fire and explosion on board

Yeoman Bontrup

Glensanda Quarry, Loch Linnhe, Western Scotland

Report No 5/2011
May 2011

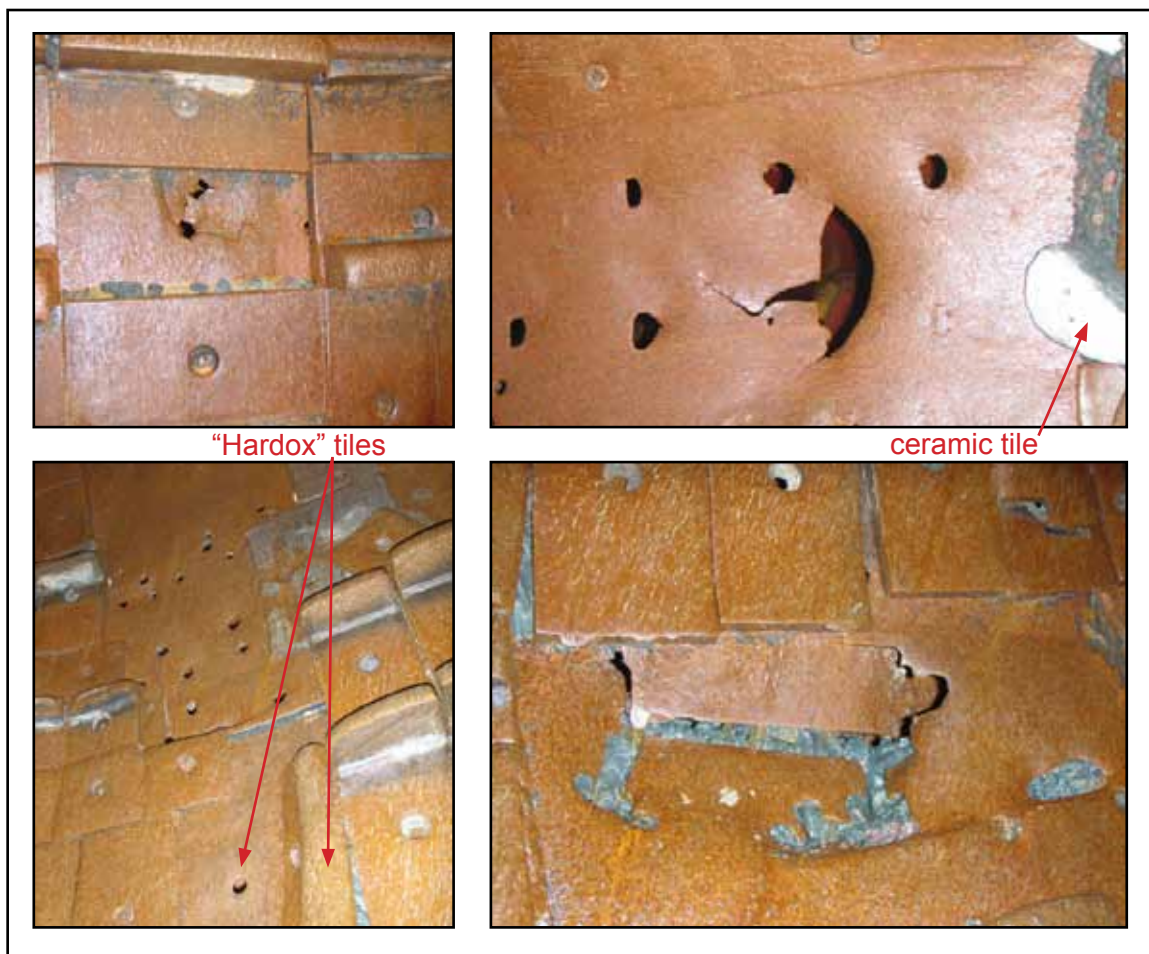
Figure 2

The inspection by the chief engineer and cargo engineer identified a small number of familiar defects associated with the SUS conveyor belts. It also identified that about 40 "Hardox" and 30 ceramic sacrificial tiles, fitted to the inside of the cargo discharge hopper, had been badly abraded or were missing. It was also found that the mild steel carcass of the discharge hopper had been holed in a number of places (**Figure 2**) by the hard sandstone cargo during the discharge operation. At 0807 on 1 July, the findings were reported, by e-mail, to the ship's manager and to the operator's technical manager.

Composite of photographs showing discharge hopper damage and wear to the "Hardox" and ceramic sacrificial protection tiles

As a limited number of "Hardox" and ceramic tiles were available on board to effect the repairs, it was decided to use a number of "Hardox" plates to cover the larger holes. The plates were cut to shape using oxy-acetylene equipment at a temporary work bench located on the main deck at the port side of the vertical conveyor tower (**Figure 3**).

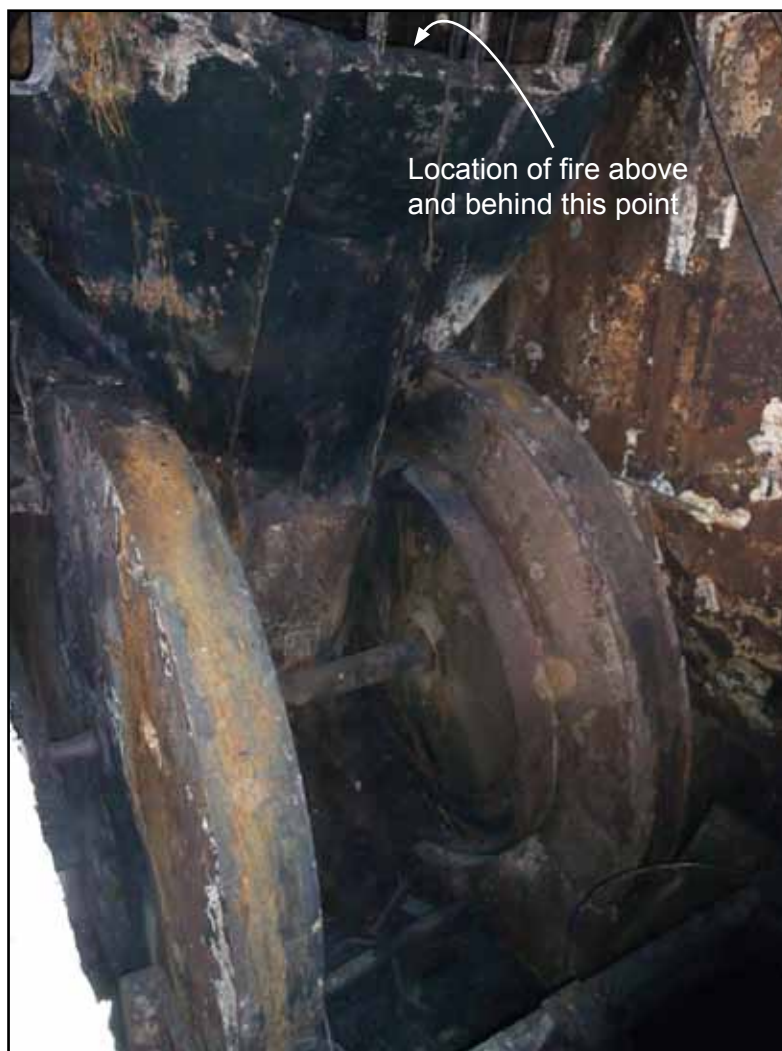
Figure 6

At 1519, the AB reached the lower platform of the vertical conveyor belt. He smelt smoke and, as he turned slightly, he saw a great deal of smoke developing and about 1.5m² of flame around the rising part of the vertical belt adjacent to the forward engine room bulkhead (**Figure 6**).

Area in which the fire was discovered

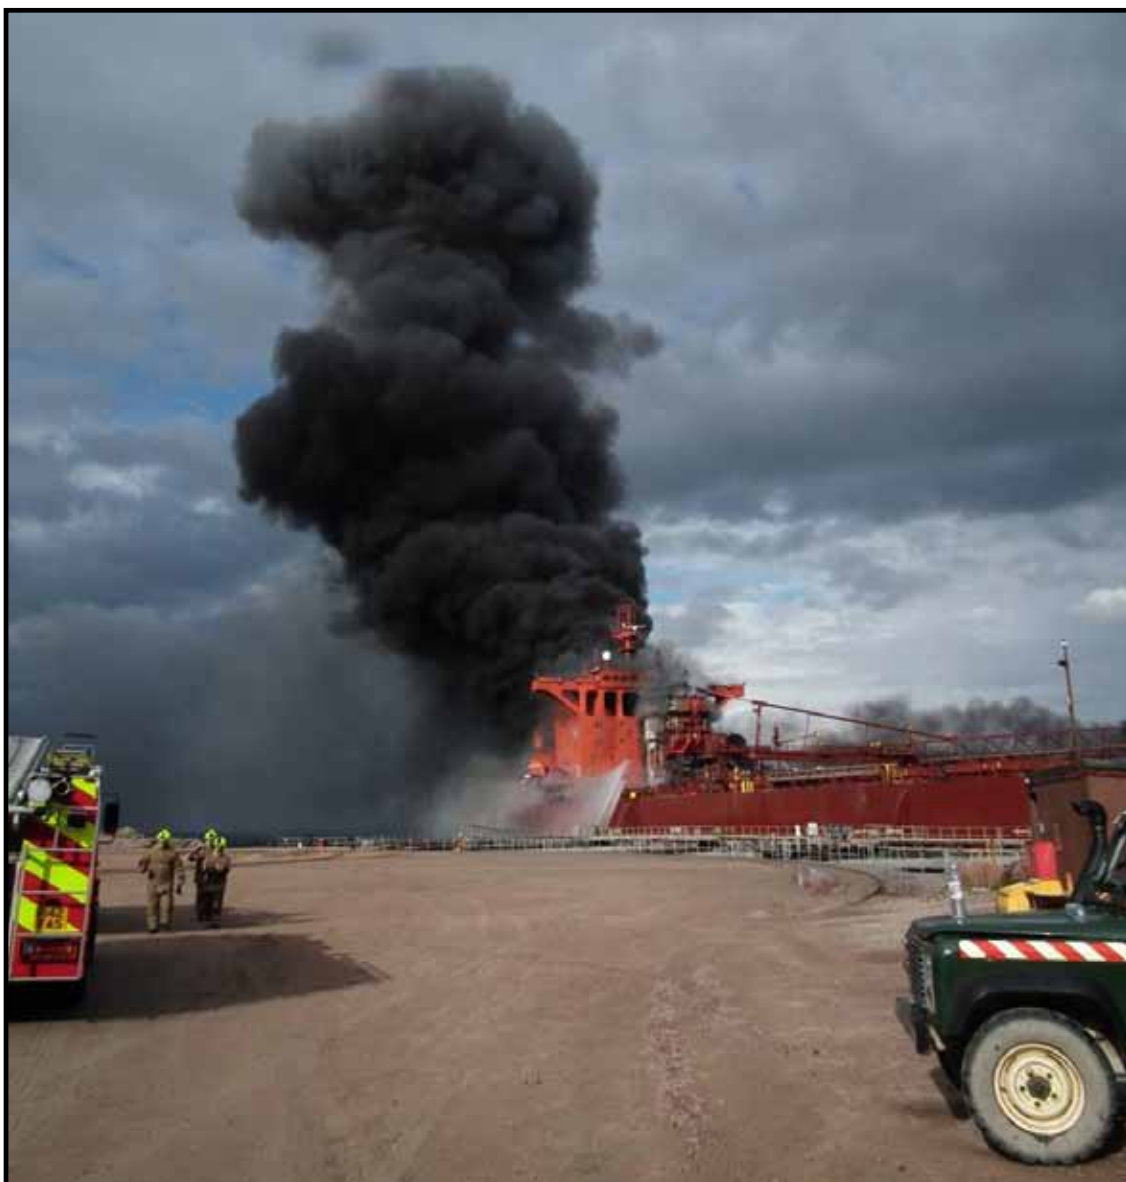
The HIFRS tenders arrived at 1825. The HIFRS had just established a 200m exclusion zone when a massive explosion (**Figure 11**) tore off the entire poop deck, projecting it up into the air and landing it on the port side of the funnel deck. Soon afterwards, flames were seen coming from *Yeoman Bontrup*'s stern area as the oils and chemicals stowed in the steering gear room, and the steering system's hydraulic oil charge, continued to burn.

Steering gear compartment explosion

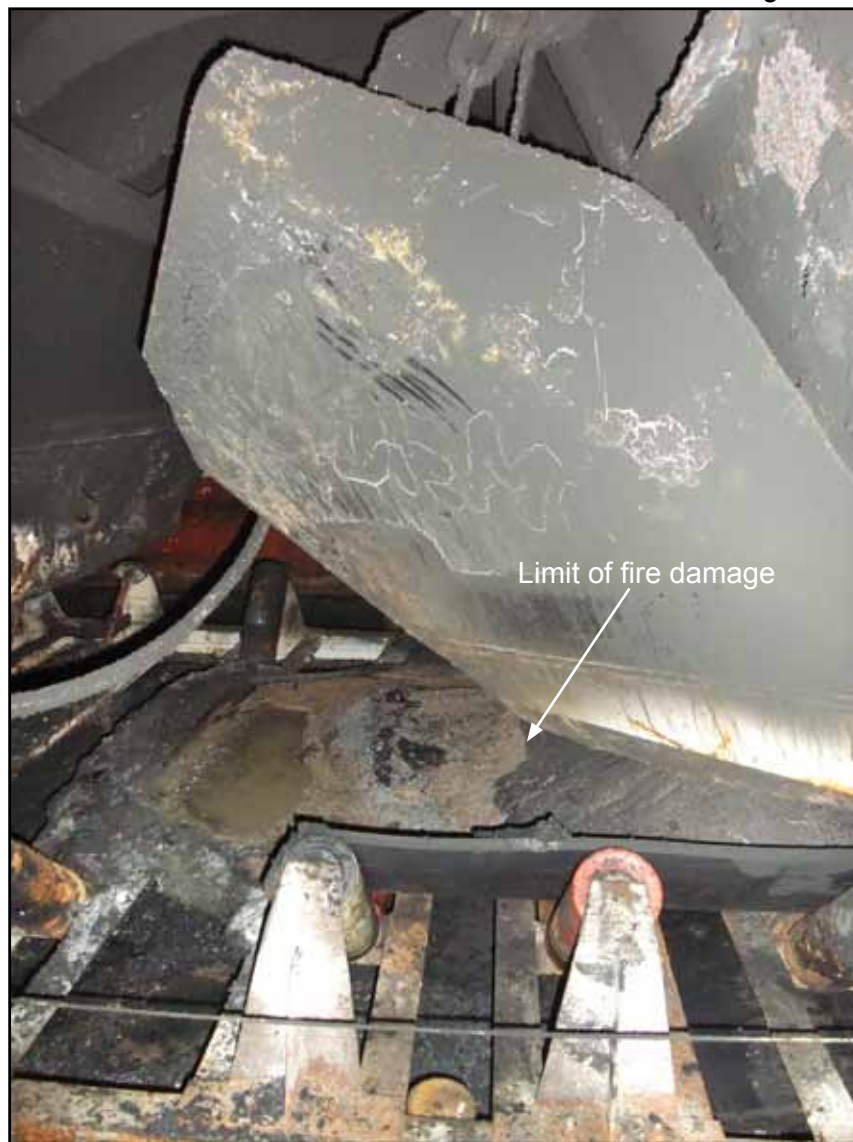
Figure 13

The fire damage in the hold tunnels reached as far forward as frame 167 with the port, starboard and centre hold conveyor belts being consumed from this point aft (**Figure 13**), as were the two cross-conveyor belts. The distinct line of the limit of damage suggests that the three tunnel belts forward of this point were covered by water that had accumulated in the tunnel⁴.

Extent of damage to tunnel conveyor belts

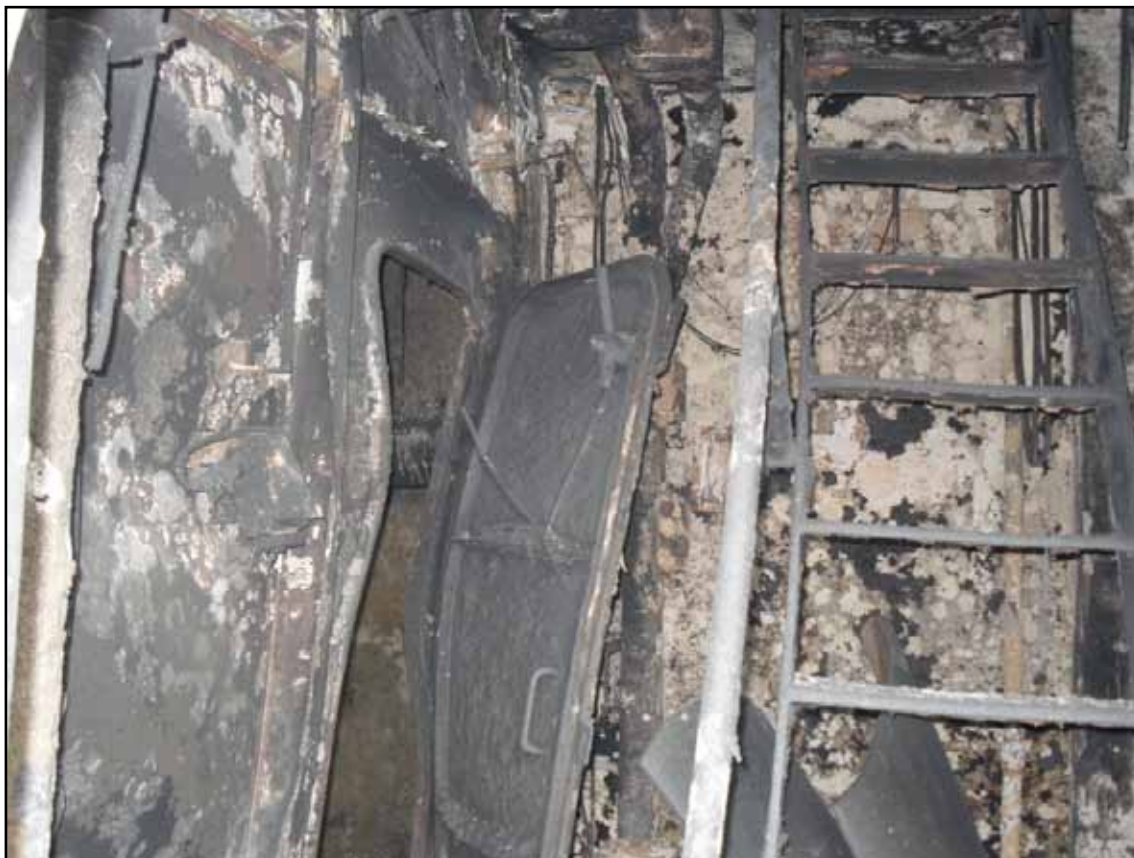
All flammable material in the vertical conveyor belt tower and the SUS hydraulic pump space was completely destroyed, and there was massive structural distortion to the steel doors, ladders and bulkheads (**Figure 14**).

Example of distortion in the SUS tower

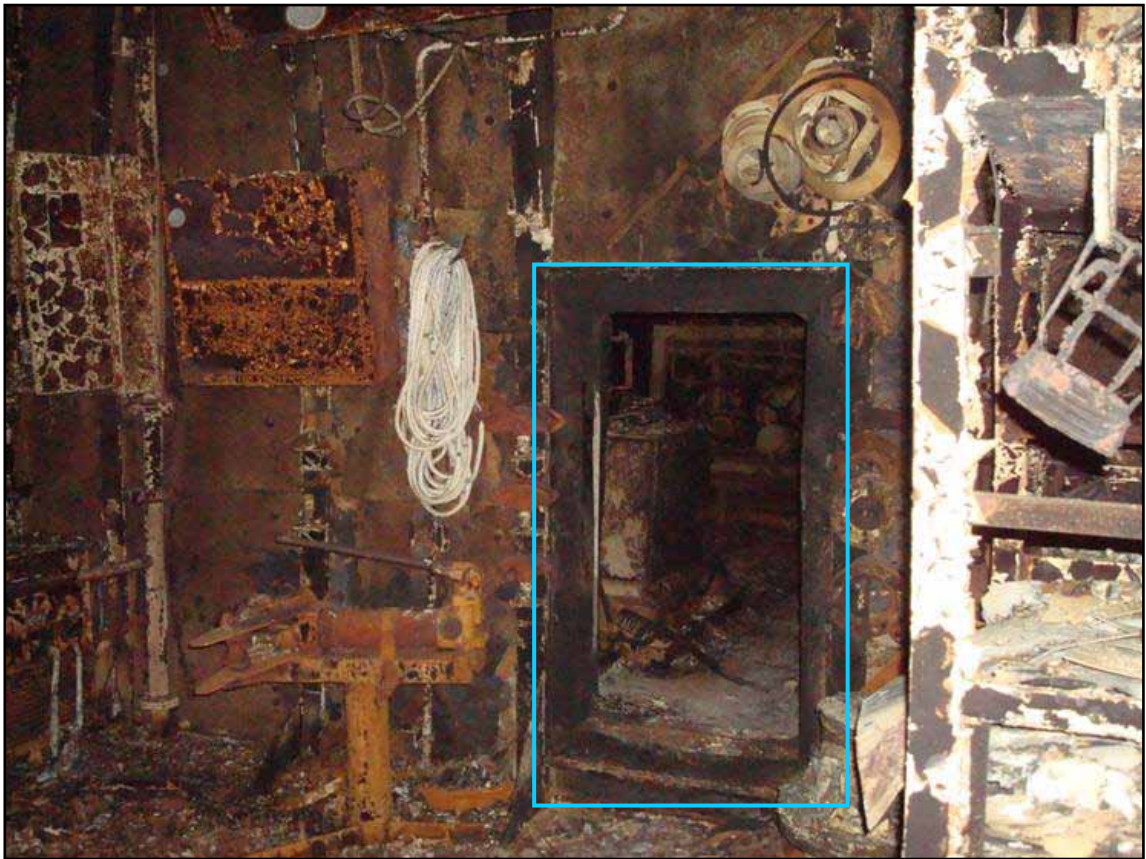
Figure 15

Engine room/SUS hydraulic pump space door

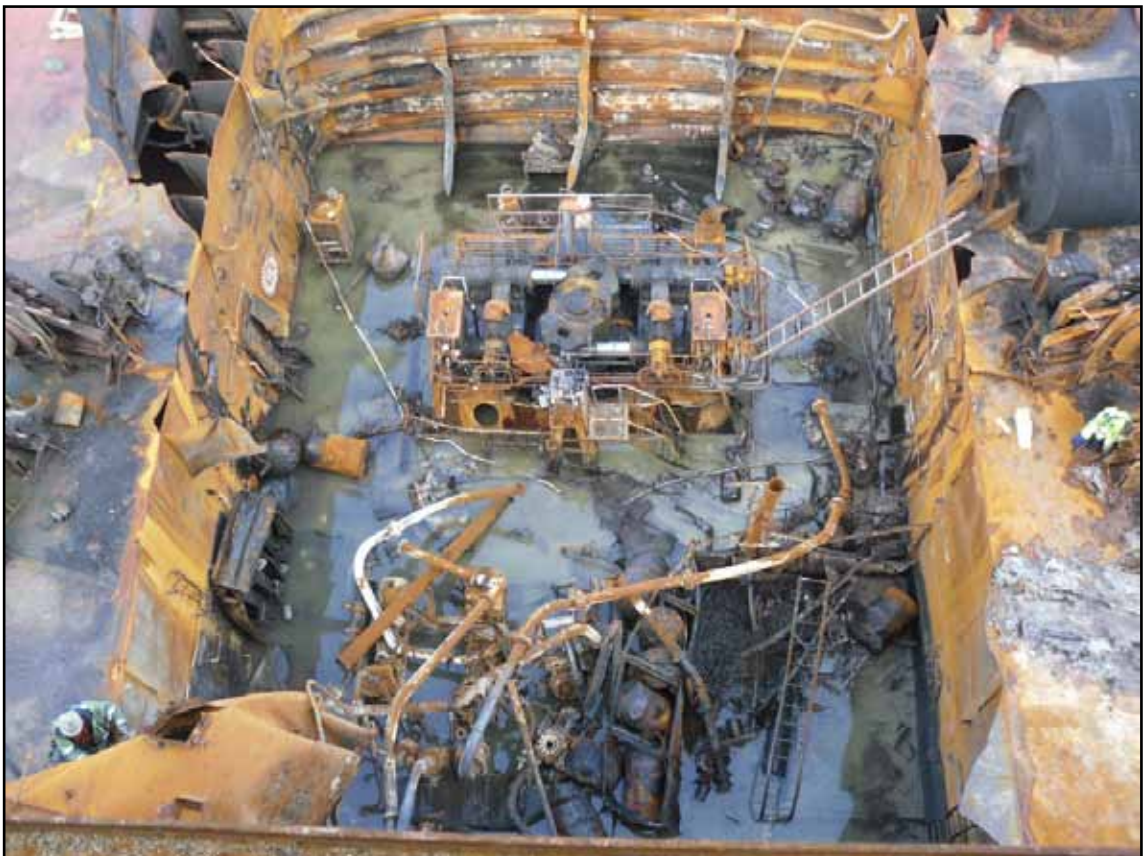
Figure 16

Exposed steering gear compartment

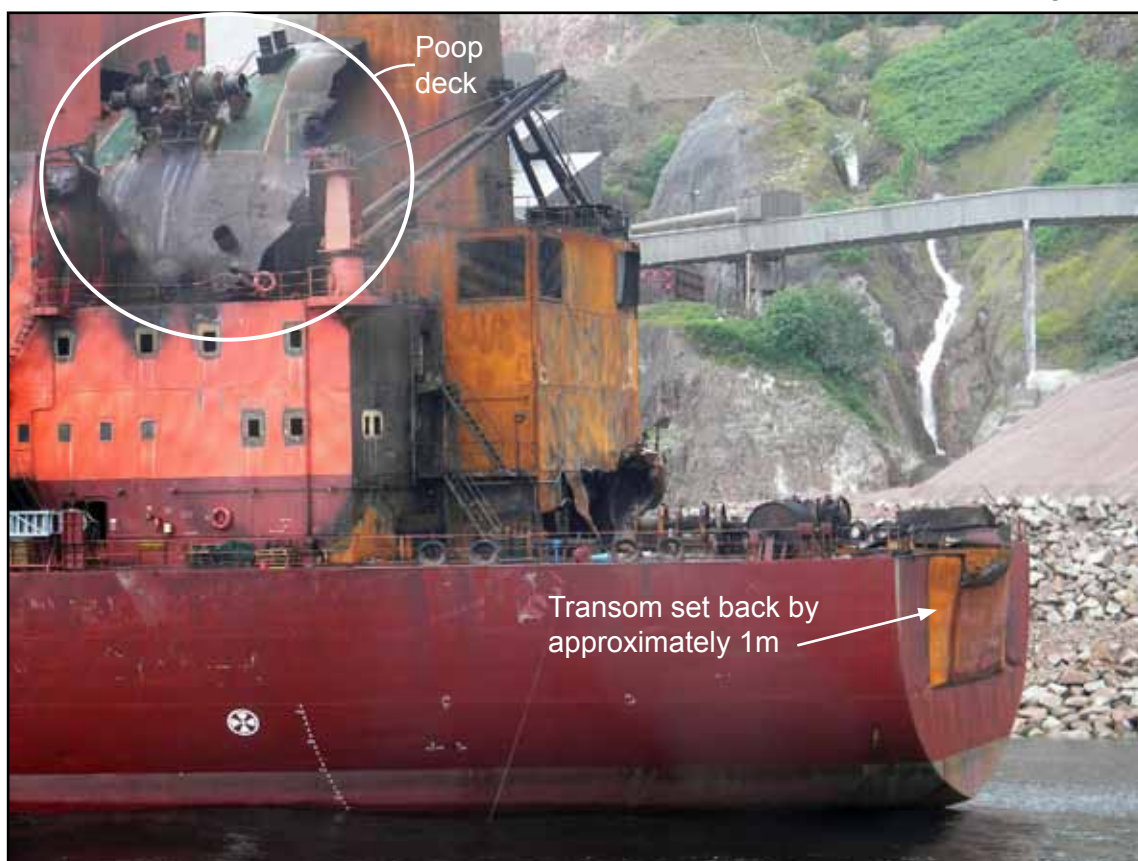
The poop deck itself had landed on the funnel deck, complete with its winches and mooring equipment (**Figure 17**).

View of poop deck relocated to the funnel deck

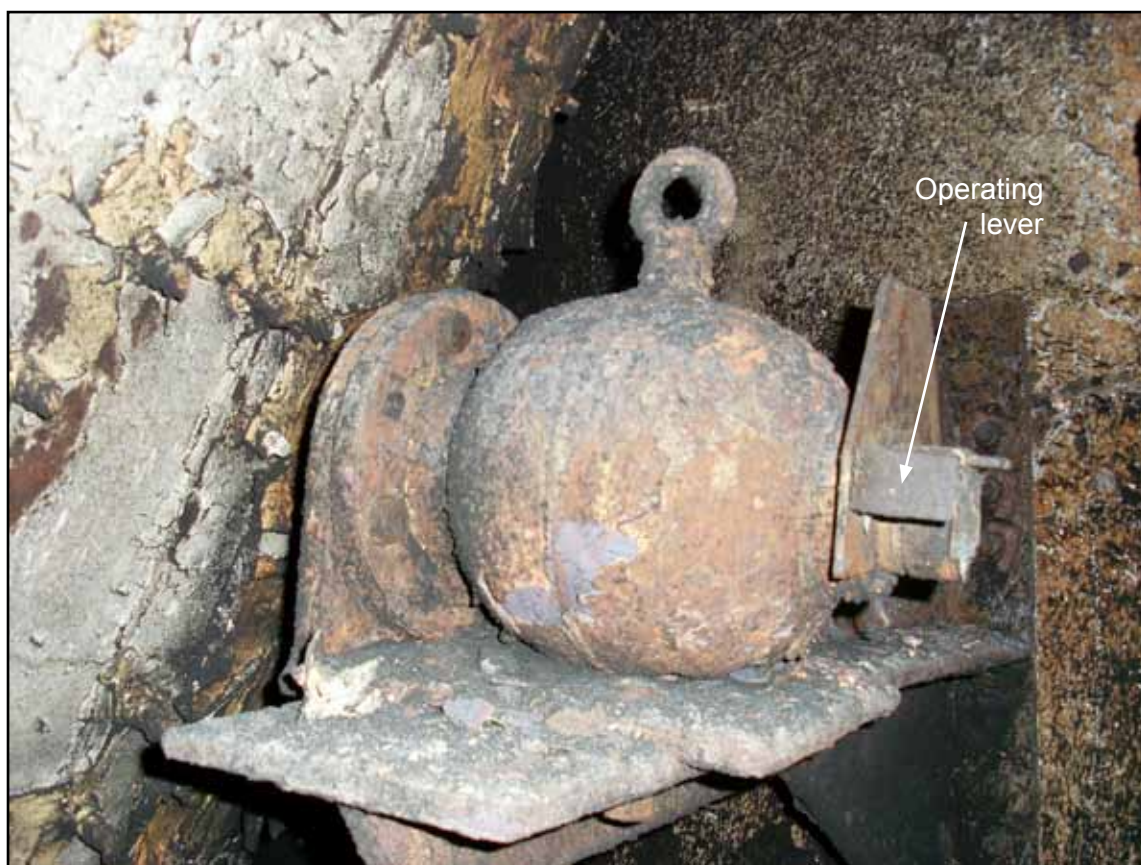
Figure 21

The access doors displayed “radioactive” warning signs, but there were none on the source containers.

Yeoman Bontrup - starboard silometer source container

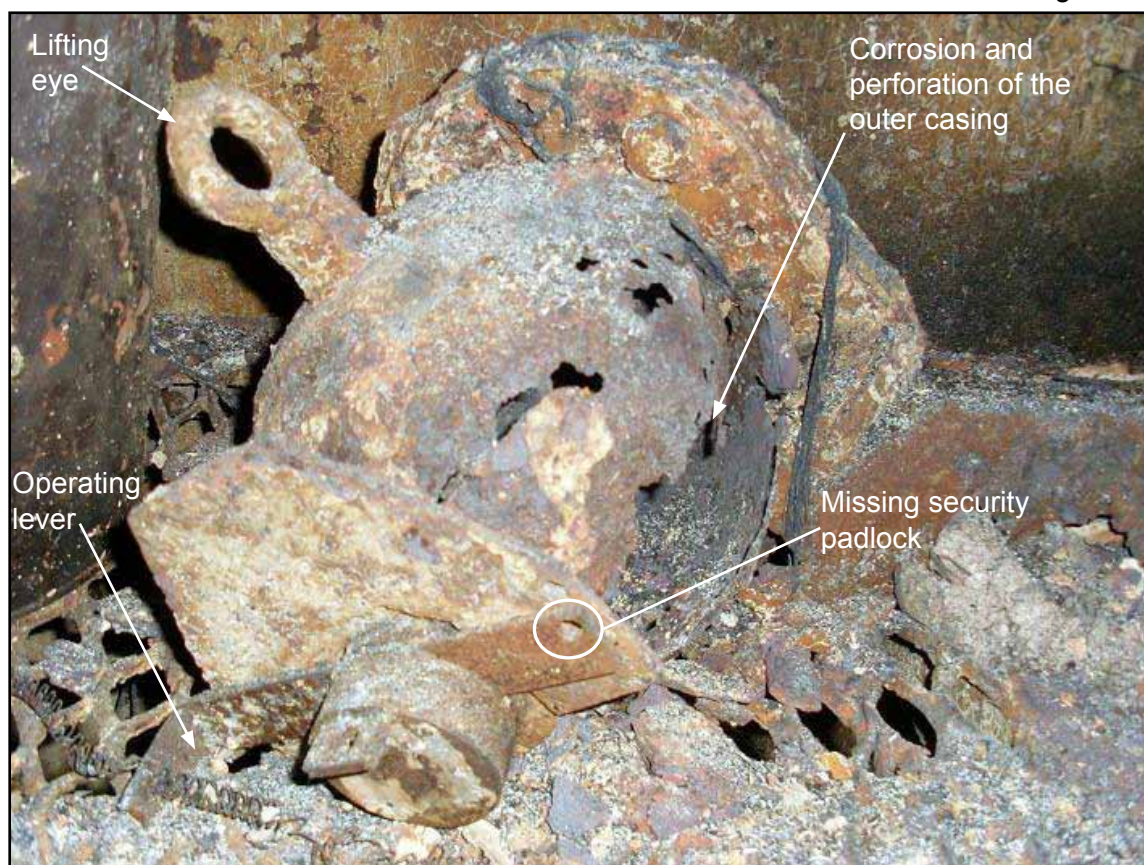
Figure 22

Yeoman Bontrup - port silometer source container

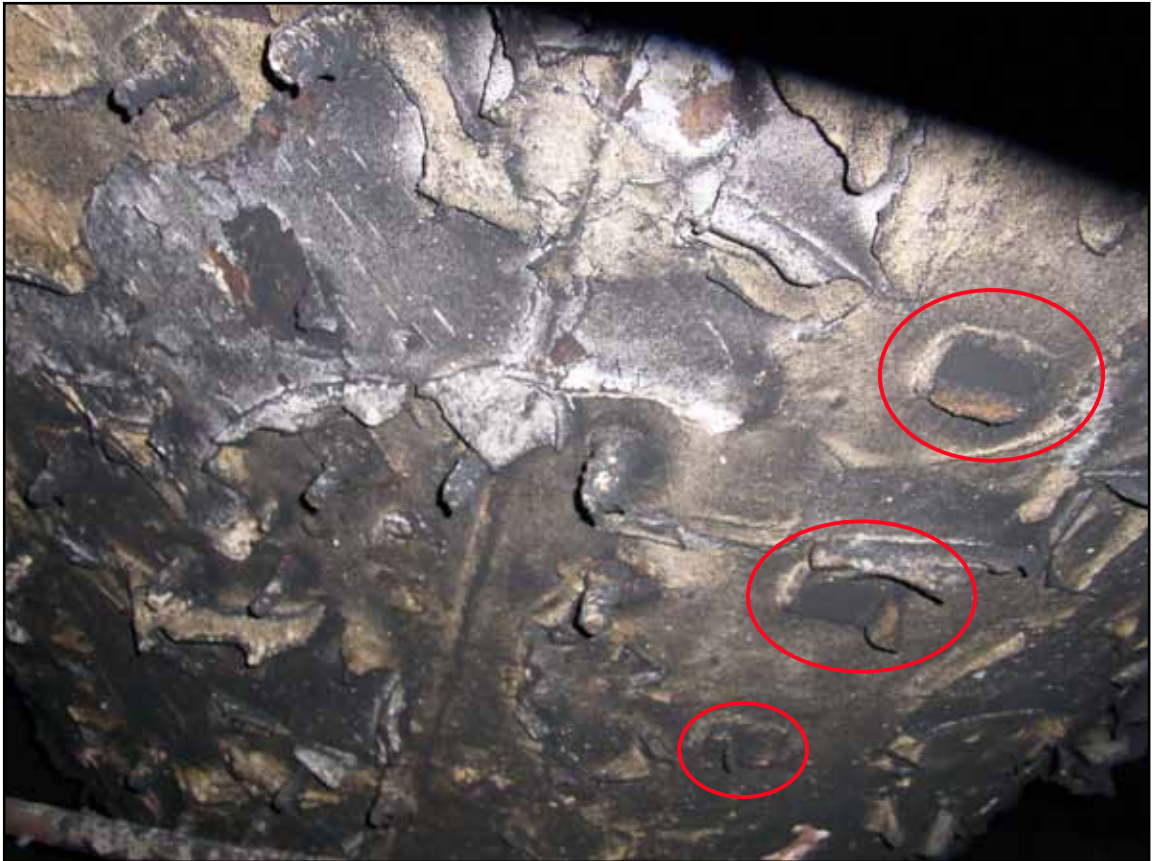
Figure 24

Doubler plates fitted to the outside of the hopper carcass

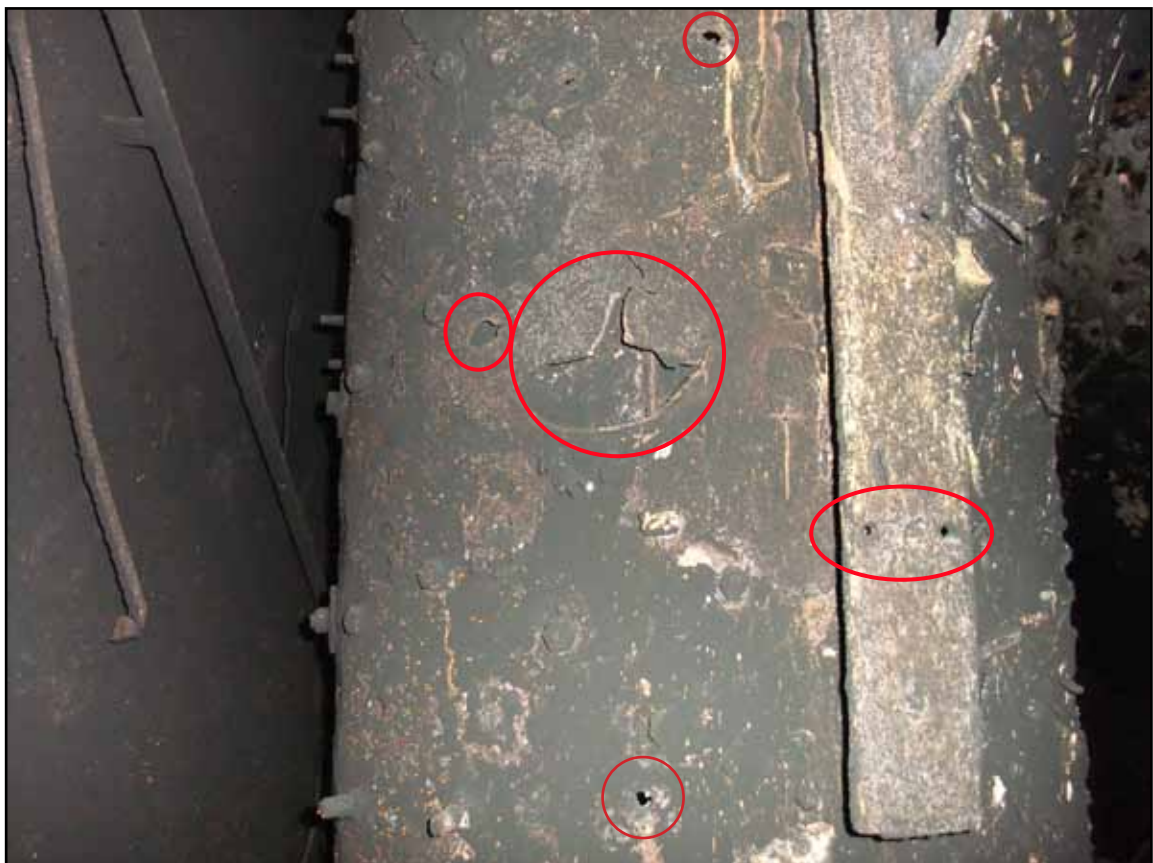
Figure 25

Hopper carcass penetrations

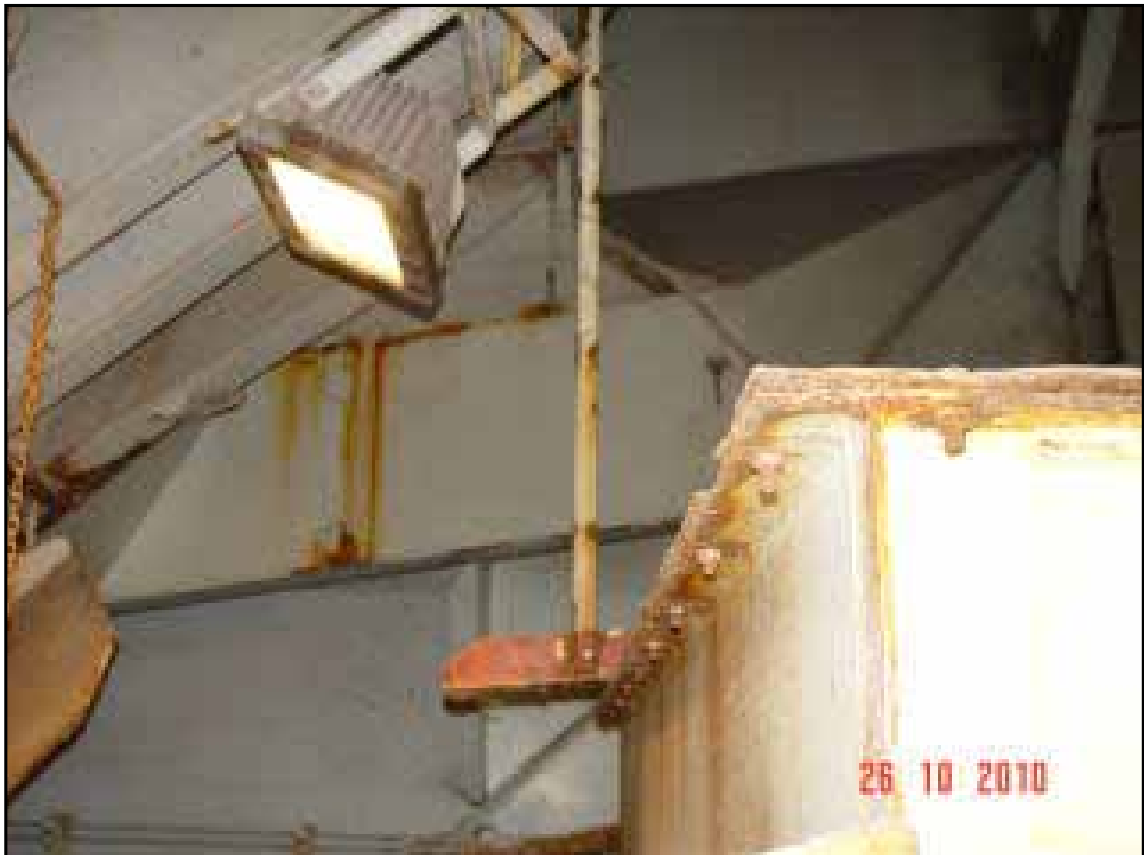
Figure 30

The surface temperature of the 500W tungsten halogen light lenses (**Figure 30**) was 135°C with the body of the light measuring 41°C. The temperatures measured at 100mm and 500mm from the halogen lights, in the direction of the vertical conveyor belt, were 40°C and 26°C respectively. The halogen lights were positioned approximately 1.3m from the vertical belt and about 2.9m from the pressured hydraulic system operating the ballast tank valves (Section 1.11.4)⁹.

500W halogen lamp fitted to *Yeoman Bridge*

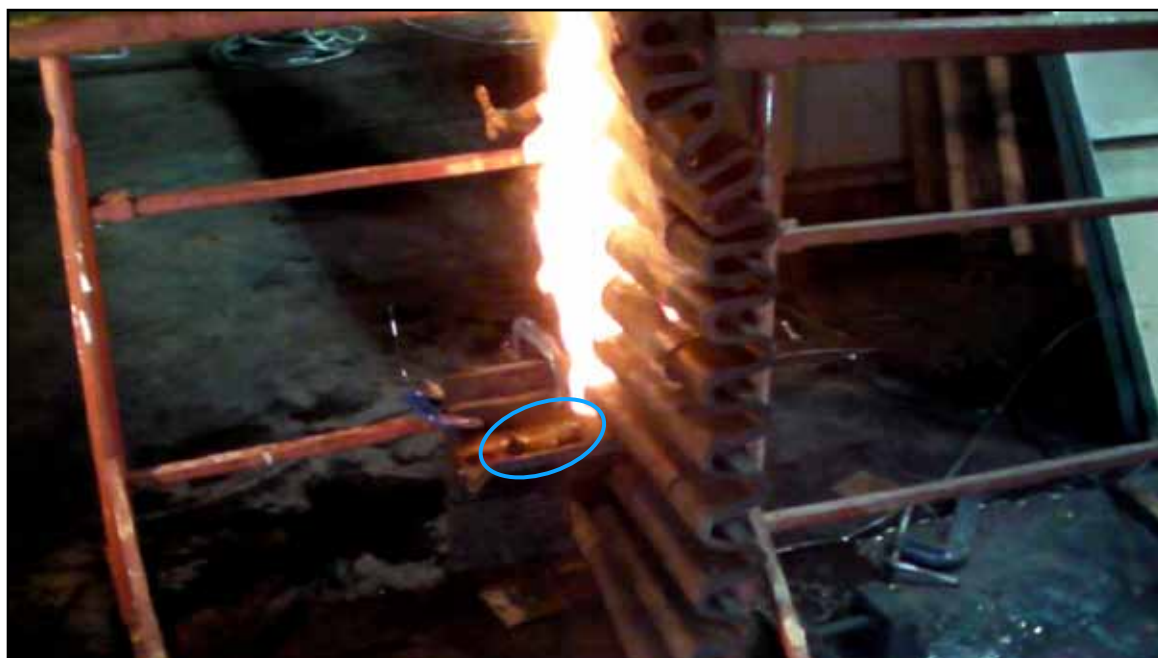
Figure 33

Fire Tests - stud and nut placed in cleat adjacent to the side curtain after 10 minutes

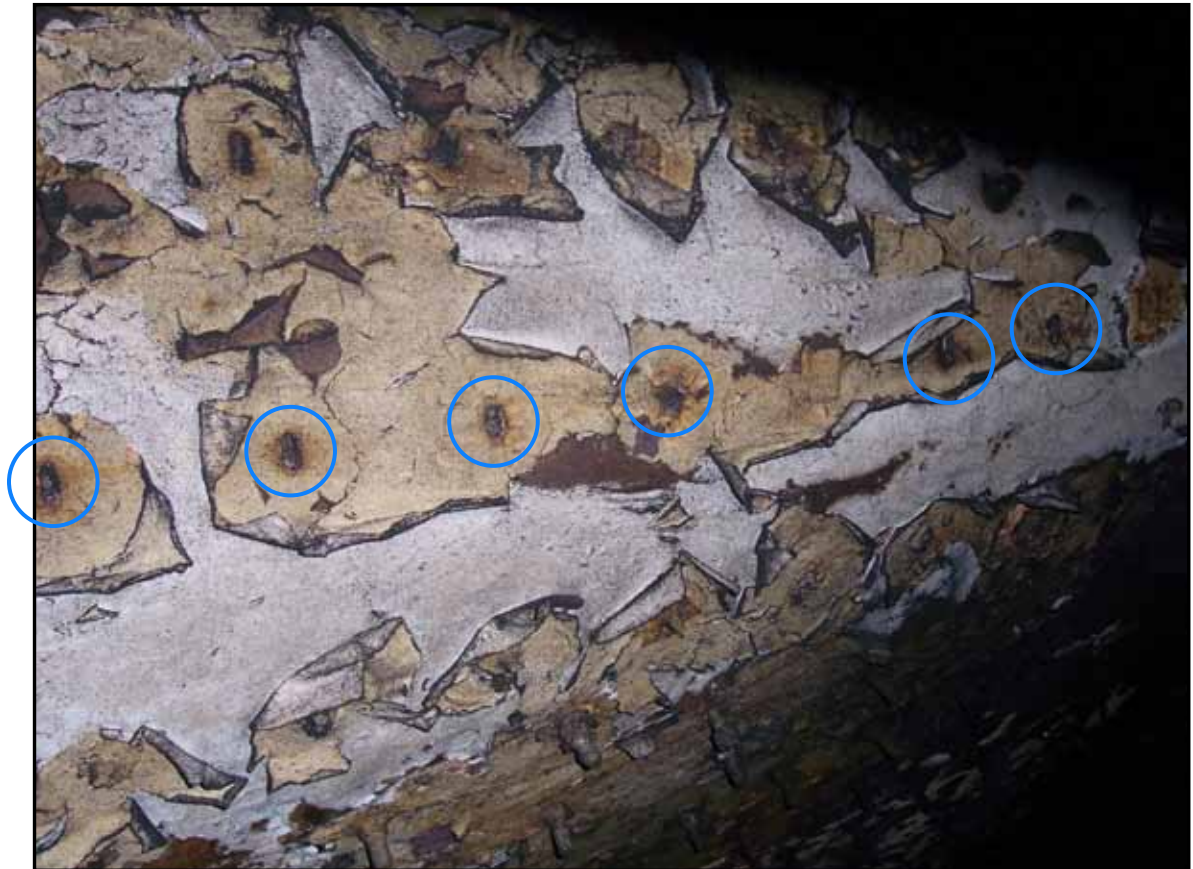
Figure 34

The repair party recognised the risk of hot debris falling onto the belt because the sloping area of the return belt was covered by a fire blanket. There is no doubt that there was a clear route for hot debris from the hopper to fall into cleats and land against the side curtain at the locus of the fire. Because of the concern over the veracity of the accounts, it is not certain whether or not oxy-acetylene equipment was used, for example to burn off "Hardox" studs, after 1400, the time at which all hopper hotwork was reportedly completed. Despite this, it was also stated that tack welding of the "Hardox" tiles took place after this time, when tack welding is clearly a form of hotwork.

Elongation of hopper carcass "Hardox" tile securing stud holes

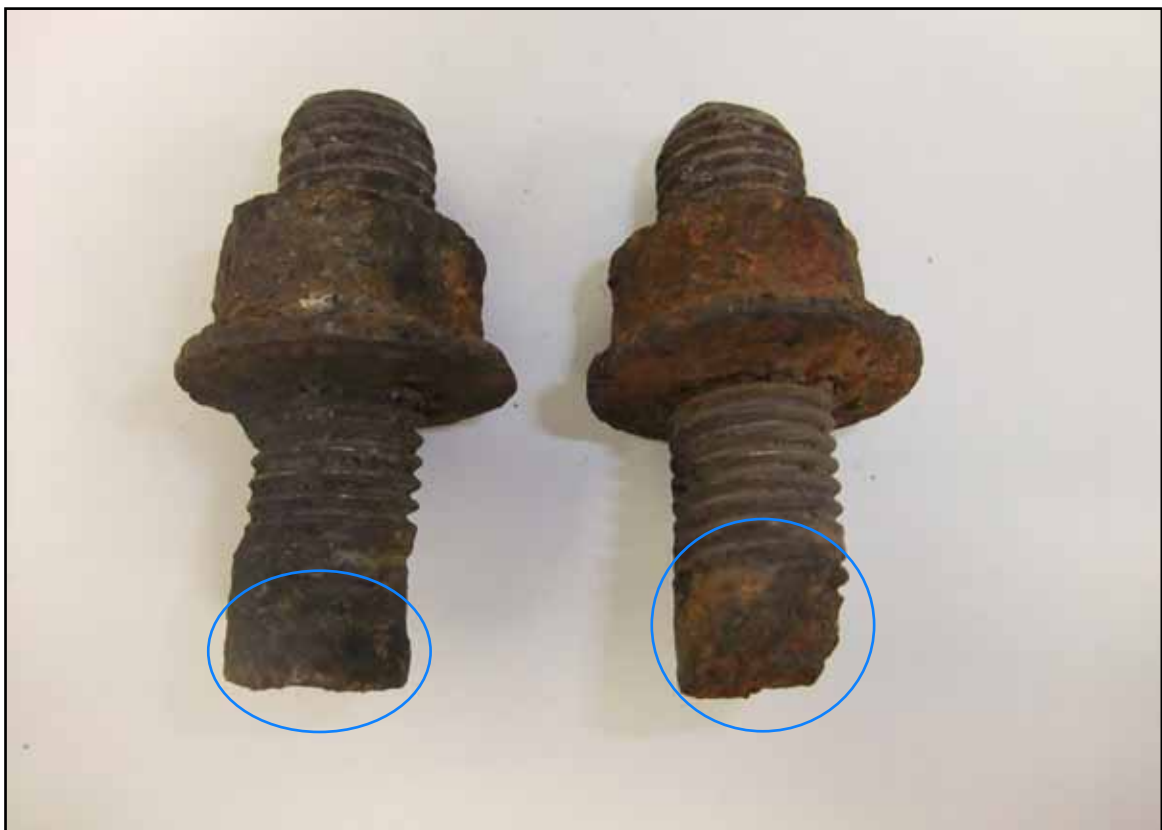
Figure 35

Flame cut bolts similar to those used to secure the "Hardox" tiles
