MAIB SAFETY BULLETIN 3/2010

Vehicle deck fire on board the ro-ro passenger
ferry *Commodore Clipper*

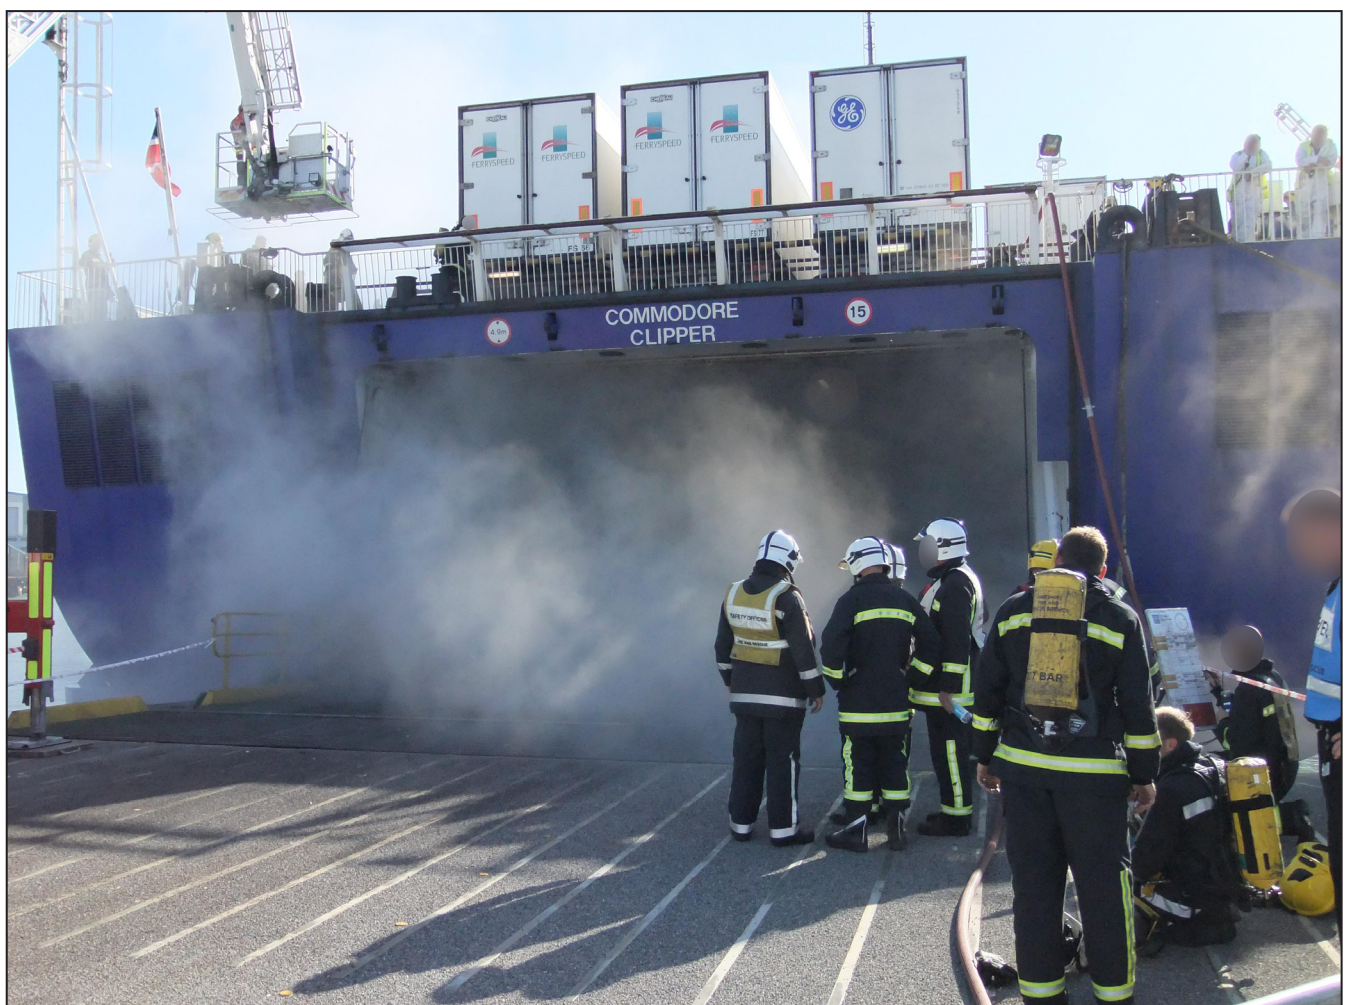
Firefighters preparing to attack the fire from the stern door

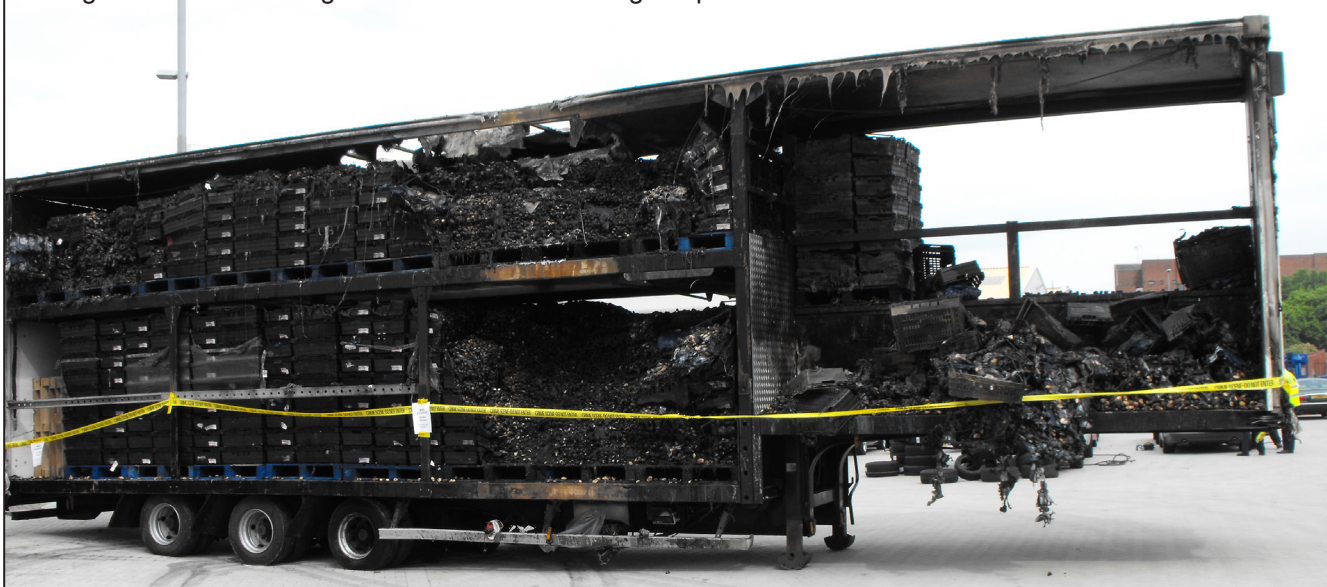
Preliminary findings of the subsequent accident investigation indicate that the fire was caused by an electrical fault involving the power supply from the ship and the trailer's refrigeration control system. The resultant sustained overheating led to the curtain-side of the trailer igniting. Although the ship's electrical breakers were found to be working correctly, they did not trip before the fire started.

Damage to one of the refrigerated trailers and its cargo of potatoes

- Take immediate action to ensure that all power supply cables and fittings provided for refrigerated trailer units are in good condition and that electrical protection devices will activate at an appropriate level.
- Until such time as the exact causes of this fire have been established, make additional checks of refrigerated trailers powered by ships' electrical systems to provide early warning of any overheating.

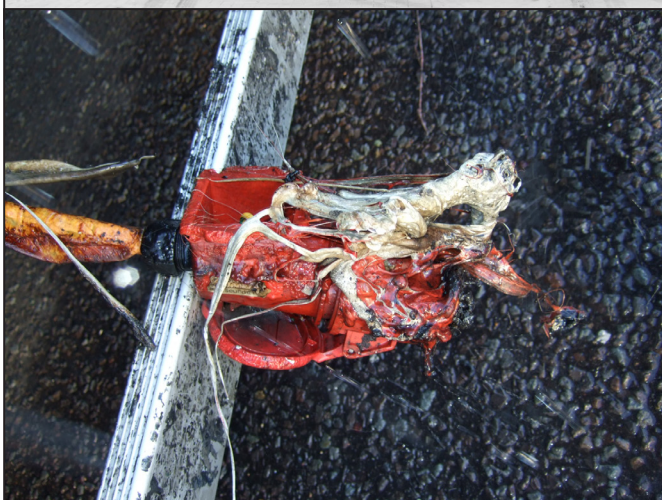
MAIB has also received other reports of power supply cables to refrigerated trailers becoming very hot while in use.

Electrical power connection

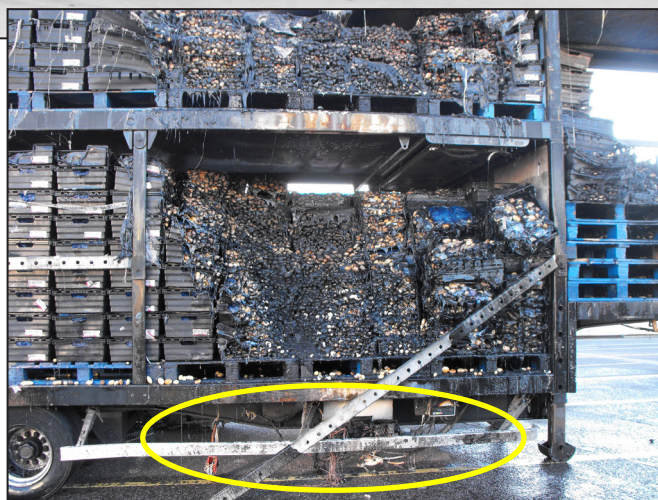
Damaged refrigeration control units
