Report on the investigation of
the fire on the main vehicle deck of
Commodore Clipper
while on passage to Portsmouth
16 June 2010

SYNOPSIS

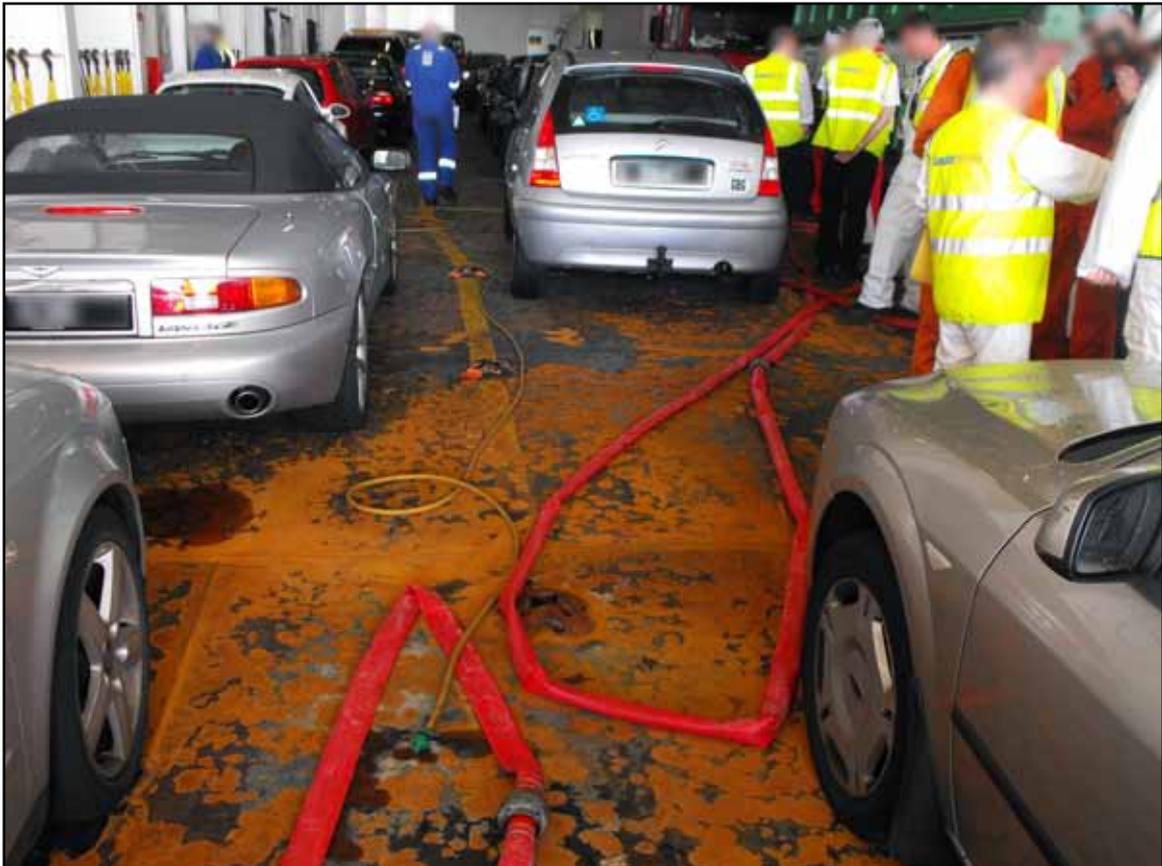
Figure 6

After about 30 minutes of drenching and boundary cooling, the chief and third engineers measured the temperature of the upper vehicle deck using a portable infra-red thermometer. They recorded average deck temperatures above the fire of 180°C, and noted that the steel plating had buckled and the paint coating had gone. The heat did not cause any of the cars parked in the immediate area above the fire to ignite (**Figure 6**).

Heat damage to the upper vehicle deck

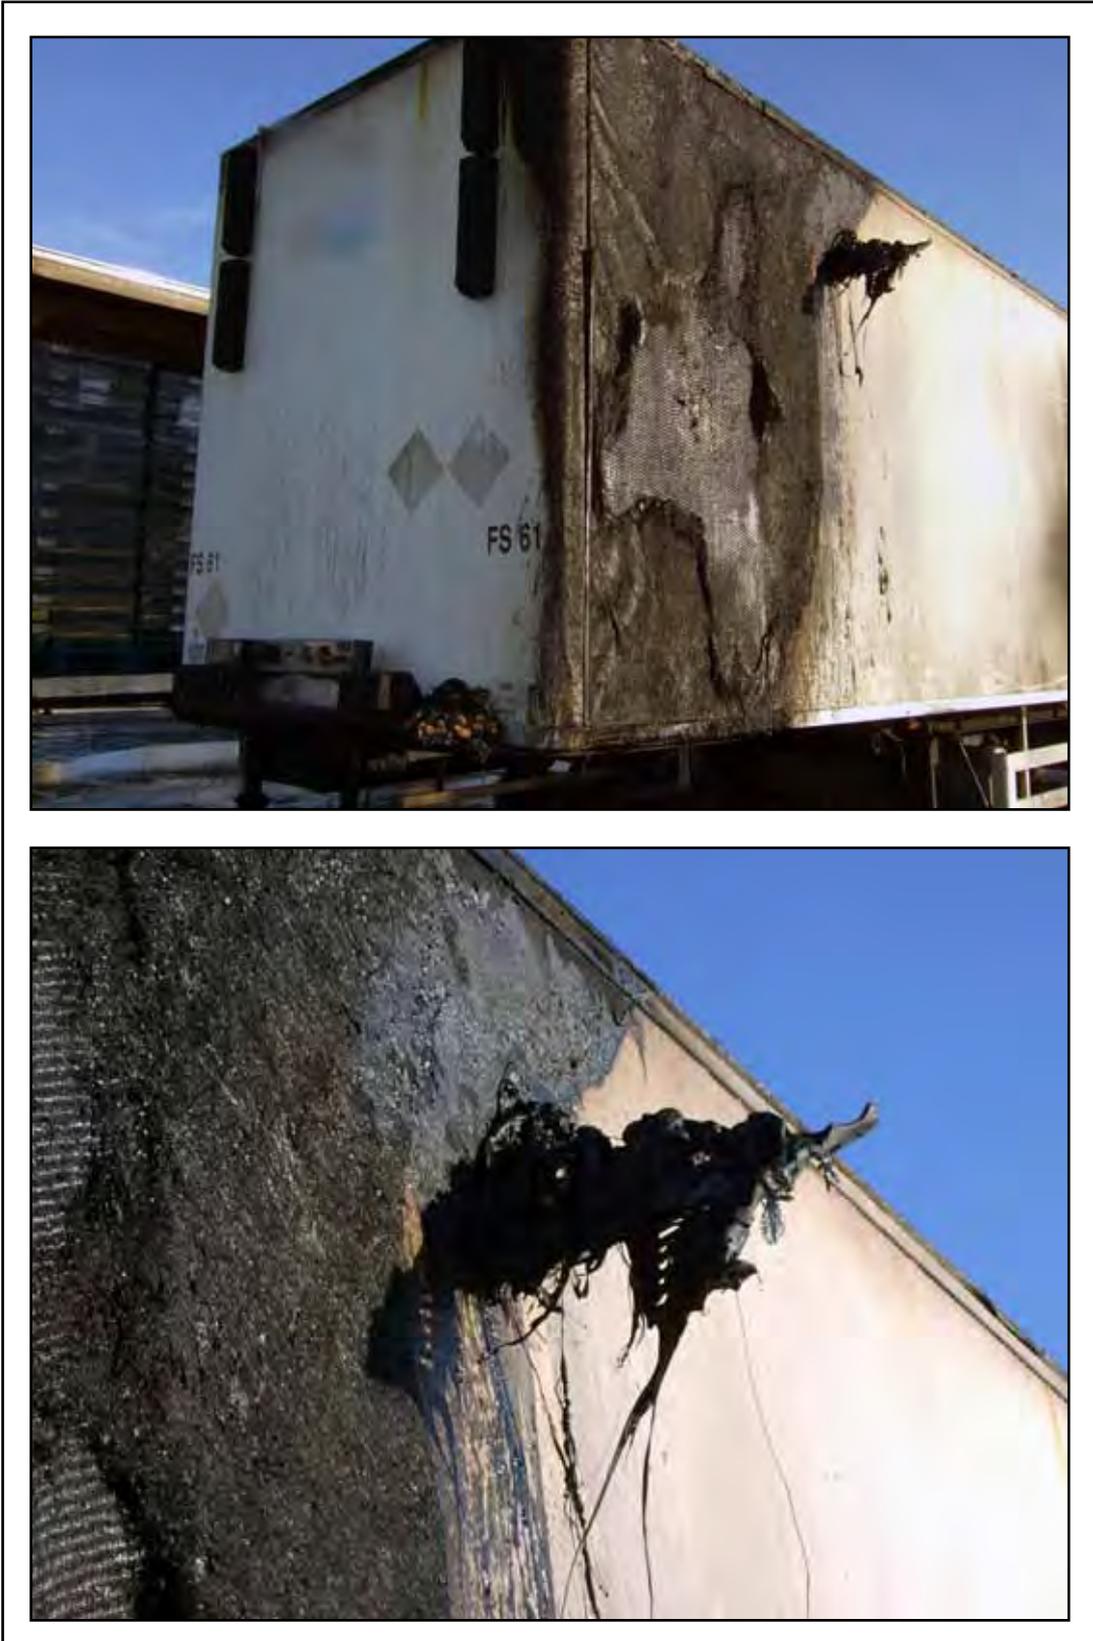
Figure 12

Partially burnt debris on trailer FS61

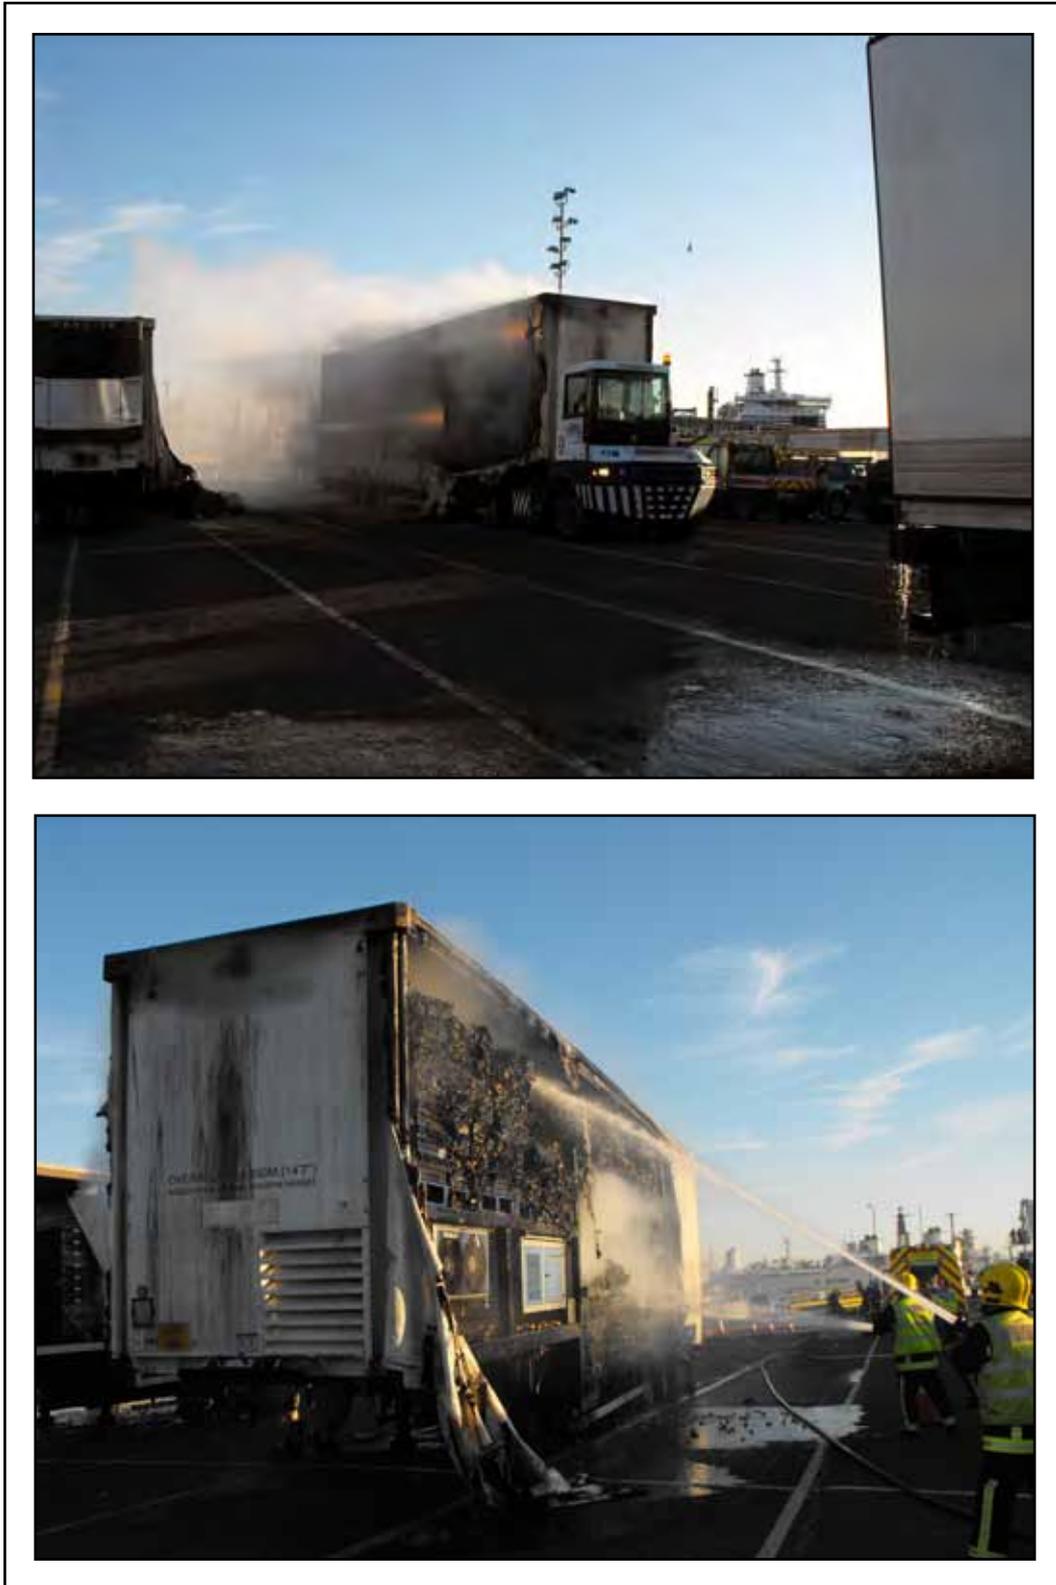
Figure 14

Trailer CRF461 continuing to burn after being removed from the main vehicle deck

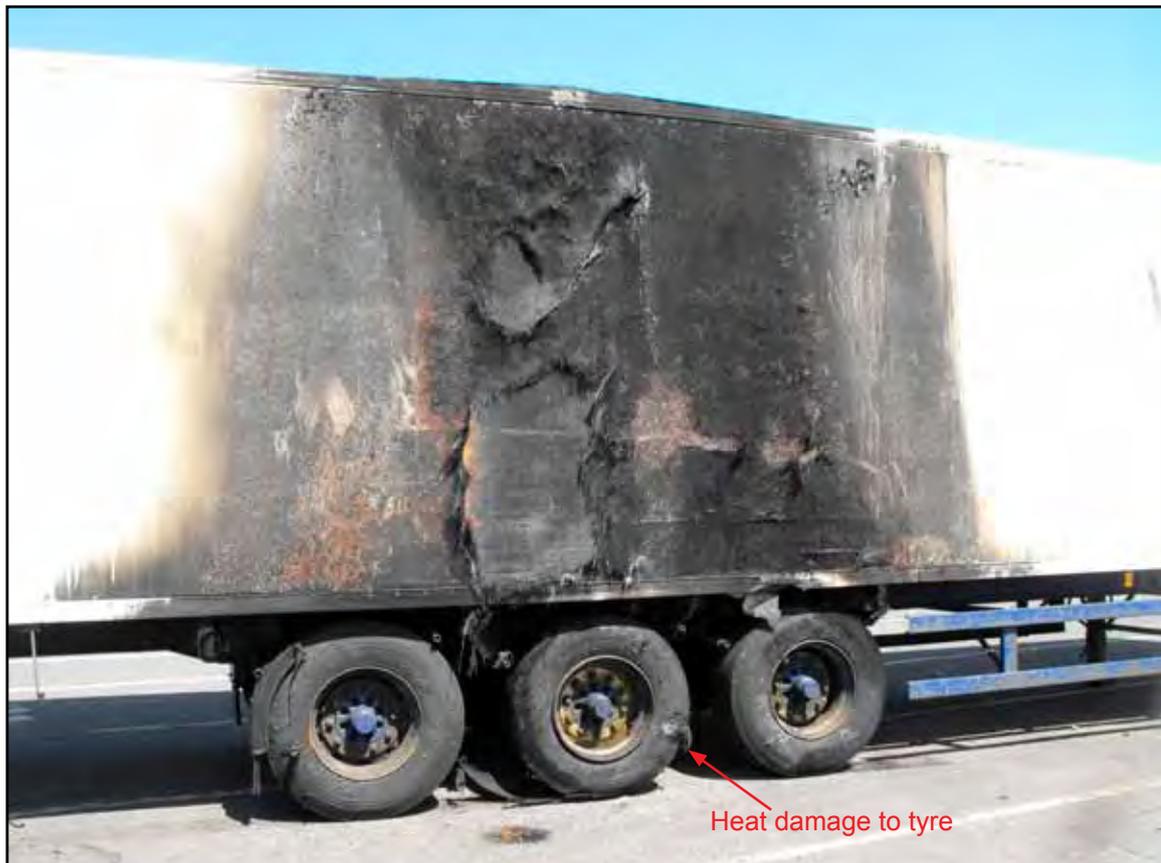
Charred and delaminated tyres on trailer GC13-1

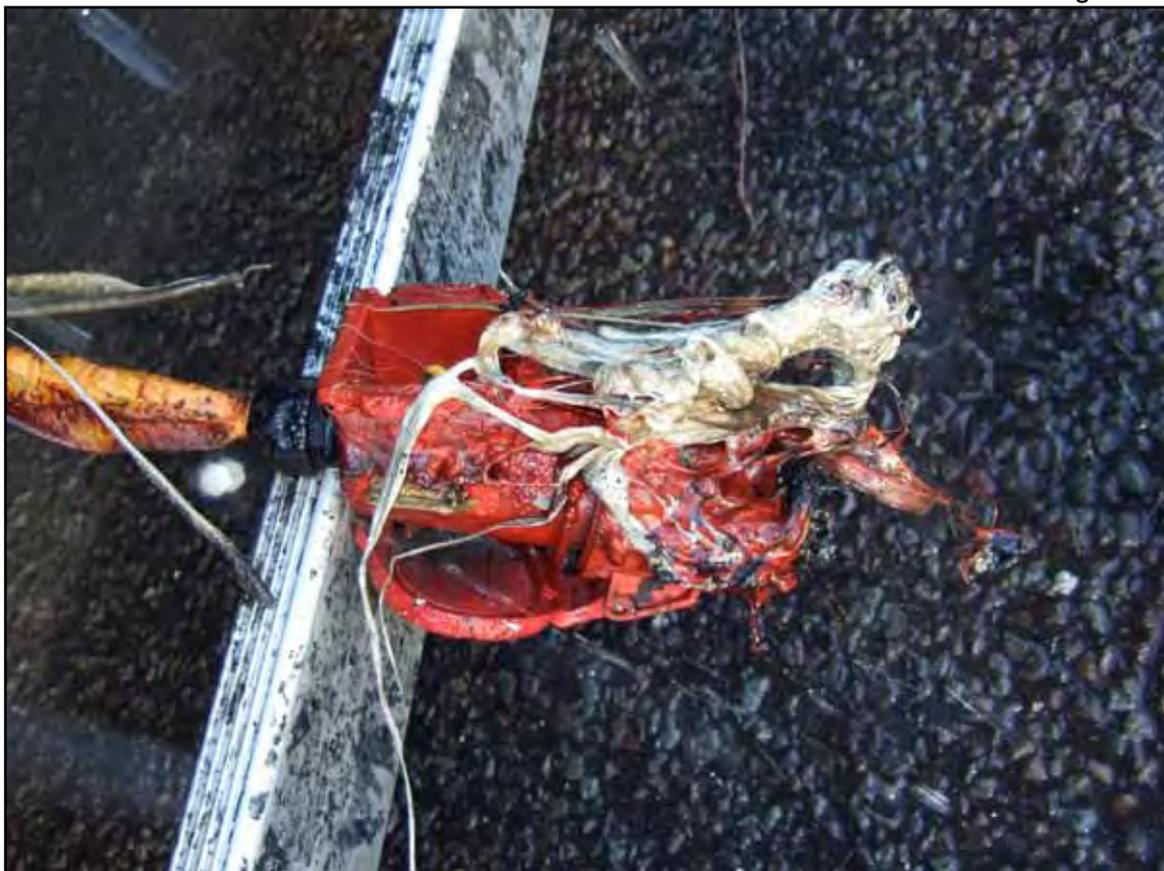
Figure 24

Damaged external power supply connection on trailer CRF459

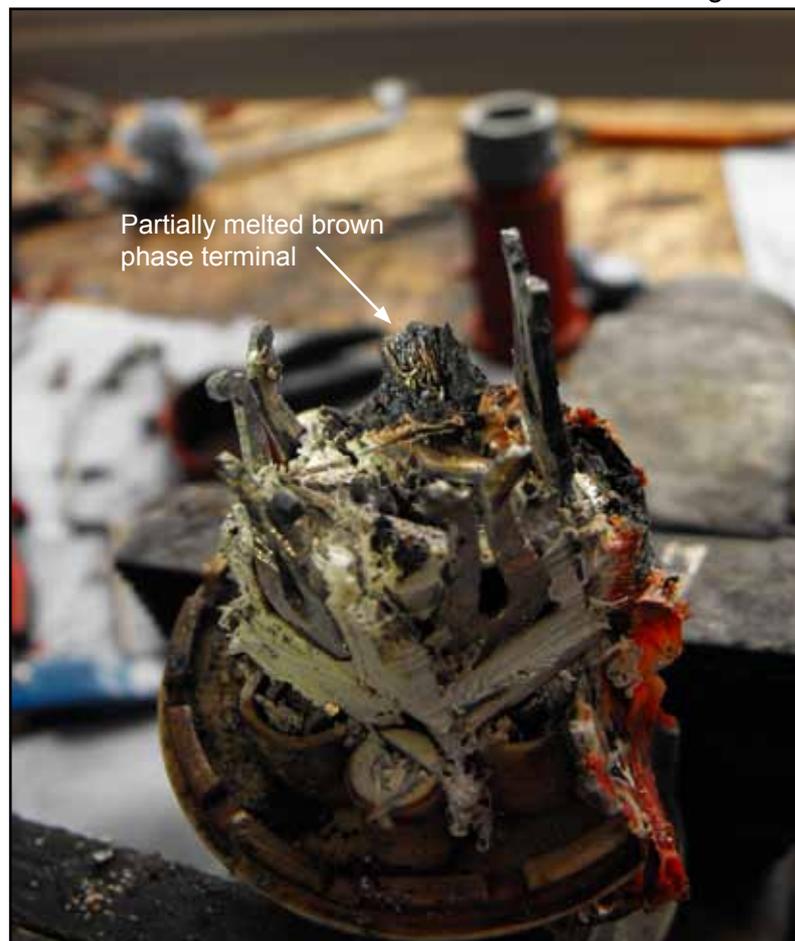
Figure 27

Examination of the reefer power supply plug attached to trailer CRF459

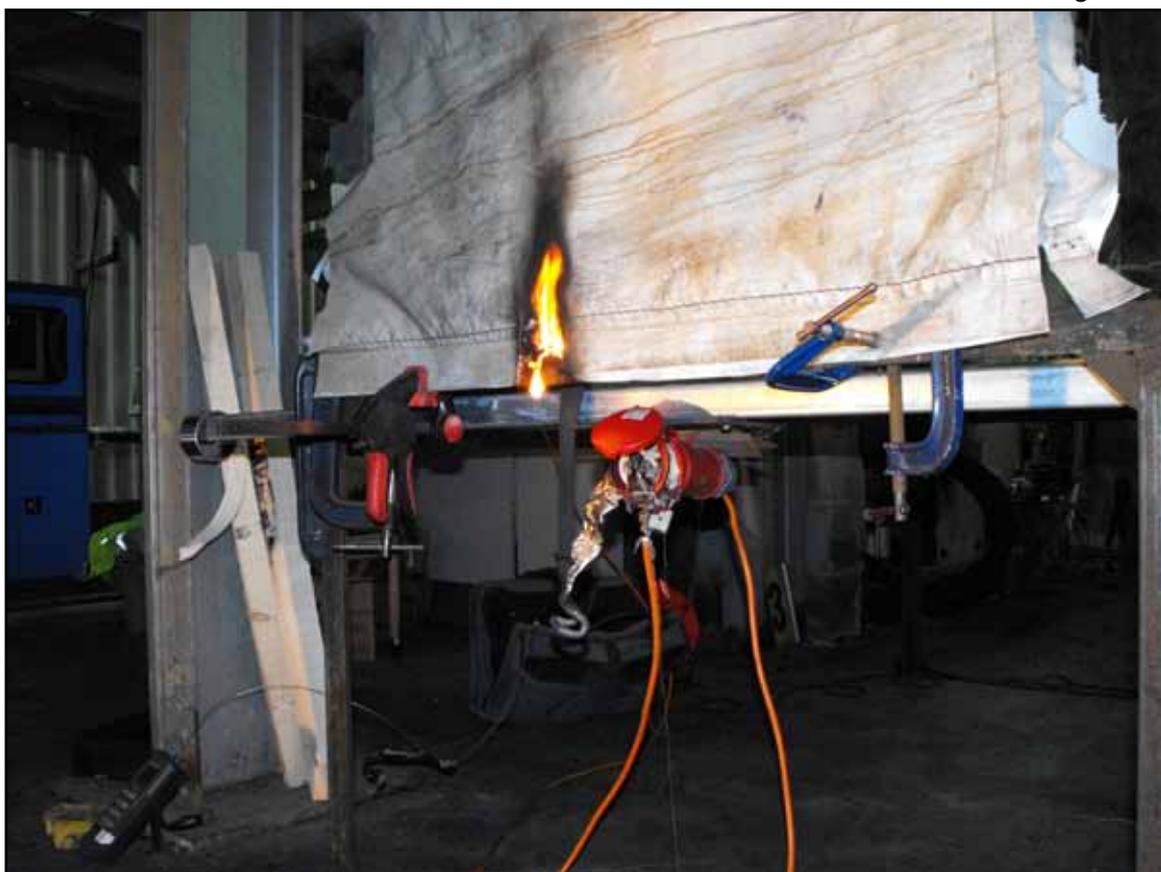
Ignition of the curtain-side material

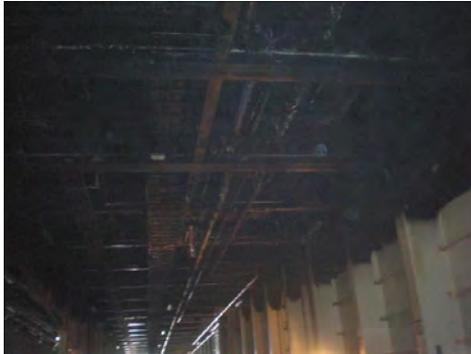
- Drencher system pipework, on deck 3.
- Fire main pipework, on deck 3.
- Fresh water pipework, on deck 3.
- Fire detection system, on deck3, steering gear and engine control room.
- Public address system, on deck 3.
- CCTV system, on deck 3.
- Steering gear, remote and local, control and feedback systems.
- Forward switchboard supply (including anchor hydraulics, car deck fans and bow thrusters).
- Main and emergency lighting, on deck 3.
- Reefer sockets, on deck 3.
- Internal ramp control and indication electrics.

After fire

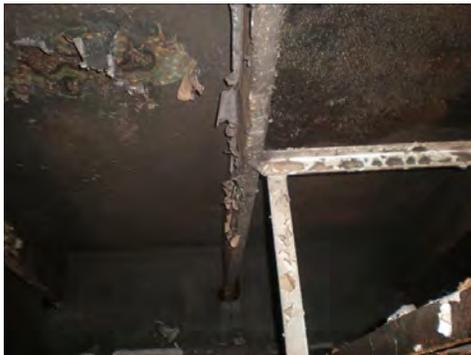
- Between frames 71 and 74 - 3 longitudinals buckled.
- Between frames 74 and 77 - 6 longitudinals and 1 deep longitudinal buckled.
- Frame 77, web and lower flange buckled.
- Between frames 77 and 80 - 6 longitudinals and 1 deep longitudinal buckled.
- Between frames 80 and 83 - 6 longitudinals buckled.
- Between frames 83 and 86 - 4 longitudinals and 1 deep longitudinal buckled.
- Between frames 83 and 86 - 1 deep longitudinal buckled, just forward of ramp.
- Between frames 86 and 89 - 2 longitudinals buckled.

Longitudinal buckled

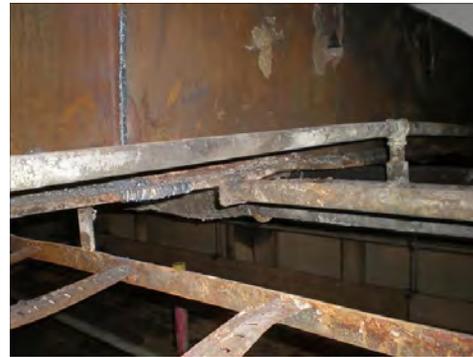
Frame 77, web and lower flange buckled (buckled longitudinal deep frame already removed)

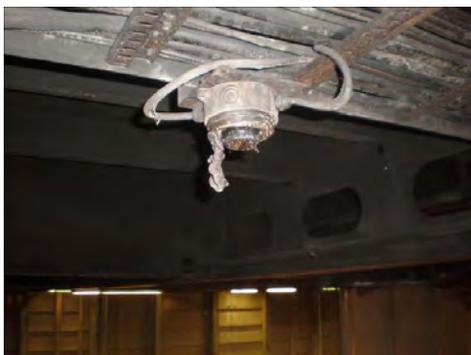
One section of the motherboard, in the control unit was also found burnt out.

Fire damaged, fire detector head

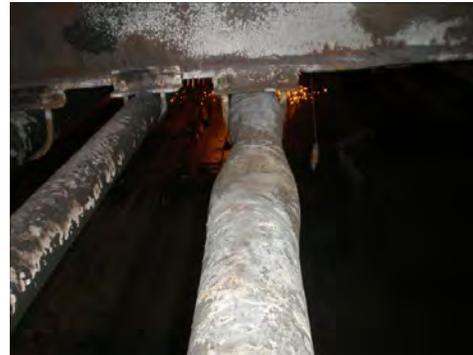
Buckled drencher main aft of frame 77

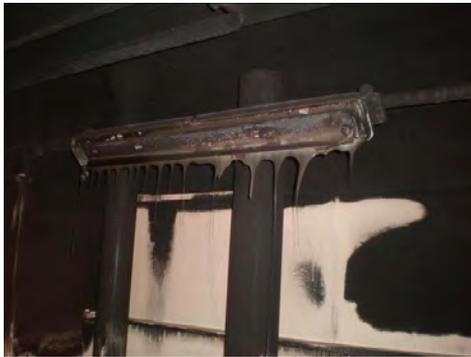
Fire damaged light

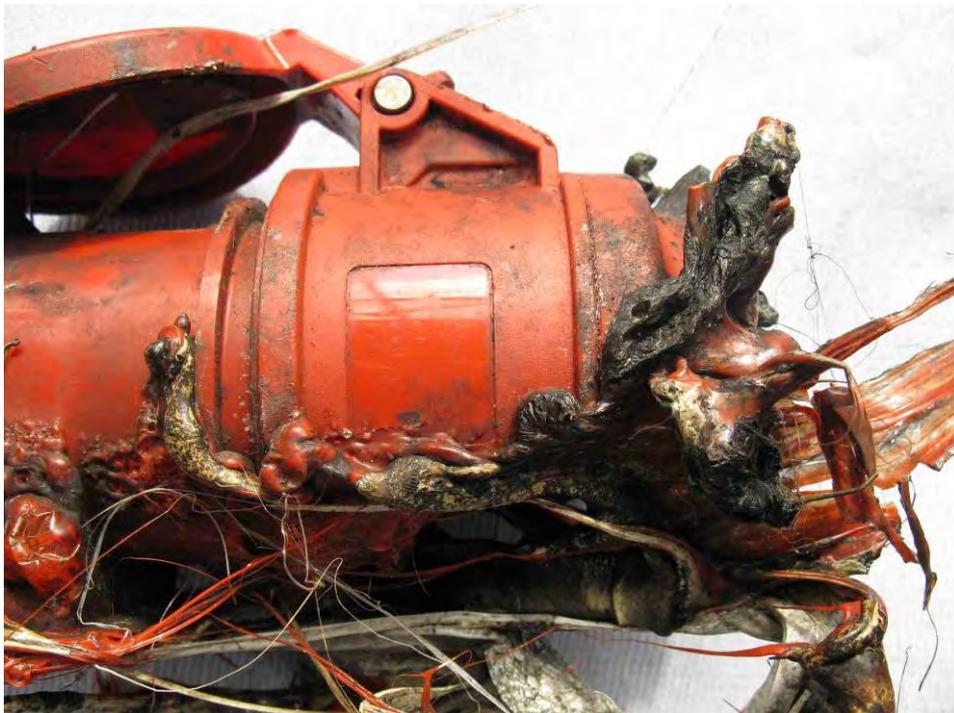
Figure 3 **Supply socket**

The plug and socket arrangement at the power intake to the trailer was badly melted and was heavily carbonised at the free socket end, Fig. 3. The free socket had been on the end of the cable from the ship's power supply.

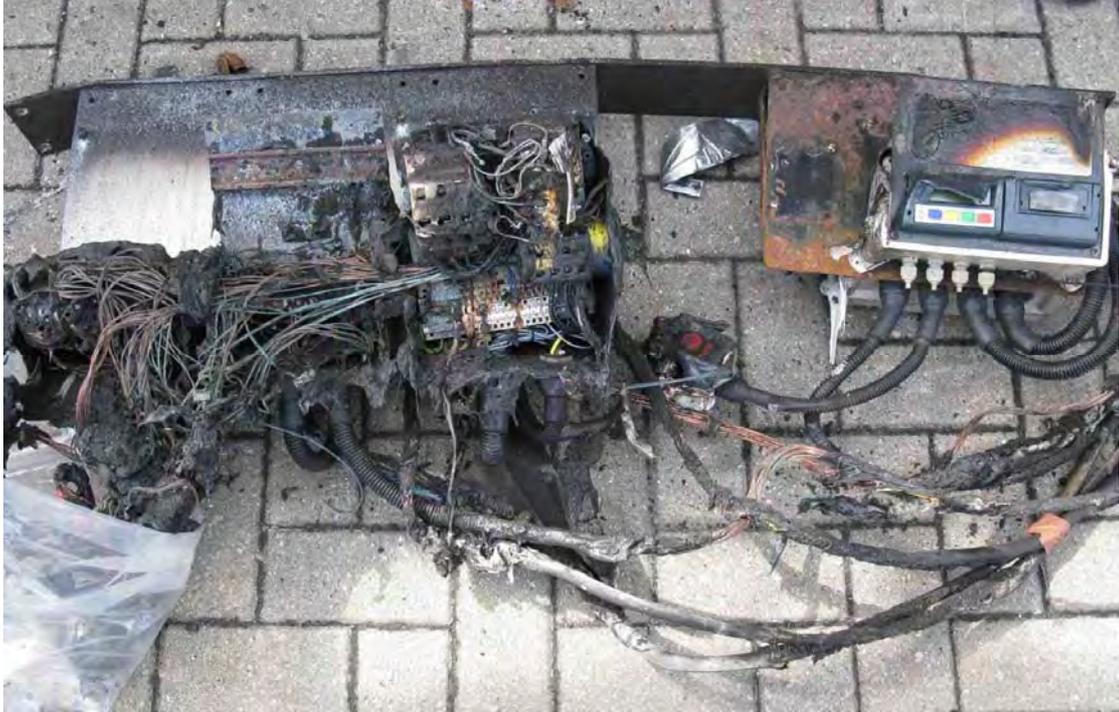
Figure 4 Control box assembly, fire damaged

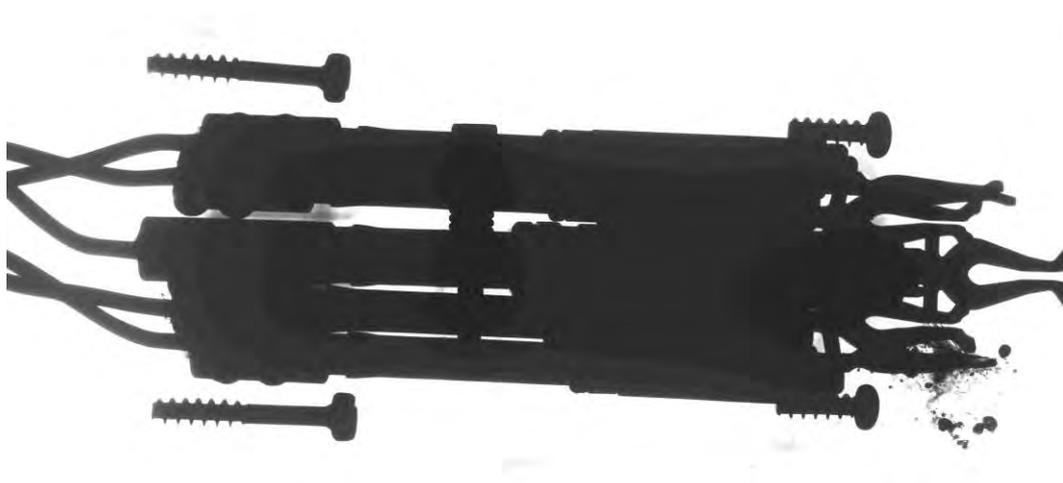
The X-rays of the plug and socket revealed that the free socket had insulation displacement connectors, IDC, at the cable terminals whereas the fixed plug on the trailer had screw terminals, Fig. 7.

Figure 7 X-ray of plug and socket

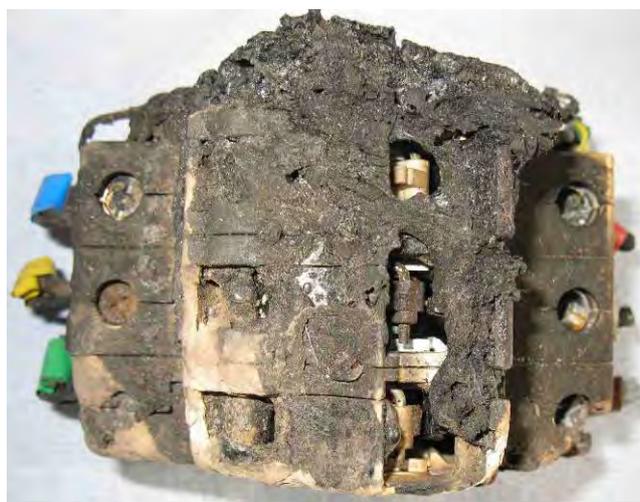
An examination of the MCB in the trailer control box showed that there was no evidence of arcing at its terminations and the condition of the MCB confirmed that the fire had not started at the MCB, Fig. 10.

Figure 10 Trailer MCB

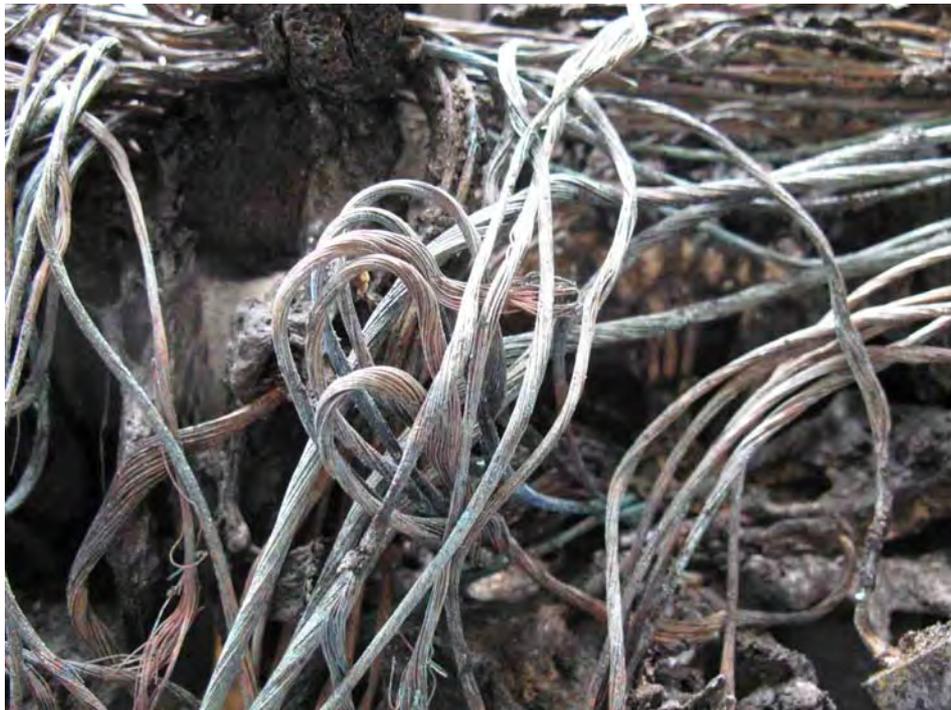
No evidence of arcing or other features that could have been the cause of the fire were found.

Figure 11 Fire damaged wiring

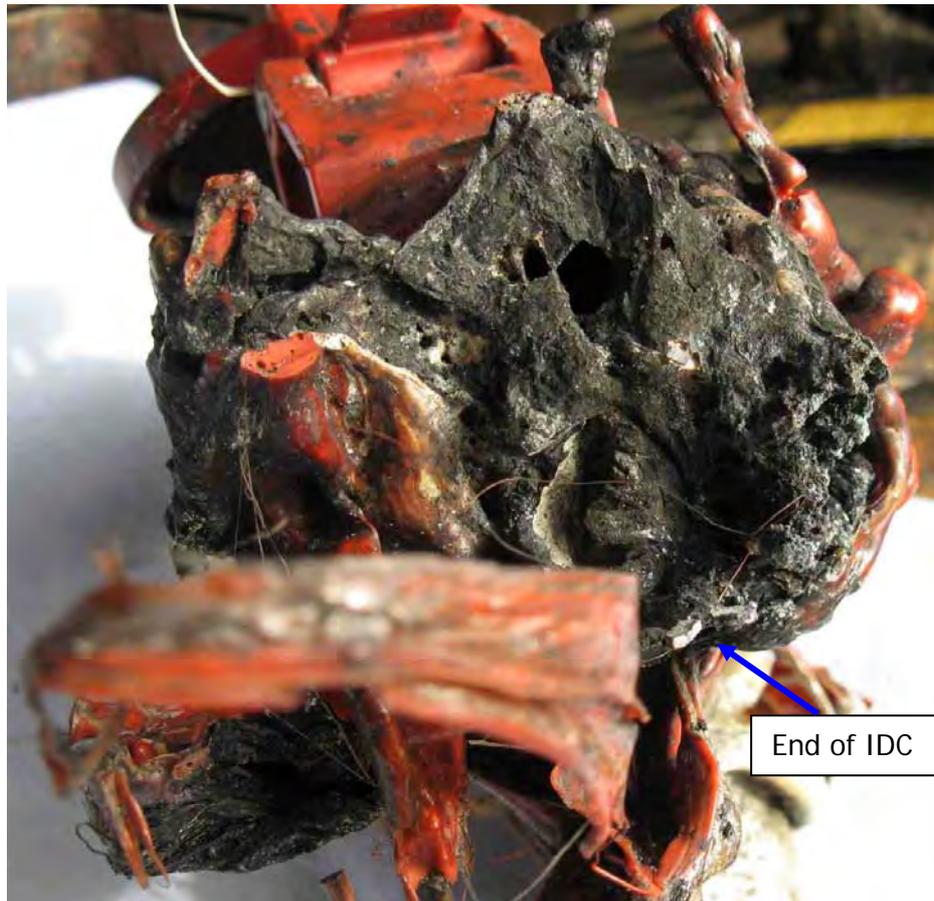
The free socket at the trailer end of the cable from the ship's supply was a five-pin, 32 A, Mennekes 'Startop' socket. The trailer mounted plug and the socket were fused together by molten plastic. At the plug end the terminals were visible and did not show any evidence of arcing or severe overheating, Fig. 14. A large portion of the free socket had burned away, Fig. 15. The ends of one of the IDC connectors could be seen emerging from the charred plastic, Fig. 16.

Figure 16 Charred free socket

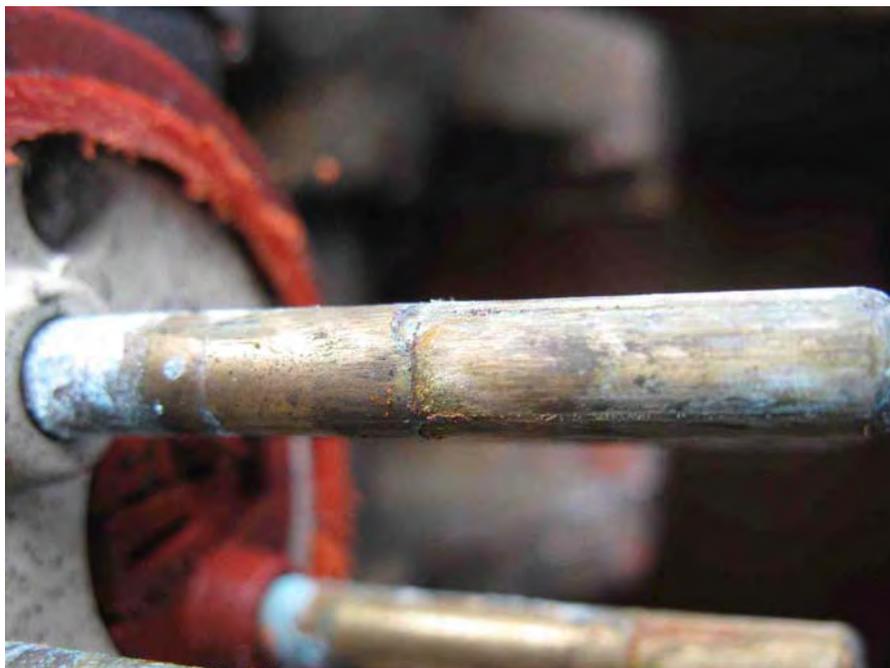
The plug and socket were separated and the contact faces of the pins were examined. The corrosion and debris seen on the pins was light and probably partially due to the fire fighting activities, Fig. 17. There was no evidence of poor contacts between the plug and the socket and no arc damage at the ends of the pins to indicate that it may have been connected or disconnected 'on-load'. From the condition of the socket it appeared that a grease may have been applied to the pins at some stage, Fig. 18.

Figure 17 Contact pins

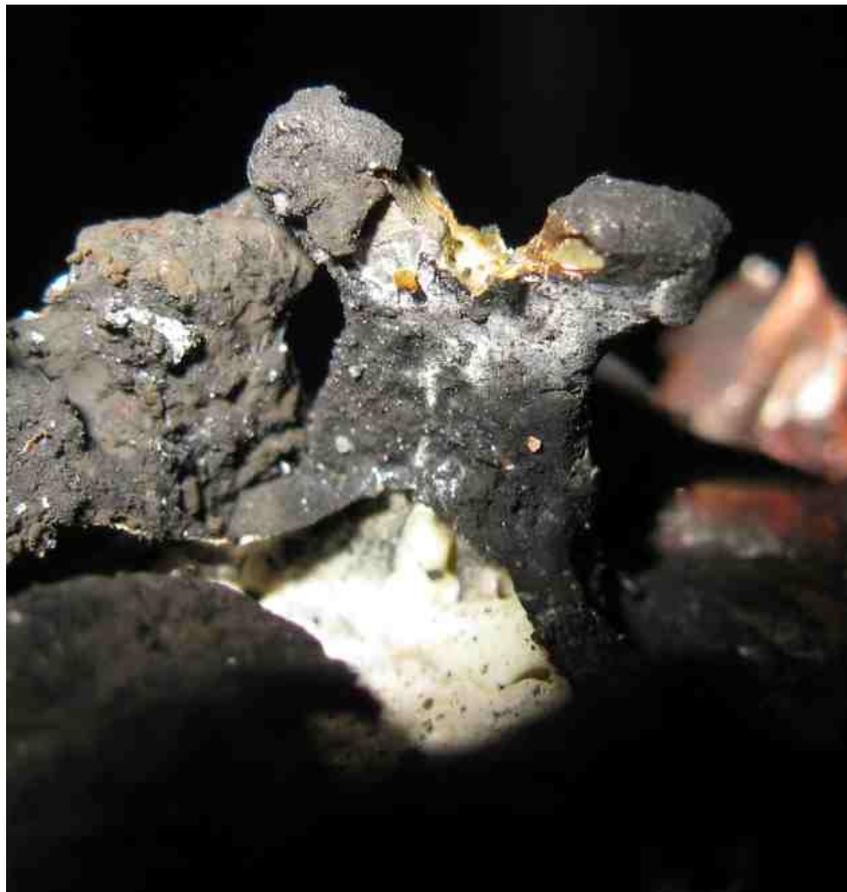
The carbonised plastic around the IDC terminals was carefully removed so that the condition of the five connectors could be examined. What appeared to be slight arcing damage was seen at the end of the Blue phase terminal, Fig. 19. Later examination showed this to be melted plastic.

Figure 19 Blue phase IDC

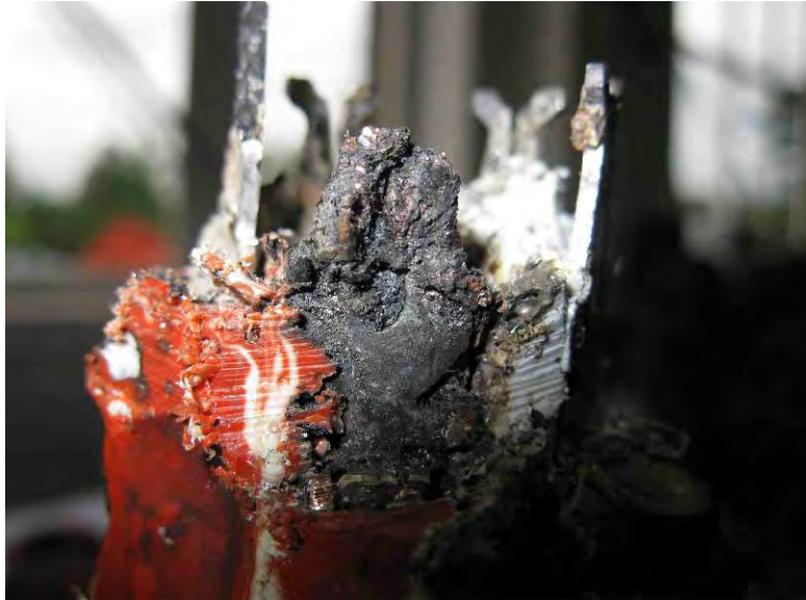
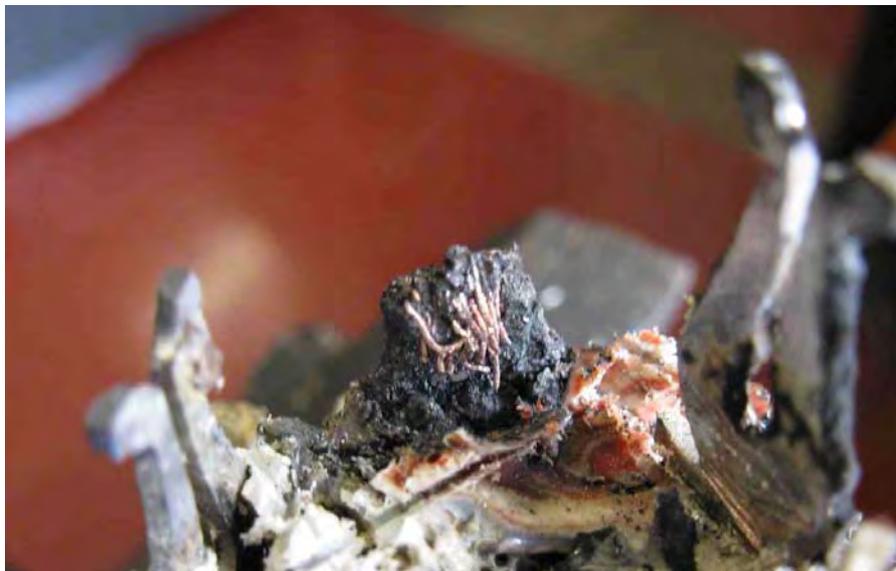
The brown phase terminal had severe arcing damage and the remains of some conductor strands were adhered to the back of the terminal, Figs 20 & 21.

Figure 20 Brown phase IDC

Figure 21 Conductor strands adhered to terminal

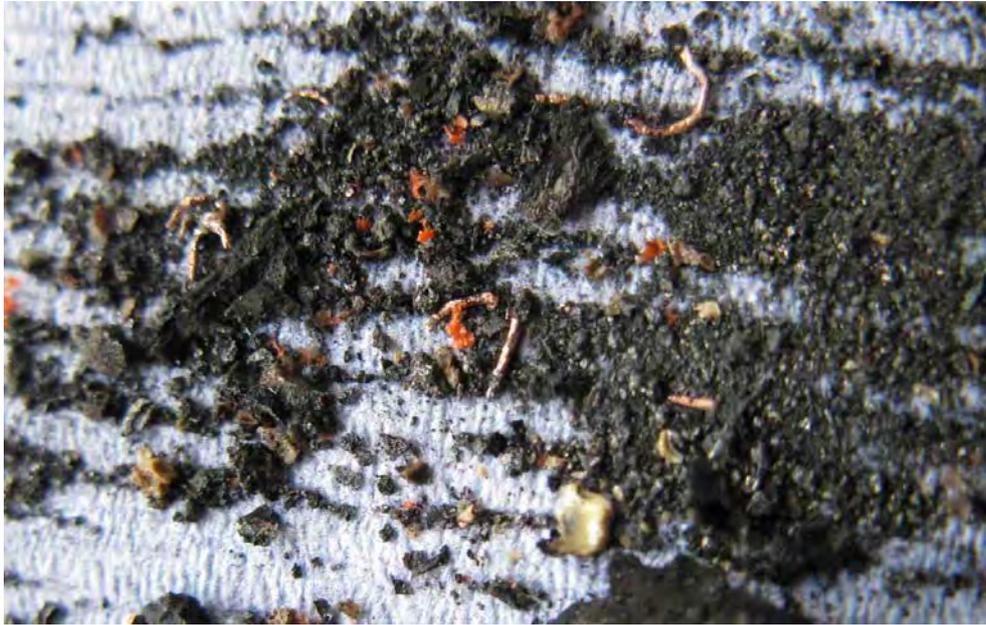
A number of conductor strands and globules of copper were found in the carbonised debris, Fig 22.

Figure 22 Conductor strands and copper globules

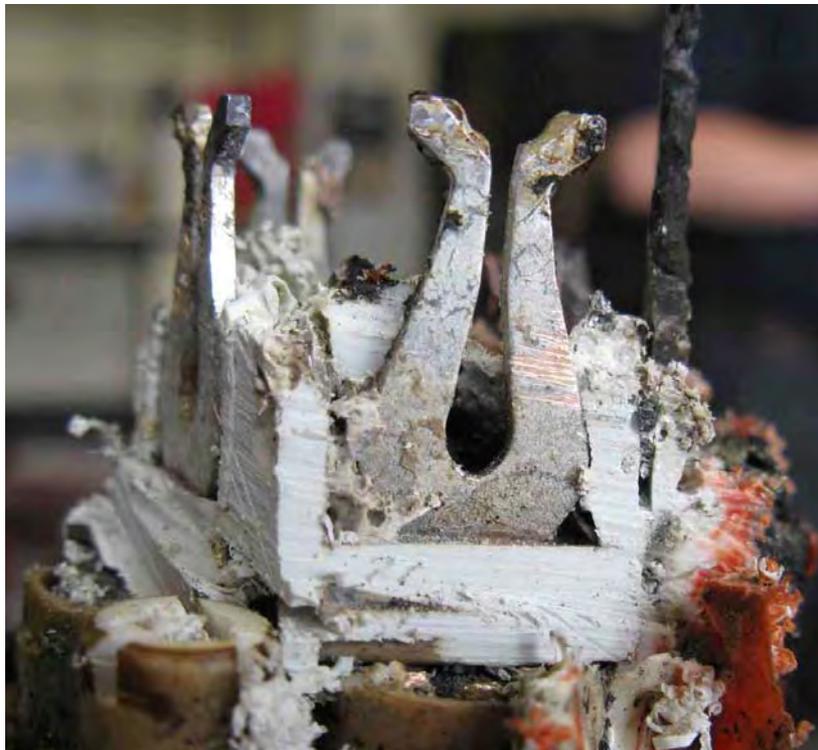
The remaining IDC showed no signs of arcing, Fig. 23

Figure 23 Undamaged IDC connector

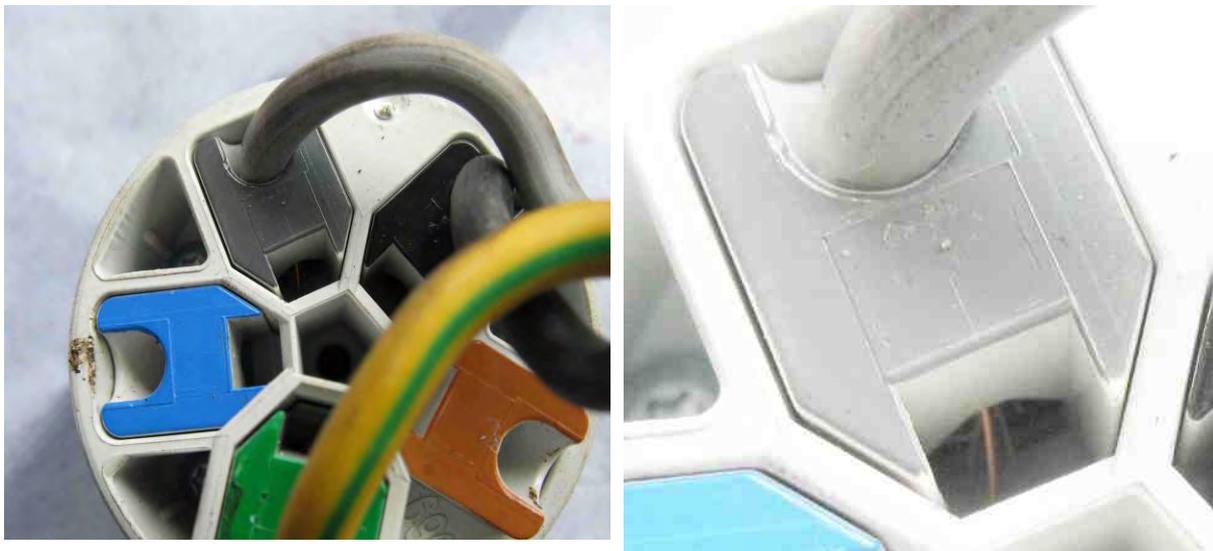
The other plugs and sockets recovered from the *Commodore Clipper* were examined. Most of these had screw terminals all of which were found to be tight with no evidence of overheating. One of the free sockets, recovered from the *Commodore Clipper*, was a 'Startop' socket with IDC terminals. On examination of this unit it was noted that the ends of some strands could be seen in the connector, Fig. 24. On dismantling the connector it was noted that the insulation appeared to have been stripped from the ends of the cable cores before the cable was inserted into the IDC, Fig. 25. Cobham remade one connection into the IDC without stripping the insulation, Fig. 26.

Figure 24 Conductor strands in connector

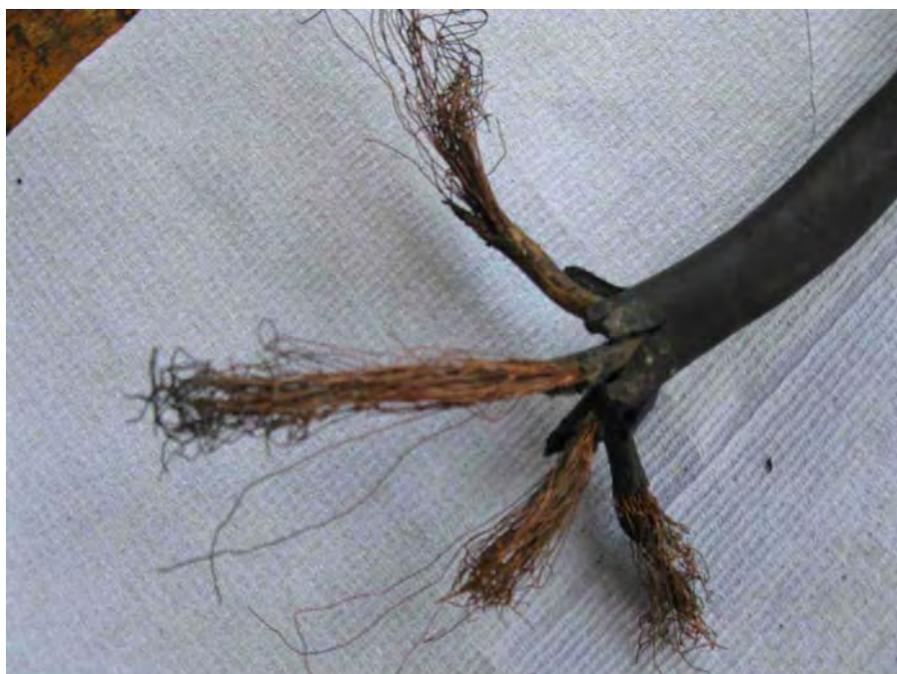
The ends of the cable that had been fitted to the free socket were examined. The exposed conductors on two of the cores were the same length; the third core had some strands broken off shorter than the rest and on the fourth core all of the strands were shorter. The fourth core was the brown phase, Fig. 27. It was reported to Cobham that the cable had been pulled out of the connector during the fire fighting operation.

Figure 27 Cable cores

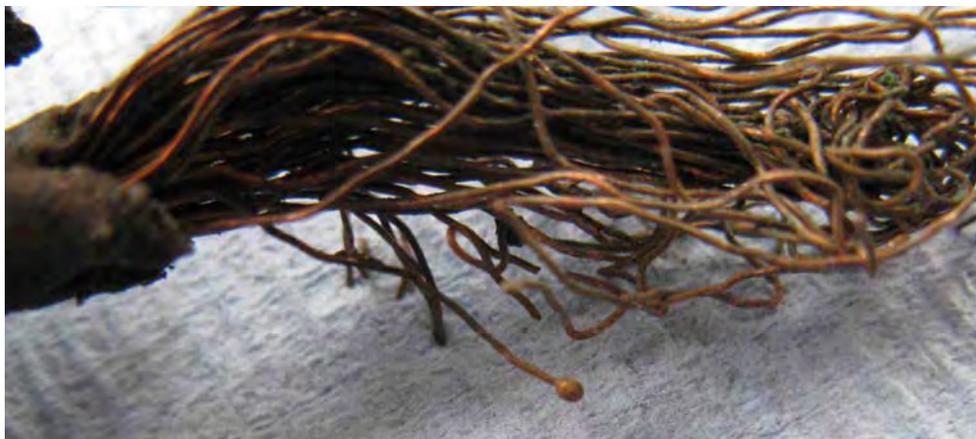
Close examination of the conductor strands of the brown core revealed several small globules of melted copper, Fig. 28.

Figure 28 Copper globule

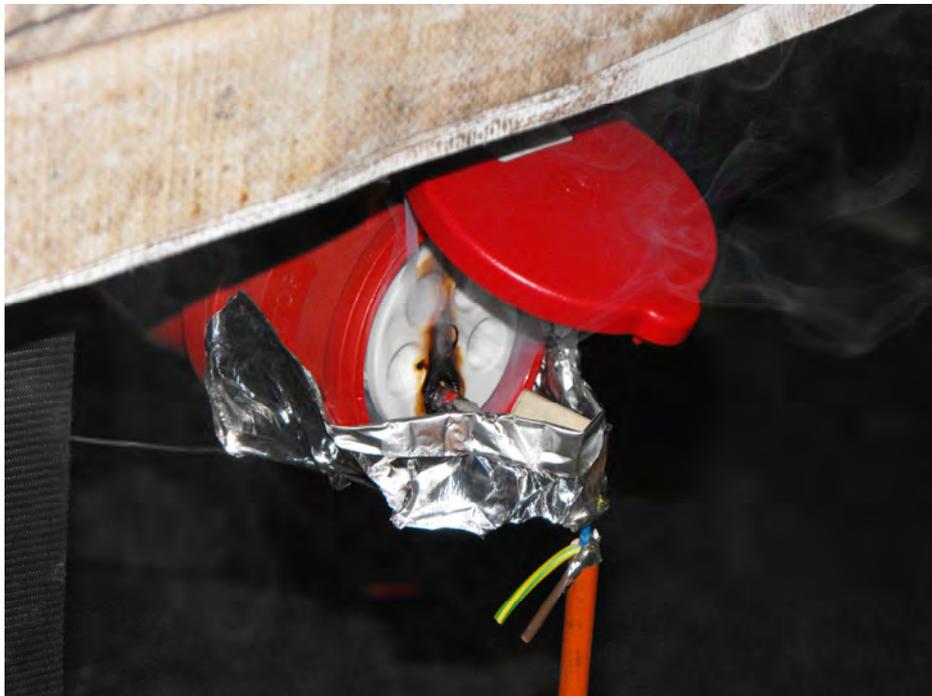
Figure 4 Localised damage to inner plastic core

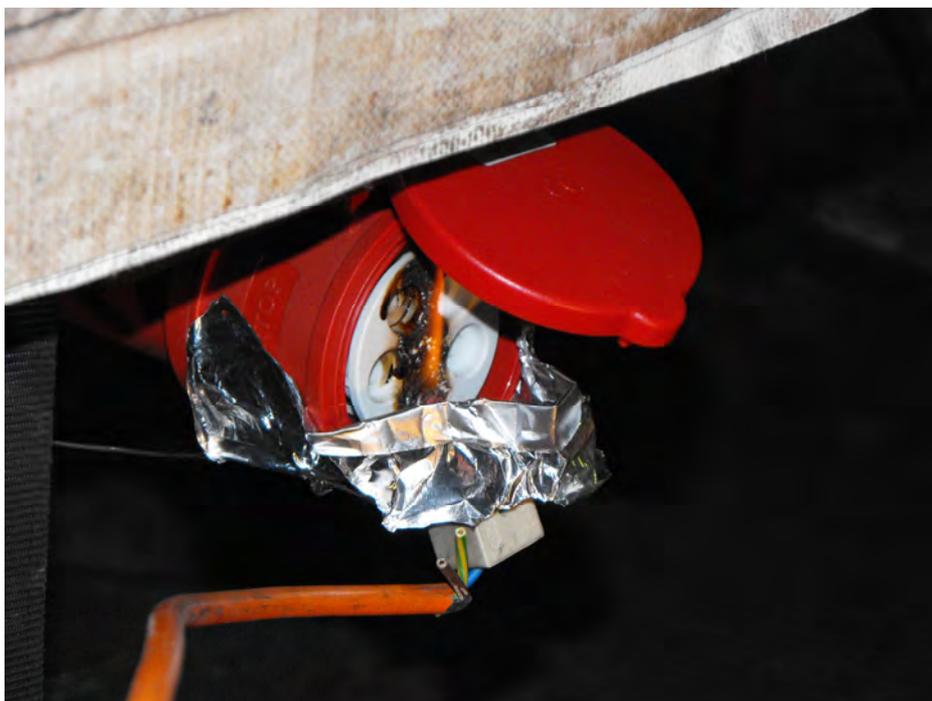
Ten minutes into the test flames could be seen in the socket and the white plastic core began to melt away (Figure 5).

Figure 5 Initial flaming of plastic core

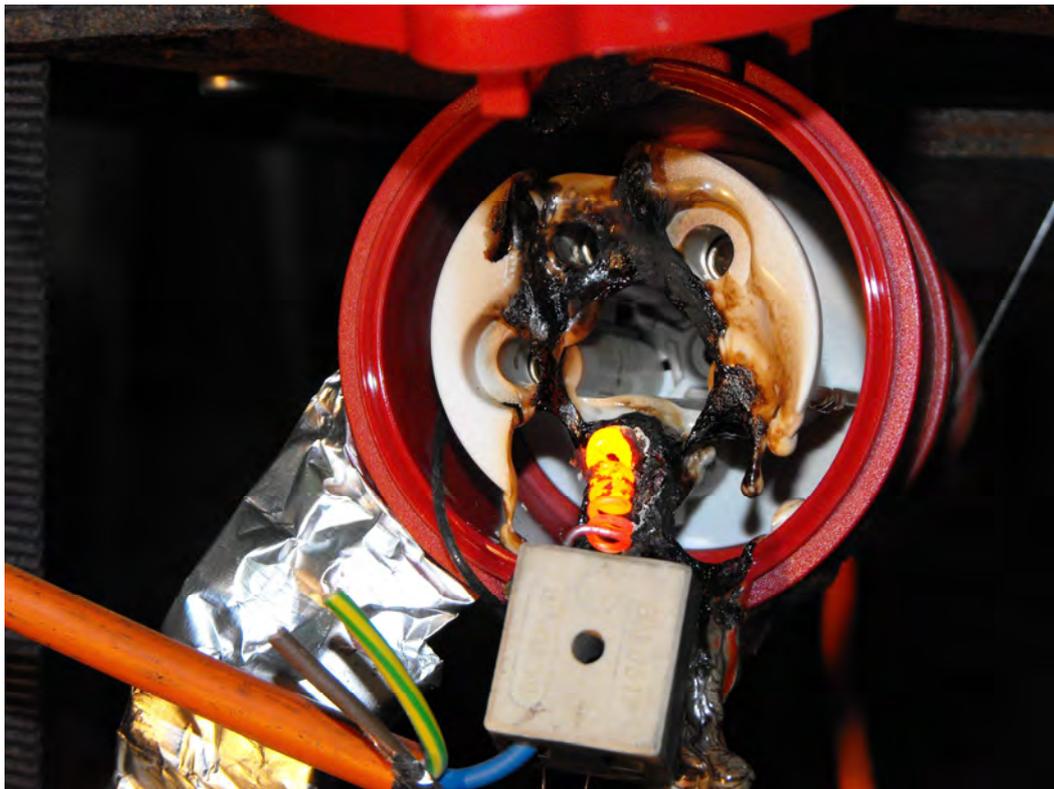
Approximately eleven and a half minutes into the test the flames had spread upwards to involve the red outer casing of the socket. Shortly afterwards the flame was extinguished. The damage to the outer casing is clearly visible in Figure 6.

Figure 6 Damage to socket from initial flaming
