Report on the investigation of
the fire on the main vehicle deck of
Commodore Clipper
while on passage to Portsmouth
16 June 2010

SYNOPSIS

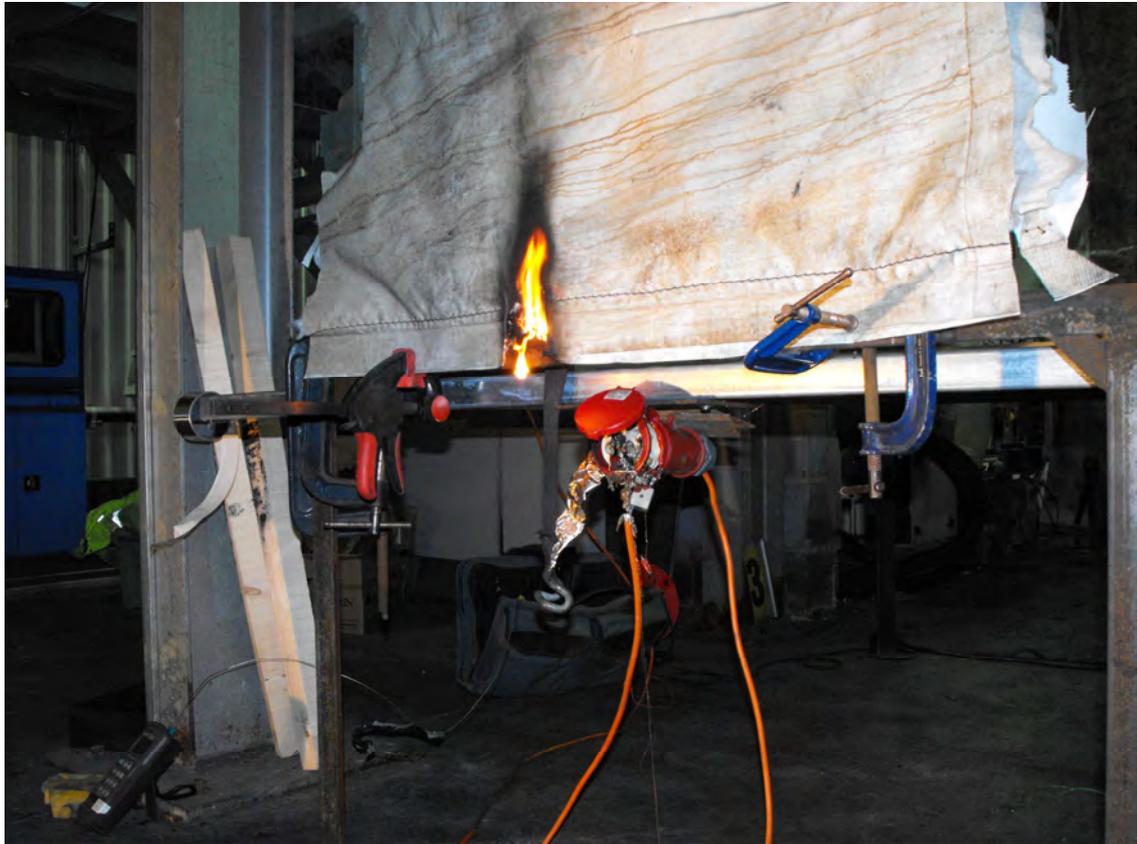
Finally a direct flame source (gas burner) was applied to the webbing straps. This caused fire spread to the curtain material (Figure 7).

Figure 7 Ignition of curtain material following direct application of gas burner to webbing strap

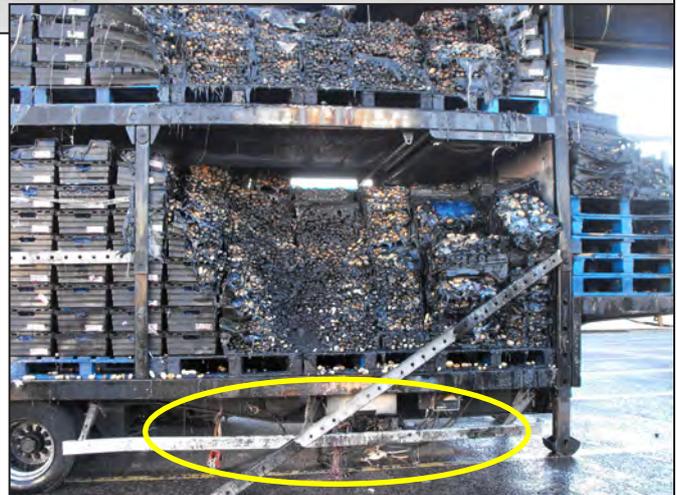
Damaged refrigeration control units
