Report on the investigation of
injury to a passenger on board a

Delta 8.5m RIB

River Thames, London

Report No 1/2011
January 2011

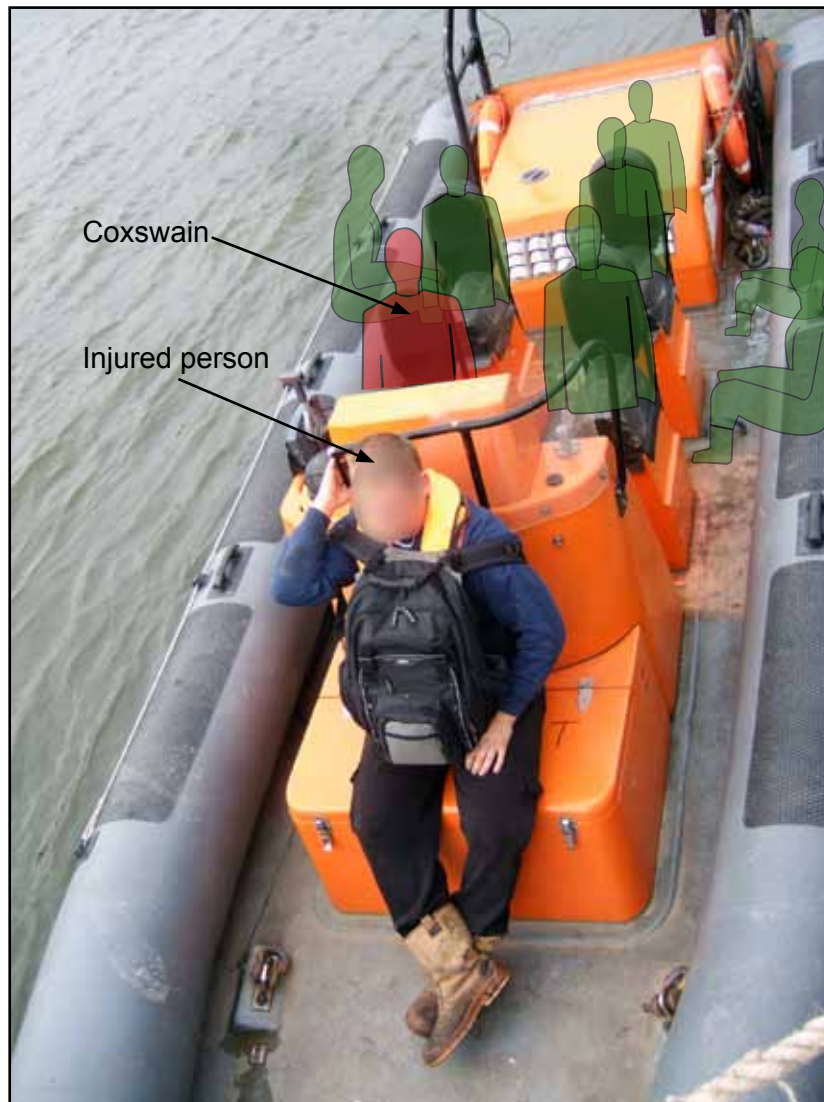
Figure 4

Reconstruction showing location of injured person and other passengers at the time of accident

There were no hand-holds or foot straps in this location so he alternated his grip between a vertical stanchion on the helmsman's console and the lip of the locker on which he was seated. During the passage, the man was frequently lifted bodily from the locker and, due to the motion of the boat was unable to alert the helmsman to his discomfort.

In this accident the injured person was seated on a forward locker. This was not intended for use as a seat, it had no padding and no available hand-holds or foot straps (**Figure 4**). His situation was exacerbated by the location of the locker in the forward part of the RIB, where the motion is most violent (**Annex B**).

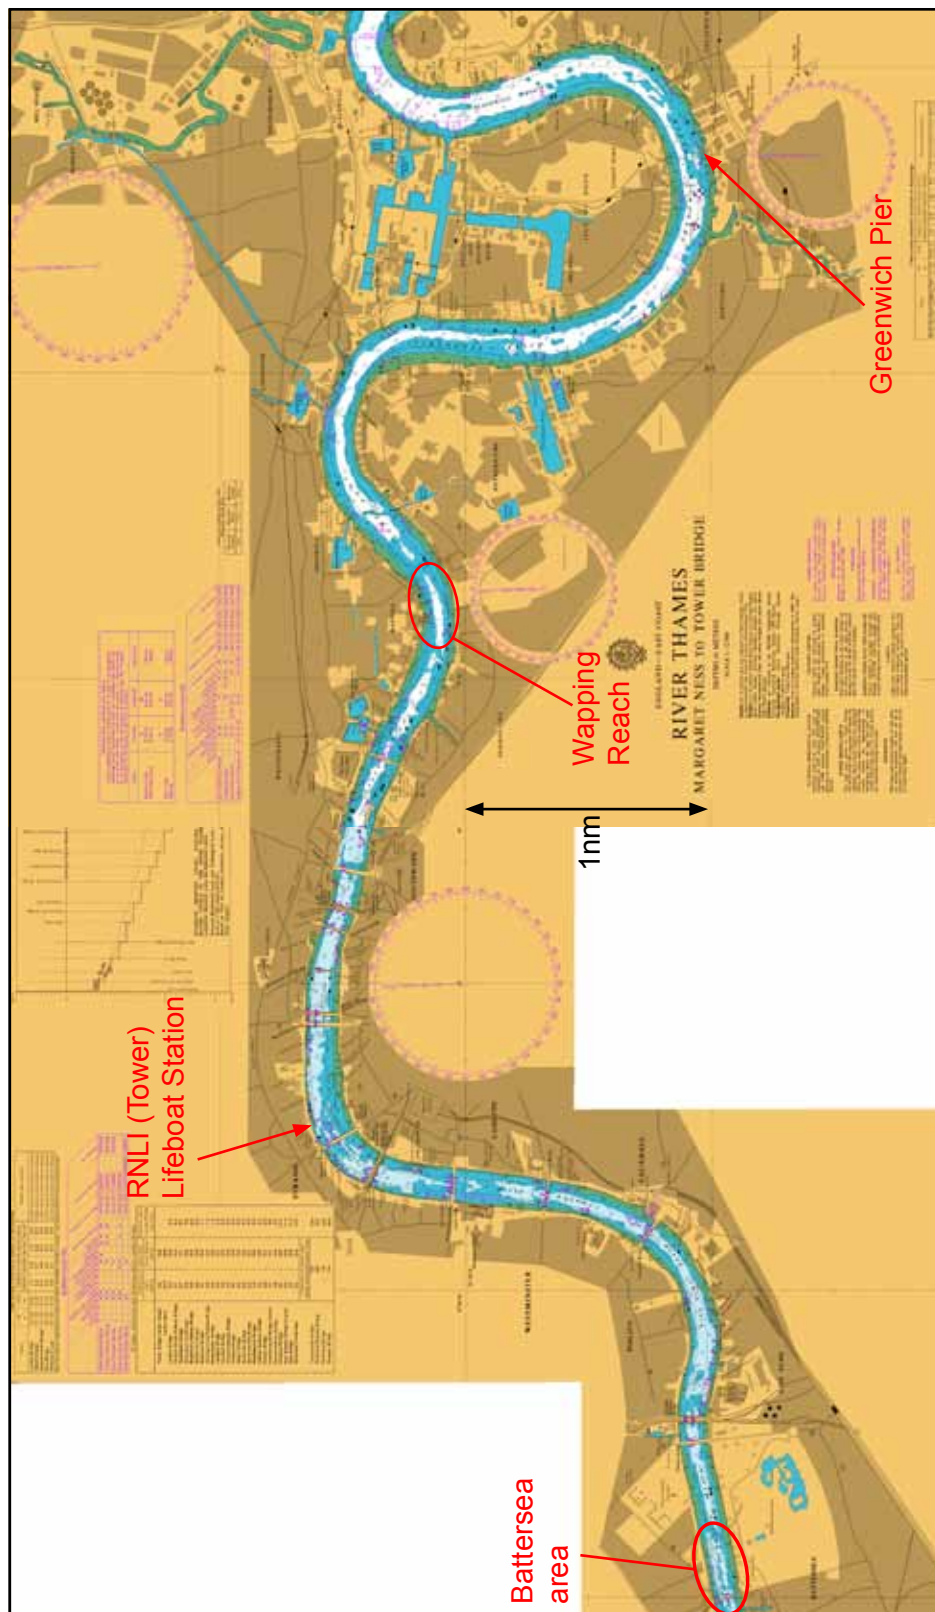
Figure 5

At 0708 the boat was in Wapping Reach (**Figure 5**) when the man felt an intense pain in his lower back. He cried out and immediately placed himself in a prone position on the forward deck of the boat. The helmsman stopped the boat and a co-worker assisted the injured man, who was in considerable distress and unable to move without intense pain in his back.

Chartlet of River Thames from Waterloo Bridge to Greenwich showing location of accident - Wapping Reach

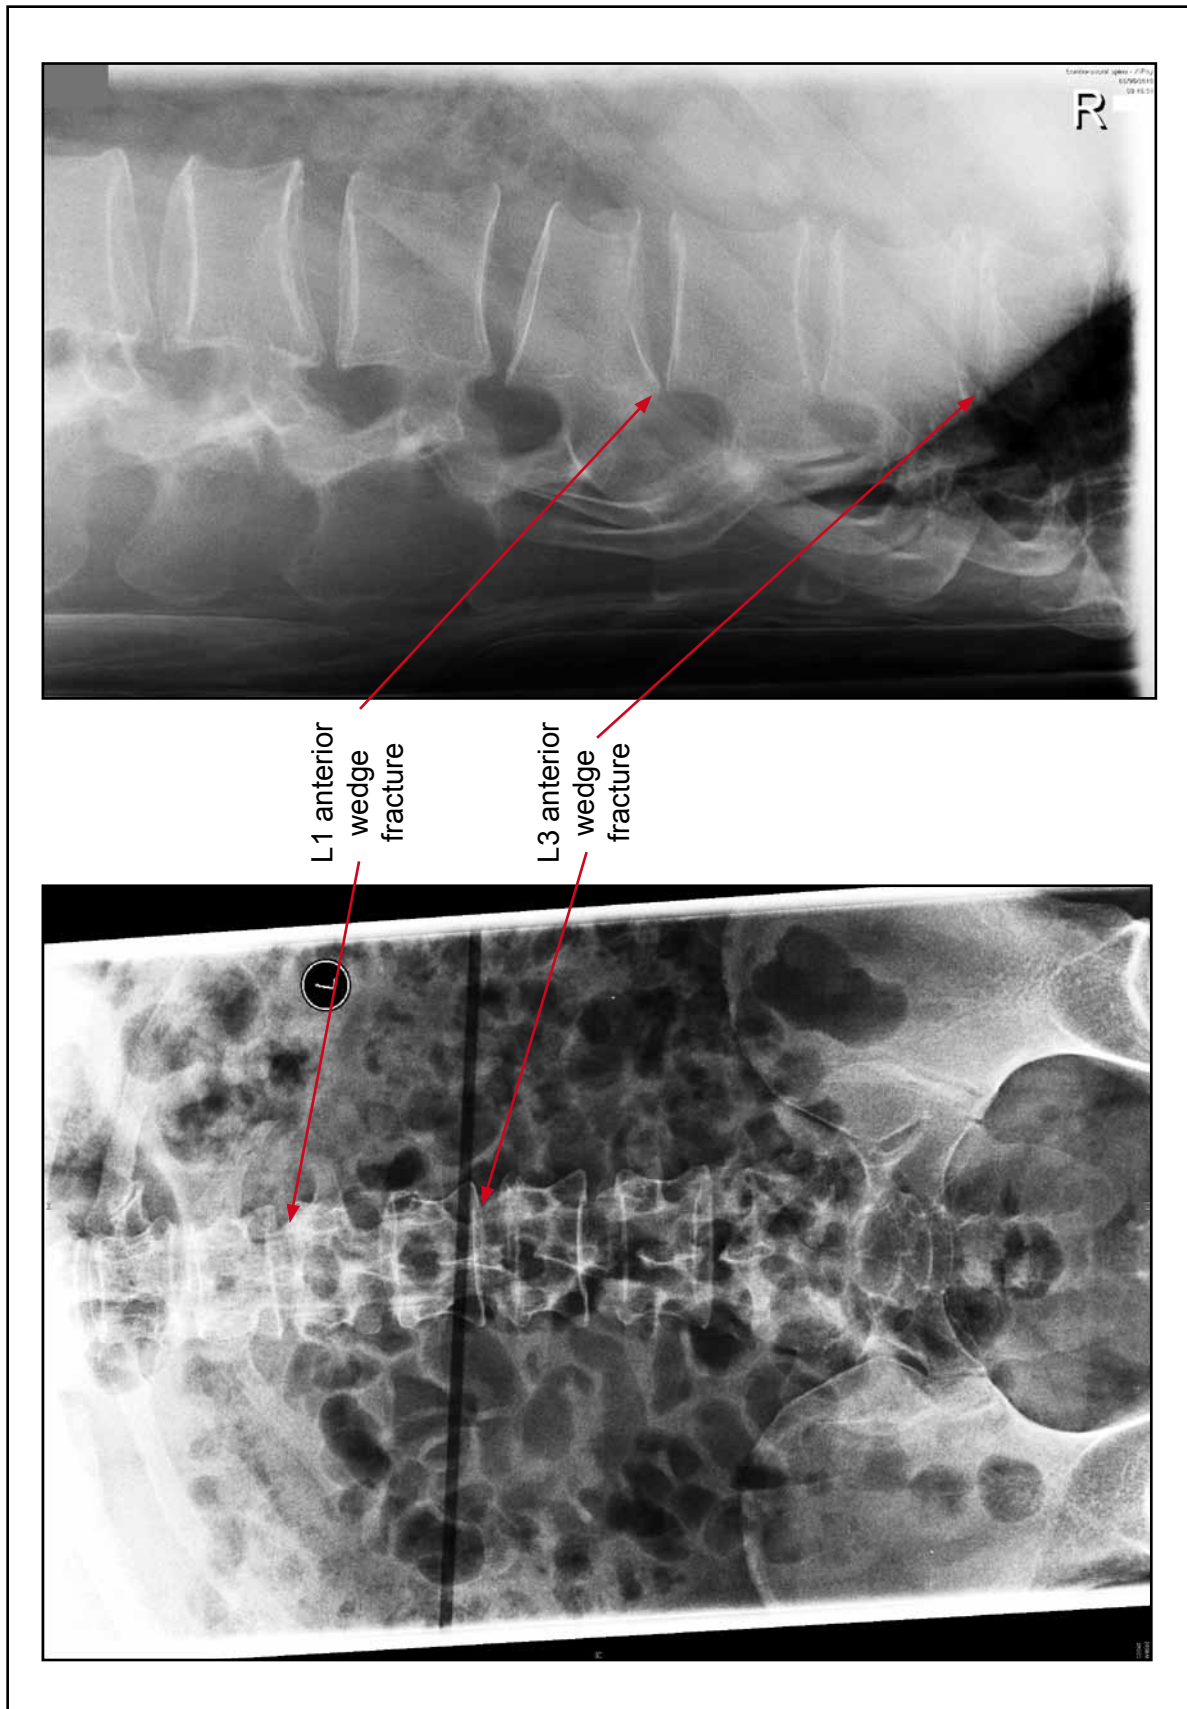
Figure 6

As a result of the accident the injured person suffered anterior wedge fractures of the first and third lumbar vertebrae (L1 and L3) (**Figure 6**). While in hospital he was also given a neurological assessment, which proved to be normal. He was mobilised and discharged the day after the accident, and a few days later was fitted with an external body brace. He remained off work for more than 4 months while he recovered from the injury. He commenced a graduated return to work a few months later and resumed full-time employment 6 months after the accident, although he was still receiving physiotherapy treatment at the time this report was published, some 8 months after the accident.

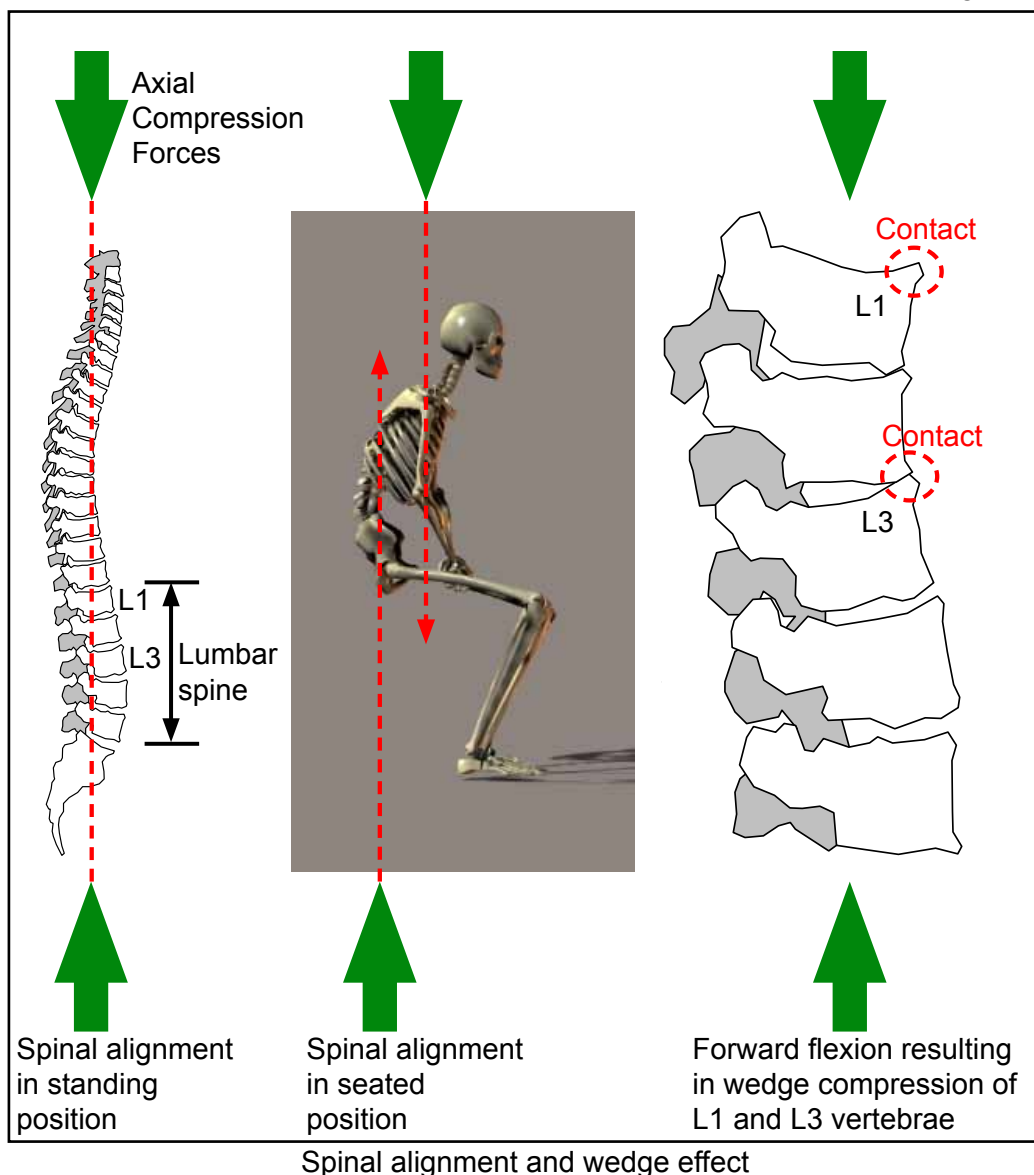
Figure 7

The human spine is at its strongest when in the standing posture on a stable surface, when it assumes a natural “S” shape and can readily support the weight of the trunk and head. In this posture an evenly distributed gap is maintained between the vertebrae by the discs, and maximum support is offered by the trunk and abdominal muscles. The spine is weaker in the seated position, when it assumes a slumped posture and many of the muscles supporting the spine cannot function effectively. The body’s centre of gravity moves forward, increasing the risk of the spine bending forward (forward flexion) during axial loading. It is the combination of the flexion of the spine and the axial forces applied that causes contact between the vertebrae and results in fractures due to the wedging effect (**Figure 7**).

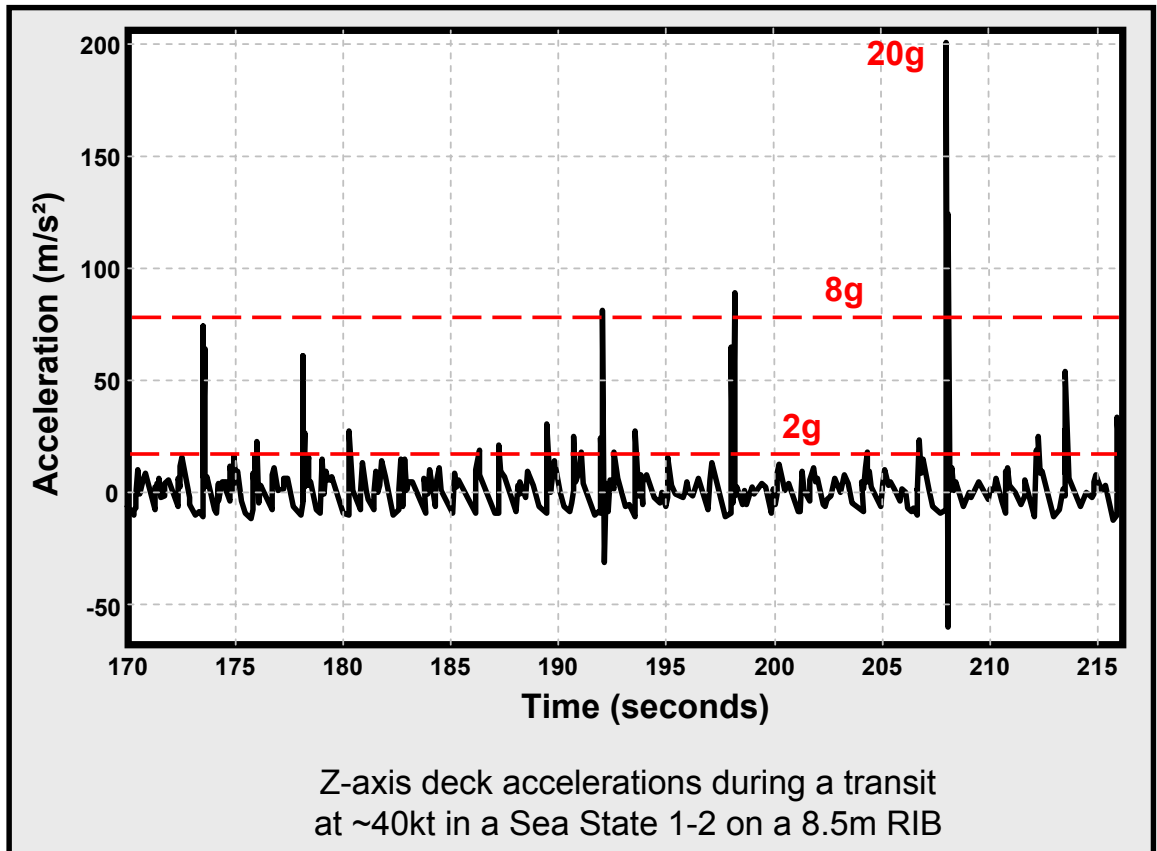
Figure 8

Research, referenced in the guide, provides a graphical example of the magnitude and frequency of repeated shocks measured during trials on the deck of an 8.5m RIB travelling at 40 knots between a sea state 1 and sea state 2 (**Figure 8**). The trials found that the occupants were exposed to constant shocks in the region of 2g, regular shocks in the region of 6g and occasional shocks of up to 20g. These figures equate to the WBV EAV being exceeded within 15 minutes and the ELV within approximately 30 minutes (**Figure 9**). The guide also states that *“the risks of acute and chronic injury are manifested in an increase in spinal, knee, arm, or neck injury. This can be from a single high energy event (e.g. a single 20g impact) or as a result of a long term exposure to a large quantity of smaller energy events (e.g. multiple 2g impacts)”*. The research also found that the magnitude of shocks transmitted through the deck of a high-speed craft is greater towards the bow.

Magnitude and frequency measurements for repeated shocks recorded on an 8.5m RIB

The trials demonstrated that the repeated shocks experienced during a high speed passage can be of sufficient magnitude to cause impact injuries. They also concluded that a person exposed to the shock and vibration levels shown in **Figure 8** dramatically exceeds the exposure limits set by the Vibration Regulations.
