Report on the investigation into the fatal
accident to the chief engineer in the lift shaft on board

Ever Excel

in Kaohsiung, Taiwan

Report No 6/2010
May 2010

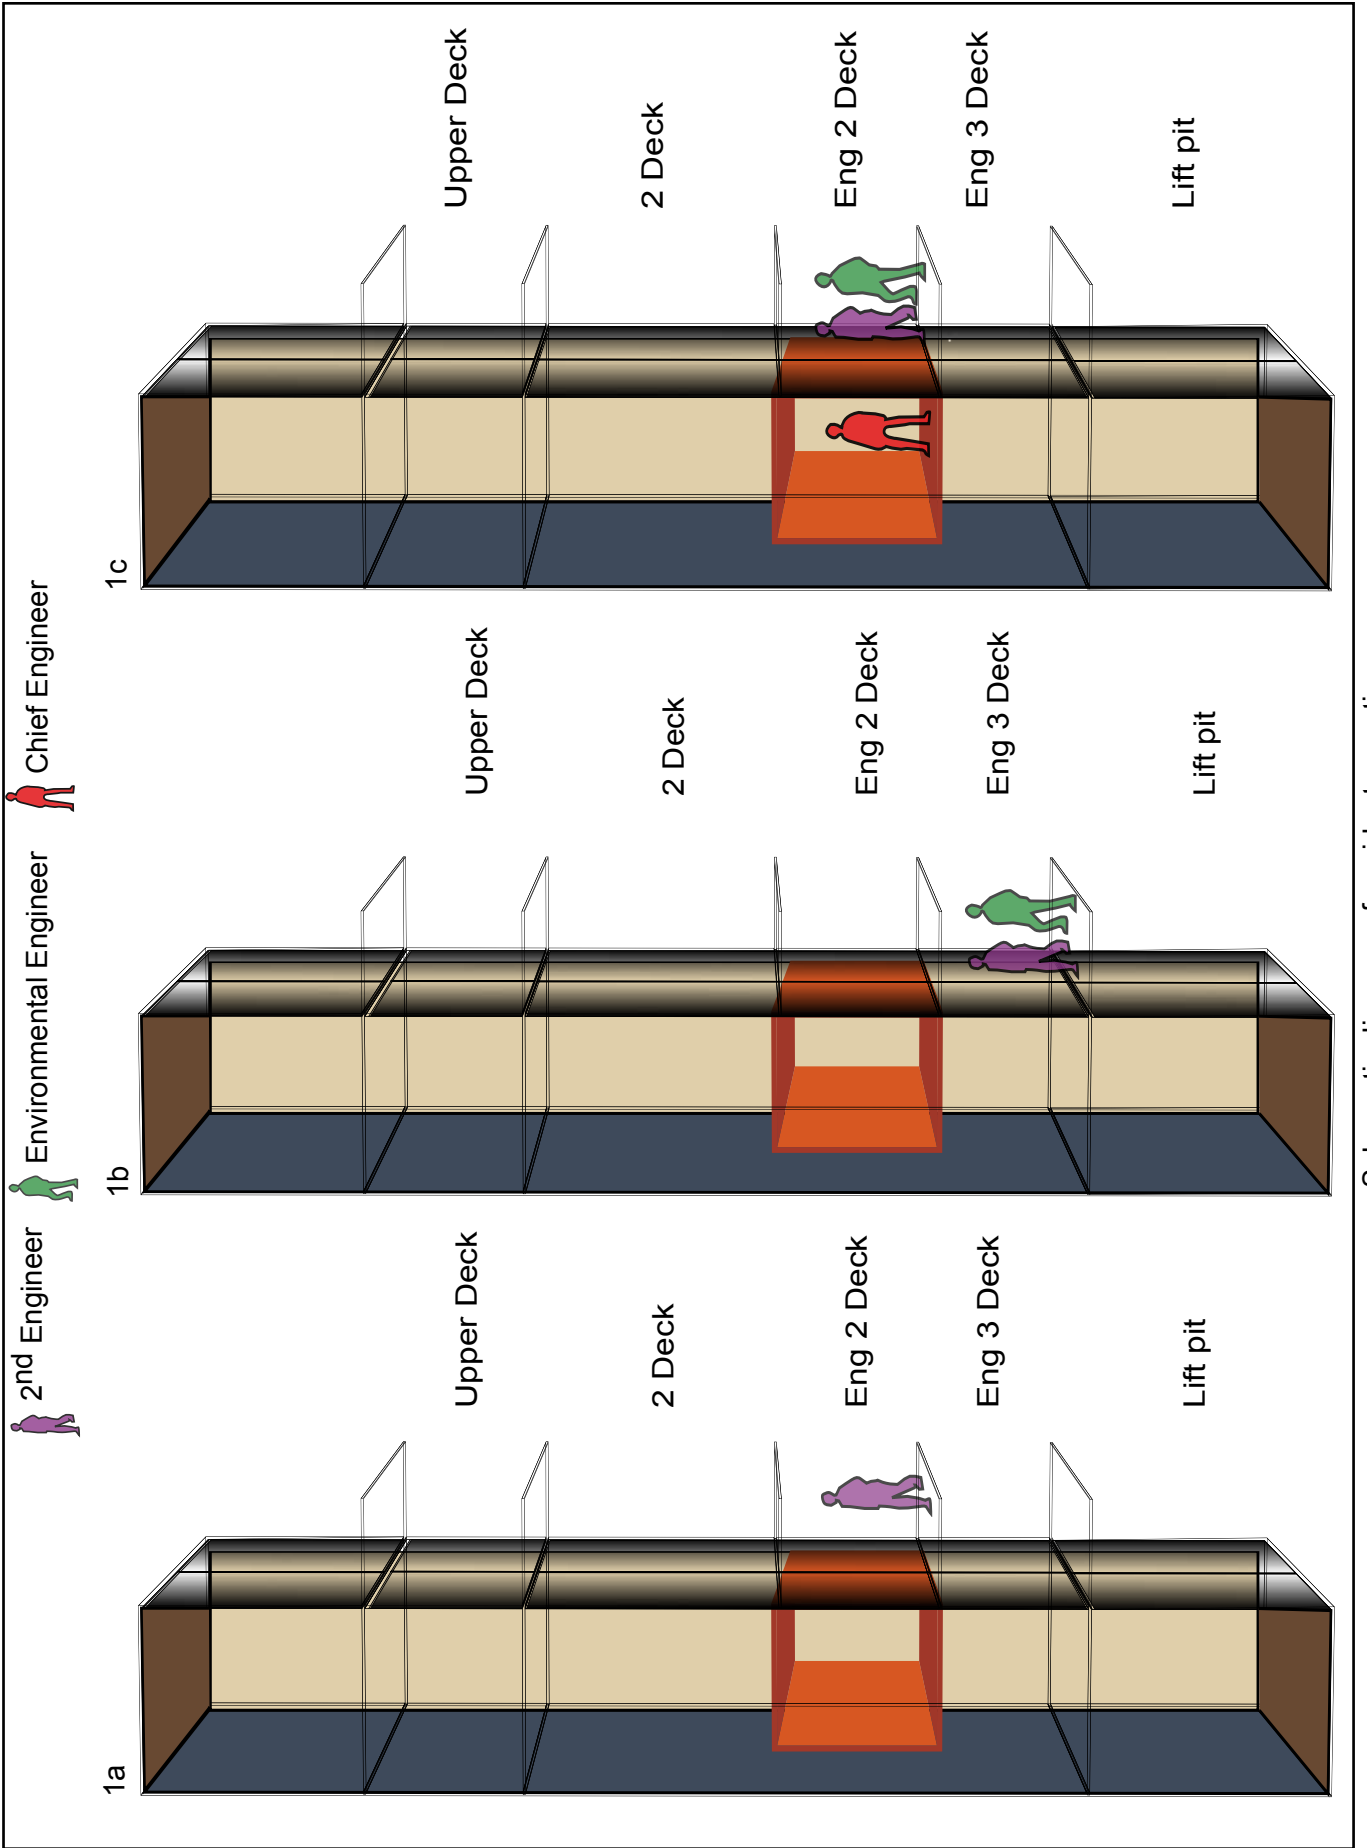
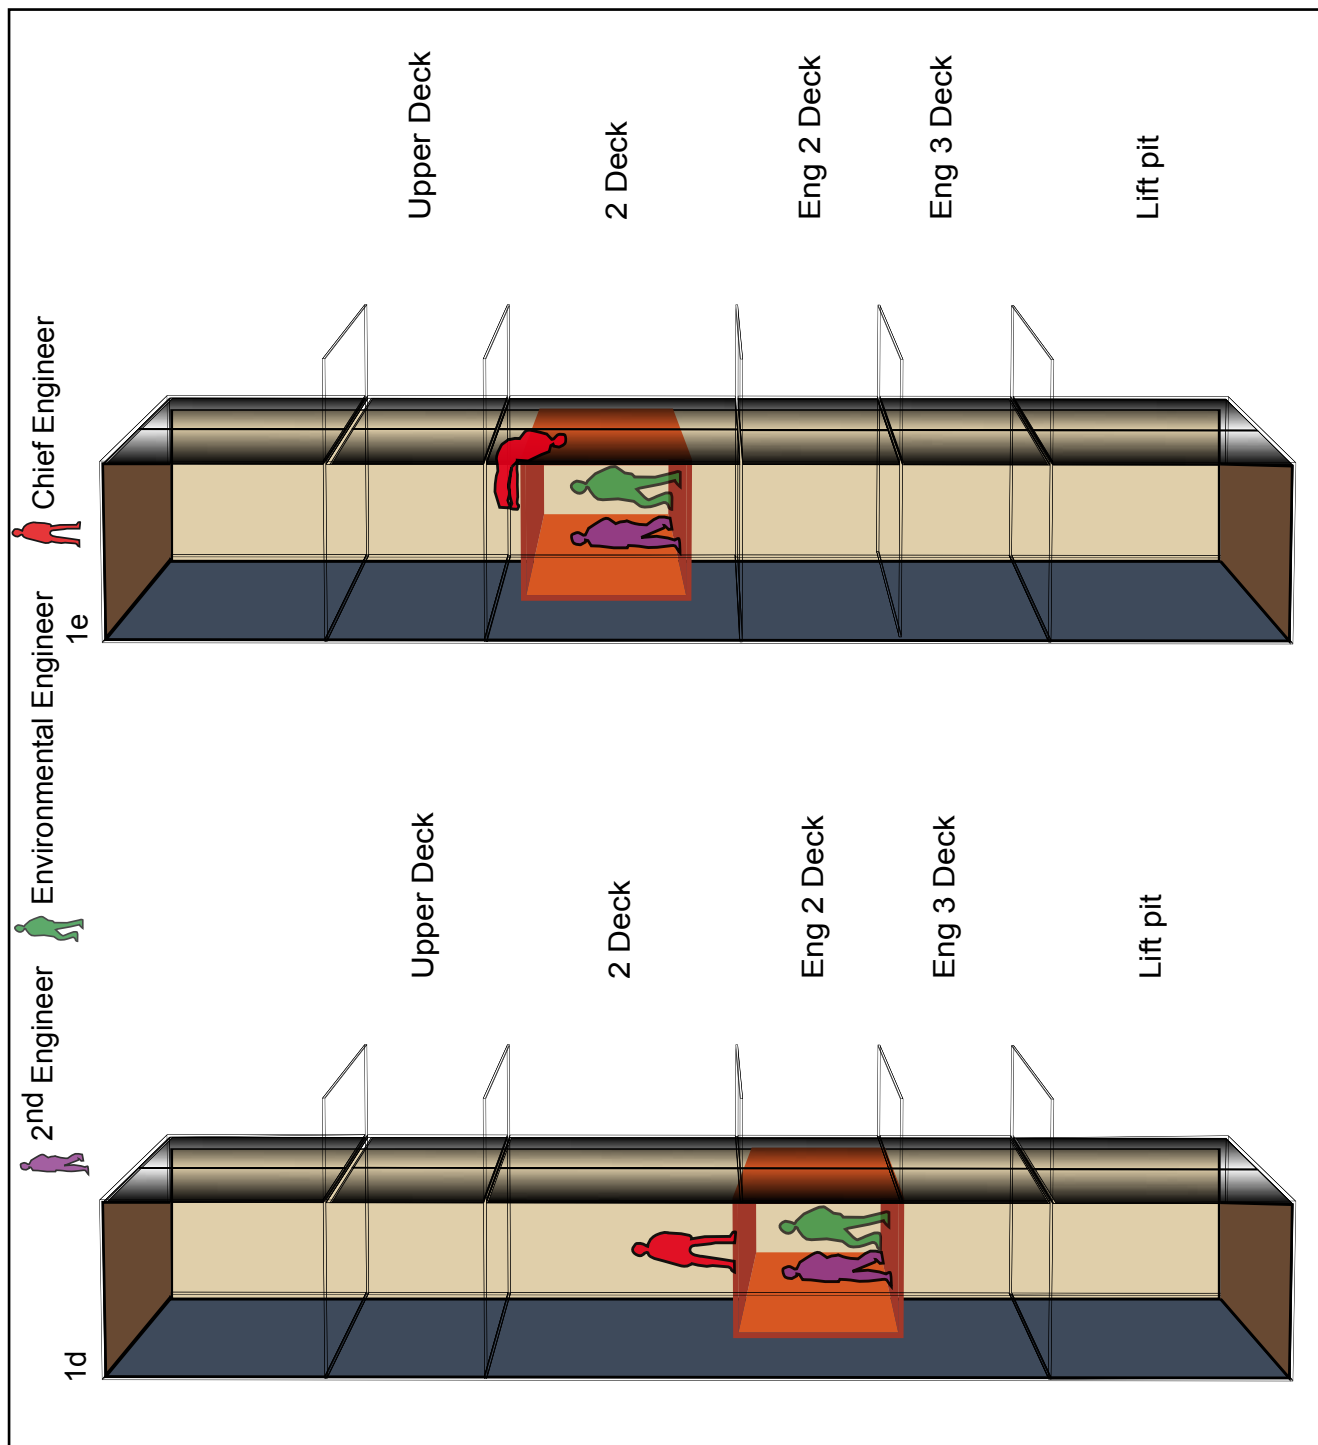
Figure 1

At around 1055 the chief engineer, apparently frustrated by not being able to open the doors, took the stairs up to the engine room 2nd deck. Once there (**Figure 1c**), he entered the lift car and, without explanation, began to climb up through the emergency escape hatch. The second and environmental engineers had followed him, and the environmental engineer shouted a warning to the chief engineer not to climb into the lift shaft. The chief engineer carried on through the open emergency escape hatch and on to the lift car roof. He then closed the hatch behind him (**Figure 1d**).

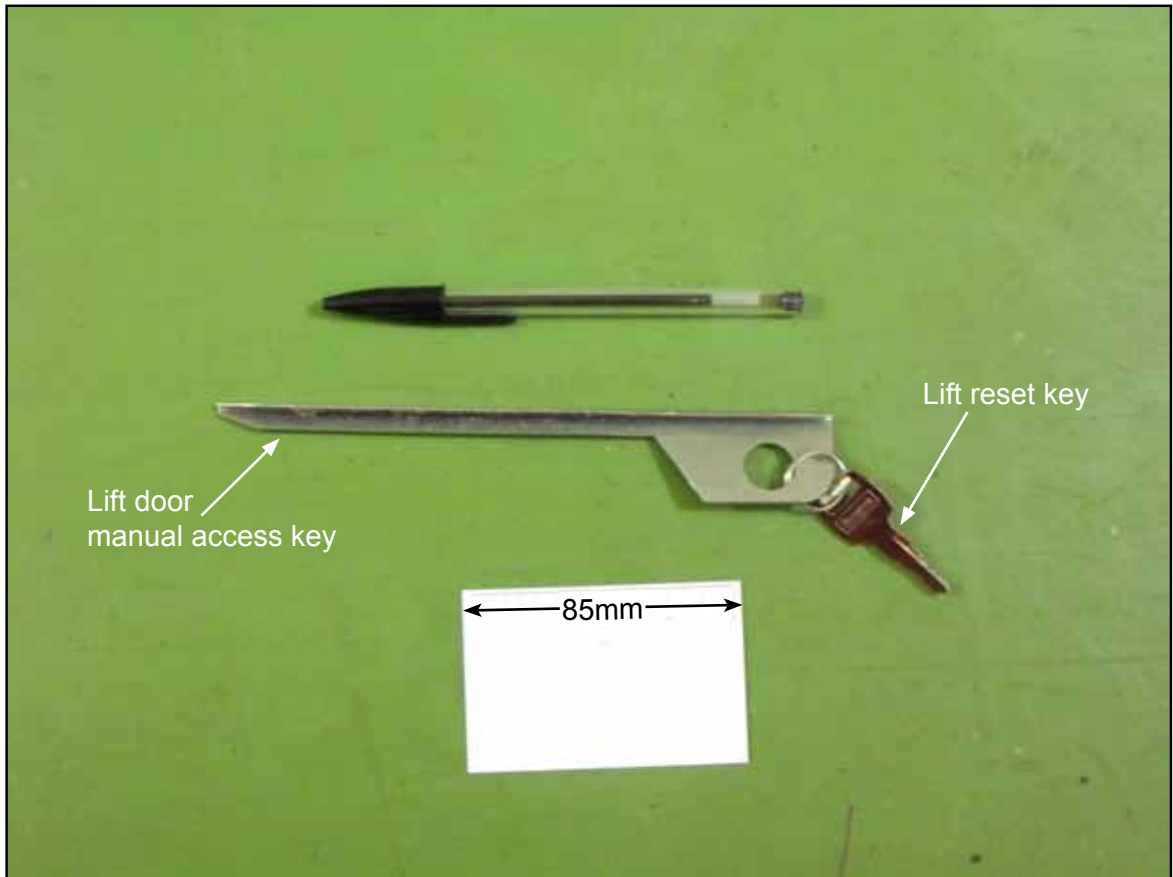
Figure 2b

Lift shaft door manual access key and reset key

The second engineer also saw that the lift car control panel was unlit, and interpreted this to mean that the chief engineer had taken manual control. In order to allow the lift to respond to manual commands, the second engineer turned and released the emergency stop button, and then turned the reset key that was attached to the lift door access key (**Figures 2a and 2b**).

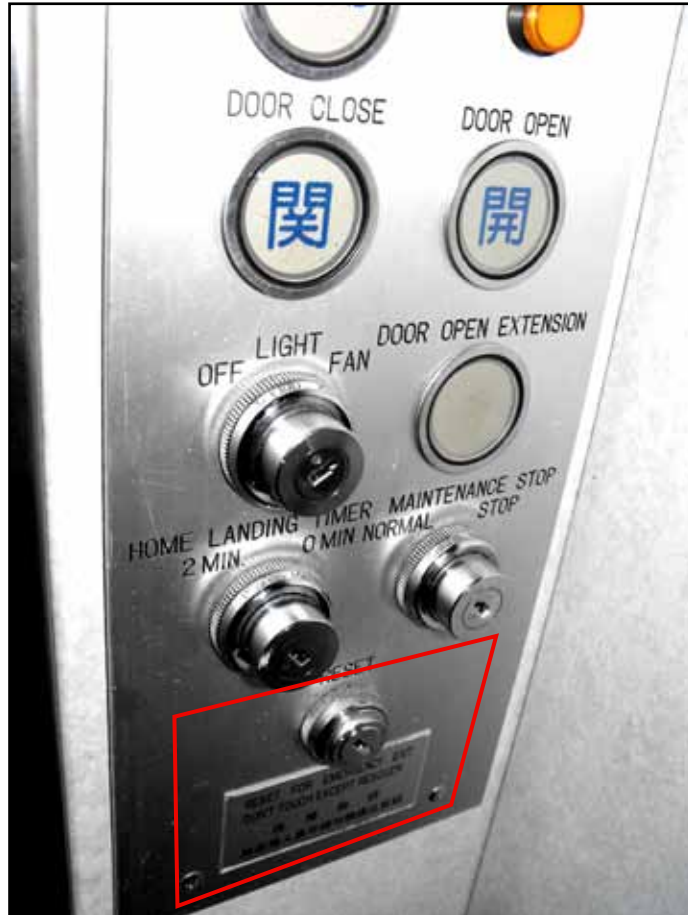
Lift reset switch - located in lift car

Although the chief engineer had not explained what he intended to do, the second engineer assumed that, as the hatch door had been closed, the chief engineer had switched the lift to '*manual*' mode, using the controls on top of the lift car (**Figure 3**) so that he could move the lift car up or down as required.

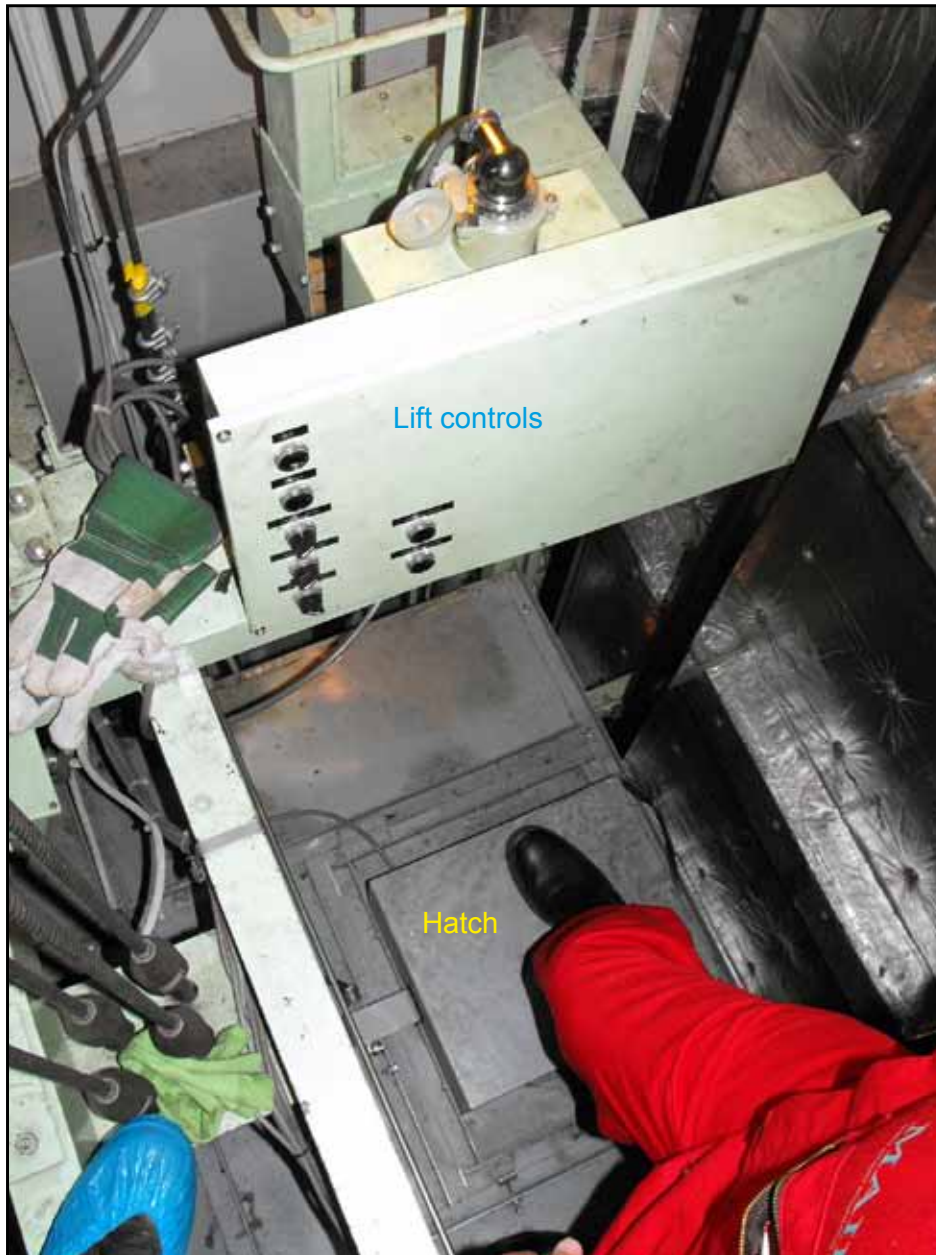
Figure 3

Lift car emergency escape hatch and local control switches

The port engineer went to the lift and found that the controls on top of the lift car had not been switched to the manual mode. The lift was therefore in automatic mode. The port engineer switched to manual mode and attempted to move the lift downwards, but the machinery did not respond.

- It would have been easiest for him to switch the lift to manual control as he was climbing through the escape hatch; however, the controls were found to be still in the automatic mode immediately after the accident.

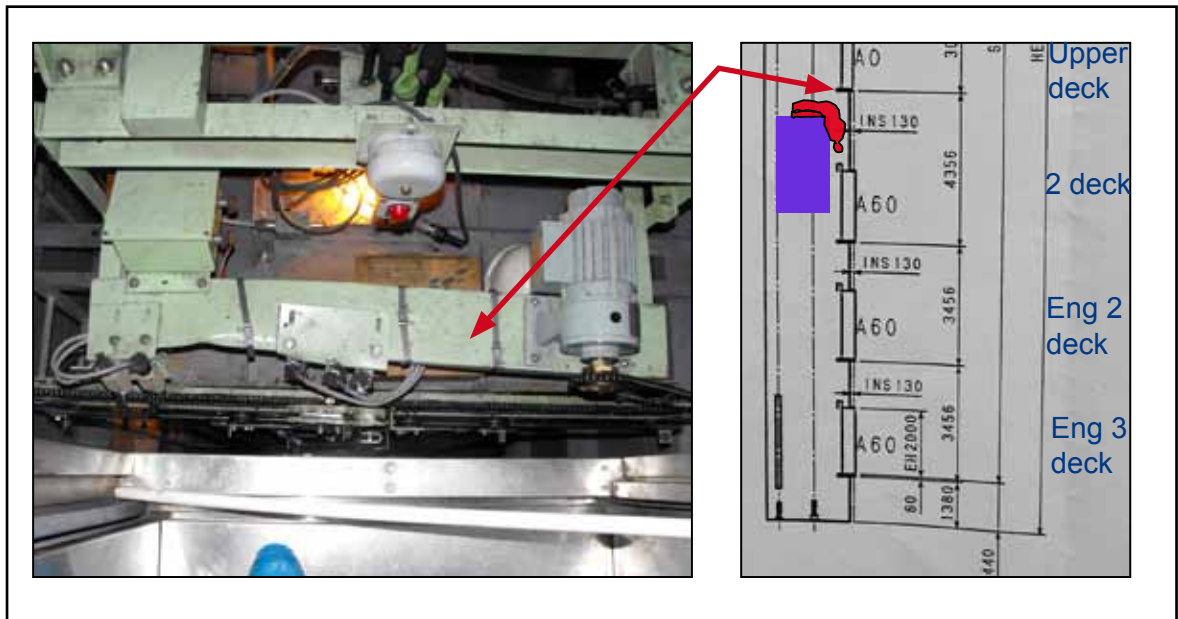
Figure 4

Casualty location

- The chief engineer was found on the opposite side of the lift car from the controls. In order to get to that position he would have had to climb over the substantial cable attachment structure. This would have been awkward for a man of his build, and therefore was a deliberate act, which also moved him away from the manual controls.
- It would have been difficult for the chief engineer to lean back across the cable attachment structure to reach or operate the controls.

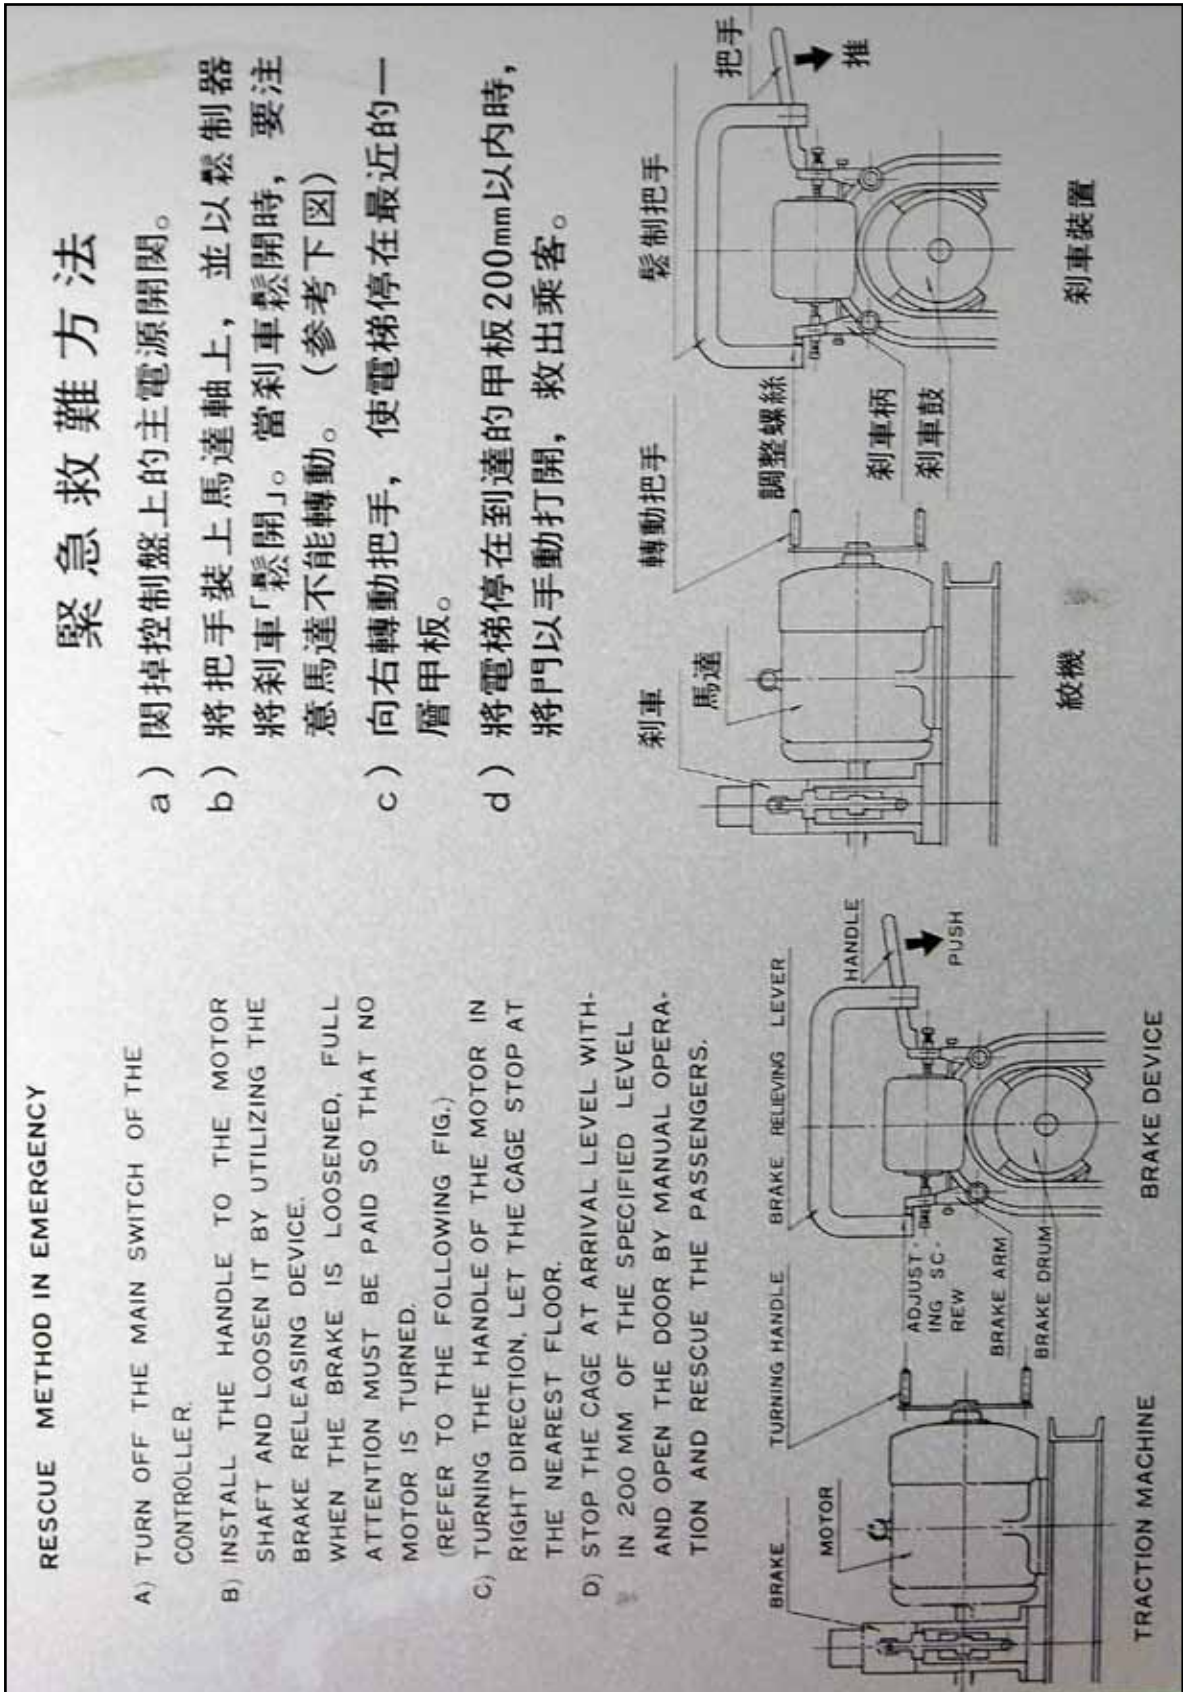
Lift emergency hand operated control

It was not possible to move the lift by using a hand crank until an electro-magnetically operated brake had been released. This was not done correctly, and so the drive shaft broke when it was forced by the second engineer. The lift car was held firmly in position by the brake, and attempts to physically force the lift car down were ineffective and only caused further damage.

If work is permitted in any hazardous environment on a ship, such as a lift shaft, procedures should be established and practised to ensure that a trapped or injured worker can be rescued.

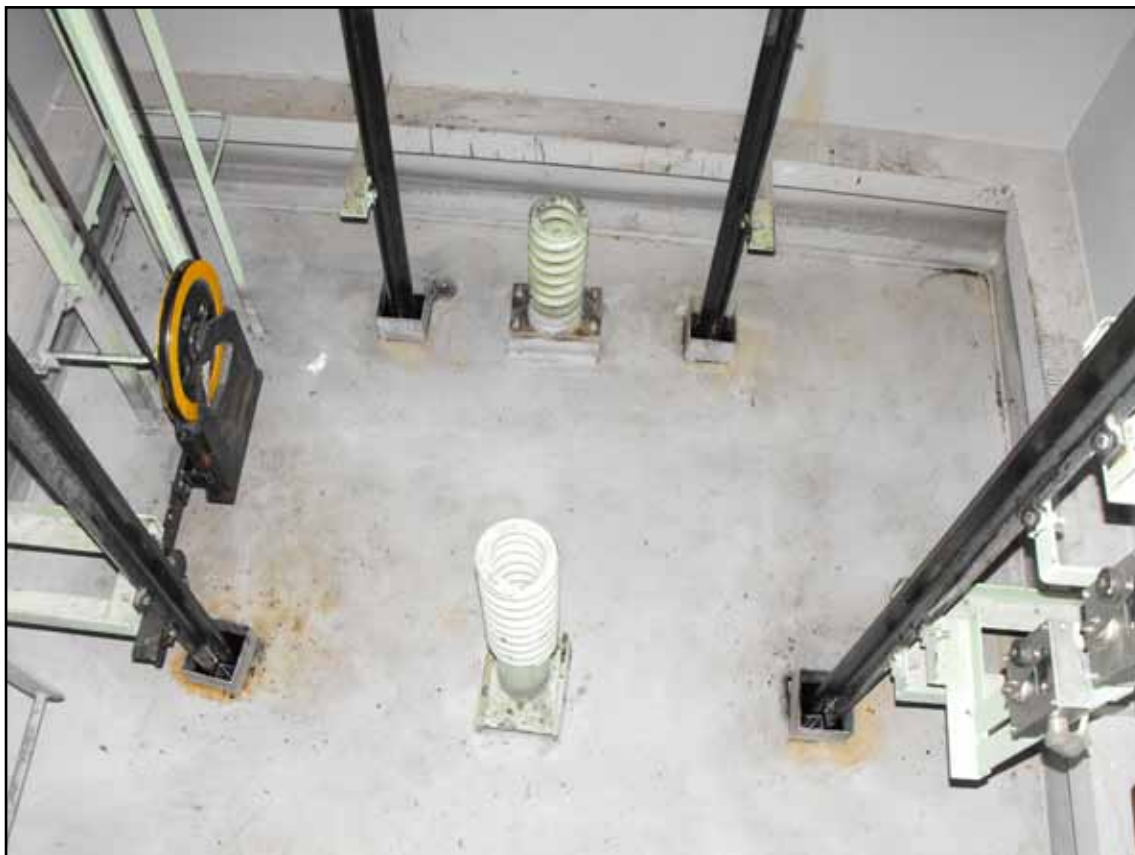
Prior to the accident, the lift was in good condition and functioned correctly. The lift pit was clean, with very small quantities of oil residues collected in save-alls (**Figure 9**).

During the investigation, the lift pit was found to be clean and there were no signs of waste fluids ever having gathered there in significant amounts. It is probable that the lift pit was checked when the VGP inspection was introduced in February 2009, but that weekly checks were thereafter found to be unnecessarily frequent, and so became neglected. Crews must inform managers when procedures are impractical so that a better solution or, in this case, a more realistic periodicity can be established.
