Report on the investigation into the
unintended movement of the ro-ro passenger vessel

Ben-My-Chree

during loading operations at Heysham

Report No 17/2010
December 2010

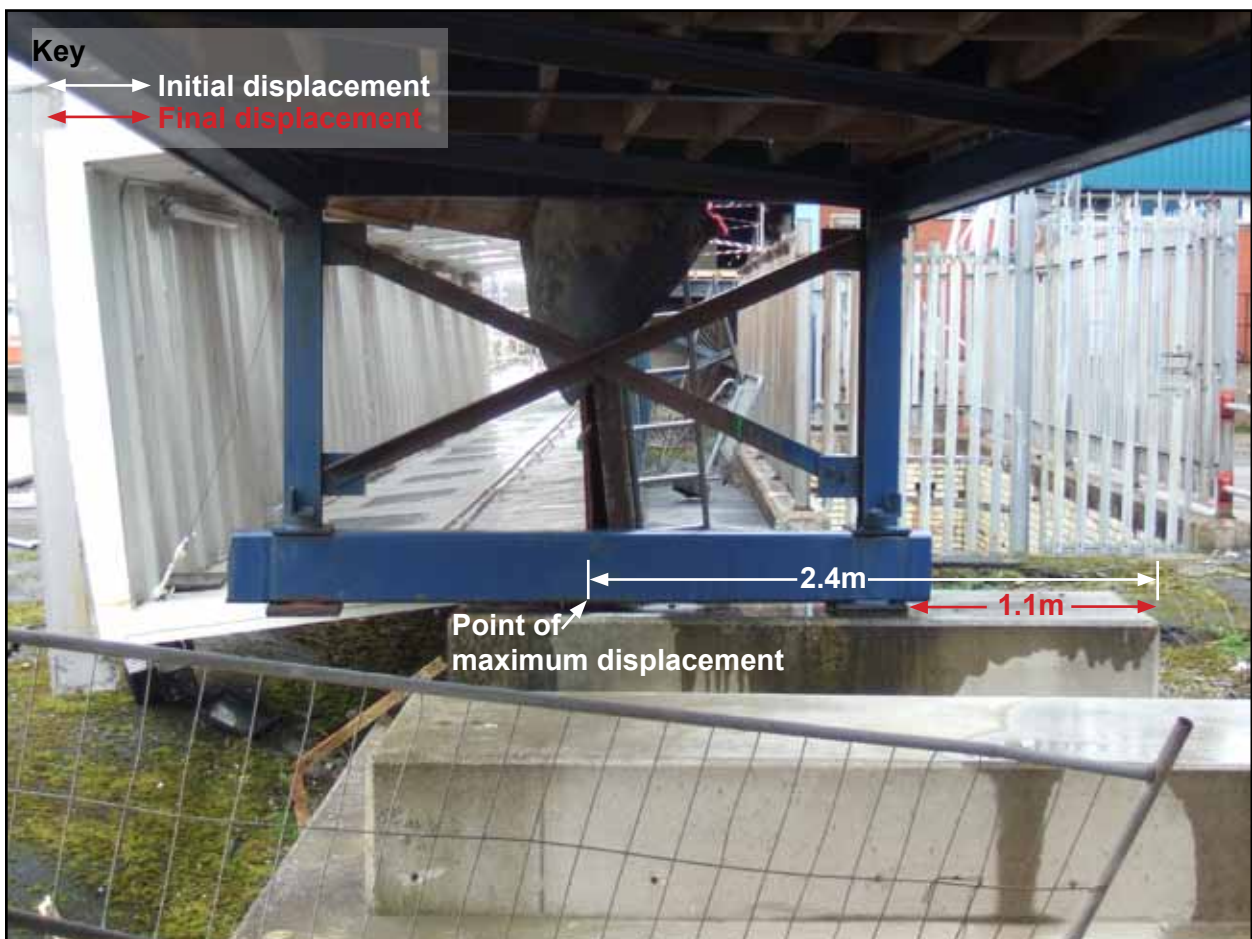
Figure 8

When *Ben-My-Chree* moved forward, the gangway compartment moved 2.4m to its side (towards the water), and it finally returned to a point 1.1m away from its original position (**Figure 8**) after the vessel had come astern. As the gangway pulled clear of the vessel, lugs at its outboard end damaged the vessel's shell door frame (**Figure 9**).

Movement of gangway compartment showing support frame in its final position after the accident

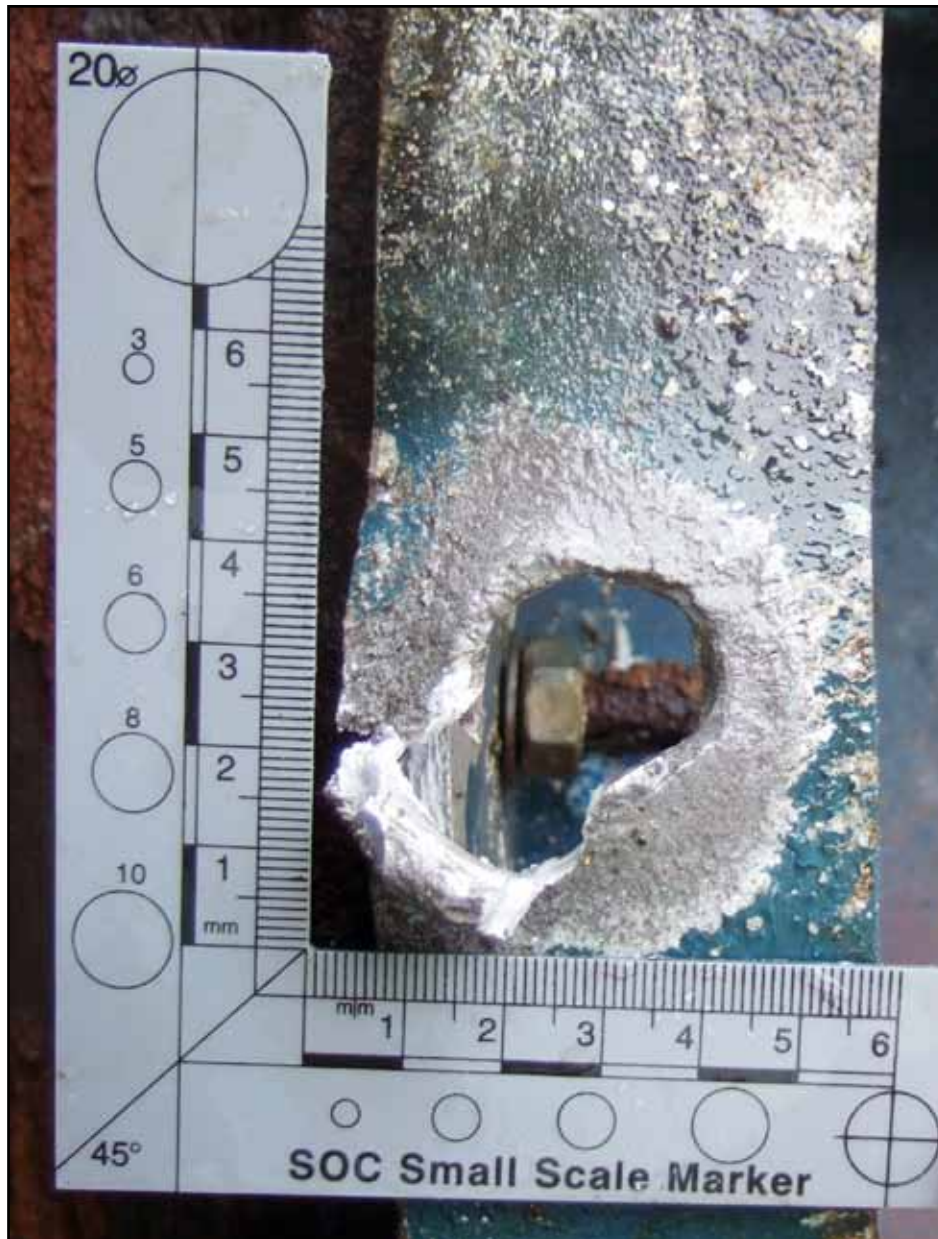
The steel fixing bolts at both ends of the suspended aluminium walkway were ripped out as it detached from the steel structures of the passenger terminal and the gangway compartment. All the electric lighting cables were sheared and the walkway fell to the quay. The ends of both the steel and aluminium in the structure showed evidence of heavy salt water corrosion (**Figure 10**).

Walkway securing boltholes showing signs of corrosion
