Report on the investigation into the
unintended movement of the ro-ro passenger vessel

Ben-My-Chree

during loading operations at Heysham

Report No 17/2010
December 2010

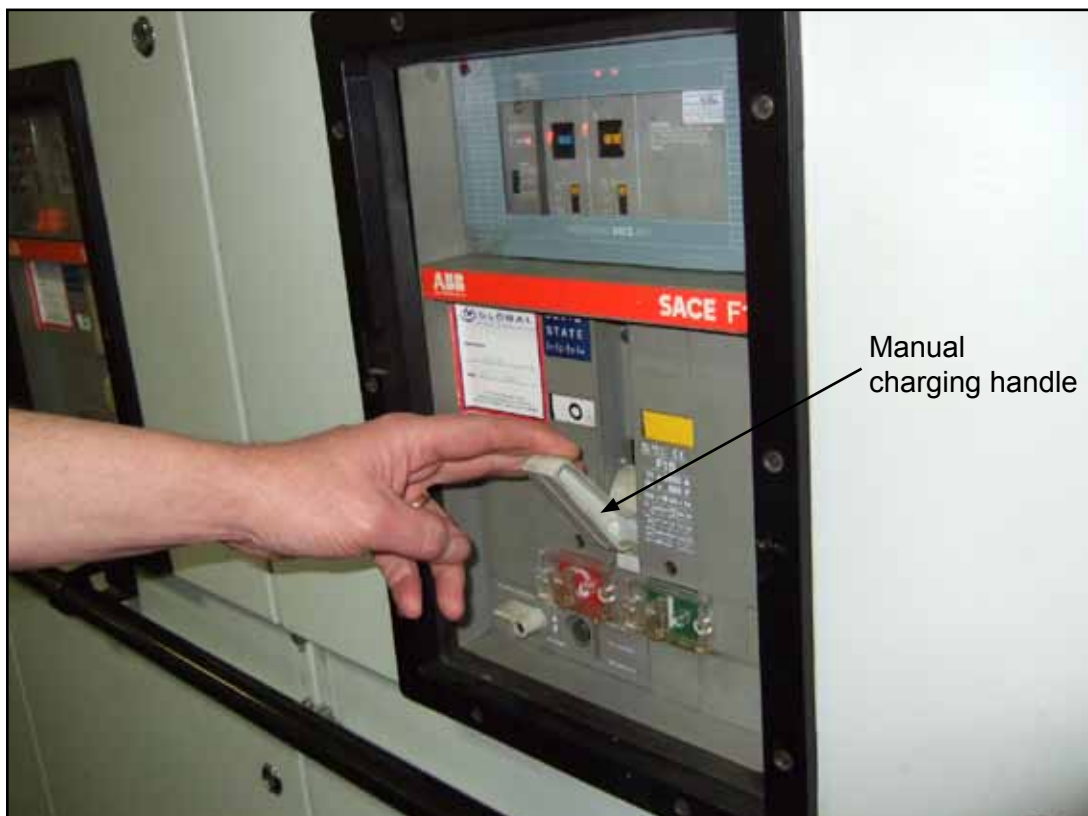
Figure 2

The bow thruster was tested twice by the master on the request of the second engineer (2/E), but without success. One of the technicians then identified that the mechanism that activated the breaker trip indication had been assembled incorrectly, and he promptly rectified the defect.

During the attempts to diagnose the MCB faults a fuse from an MCB charging spring motor fell out of its holder; but no one noticed it fall. The technicians then discovered that they could only engage the MCB manually by physically winding up the charging spring motor using its handle (**Figure 2**). They requested a third test and, at 1342, the 2/E asked the master to switch on the bow thruster again. This time the master observed the bow thruster motor start up as normal, and 2 minutes later he received a call from the 2/E who informed him that the tests were completed. At about 1350, the chief officer and master left the bridge and the 2/E left the ECR to prepare the port engine for departure. The starboard engine, still in engine room control, was left running.

Main circuit breaker

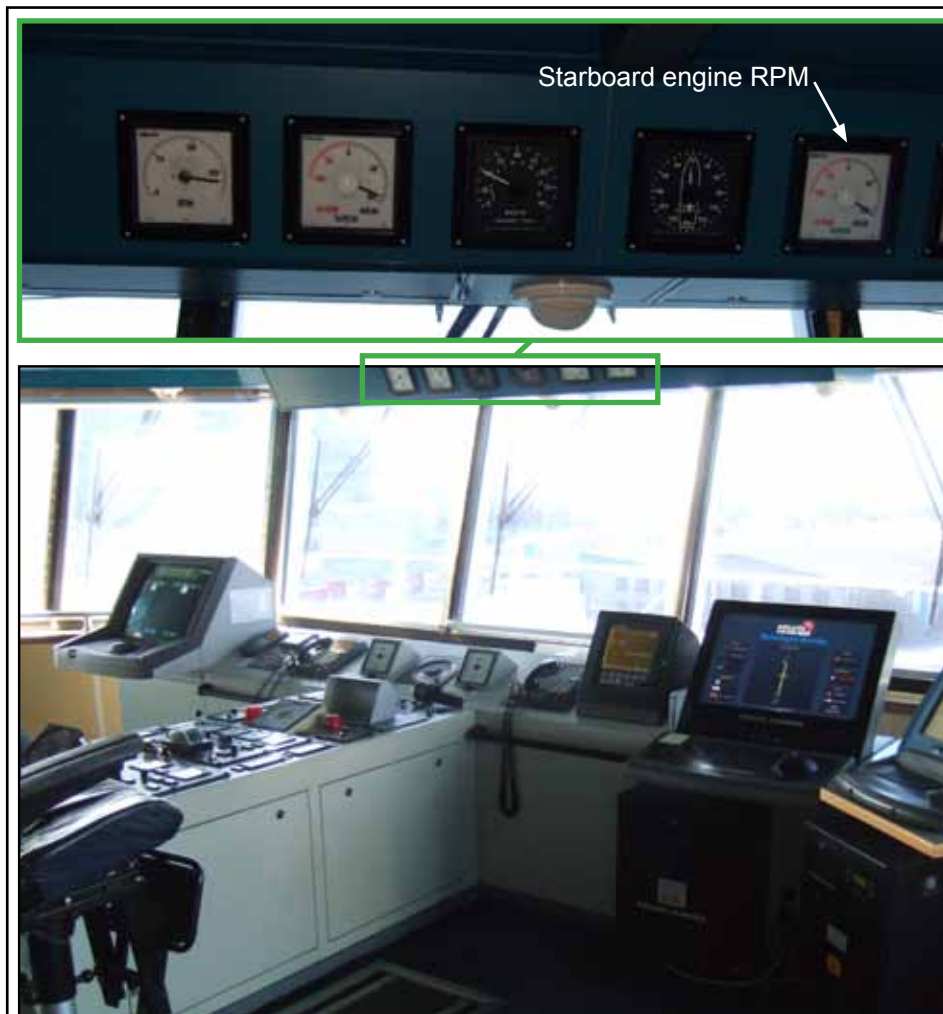
Figure 3

The chief officer approached the centre console from its side (**Figure 3**) and at 1357:22 moved the pitch control levers on both engines to the 100% ahead position. He also put both rudders hard to starboard. The rudder angle attained was 18.5 degrees on both rudders. He then asked the master if he could test

Central control station on bridge.
Insert - deck head repeaters above bridge windows

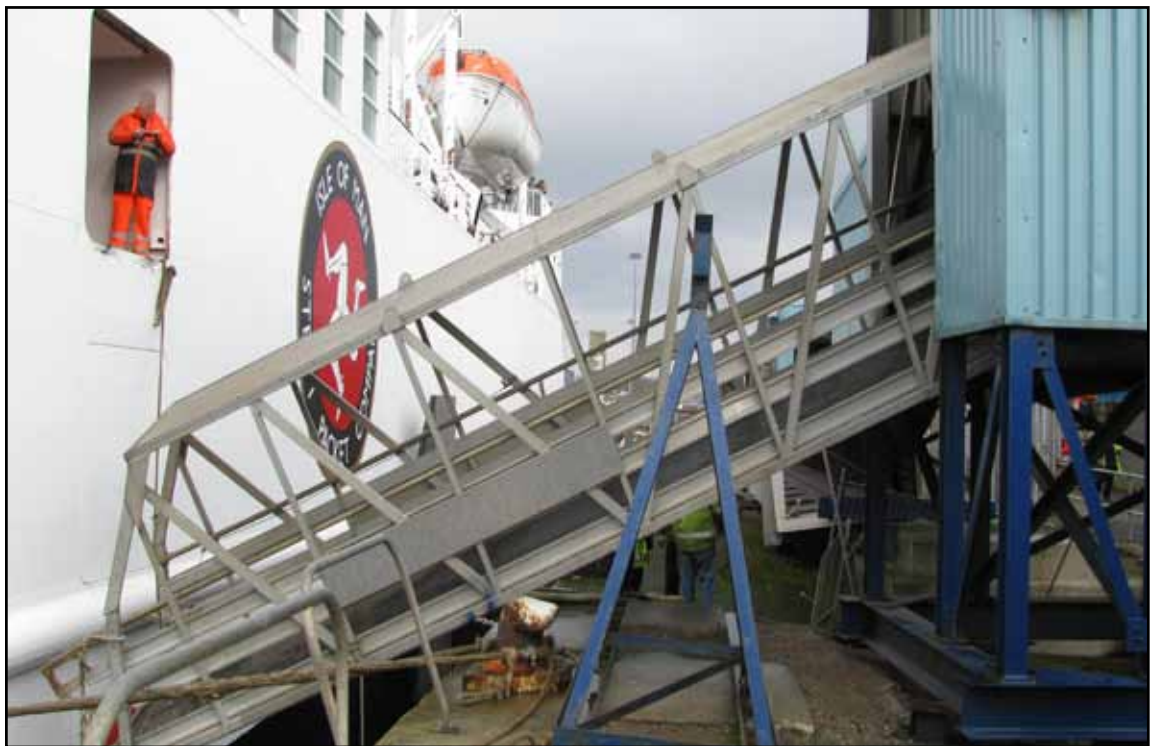
Figure 4

Two or three passengers, who were on the gangway and about to embark, ran inside the vessel. Some others, who were stepping on to the gangway from its shore compartment, were told by the gangway watchman to remain in the compartment of the shore structure, and they retreated quickly. The watchman then tried to disconnect the gangway from the vessel. He unlash the forward securing line and, while he was trying to unlash the aft line the gangway pulled clear of the vessel and hung, suspended by its aft line (**Figure 4**).

Gangway collapse

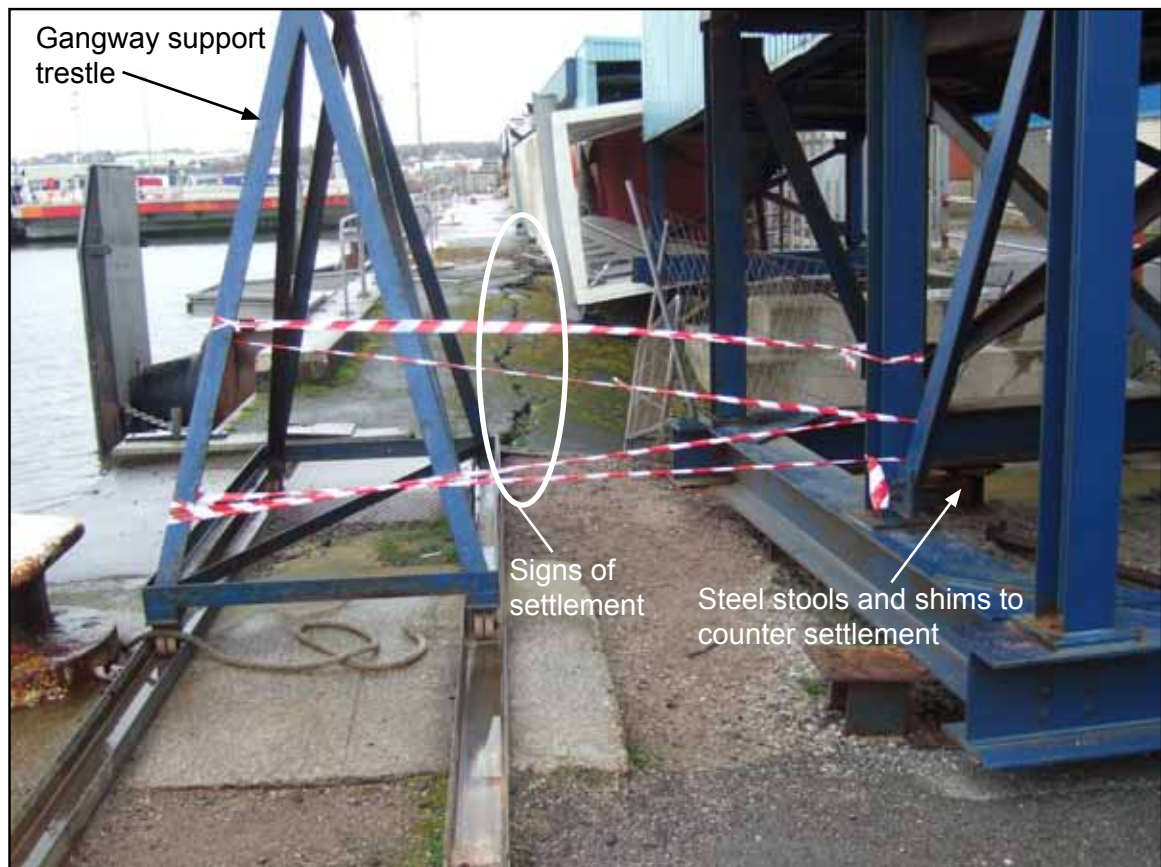
Figure 7

The gangway compartment was constructed over a disused underground tunnel originally used for cattle access. Although the original technical drawing showed that the supporting frames should have been secured to the foundation with 32mm diameter resin anchored bolts, the structure was free-standing and had not been bolted down. Settlement (**Figure 7**) of the ground in the area beneath the access structure and all along the quay had begun late in 1999 and had been a persistent problem.

Gangway compartment support and settlement

At the time of the accident, the ground had settled by approximately 800mm. The rate and extent of the settlement had been monitored since 2001 and, although efforts to strengthen the wall of the quay have been ongoing, there had been no investigation into the cause of the settlement. In 2000, additional concrete platforms were built and steel work added to the base of the gangway compartment to compensate for the settlement. Metal shims had also been added under the feet of the gangway compartment to maintain its height as the ground continued to settle. There was no routine maintenance or inspection of the passenger access structure, disused subway or cattle access tunnel.

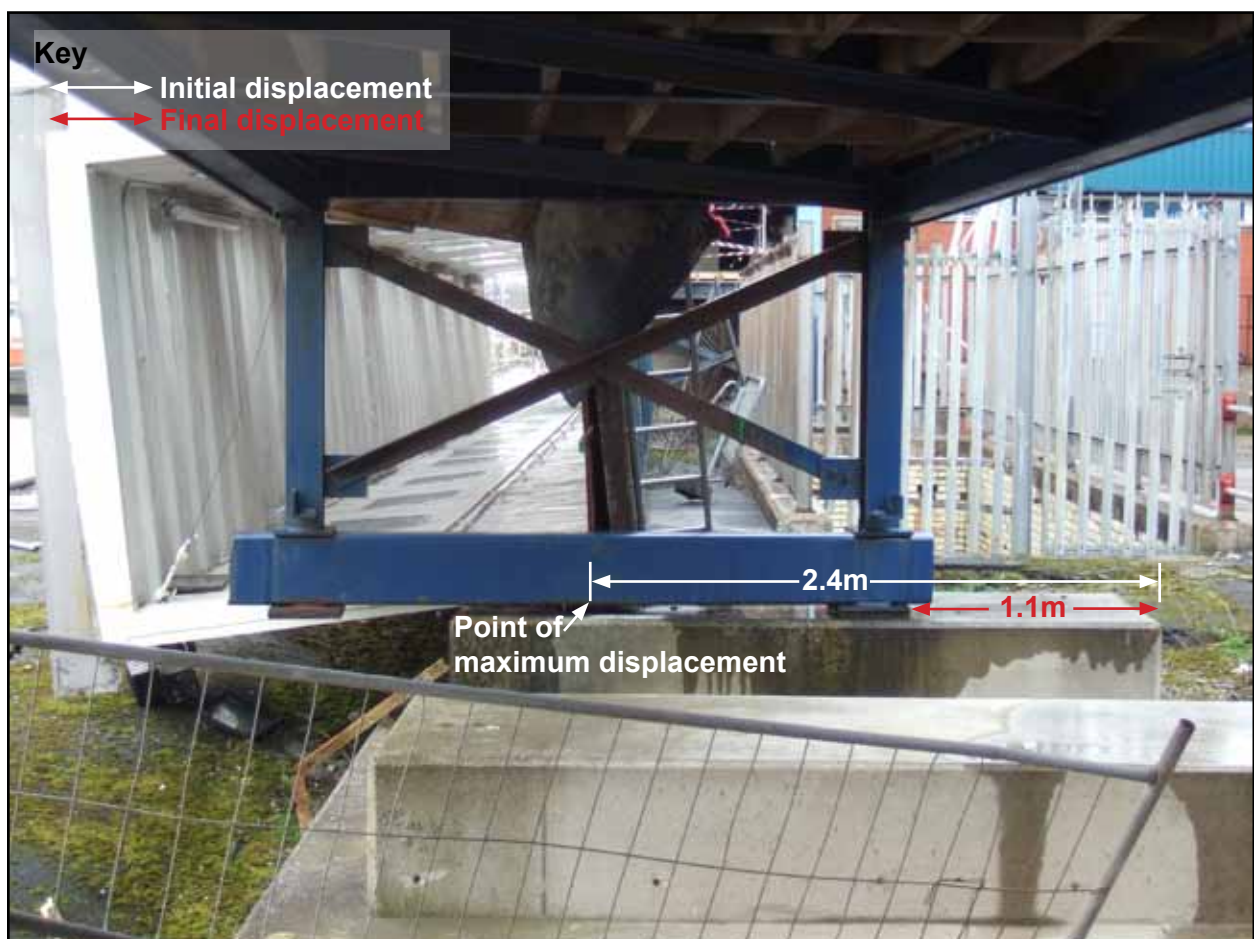
Figure 8

When *Ben-My-Chree* moved forward, the gangway compartment moved 2.4m to its side (towards the water), and it finally returned to a point 1.1m away from its original position (**Figure 8**) after the vessel had come astern. As the gangway pulled clear of the vessel, lugs at its outboard end damaged the vessel's shell door frame (**Figure 9**).

Movement of gangway compartment showing support frame in its final position after the accident

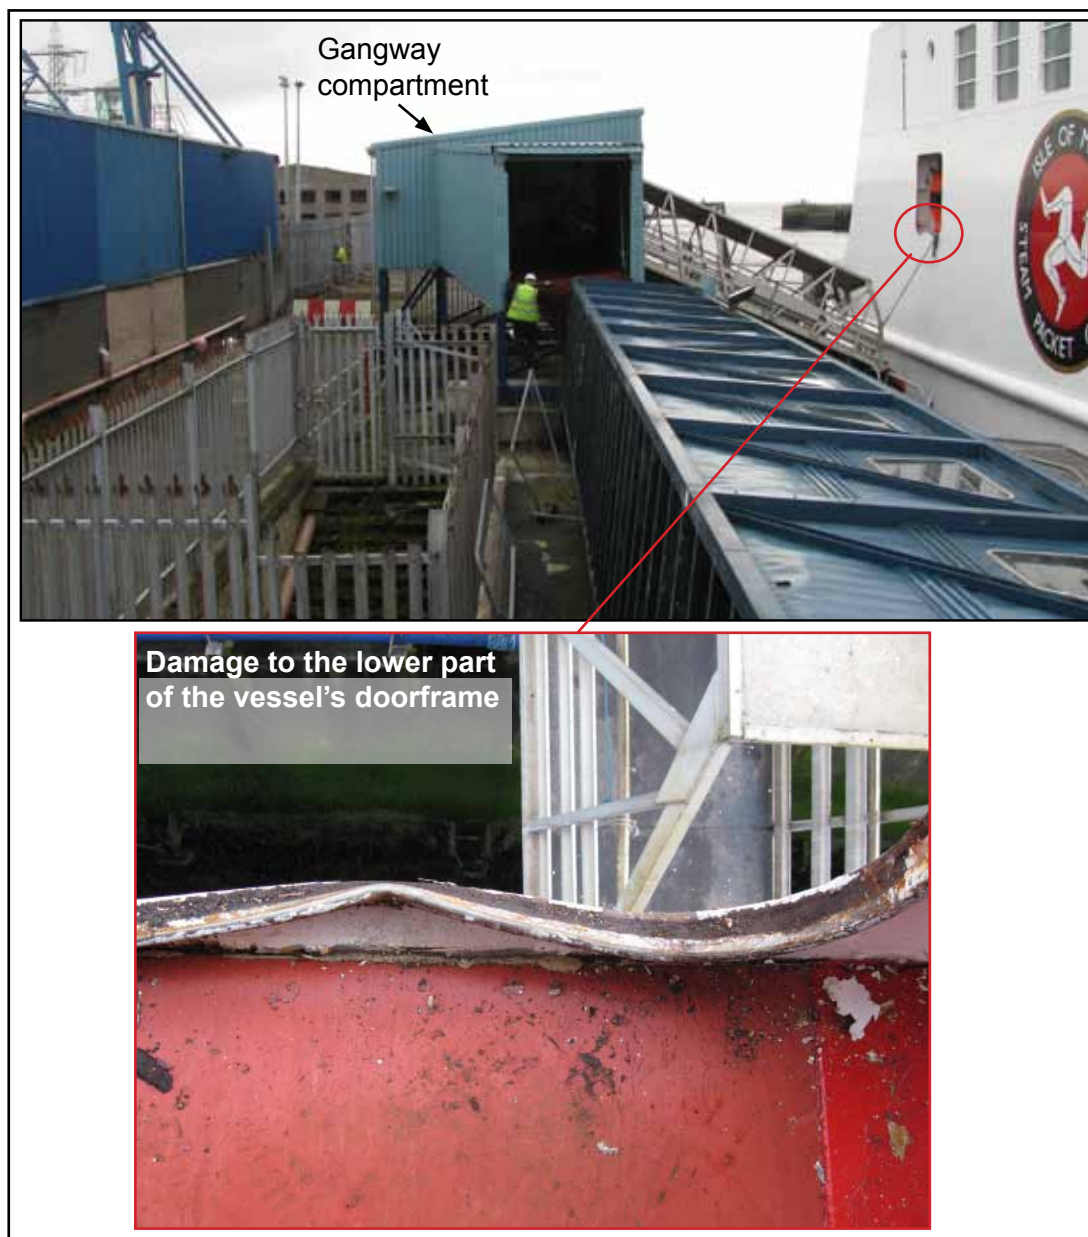
Figure 9

The scene immediately after the accident

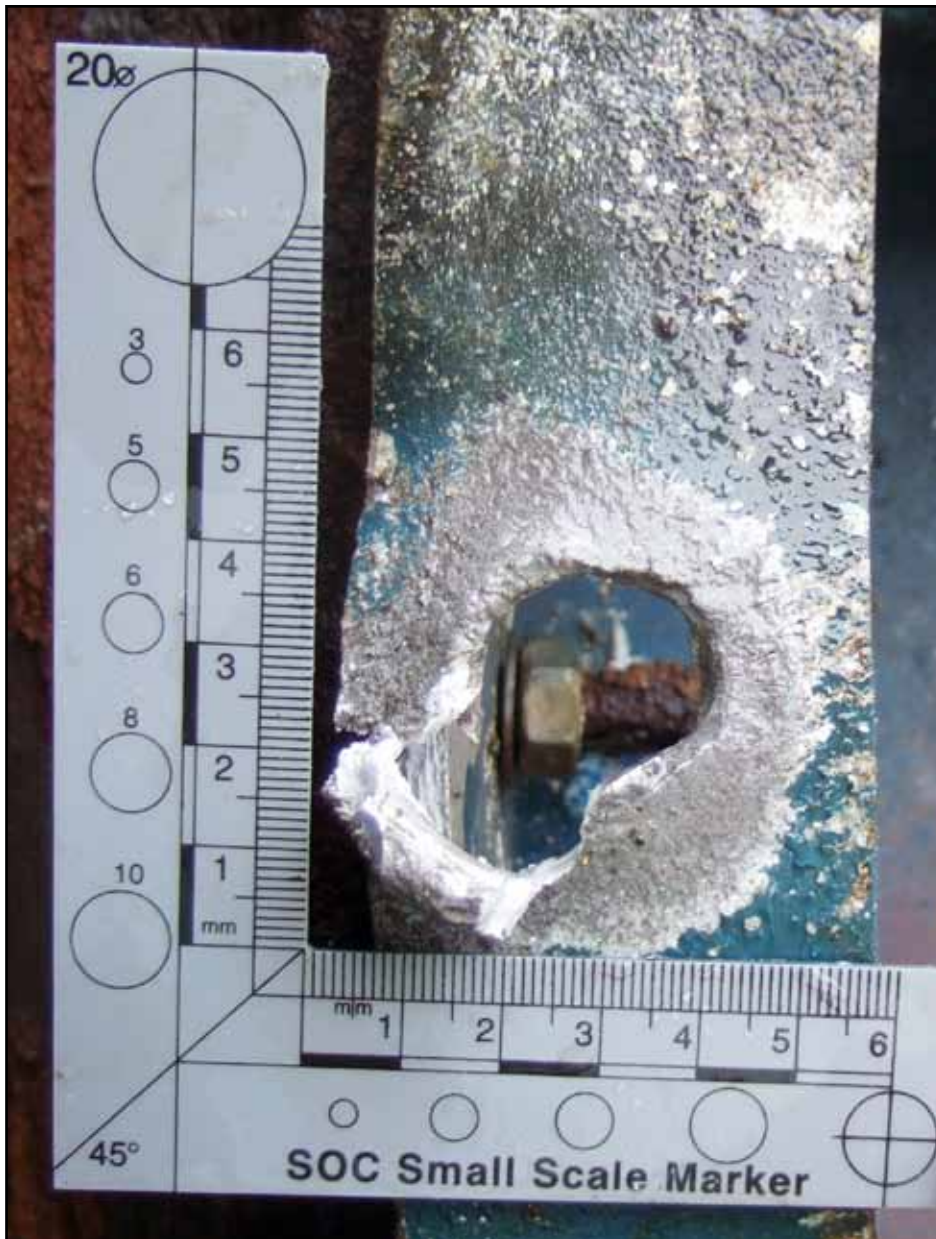
The steel fixing bolts at both ends of the suspended aluminium walkway were ripped out as it detached from the steel structures of the passenger terminal and the gangway compartment. All the electric lighting cables were sheared and the walkway fell to the quay. The ends of both the steel and aluminium in the structure showed evidence of heavy salt water corrosion (**Figure 10**).

Walkway securing boltholes showing signs of corrosion

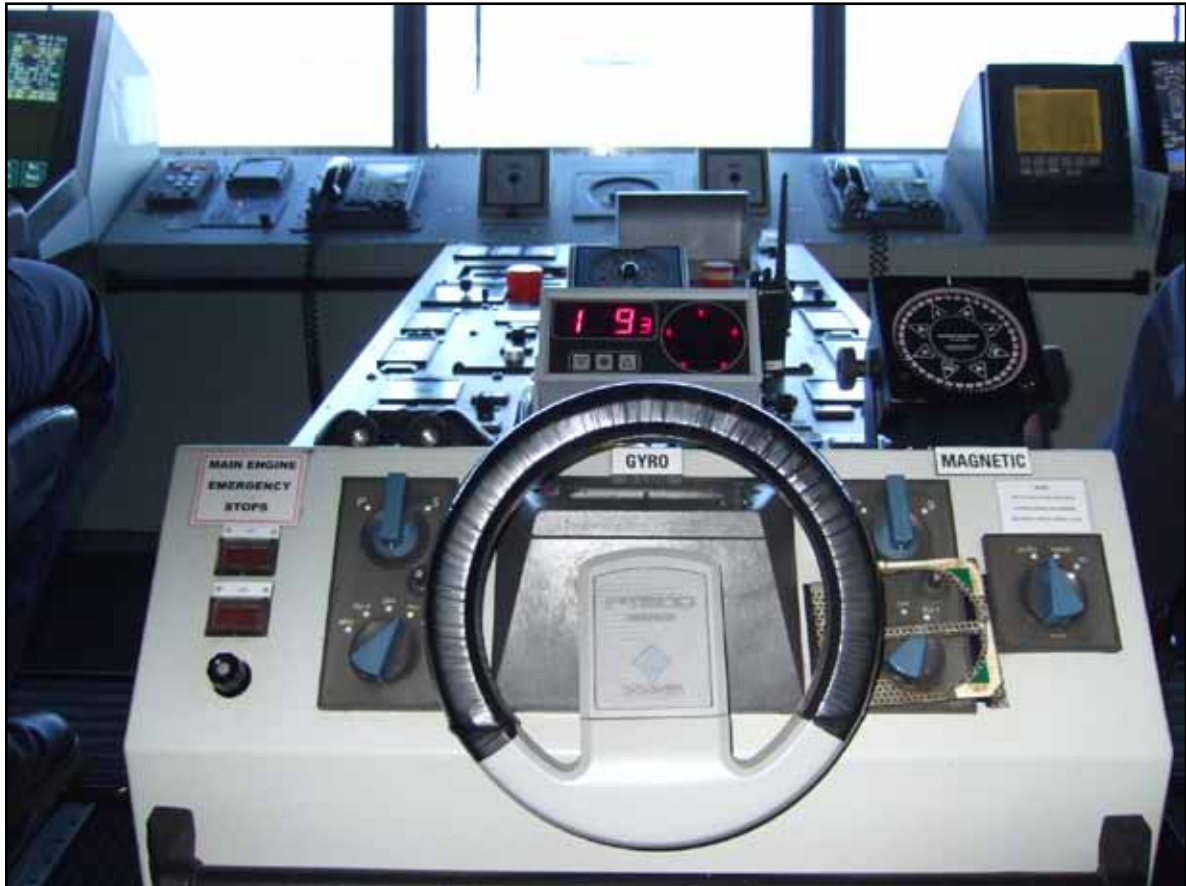
Figure 11

A talk-back system to the ECR was available at the main control panel and an internal telephone was located at the chart table. As the helm control panel was located at the end of the main control panel, the engine and bow thruster controls could only be reached from the side of the panel.

Centre control panel (bridge), looking forward

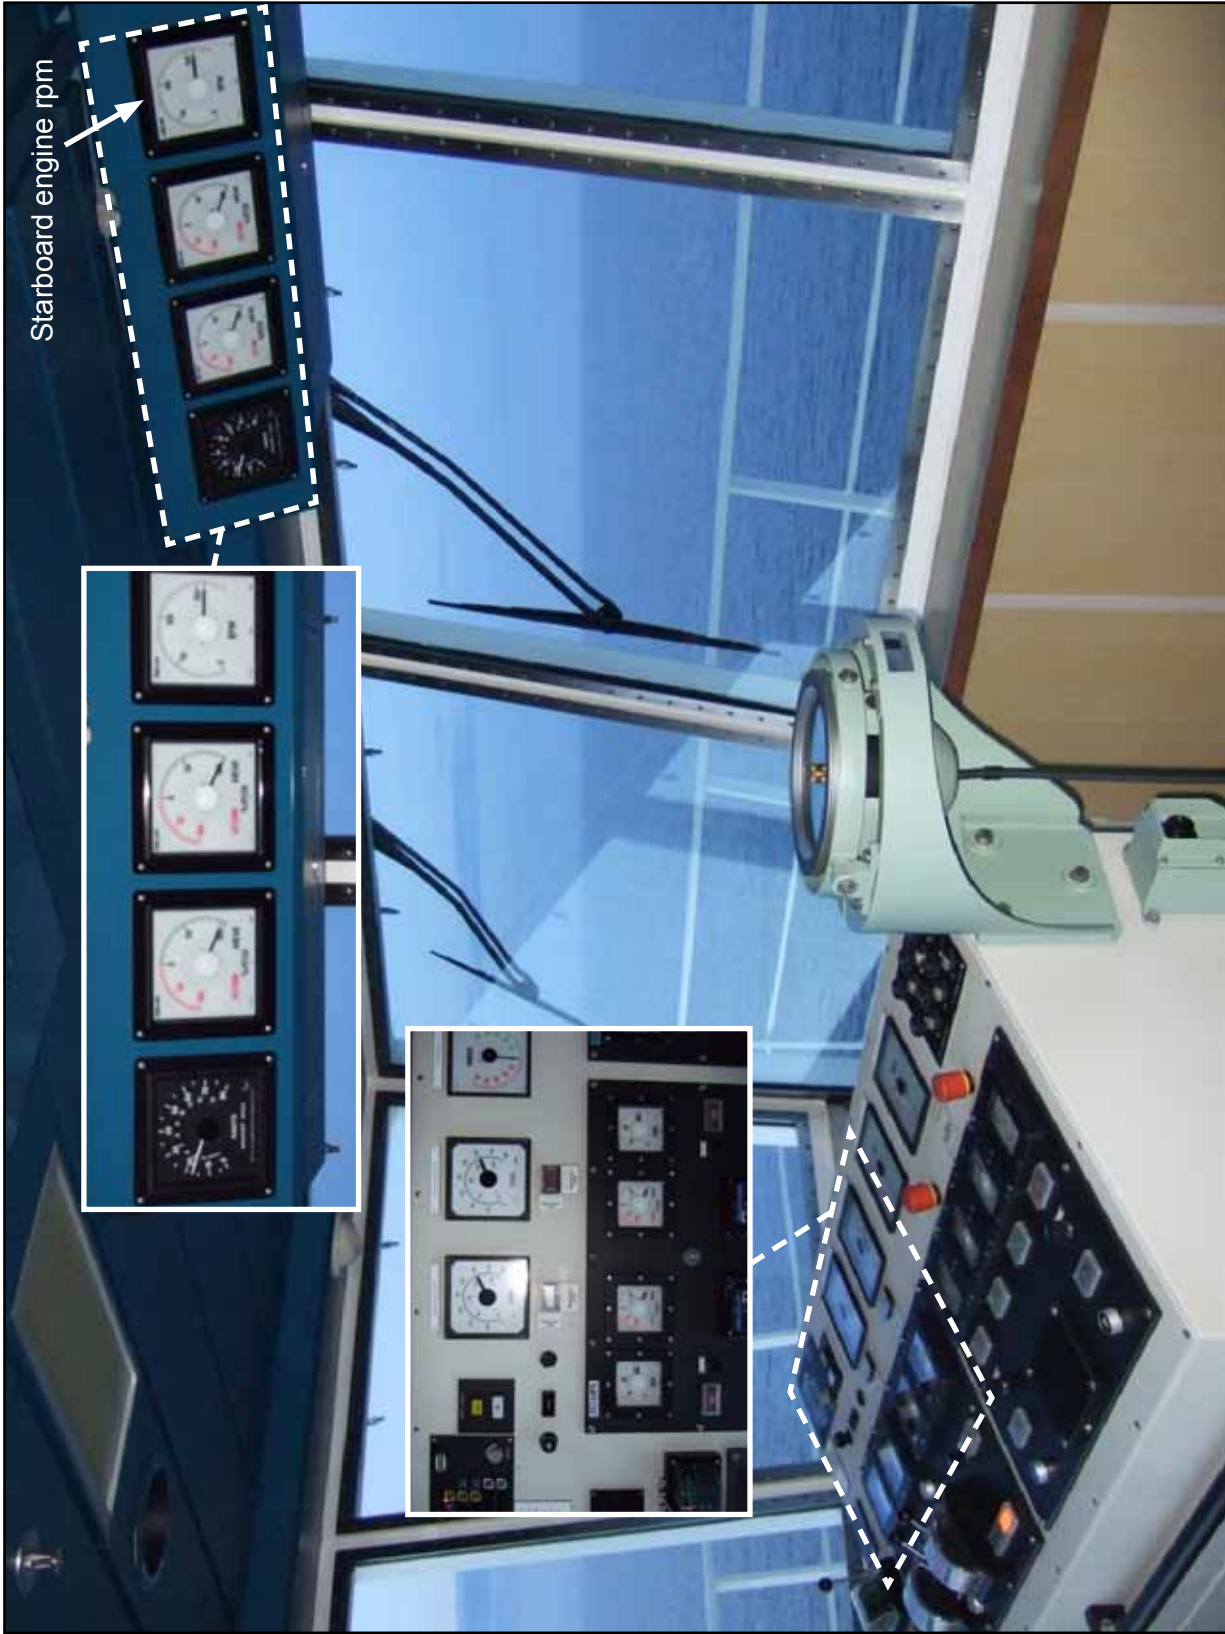
Figure 13

Port wing station (inserts show rpm and pitch gauges)
Note: Black faced gauge is an anemometer that has replaced the port engine rpm gauge

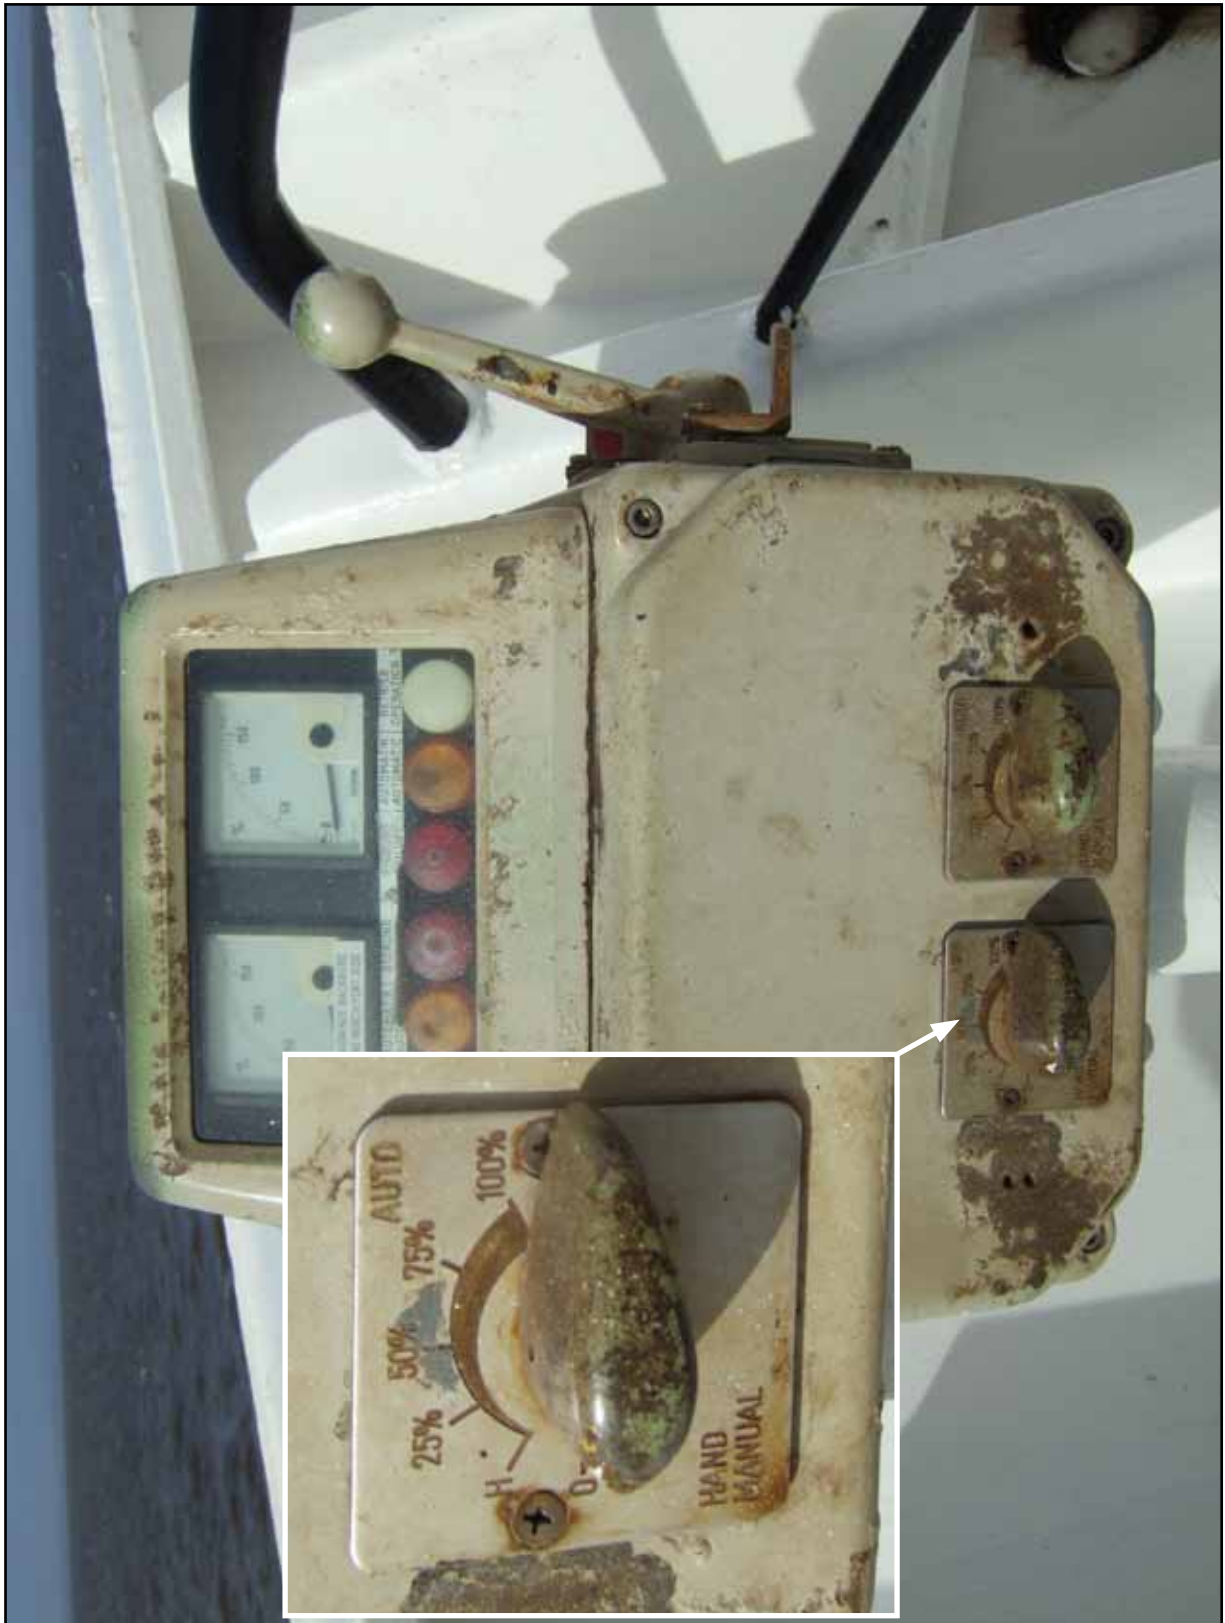
Figure 16

Autotension winch setting
