Report on the investigation into the
unintended movement of the ro-ro passenger vessel

Ben-My-Chree

during loading operations at Heysham

Report No 17/2010
December 2010

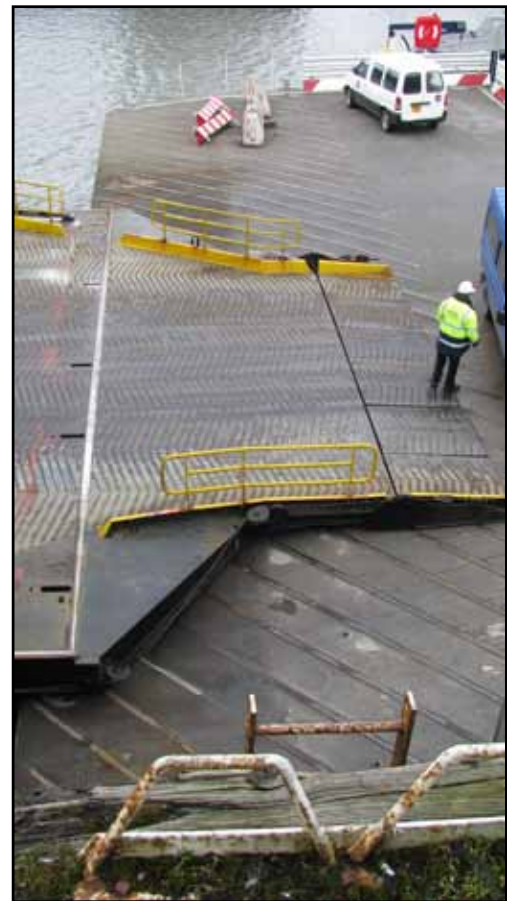
At the stern of the vessel, a charge hand (harbour employee) was supervising vehicle loading at the linkspan while the ship's second officer was talking to the trainee second officer. They all noticed the ship's movement when they heard the stern ramp scrape along the linkspan (**Figure 6**). The second officer ran into the ship and raised the stern ramp, closing it completely, thereby preventing vehicles from embarking.

Stern ramp on linkspan

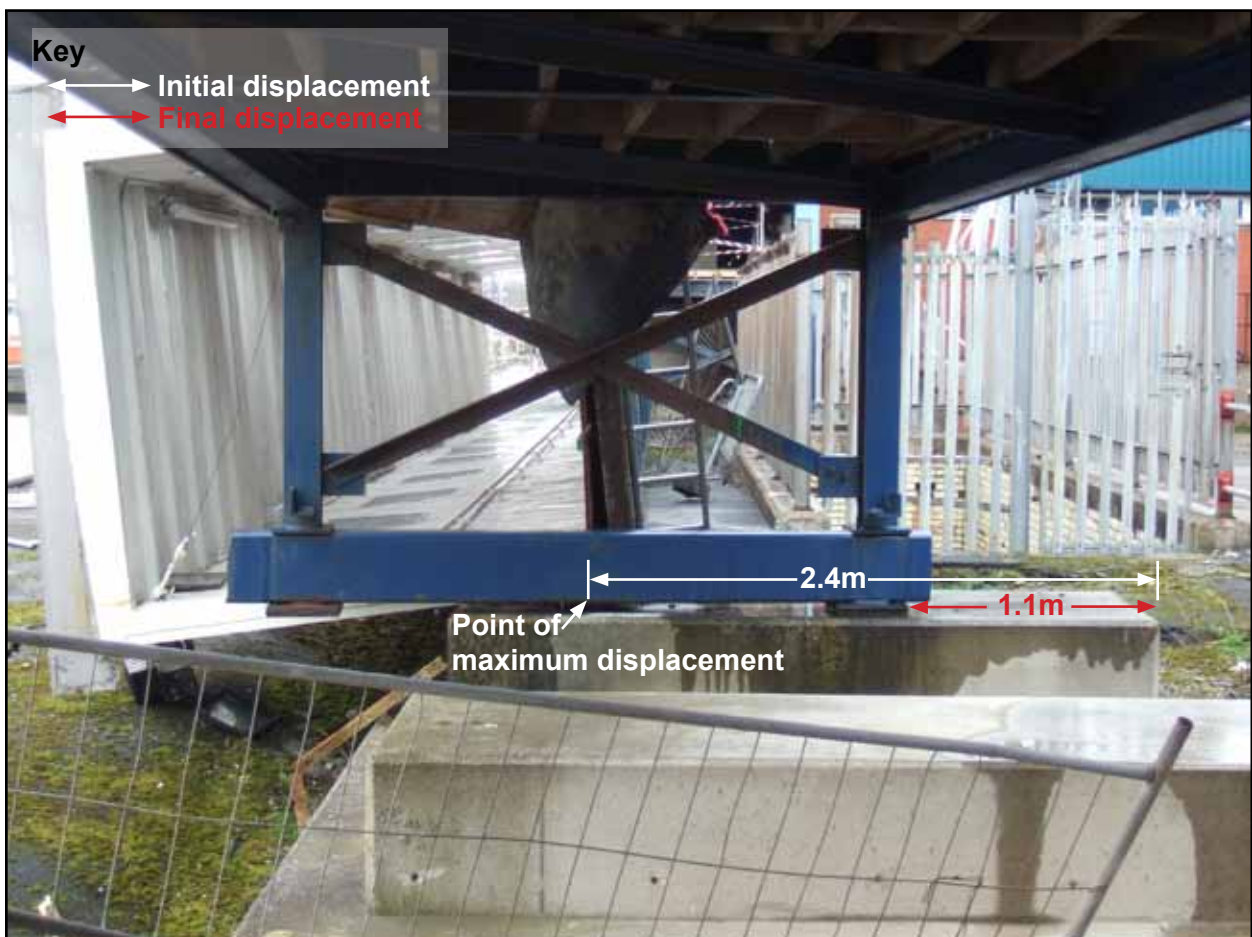
Figure 8

When *Ben-My-Chree* moved forward, the gangway compartment moved 2.4m to its side (towards the water), and it finally returned to a point 1.1m away from its original position (**Figure 8**) after the vessel had come astern. As the gangway pulled clear of the vessel, lugs at its outboard end damaged the vessel's shell door frame (**Figure 9**).

Movement of gangway compartment showing support frame in its final position after the accident

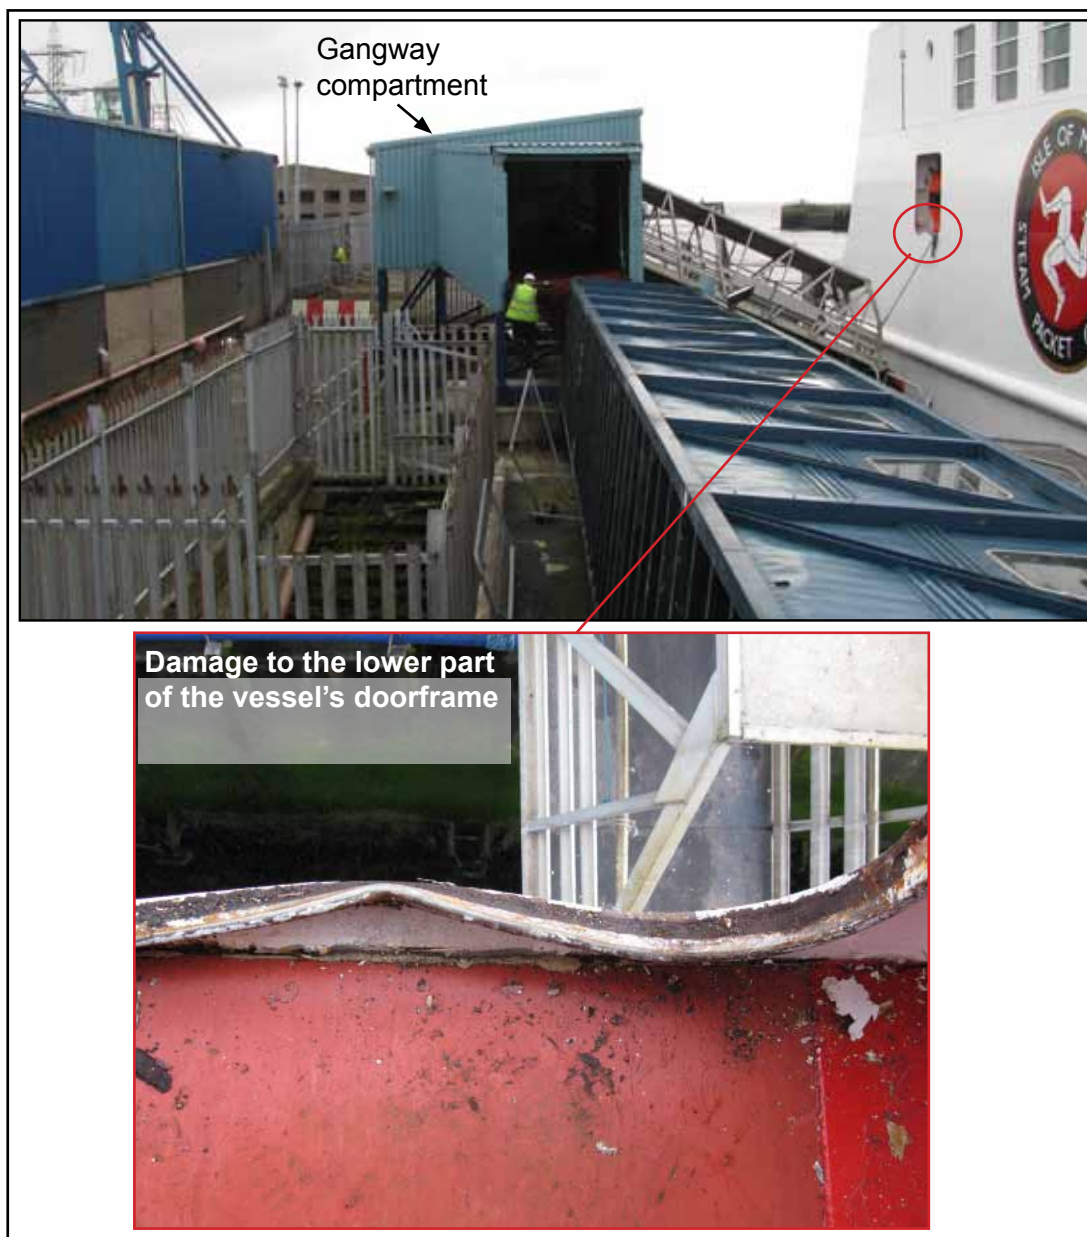
Figure 9

The scene immediately after the accident

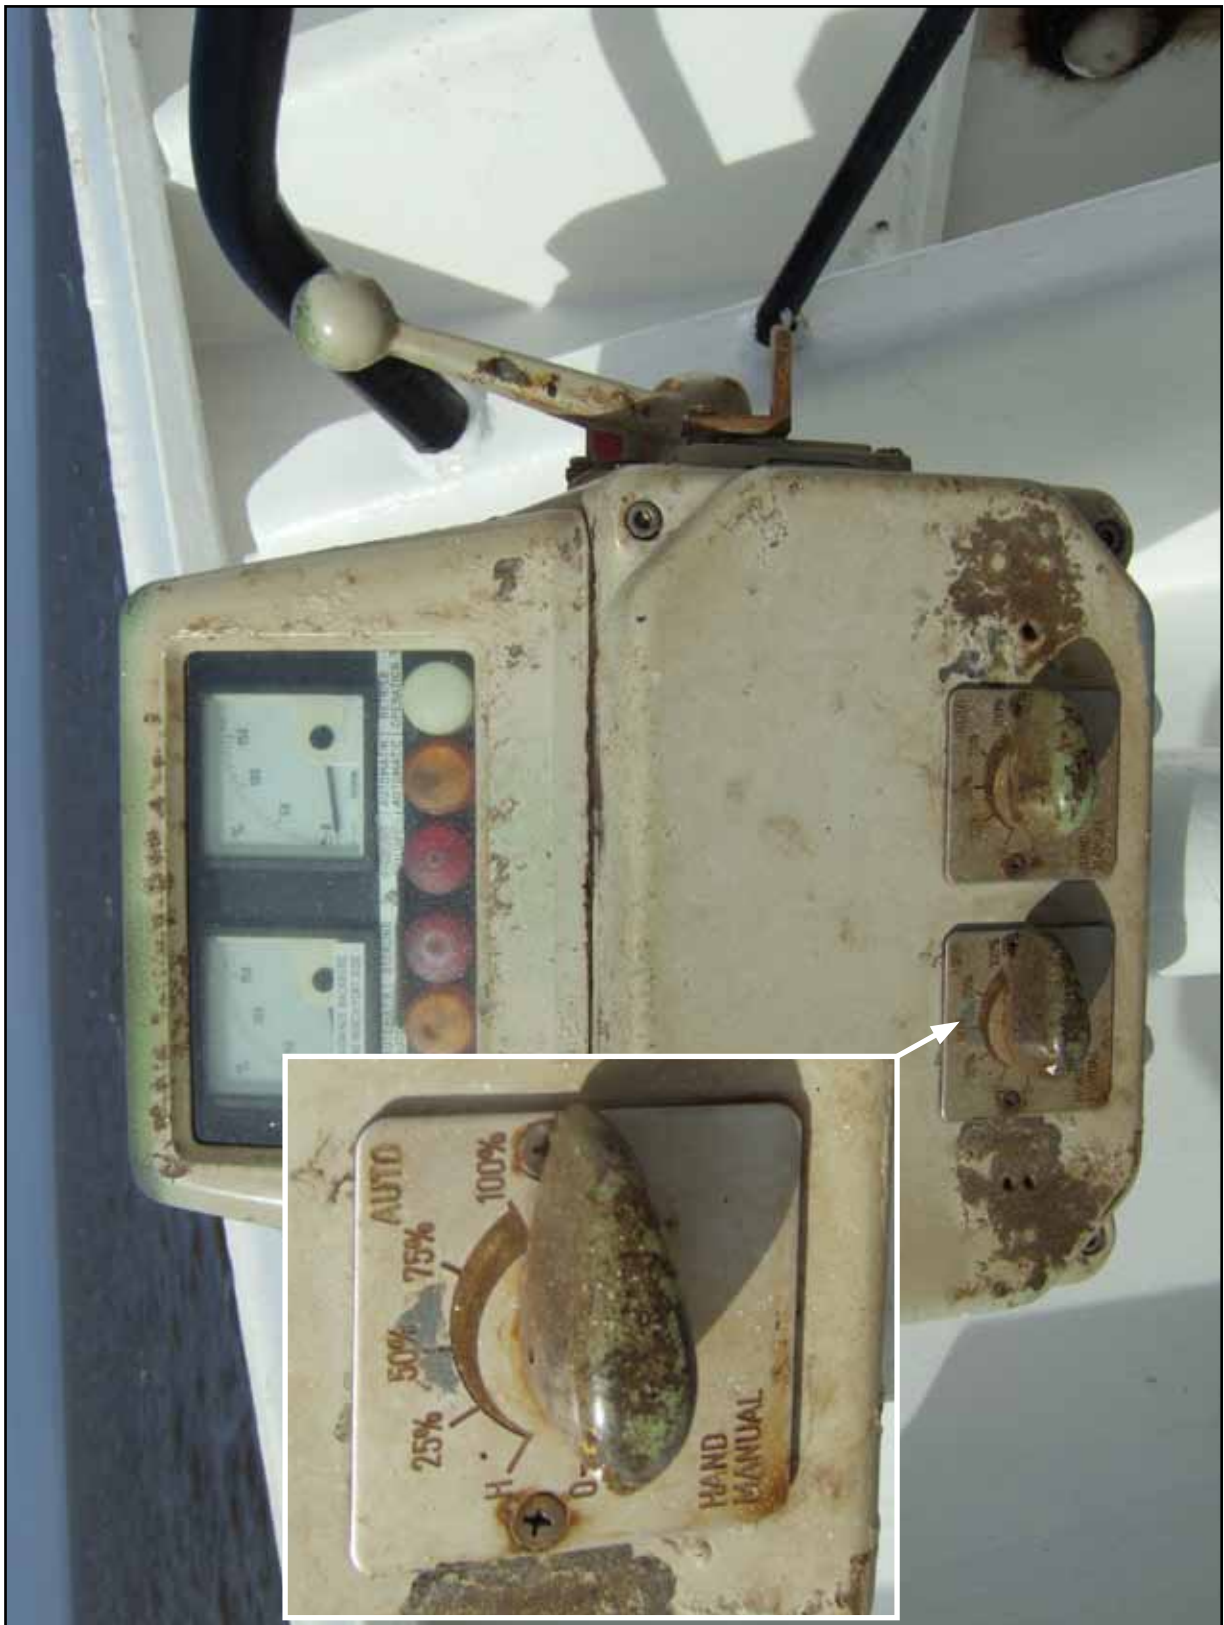
Figure 16

The Oil Companies International Marine Forum's (OCIMF) Mooring Equipment Guidelines state that spring lines should not be used in autotension mode "...as it has been known for the winches to cause the ship to 'walk' along the pier".

Autotension winch setting

In ports such as Heysham, which have a large tidal range, but limited tidal stream, autotension winches can enhance the safety of the vessel by always maintaining the correct tension on the lines while the tide rises or falls. Conversely, the use of winches in autotension mode is prohibited in most oil, chemical and gas terminals due to their propensity to cause the vessel to 'walk' along the jetty.
