Report on the investigation into the
unintended movement of the ro-ro passenger vessel

Ben-My-Chree

during loading operations at Heysham

Report No 17/2010
December 2010

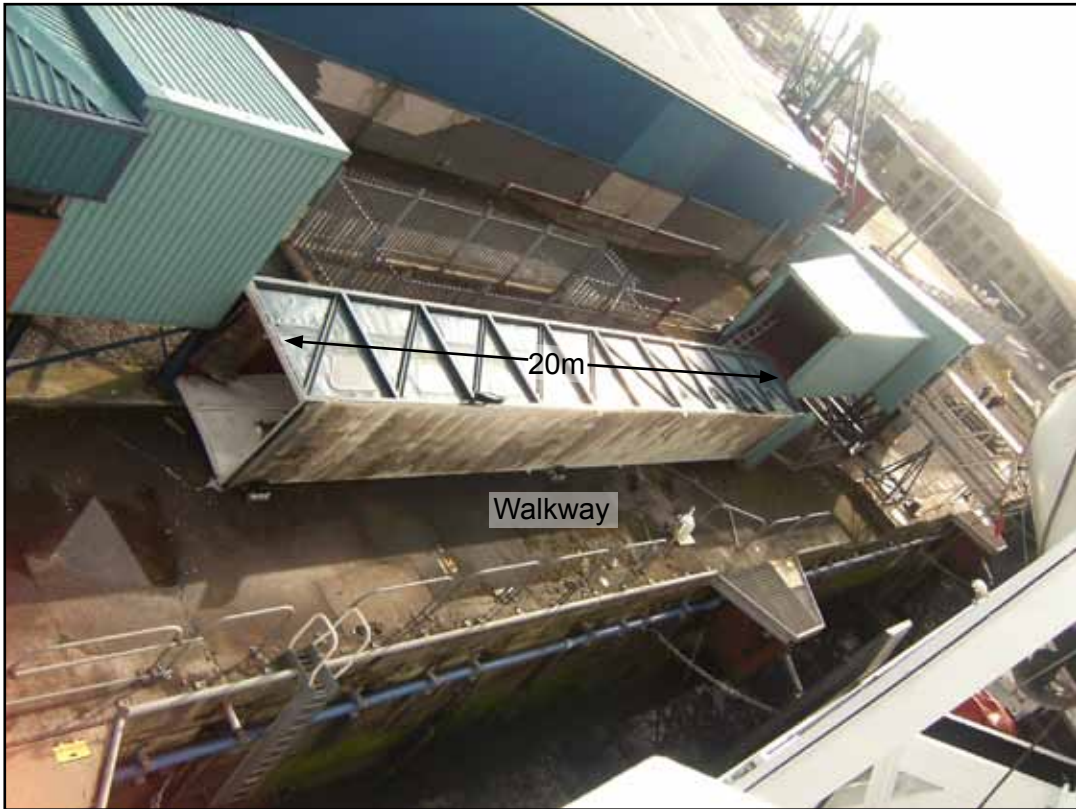
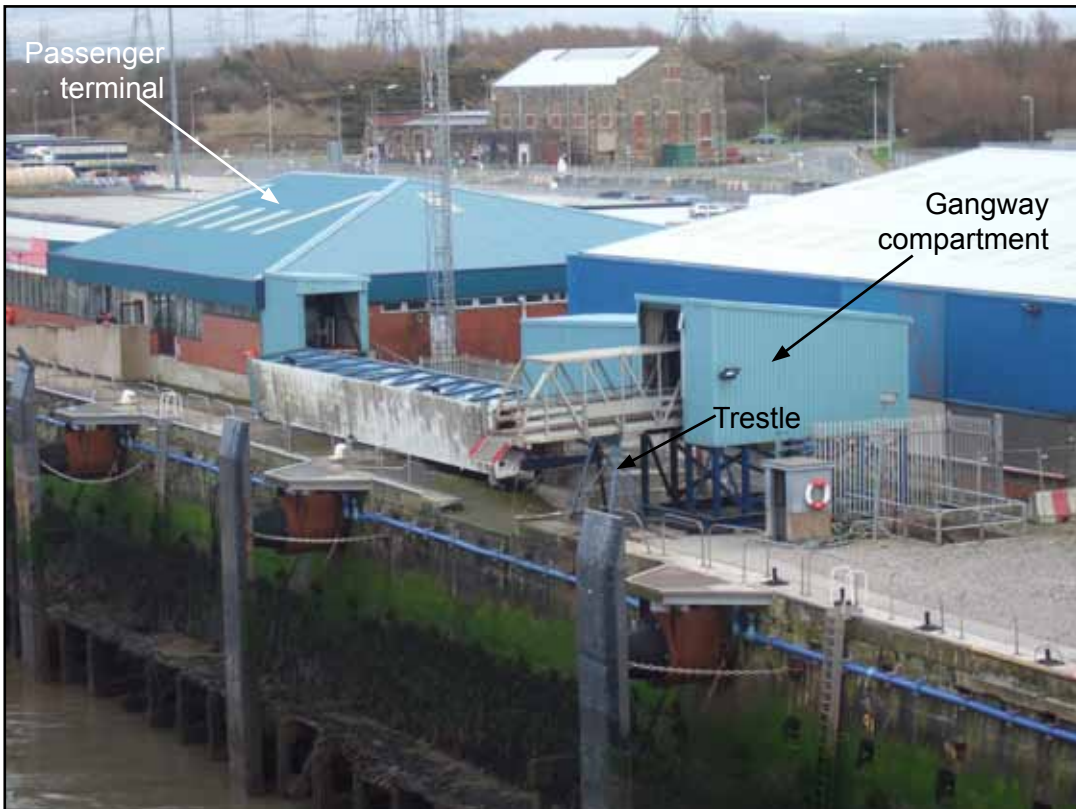
Meanwhile, the walkway connecting the passenger terminal to the gangway compartment detached at both ends and fell about 2m, first landing on a metal fence, then falling to the quay having turned 90 degrees to lie on its side (**Figures 5a & 5b**). In the passenger terminal, a party of 26 school children who had been about to enter the walkway had been held back by their group leader to allow one of their members to catch up. At the other end of the walkway, a mother and child

Passenger access structure

Passenger terminal and access structure
