Tension Technology International Ltd - Test Report

Chain inspection and testing for MAIB

TTI-IMLR-2010-663R

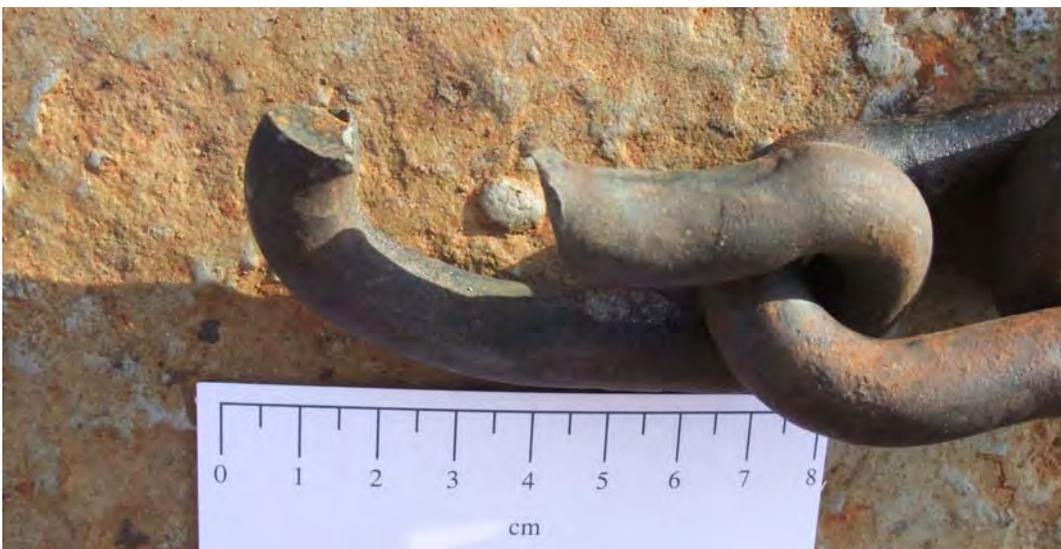
TTI Testing (the testing subsidiary of Tension Technology International) was contracted by the MAIB to undertake a review of a chain sling failure (see Figures 1 and 2 below). These Figures show the sling shortly after the failure: Figure 1 shows the chain with its two master links connected by a bow shackle, whilst Figure 2 provides a close up of the failed link.

Figure 2: Failed chain link.

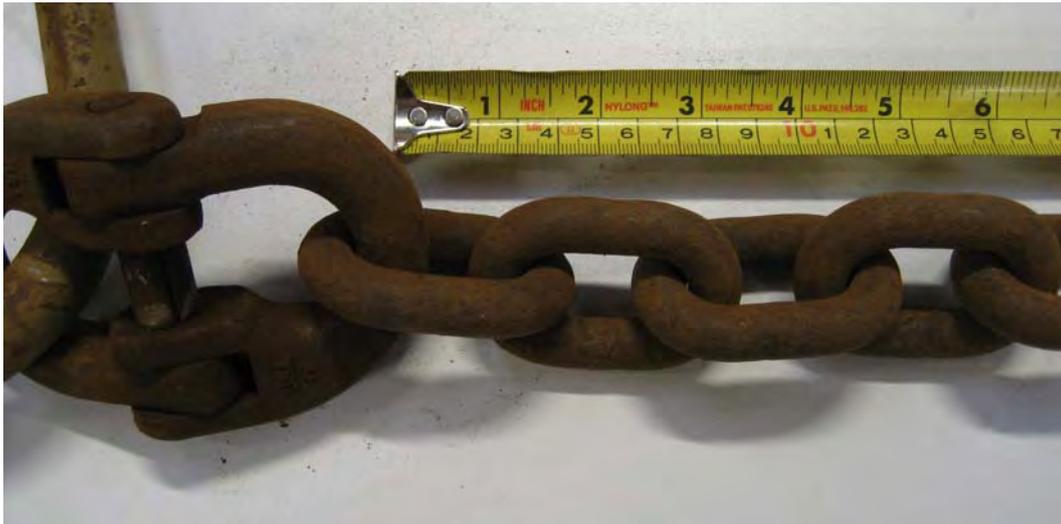
The failed sling was sent to TTI Testing's premises in Arbroath for inspection. Figure 3 below shows a section of the chain (labelled exhibit ref. No. 011101133), which was typical of the condition. A preliminary measurement showed it to be 13 mm chain. It can be seen that the chain had a superficial uniform coating of rust, which is entirely consistent with use in a marine environment. It is not thought that this level of rust would be sufficient to affect the chain's performance. Otherwise the chain appeared in good order. In all, thirty two links were counted in this section of chain.

Figure 3: Typical condition of the chain sling away from the failure point.

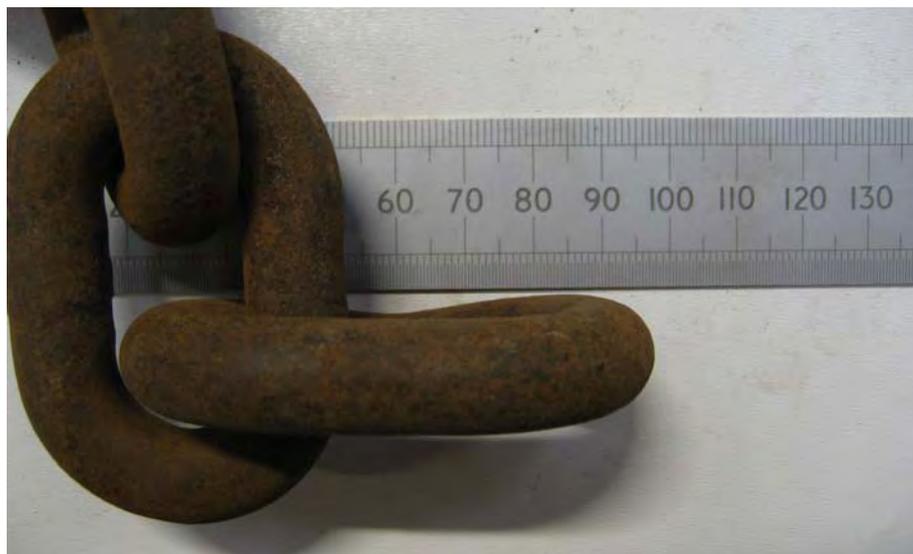
Figure 4 shows the condition of the chain adjacent to the link which failed. It can be seen that at some stage in service, this link has been subject to forces out of the plane of the link sufficient to bend the link.

Figure 4: Link which would have been adjacent to failed link prior to sling failure.

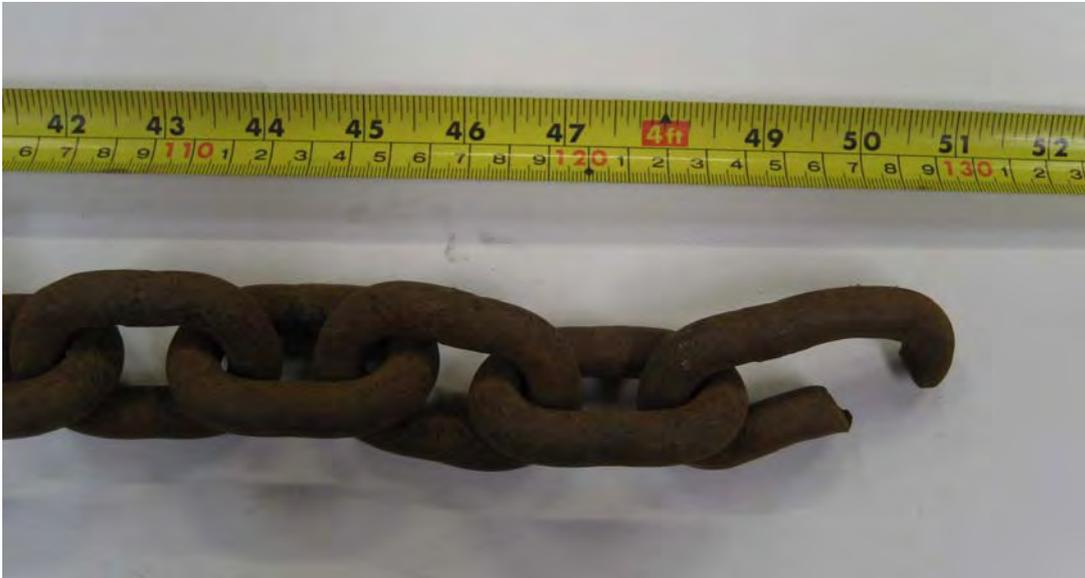
Figure 5 shows a photograph of the second section of chain sling with the failed link still attached. This length of chain was counted as a further 32 links plus the failed link, 33 in total. Figure 6 shows a close up on the link next to the failed link, it too can clearly be seen to be bent out of the plane of the link.

Figure 5: Section of chain sling with failed link attached.

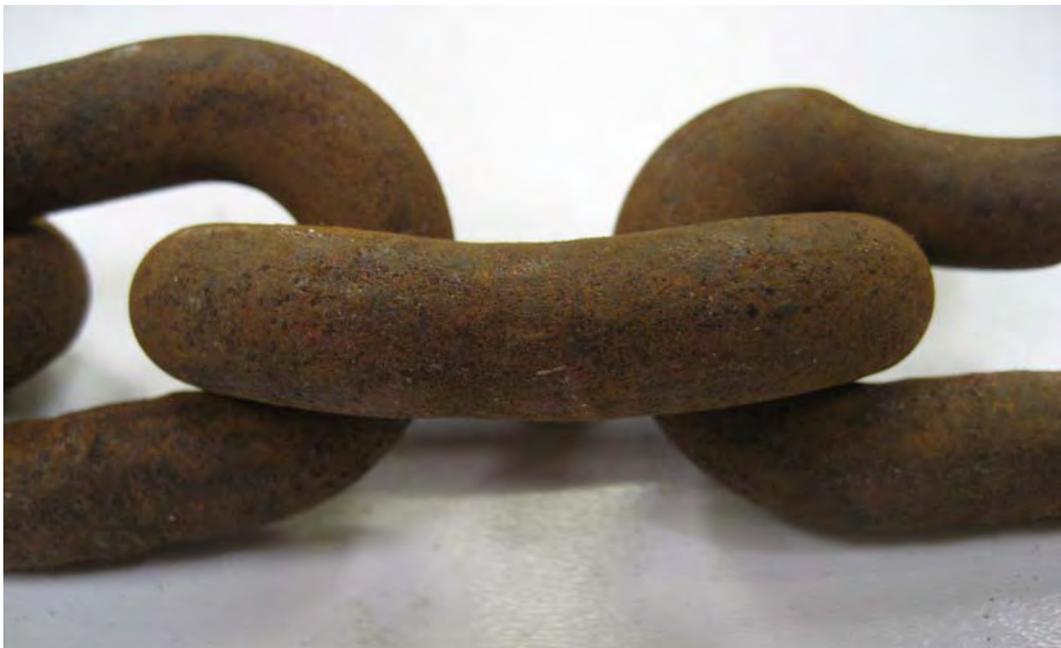
Figure 6: The link adjacent to the failed link can clearly be seen to be bent.

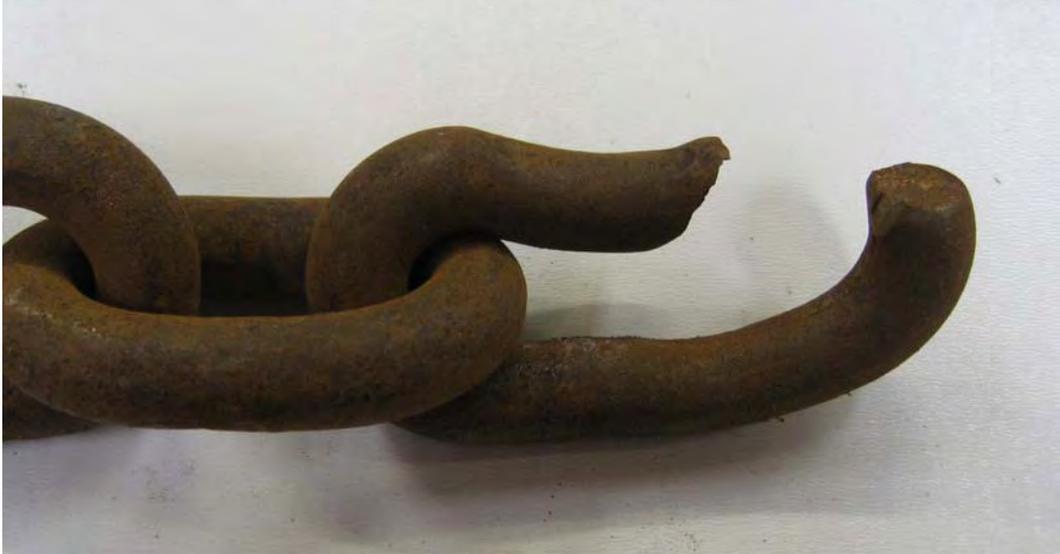
Finally, Figure 7 below shows the condition of the failed link. It can be seen that the link has been subject to significant plastic deformation in the plane of the link. The indentation on the side (at the top of the image) is consistent with the link having been in operation over an edge or around a pin – i.e. in contact with a third body leading to a transverse load on the

link. Unfortunately the fracture surface was too corroded to provide any indication of whether fatigue had taken place (the fracture surface is more corroded than in the photograph shown in Figure 2). However, the gross plastic deformation of the failed link and those either side of it are indicative of gross overload rather than fatigue.

Figure 7: The failed link.

4. The fracture surfaces of the failed link have become too corroded for detailed examination. However, the general appearance of the failure (gross plastic distortion) indicates a failure caused by high loading rather than fatigue.

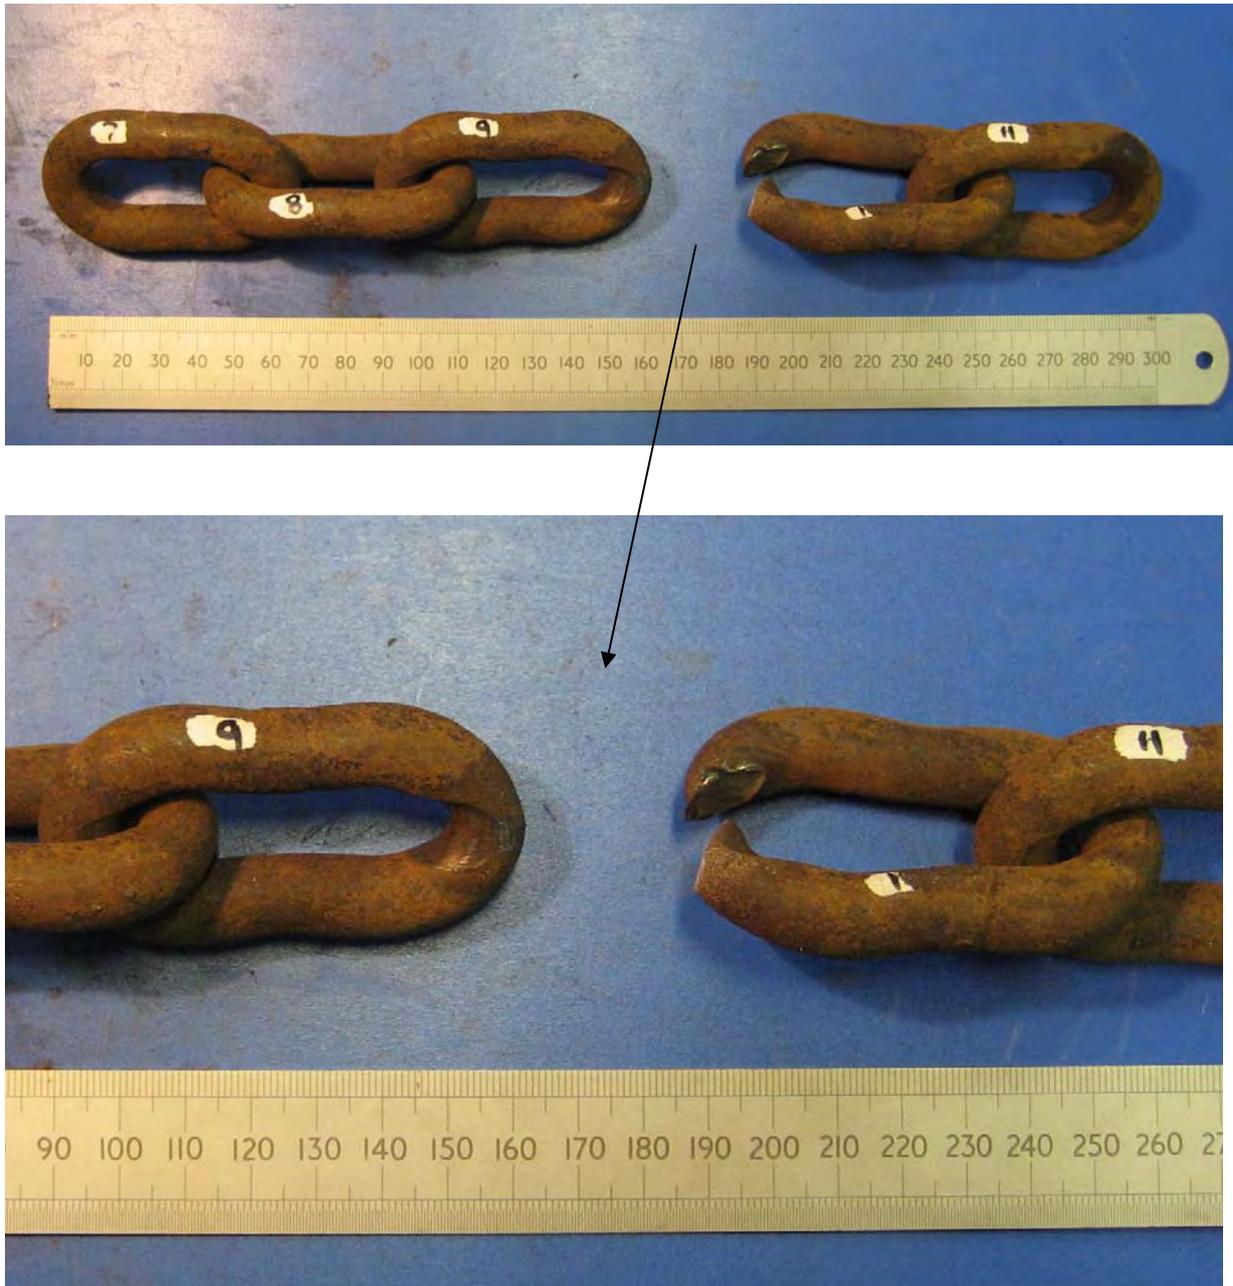
Figure 11 shows the appearance of the chain after failure (second breaking load test). The appearance is quite characteristic, with *all* links elongated and the parallel sides of the links pulled inwards. The failed link has yielded obliquely (suggesting a shear failure) at the area of interlink contact, whilst the un-failed link (number 9) has a heavy indent at the end from the failed link.

Figure 11: Typical appearance of a chain failure caused by pure tensile overload.

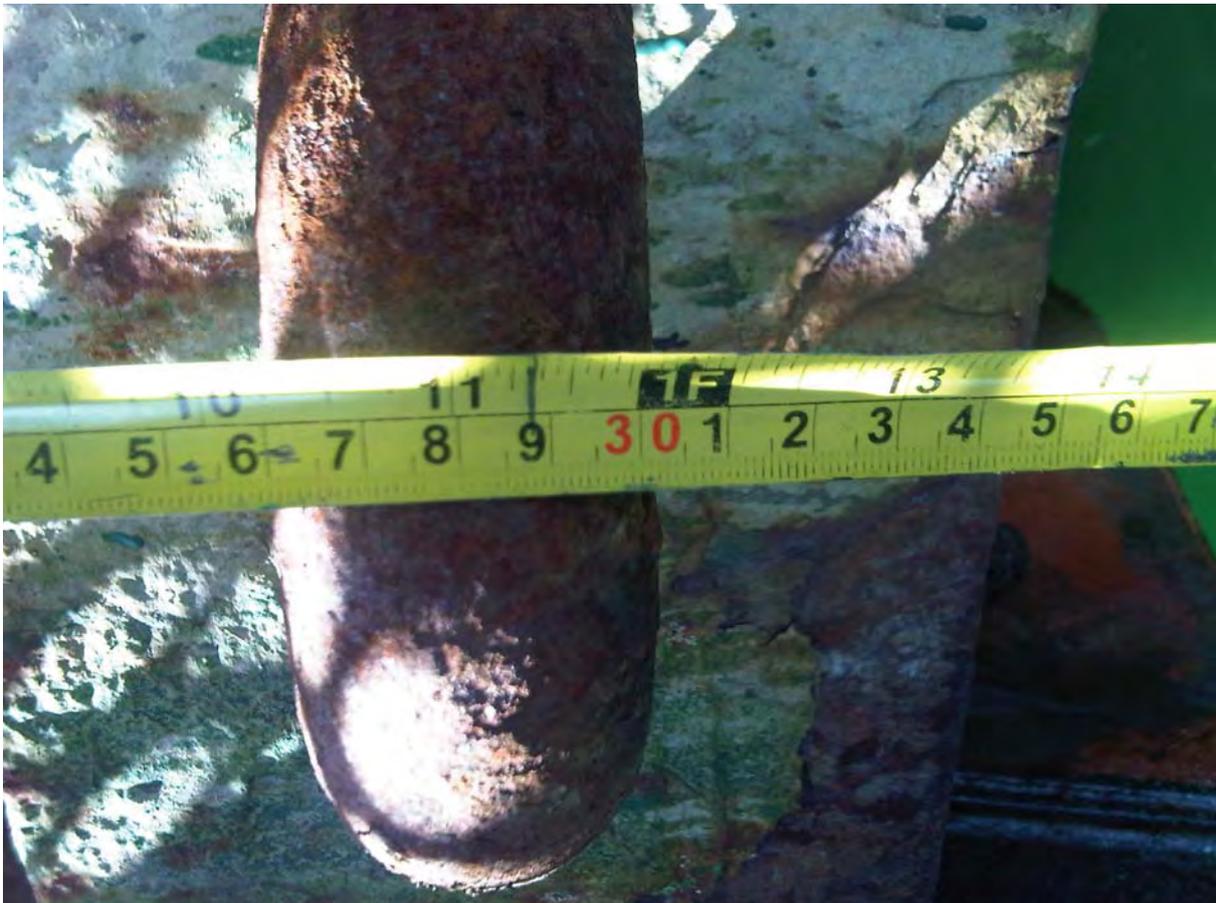
Figure 13 shows a picture of the pad eye received from the MAIB. From this photograph it was estimated that the pad eye bar diameter was 41 mm. Therefore, in the test a pin diameter of $(7/13) \times 41 = 22$ mm was used.

Figure 13: Pad-eye across which 13 mm chain was operating when it failed.

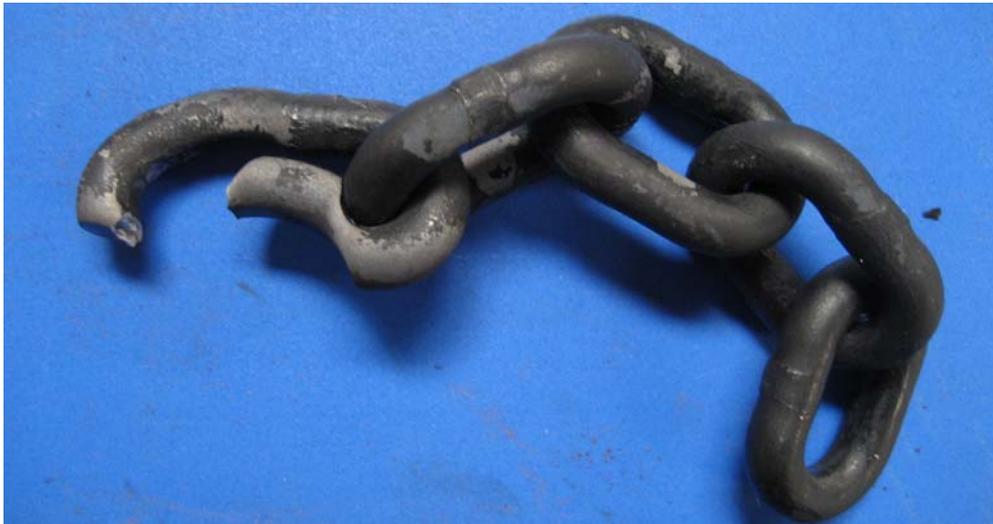
Figures 15 and 16 show the failed sample. The failed link is the 5th, the middle link of the sample which was on the pin during the test. The appearance of the failed link is very similar to that of the 13 mm sling failure (Figure 7). As with the 13 mm chain one side of the chain is bent to conform to the profile of the pin. In Figure 16 it can be seen that the link adjacent to the failed link has been bent out of plane and in the same direction as was found in the 13 mm sling (see Figure 6). These similarities suggest that the test is an accurate model of what happened in service.

Figure 15: Sample MAIB06 after failure, the 5th (middle) of 9 links has failed.

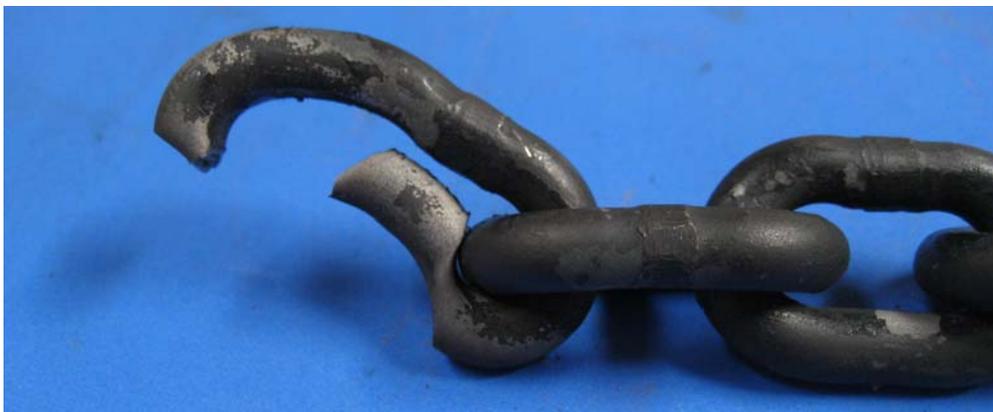
Figure 16: Close up view of the failure region. Note that the link adjacent to the failed link is bent in the same manner as that found on the 13 mm chain sling.

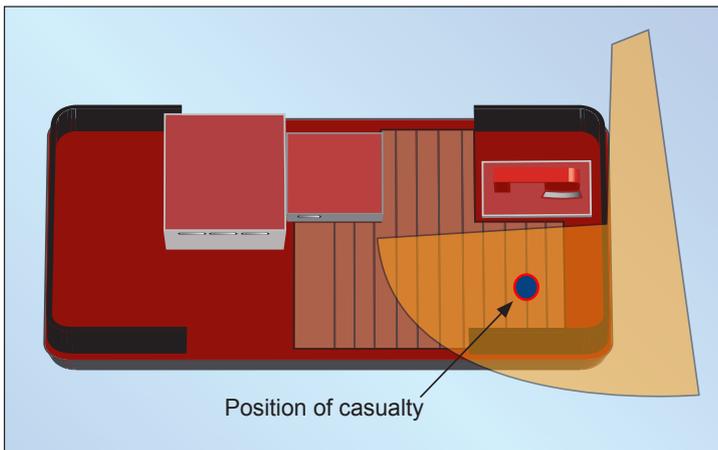
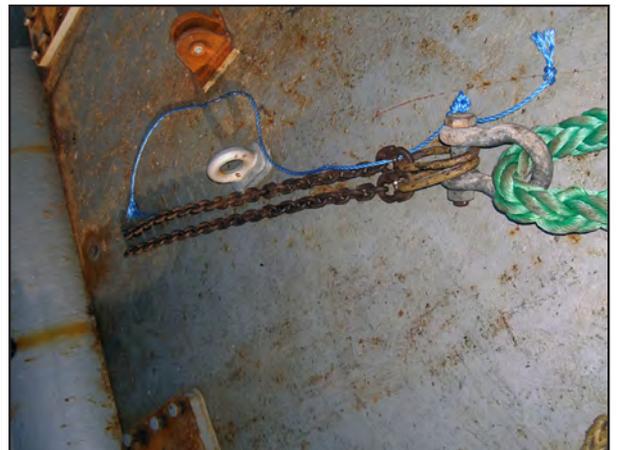
A 13mm steel chain sling, used to connect a rope stretcher to the dredger, had failed. It had been passed through a pad eye on the dredger's stern and then doubled-up and re-connected to the rope stretcher by a shackle. No thimbles were used in the hawser and the safe working load of many components, including the chain, was not known. Prior to the accident, the workboat's skipper did not hear a call from the backhoe operator informing him that the dredger was in position and that he was lowering the spud legs. The deckhand had not been told that it was safe to approach the tensioned hawser.

- **The deckhand was in the ‘snap-back’ zone when the hawser parted.** When a line is under tension or can tension without warning, it is dangerous to enter its ‘snap-back’ zone. Where it is impractical to mark ‘snap-back’ zones on decks, extra vigilance is required and anybody seeing another crewman approaching an area of potential recoil should not hesitate to warn the person concerned.
