Report on the investigation of
the grounding and subsequent foundering of
fv Kerloch (J235)
at Crow Rock, off Linney Head, Wales
on 20 February 2010

Report No 12/2010
October 2010

SYNOPSIS

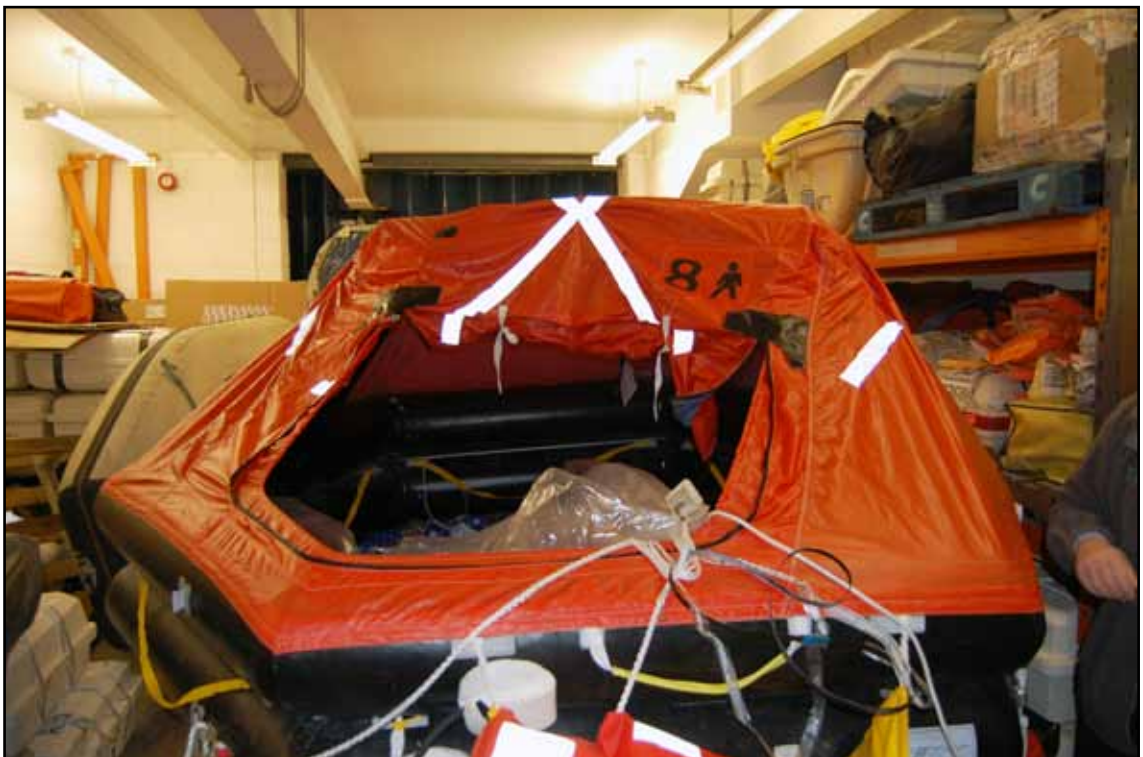
Figure 8

Photograph of liferaft used during abandonment from *Kerloch*

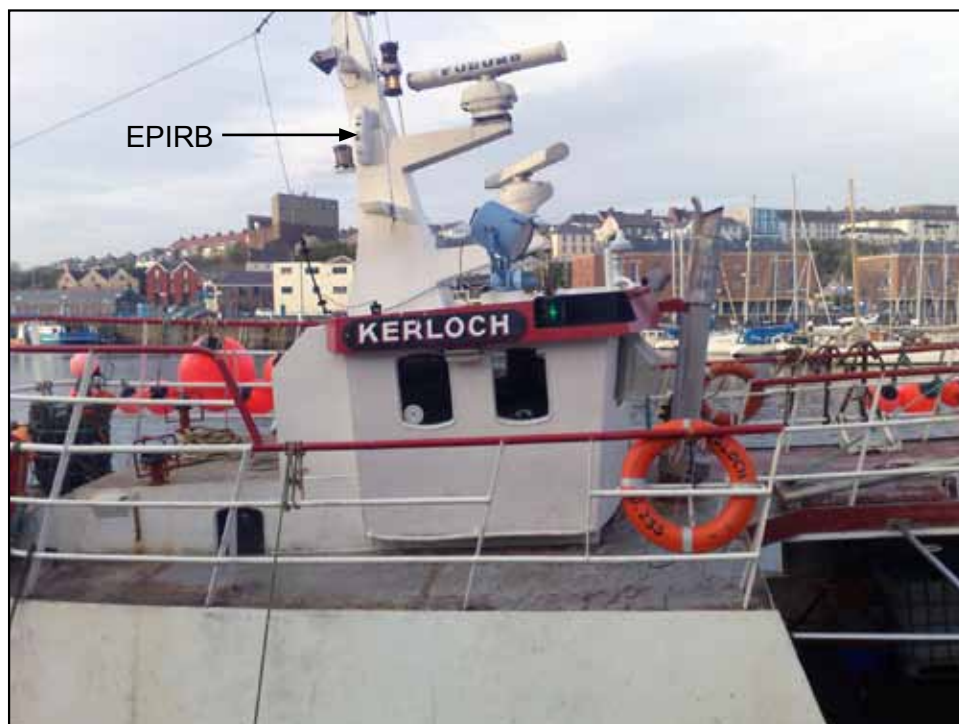
Figure 10

Photograph of *Kerloch* showing EPIRB mounted on mast

The EPIRB failed to activate immediately after the vessel foundered. The unit eventually deployed 3 days later, and it seems most likely that a period of worsened weather following the accident helped to eventually dislodge the unit from the wreck, perhaps when the wreck itself moved. Although the battery had expired, the EPIRB successfully transmitted.

The unit, however, stopped transmitting before it could be recovered, and any evidence regarding its initial failure to deploy was lost. Although fitted in a proprietary stowage, apparently free of obstructions, the EPIRB was located on the side of the mast. MGN 267 (F) notes that such a location will reduce the likelihood of a correct deployment; the installation position needs to be carefully considered.
