Report on the investigation of
the grounding and subsequent foundering of
fv Kerloch (J235)
at Crow Rock, off Linney Head, Wales
on 20 February 2010

Report No 12/2010
October 2010

At 1725 on 20 February 2010, the Jersey-registered crabber *Kerloch* (J235) was returning to port when she ran aground on Crow Rock, off the Pembrokeshire coast. The vessel began to sink rapidly and all four crew donned their lifejackets, then deployed and got into the liferaft. The crew were recovered from their liferaft by another fishing vessel and subsequently transferred to the Angle ALB and then ashore. There were no injuries and no pollution.

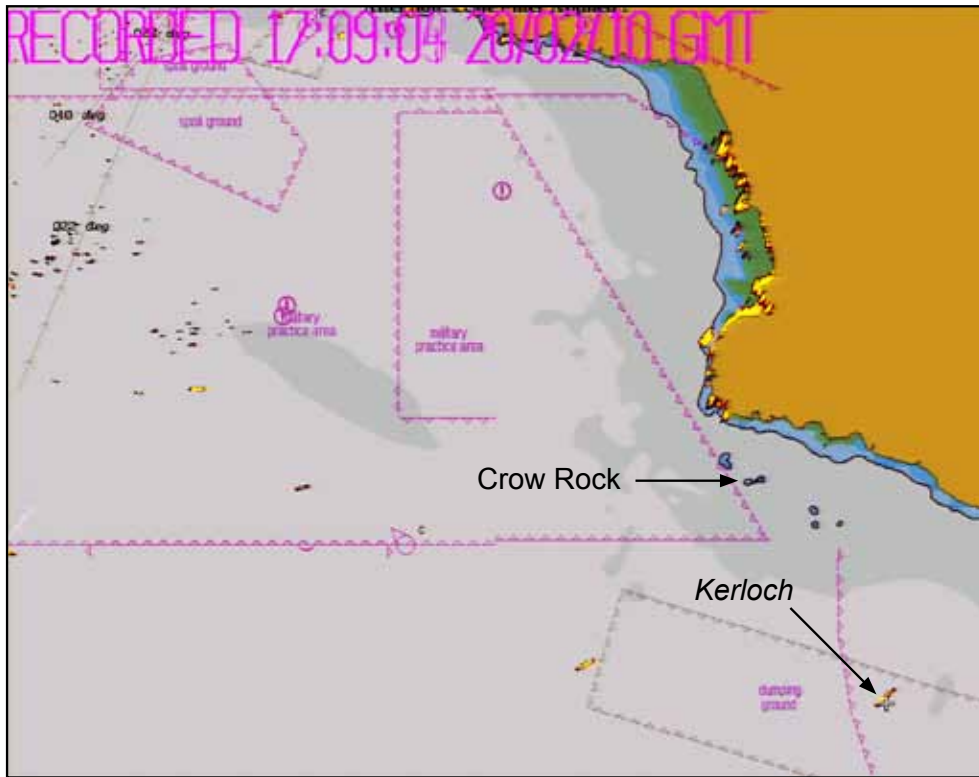
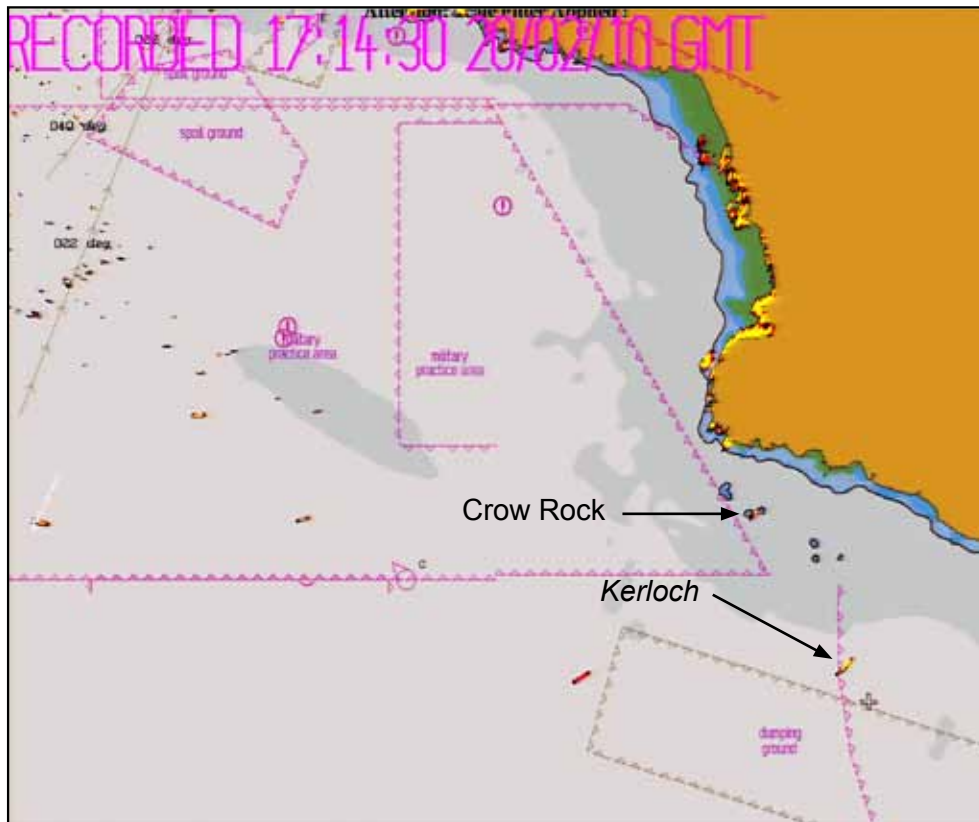
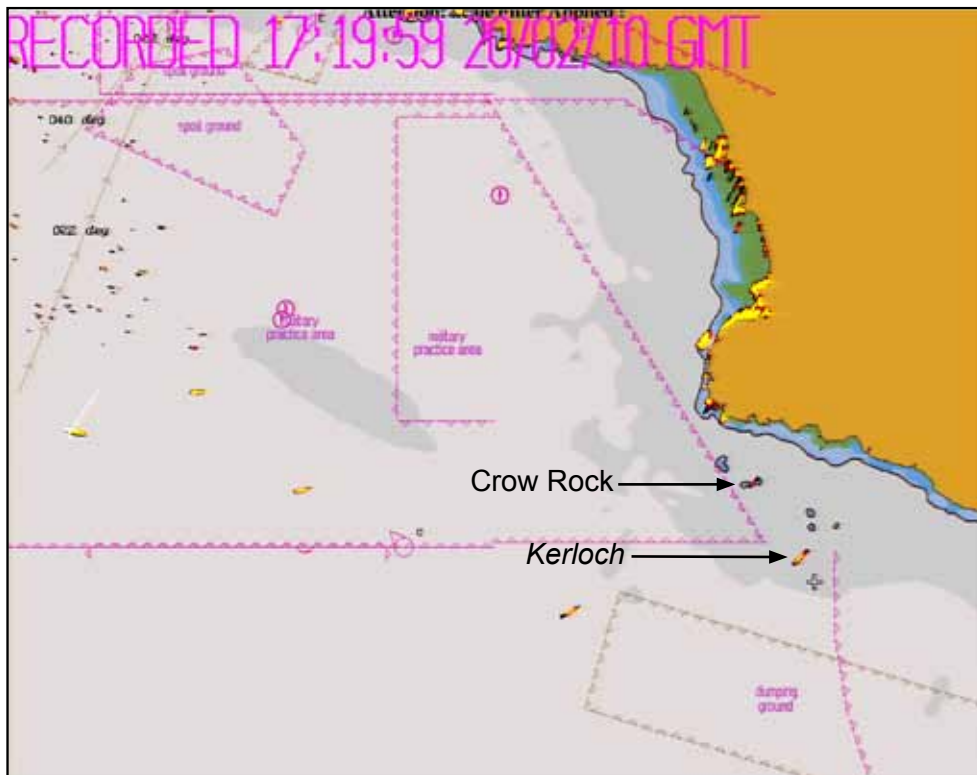
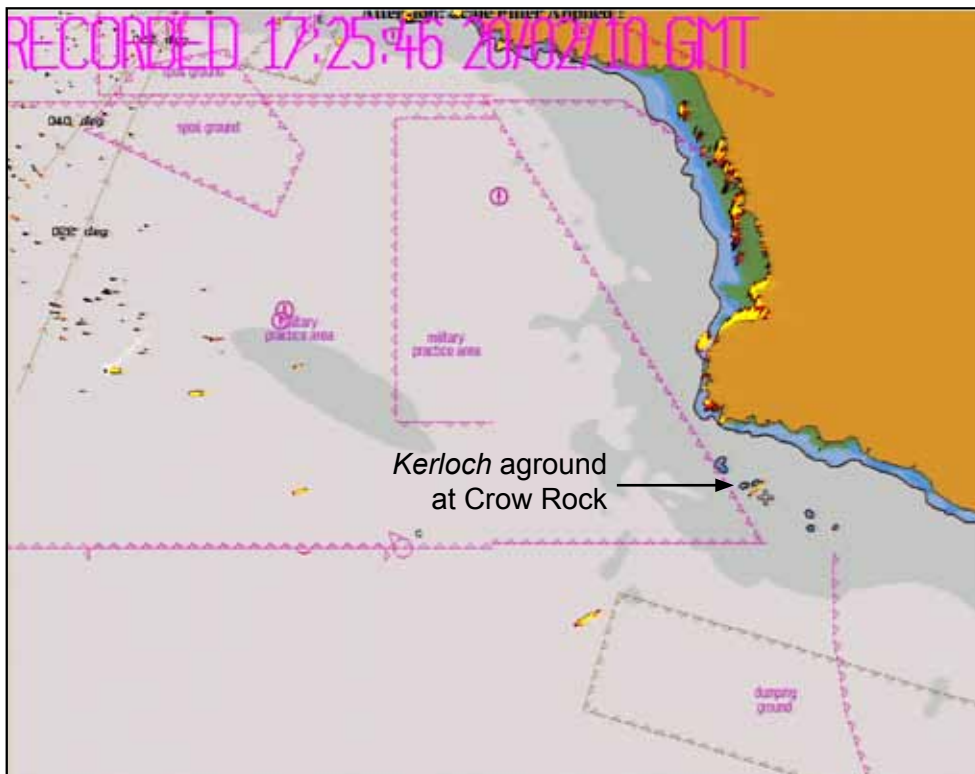
Figure 4a

The Milford Haven Port Authority (MHPA) Vessel Traffic Services (VTS) radar system recorded images of the vessel from 1708 onwards (**Figures 4a, 4b, 4c & 4d**). The vessel remained outside the port limits at all times, and was therefore not being actively monitored by VTS.

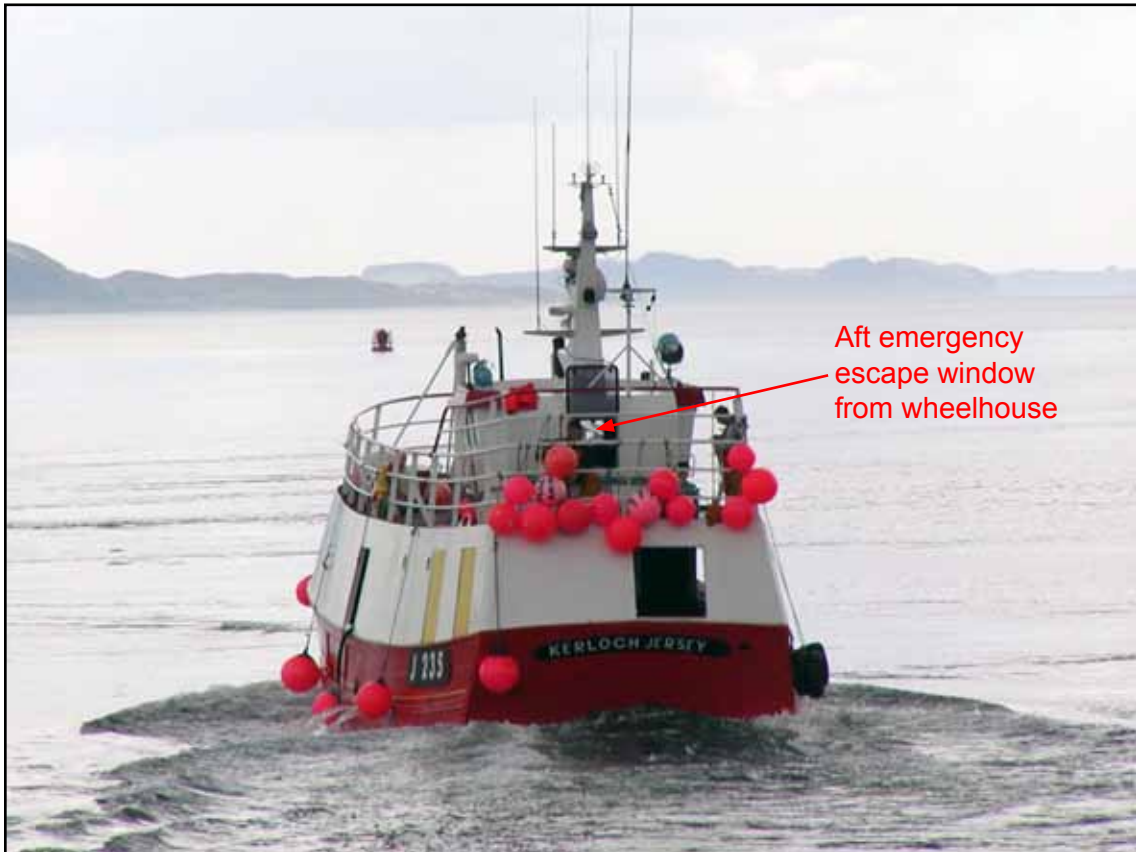
All three crew men arrived in the wheelhouse, just as the skipper was making his way out of the aft emergency escape window (**Figure 5**), he having decided that there was insufficient time to activate the vessel's DSC radio alert. The skipper also forgot to collect a hand-held VHF radio, located by the escape window. The deckhands immediately followed him out the window, and all four mustered on the port side of the shelterdeck top in the vicinity of the vessel's two liferafts and dedicated lifejacket stowage (**Figure 6**). No attempt was made to remove the EPIRB from its mount on the starboard side of the mast.

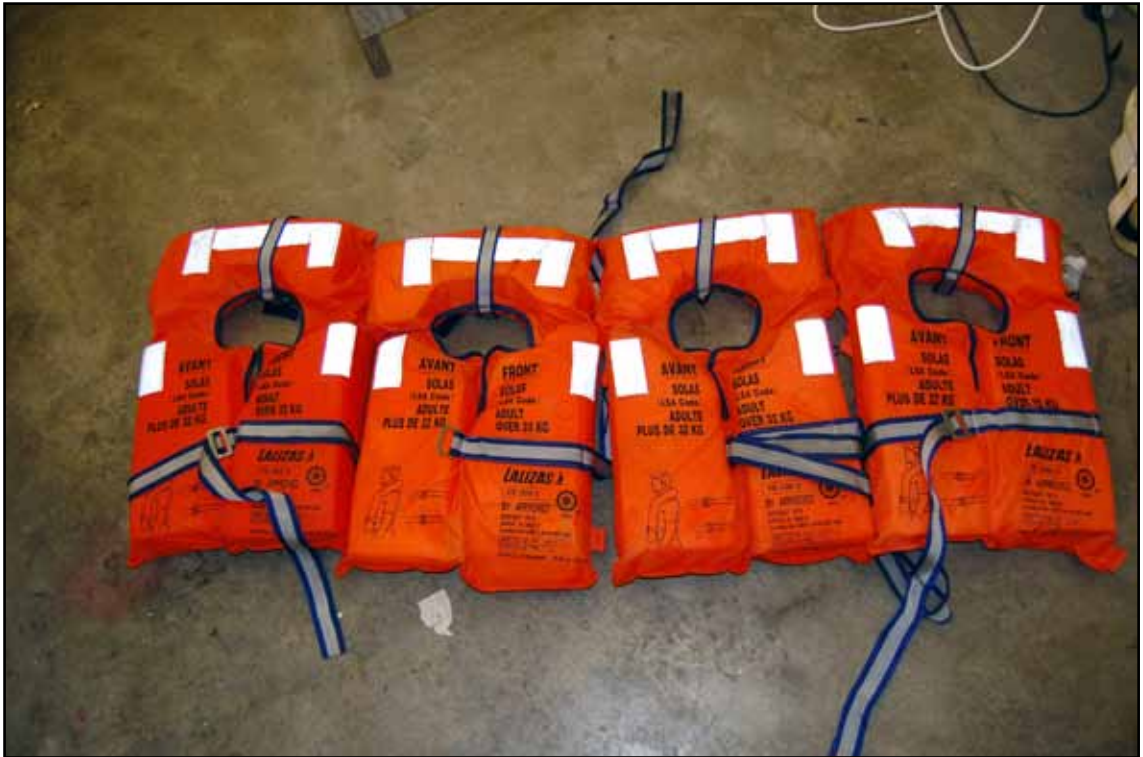
Figure 7

They each donned a lifejacket (**Figure 7**), then the skipper and one of the crew jettisoned the 8-man liferaft canister and started to deploy the painter. As the vessel continued to sink by the bow the crew became anxious about the time it was taking for the raft to activate, due to the length of painter that had to be pulled from the canister. However, the liferaft finally inflated upright (**Figure 8**), and the painter was then cut. One of the deckhands held onto the cut end, while the other two deckhands, then the skipper, jumped onto the liferaft, before boarding himself.

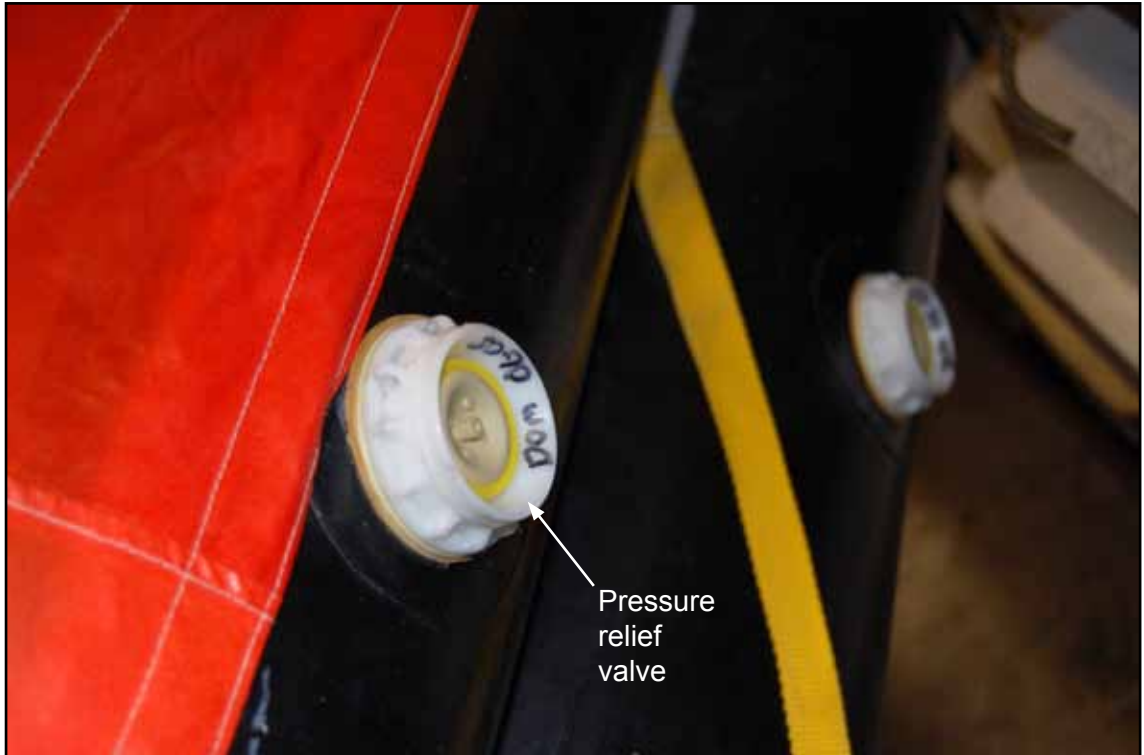
Figure 9

The liferaft remained safely afloat following the sinking, although the sound of escaping air caused some of the crew to again become anxious, thinking that a leak had developed. The noise was later attributed to a pressure relief valve (Figure 9).

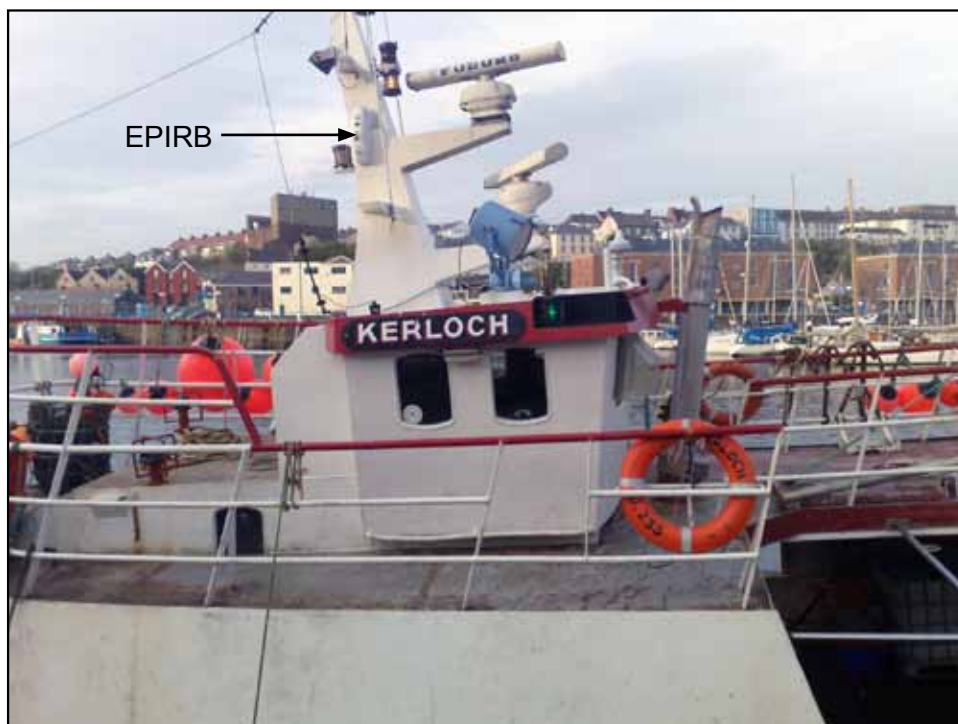
Figure 10

The EPIRB failed to activate immediately after the vessel foundered. The unit eventually deployed 3 days later, and it seems most likely that a period of worsened weather following the accident helped to eventually dislodge the unit from the wreck, perhaps when the wreck itself moved. Although the battery had expired, the EPIRB successfully transmitted.

The unit, however, stopped transmitting before it could be recovered, and any evidence regarding its initial failure to deploy was lost. Although fitted in a proprietary stowage, apparently free of obstructions, the EPIRB was located on the side of the mast. MGN 267 (F) notes that such a location will reduce the likelihood of a correct deployment; the installation position needs to be carefully considered.

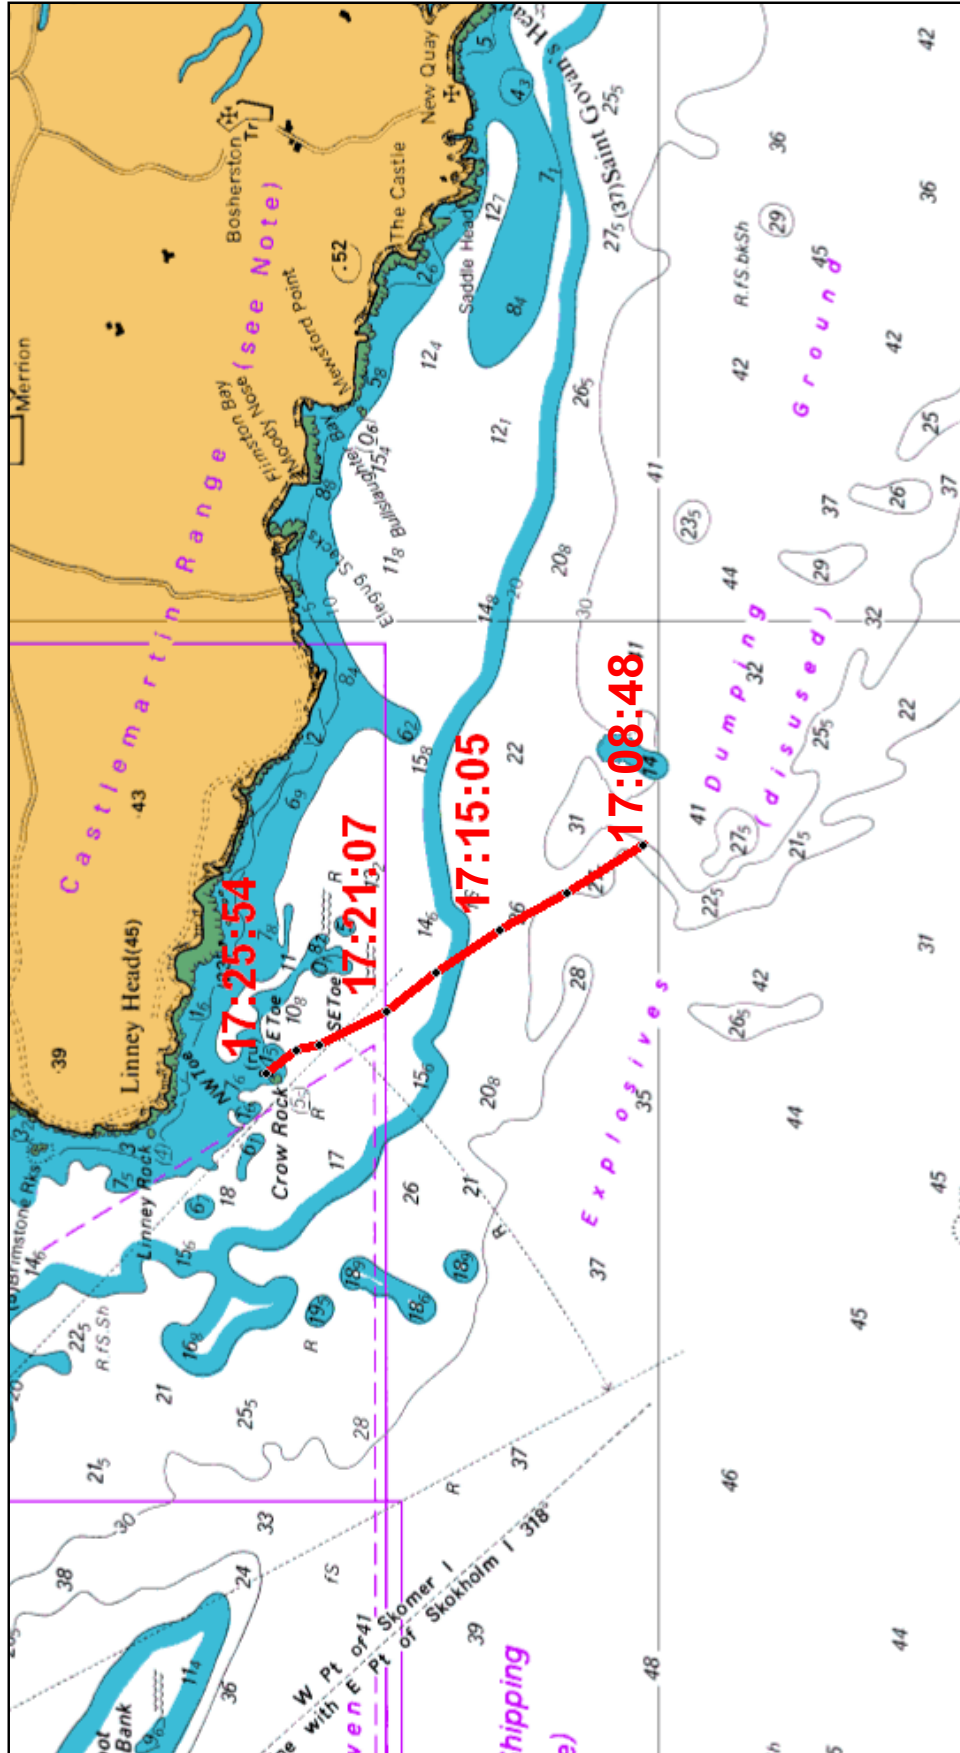
The skipper recalled passing St. Gowan lightbuoy, about 5 miles south-east of Linney Head, but at some point later he fell asleep. He was next aware of being woken up at 1725 as he was thrown from his chair by the impact of the vessel grounding on Crow Rock.

Representation of track of Kerloch from 1708 onwards, based on approximate positions identified from MHPA VTS radar
