Report on the investigation of
the fatality of a shore worker in No 2 cargo tank
on board the oil/chemical tanker

Bro Arthur

at the Cargill Terminal, Hamburg, Germany

Report No 9/2010
August 2010

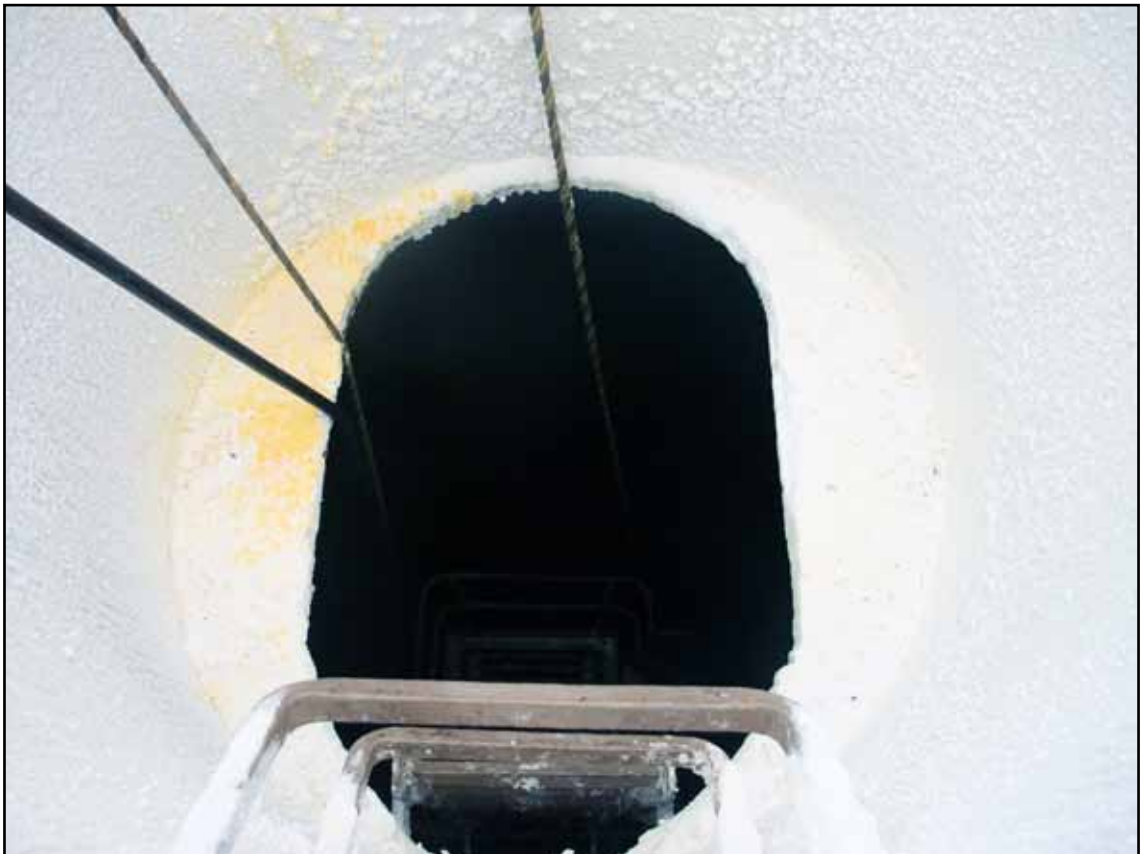
Figure 5

At about 2220 the ventilation fan was restarted and the three "sweepers" met with the chief officer and supercargo adjacent to No 2 cargo tank hatch. Both noticed that the alcohol they had previously smelt had disappeared. As an AB lowered the "sweeping" squeegees to the bottom of the 17.34m deep tank, it was noted that surfaces of the hatch coaming and ladders were covered with a slippery coating of hard, white, waxy, solidified stearin (**Figure 5**).

No 2 cargo tank hatch coaming showing solidified stearin coating

The reason why “Sweeper” 2 fell backwards was probably a combination of his physical impairment due to the influence of drugs, and the slippery nature of the residual solidified stearin cargo on the ladder rungs. He might also have been adversely affected by the tank temperature and fairly arduous work. When the right plasticised faced glove was recovered it was found to be heavily contaminated with solidified stearin, which would have made it extremely slippery and would have made his hand grip on the vertical ladder more difficult, especially in his impaired state.

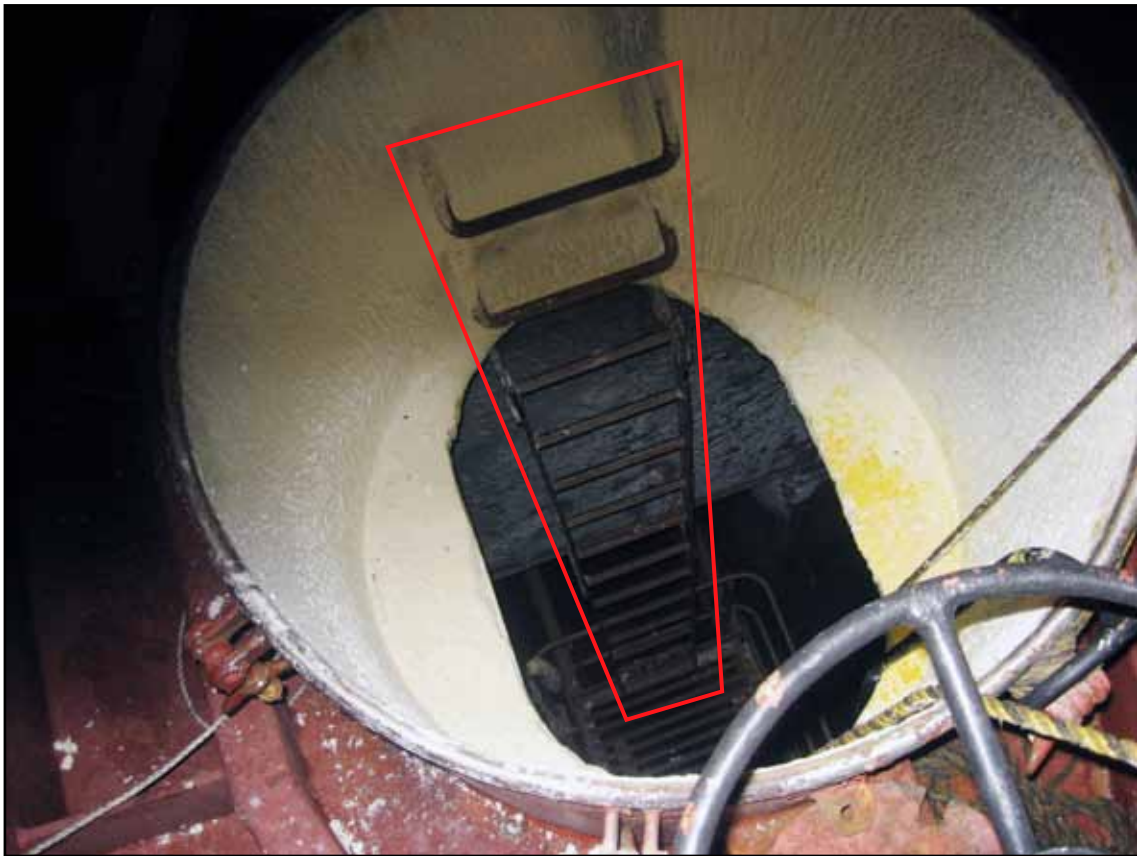
No 2 cargo tank - vertical ladder

It is likely that the casualty was at least on the fourth rung up of the vertical ladder (about 1.2m from the top resting platform), and as he adopted the naturally backward leaning posture of about 20° to the vertical (**Figure 20**) he lost his handgrip and fell backwards, initially pivoting about his feet on the ladder rung. As he rotated backwards he is then likely to have passed over the top guardrail of the top resting platform and fallen about 18m onto the tank top. If he was lower than 1.2m on the vertical ladder it is doubtful that his body pivot point would have been low enough for him to pass over the top guardrail, in which case he would have landed on the platform itself.

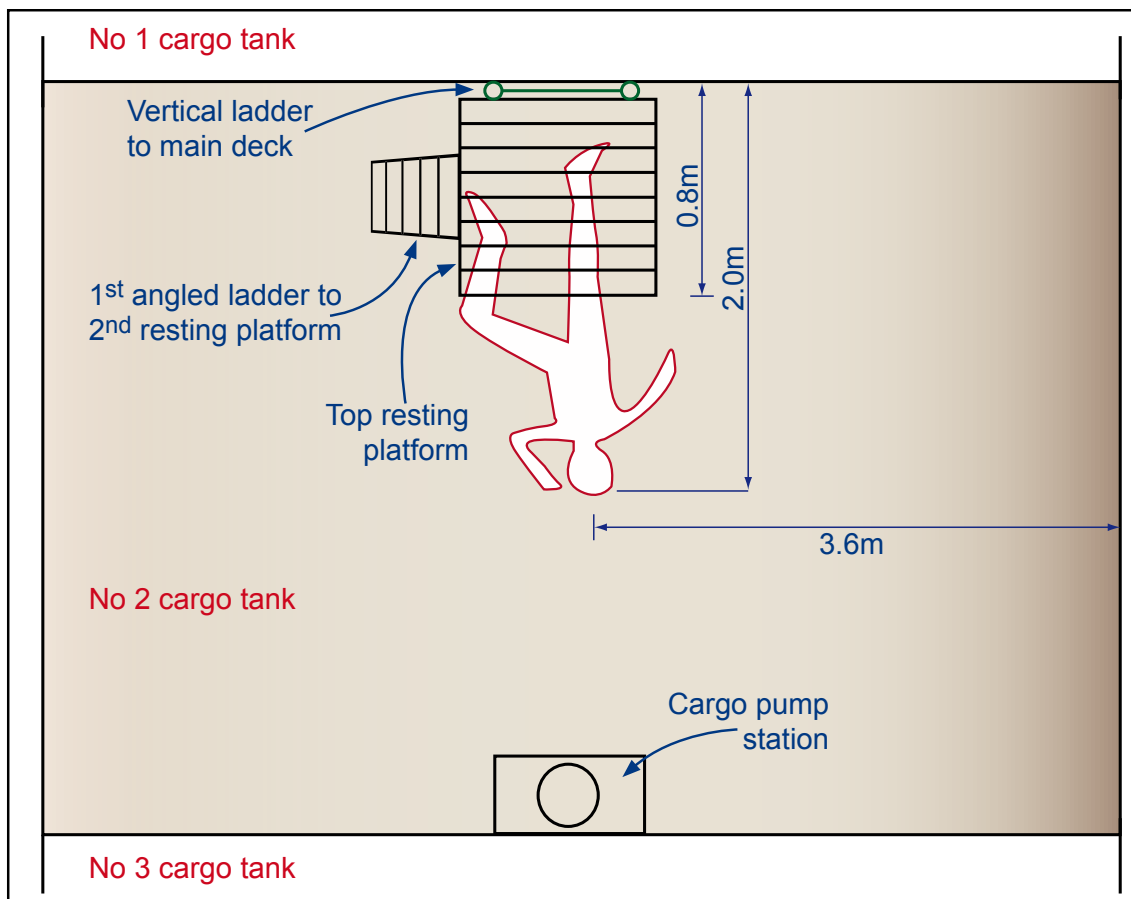
Figure 10

The casualty, who was a 56 year old German national, was found lying on his back with his head pointing towards the after bulkhead of No 2 cargo tank. He was positioned aft of, but directly in line with, the centre of the top resting platform which was also in line with the vertical ladder giving access to and from the main deck. His position is shown in the schematic at **Figure 10**. He was wearing overalls, both his boots and at least his right-hand glove (**Figure 11**). Witnesses were unsure if the casualty was wearing his left-hand glove.

Schematic showing position of the casualty (not to scale)

It is known that the approximately 1.6m tall casualty was found directly in line with the centre of the top resting platform, which is itself directly in line with the centre of the vertical ladder accessing the main deck. The three squeegees were found on the top resting platform, which indicates that the casualty had reached this level.

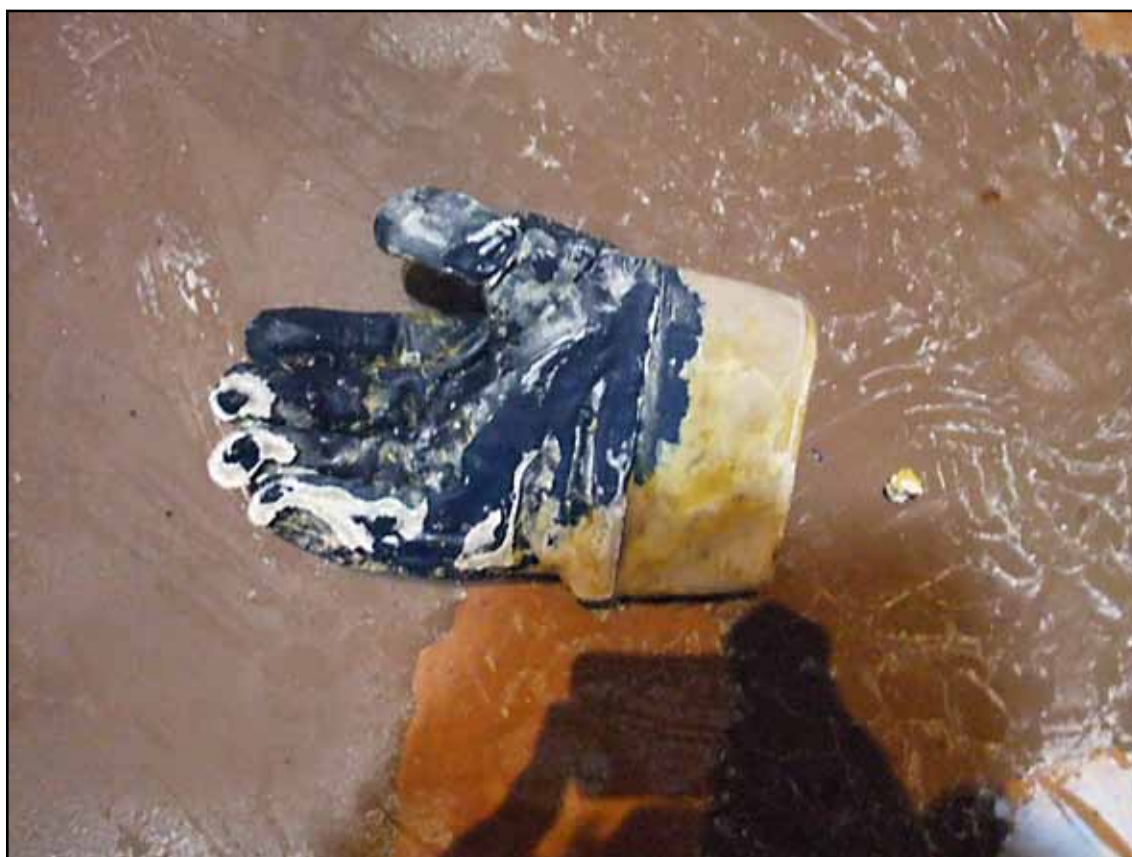
Figure 11

"Sweeper" 2's right hand, palm plasticised faced glove

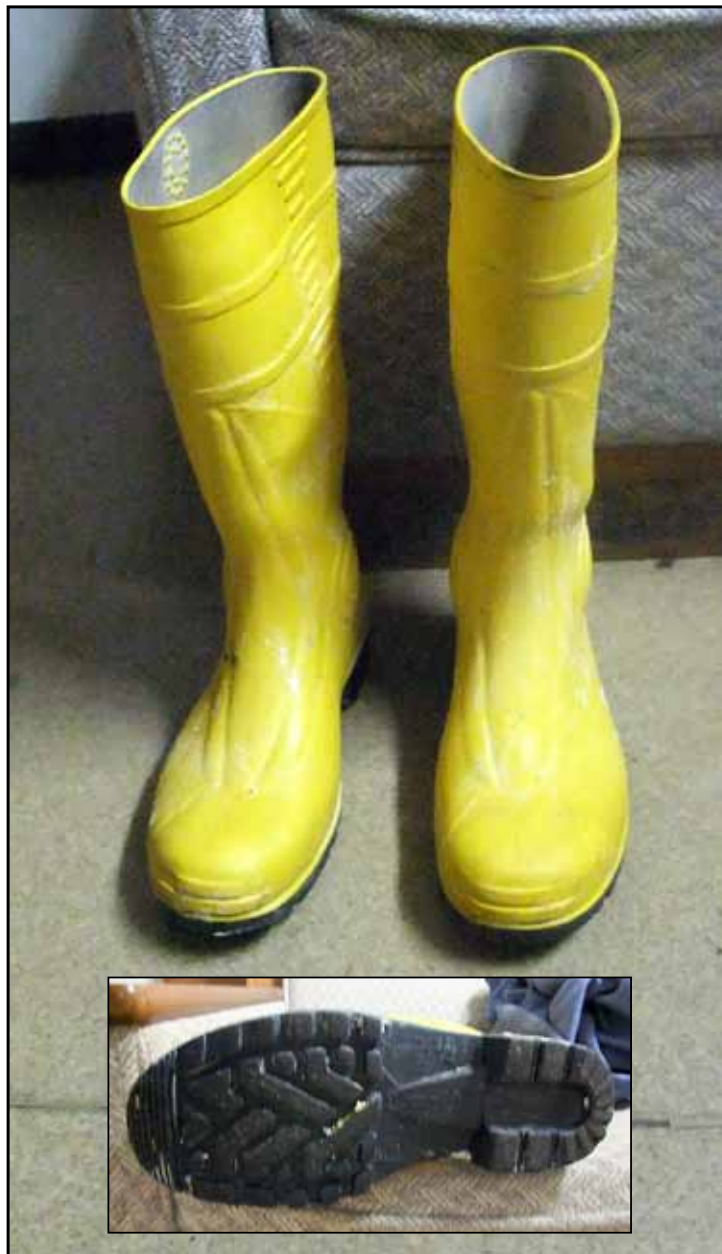
Figure 12

Hamburg “sweepers” industrial rubber boots

The casualty’s industrial rubber boots were in very good condition with a deep tread which would have given good grip. Had his feet slipped while maintaining a hand-hold, he would have fallen vertically onto the platform.

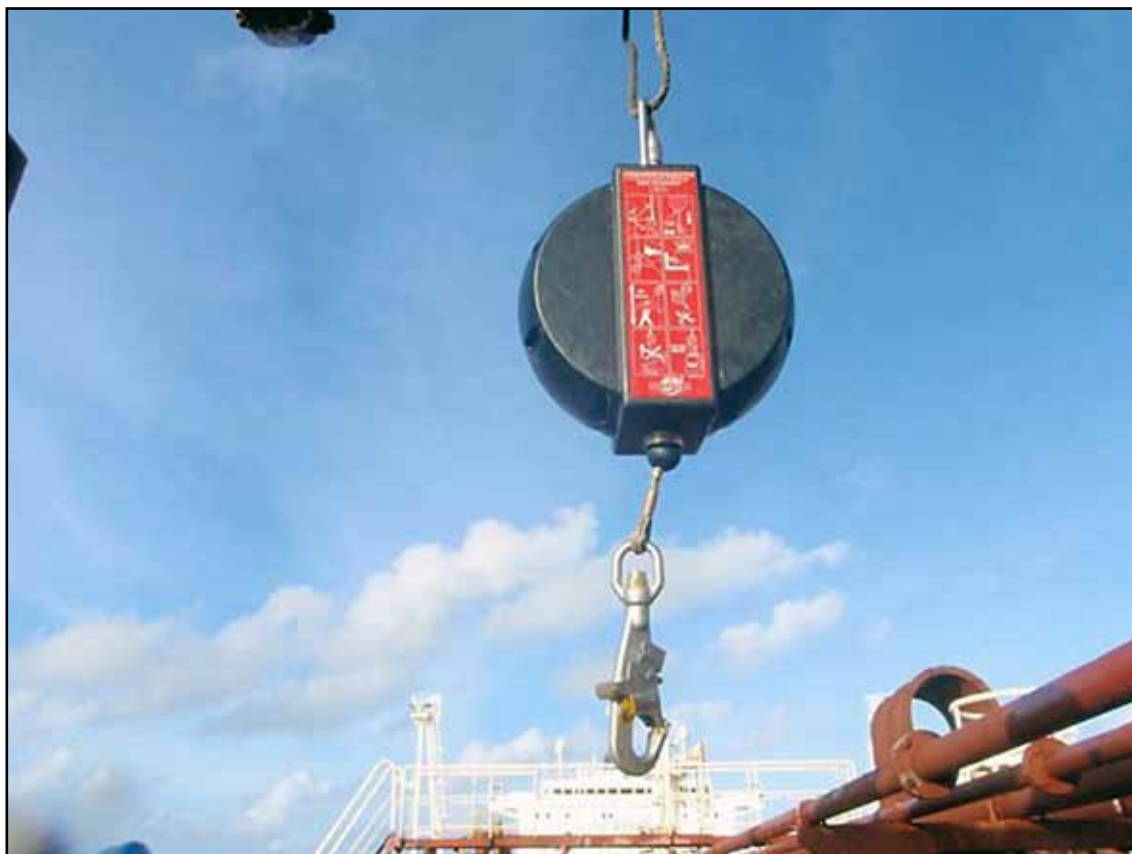
Fall arrestor

After the accident the harnesses were replaced with double clip versions conforming to EN 355. A fall arrestor was also provided which could be connected to the safety harness and secured at the hatch coaming or to an overhead support (**Figure 15**).

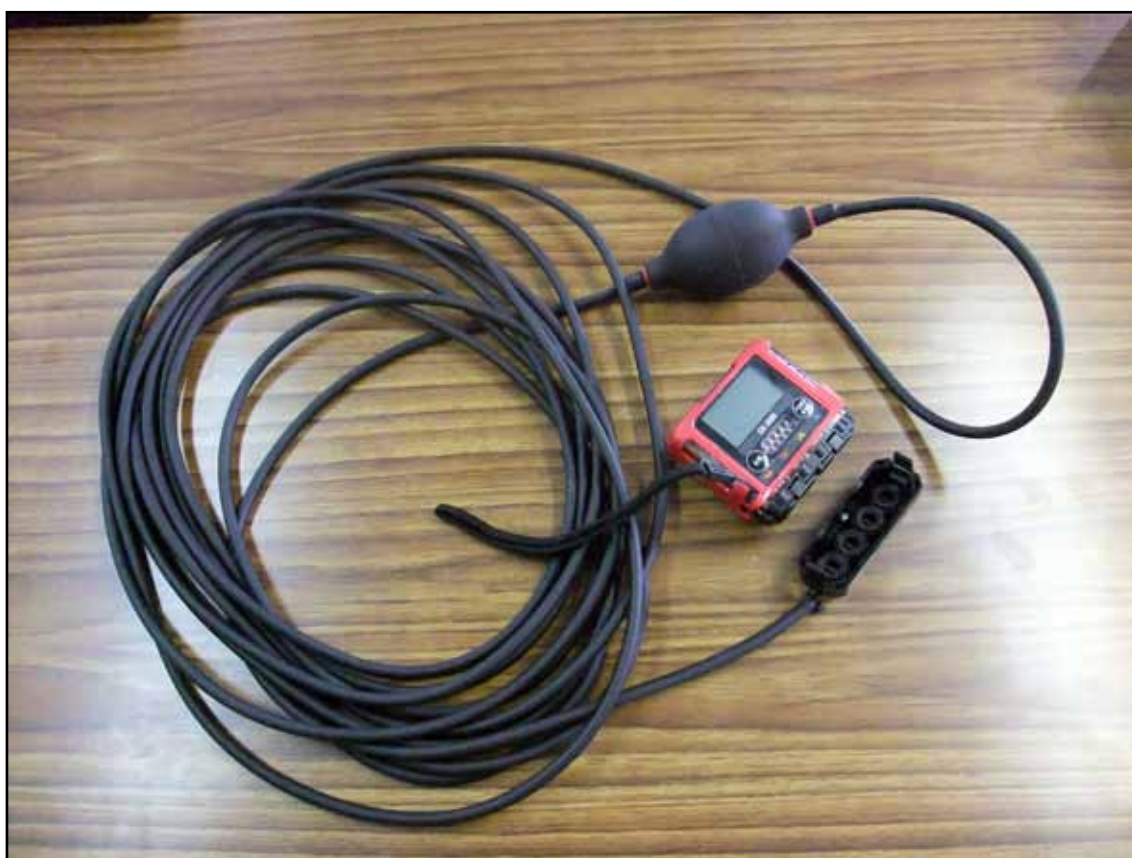
Figure 18

The PGM can be fitted with an aspirator adapter connected to a 3m (10 feet) extension hose when it is necessary to draw a sample from an area, such as a cargo tank, before entry. The unit used by the chief officer to test the atmosphere in No 2 cargo tank was fitted with a 10m extension hose (**Figure 18**).

Riken Keiki GX-2009 (Ex Type A) Personal Gas Monitor,
with aspirator and 10m sampling hose extension arrangement

This was not the case when the atmosphere was tested for the presence of other gases including CO. The tests were carried out from the main deck using the Riken Keiki, GX-2009 Personal Gas Monitor connected to a 10m extension hose. The readings obtained for combustible gas, H₂S and CO levels were 0%. It was on the basis of these readings, and the 20.9 - 21% O₂ obtained using the O₂ meter, that it was decided that the tanks were safe to enter and the Entry Permit signed. This was an unsafe act because the hose was only 10m long

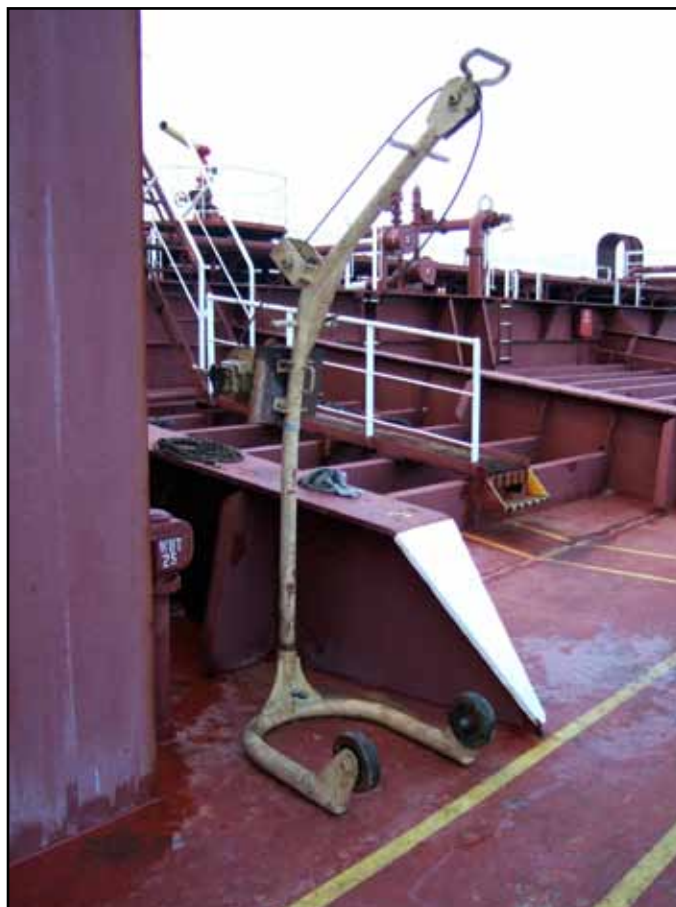
Figure 19

Bro Arthur's casualty rescue equipment

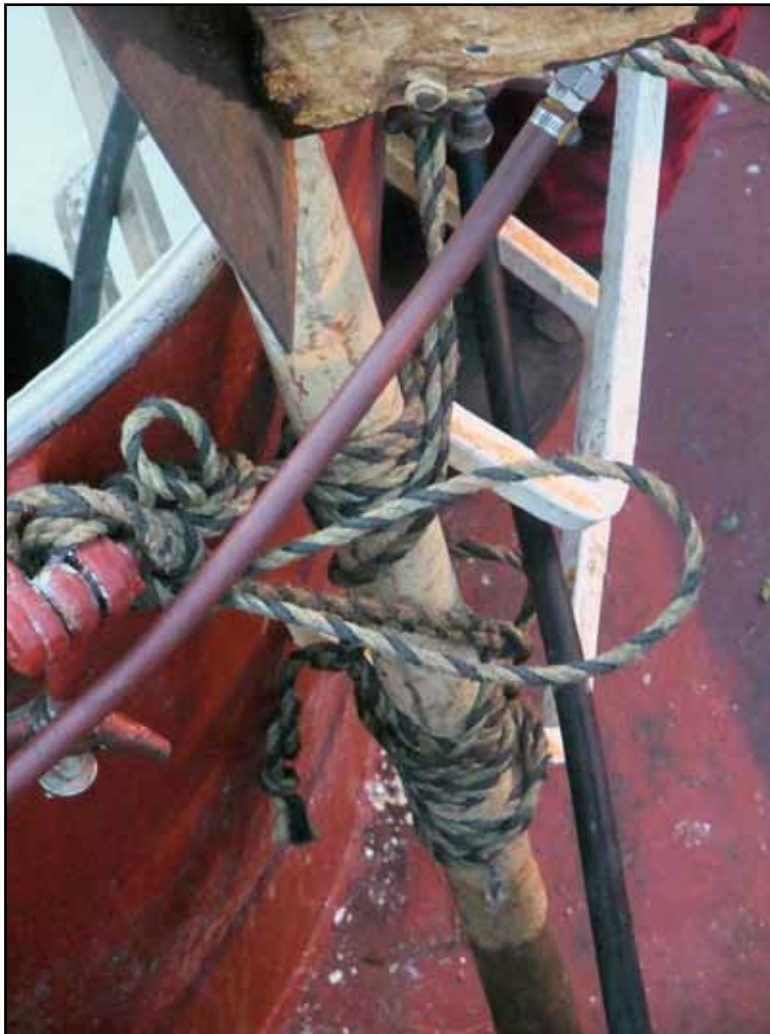
Figure 21

During a demonstration of *Bro Arthur's* casualty recovery equipment it was noted that, because of its weight and awkward design, it was very difficult to man-handle across the deep, main deck longitudinals. Once adjacent to No 2 cargo tank hatch it was found that the davit arm was unable to directly plumb the hatch when fitted to the unit's base. The davit arm was removed from the base and attempts made to secure it to the hatch coaming's external rungs using rope because there were no brackets or sockets fitted to the hatch coaming (**Figure 21**). This proved very difficult, and the arm was extremely unstable, and again a straight plumb through the hatch could not be achieved. In addition, when the wire was eventually lowered, it repeatedly came off the central guide wheel.

Casualty rescue equipment securing arrangements to
No 2 cargo tank hatch coaming

The team was clearly unpractised in rigging the equipment for recovery. The demonstration took 18 minutes from the initial movement of the unit from outside the deck store to the wire passing through the hatch. Even then it was poorly secured, and it is quite possible that its use could have caused additional injuries to a casualty.
