Harris Pye report

M.V. Isle of Arran MI 11546

Atlantic Engineering metallurgical report

Subject: **Spherical Eyebolts 1 + 2**

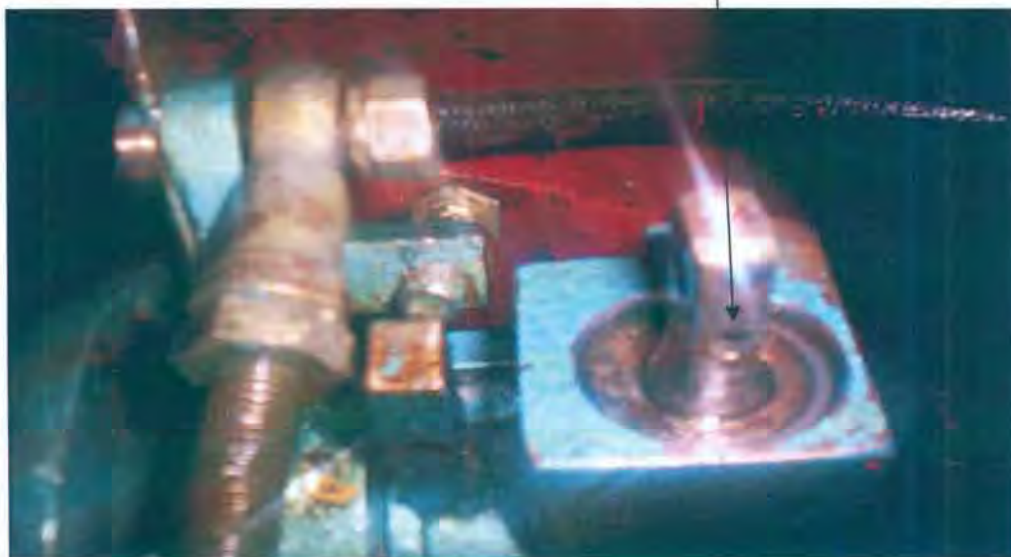
Photo 1: Shows indent of what we believe are mark made by the link arm adjusting screw which was protruding through the link claw and fouling the servomotor arm, over a period of time this would weaken the linkage and eventually total failure of the linkages

Both control units were function tested and found to be working correctly with no oil leaks being found on or around the units. Every thing suggest that the failure of was due to the link arm between the telemotor valve and the power transmitter not being correctly fitted .The over extension of the adjustment fouled the flexibility of the link at the pitch shedding piston and so put an unnatural bending force on the swivel bearing end with the resultant failure of this swivel bearing.

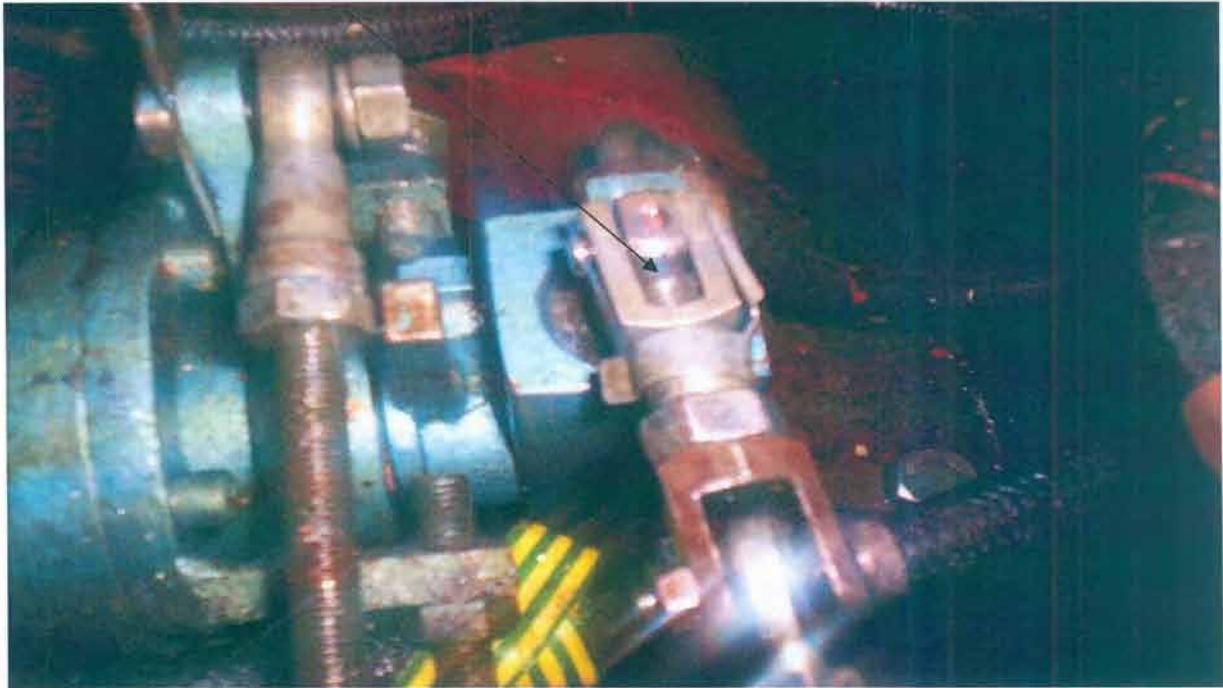
Photo No2 Shows replacement link arm with adjusting screw protruding through the link claw but not fouling the servomotor arm.

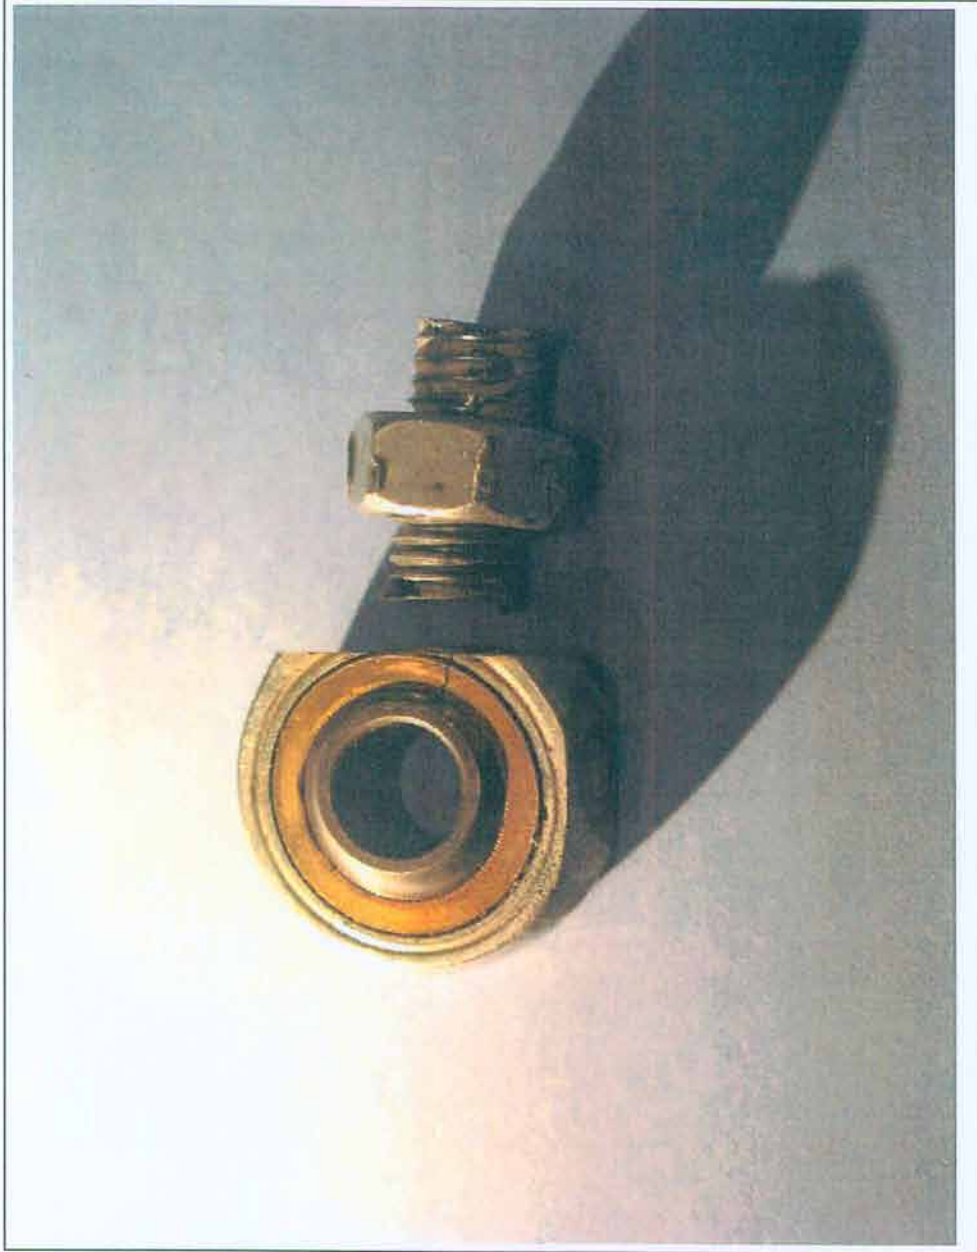
Photograph 1.

- 1.0 We were asked to investigate two failed spherical eyebolts. No 1 recently failed and No 2 failed six months ago. These will be dealt with Separately, Eyebolt No 1 see photograph number 1.

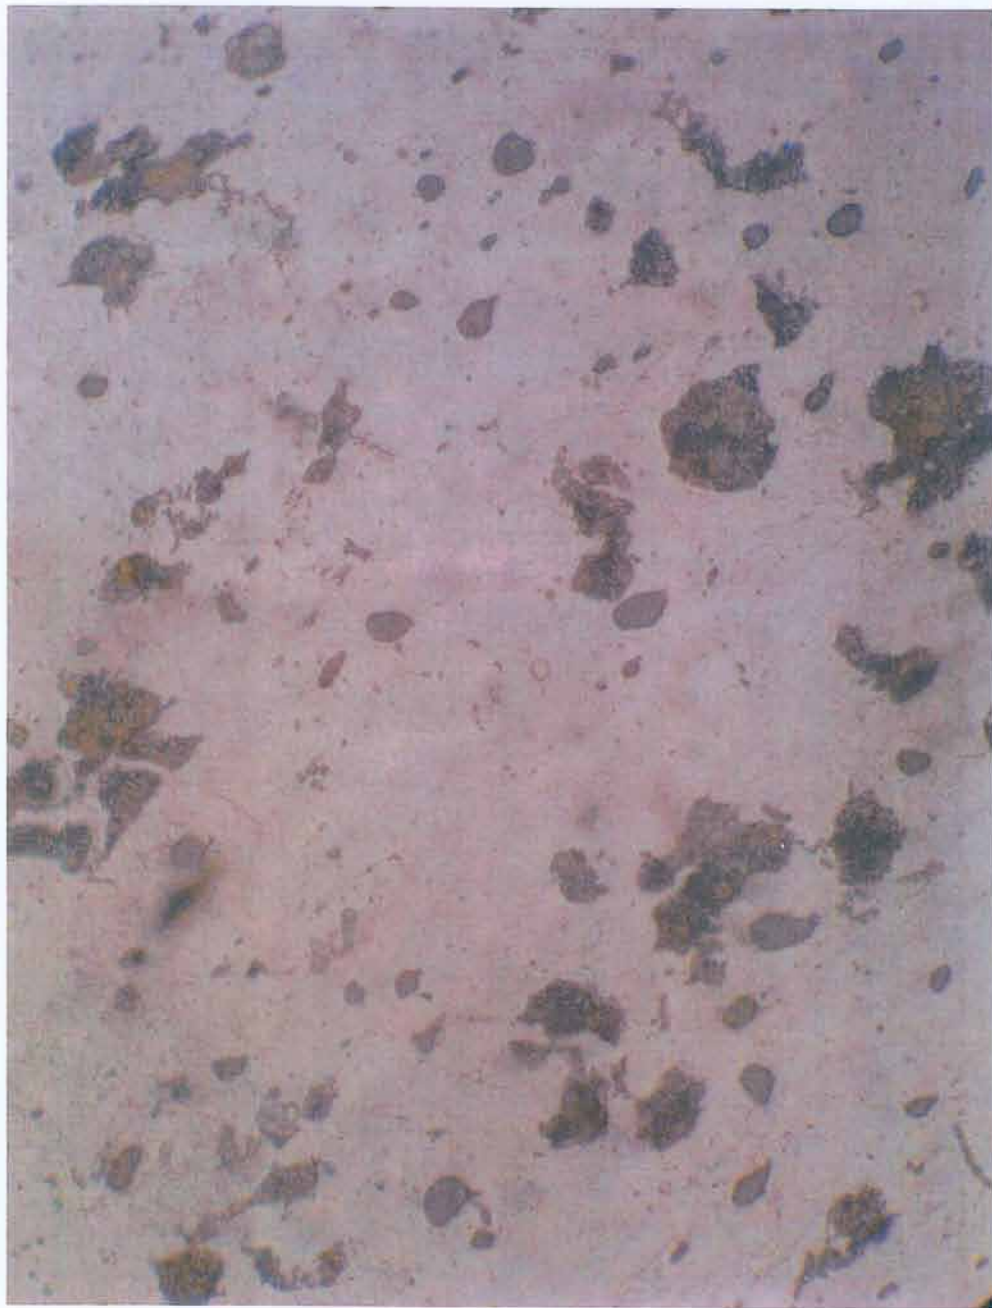
Photograph 2

- 3.1 To further check the heat treatment condition, a micro specimen of the cross-section of the thread was made, this specimen was polished to 3 micron and etched using Nital 2%, this was examined using a high magnification at 1200x.
- 3.2 The microstructure consisted of ferrite and pearlite (see photograph 2 appendix 1). The ferrite crystals were equi-axed and covered about 80% of the specimen area. The pearlite Crystals were smaller than the ferrite ones and the iron carbide layers had a fine distribution.
- 3.3 This structure is typical of a normalized low carbon steel. The manganese is in solution with the iron so this cannot be seen.

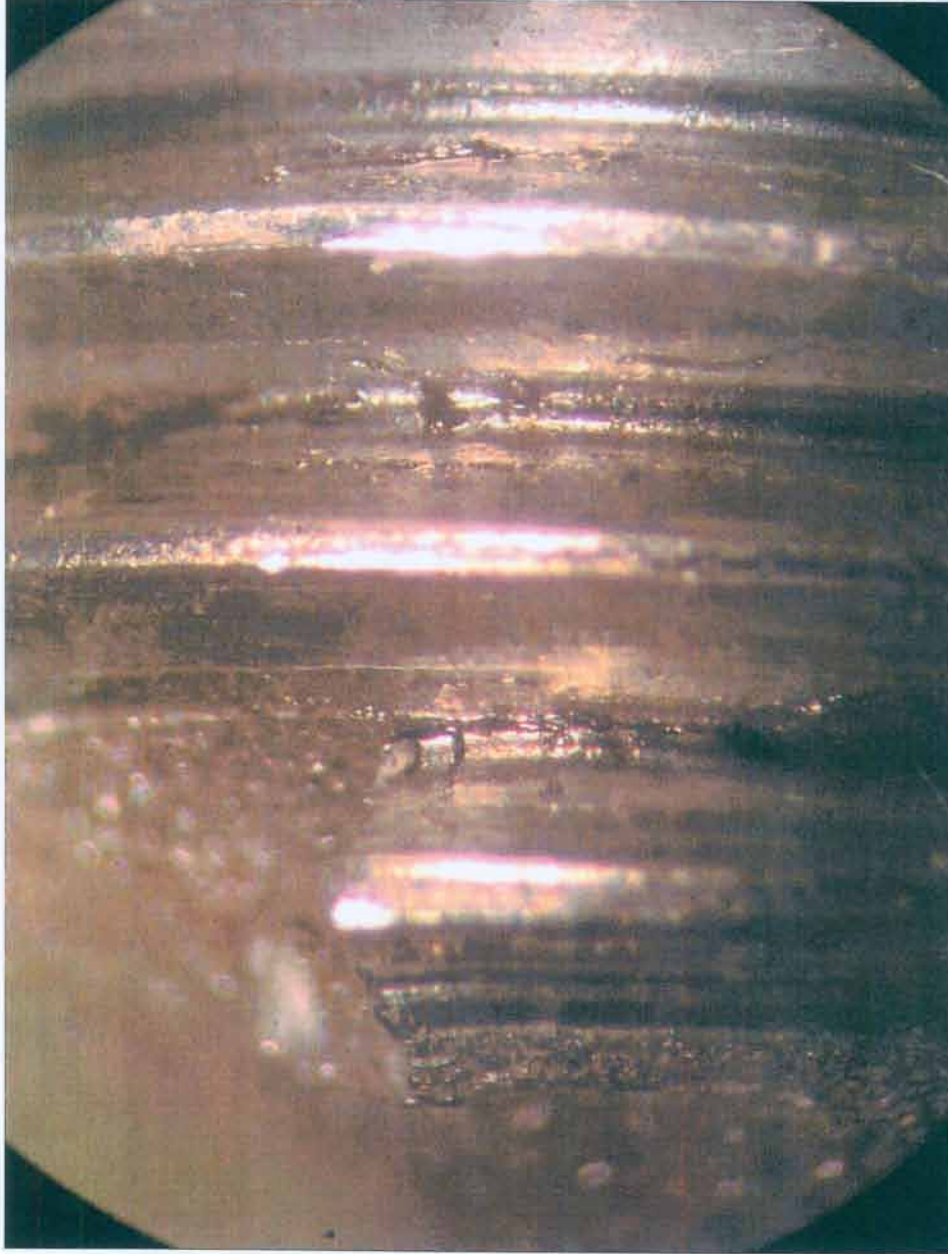
Photograph 3

- 4.1 The thread fractured area was examined using a stereo-microscope. A crack at the root of the thread could be clearly seen. This crack extended to the fracture surface (see

photograph No3). There was also evidence of damage to the flanks and crests of the thread.

- 5.1 The threaded seems to have been over-tightened damaging the flanks and crests and causing a crack in the root.
- 5.2 This crack eventually extended to the area where the thread fractured.
- 5.3 The thread failed because of a combination of torsional and bending stresses. The mechanism of failure seems to have had a bending fatigue component.
- 5.4 The coarse nature of the vee thread could have acted as a stress raiser.
- 5.5 The thread was subjected to overload, bending and torsional stress.

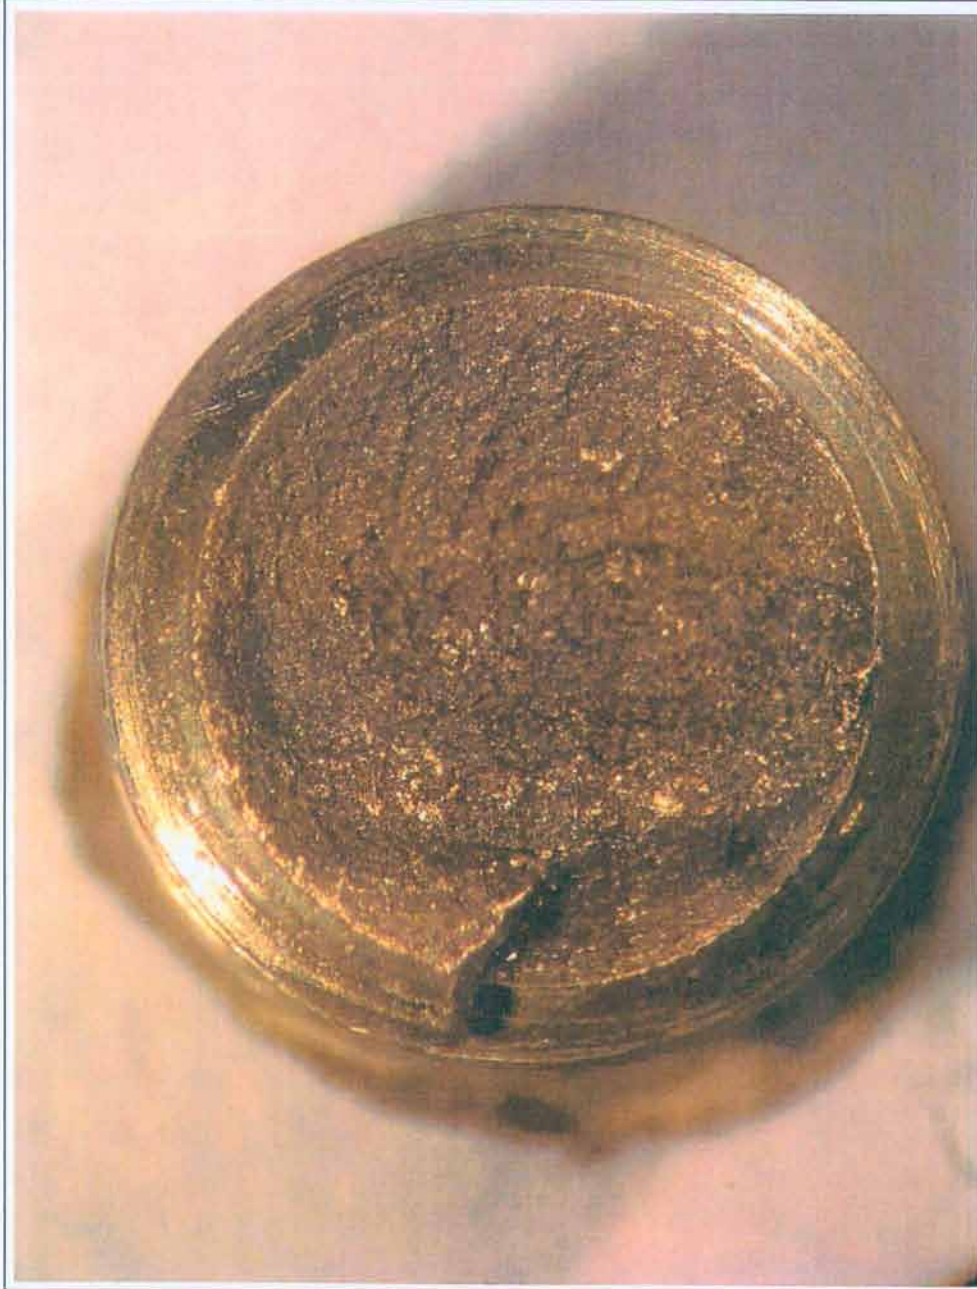
Photograph 4a

- 4.2 The fracture surfaces were examined using the stereo-microscope which showed the material had fractured around the crystal boundaries giving a coarse fracture face (see photograph No4 appendix 1)
- 4.3 There was evidence of metal fatigue but also evidence that the steel had been subjected to bending and torsional stresses.
- 4.4 The corners of the nut were damaged (photograph No5 & 6)
- 4.5 The thread size was 8 mm metric coarse and the nut was loose on the thread, the male thread measured 7.79mm diameter.

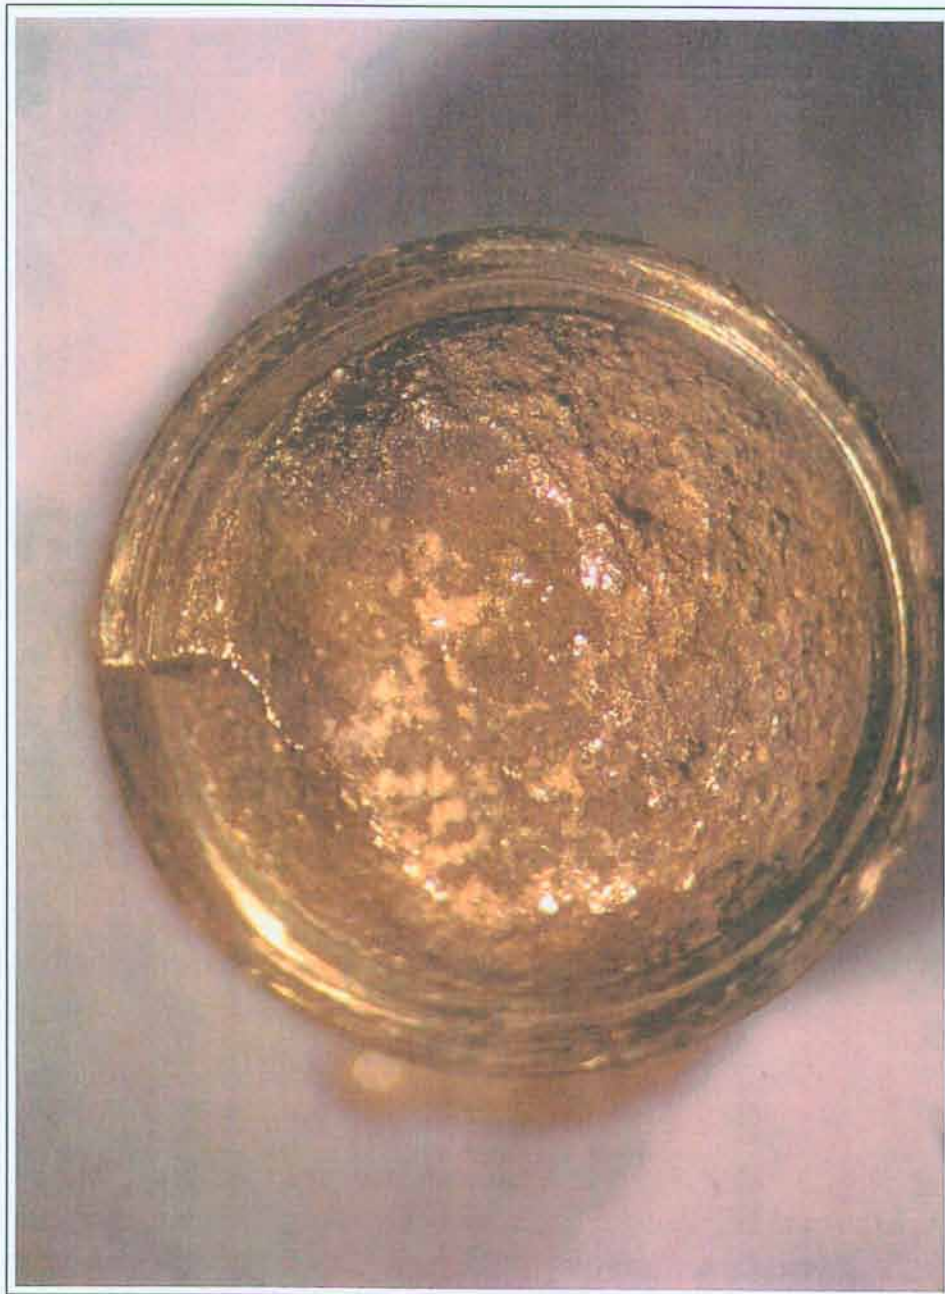
Photograph 4b
Mating fracture surface to Photograph 4a.

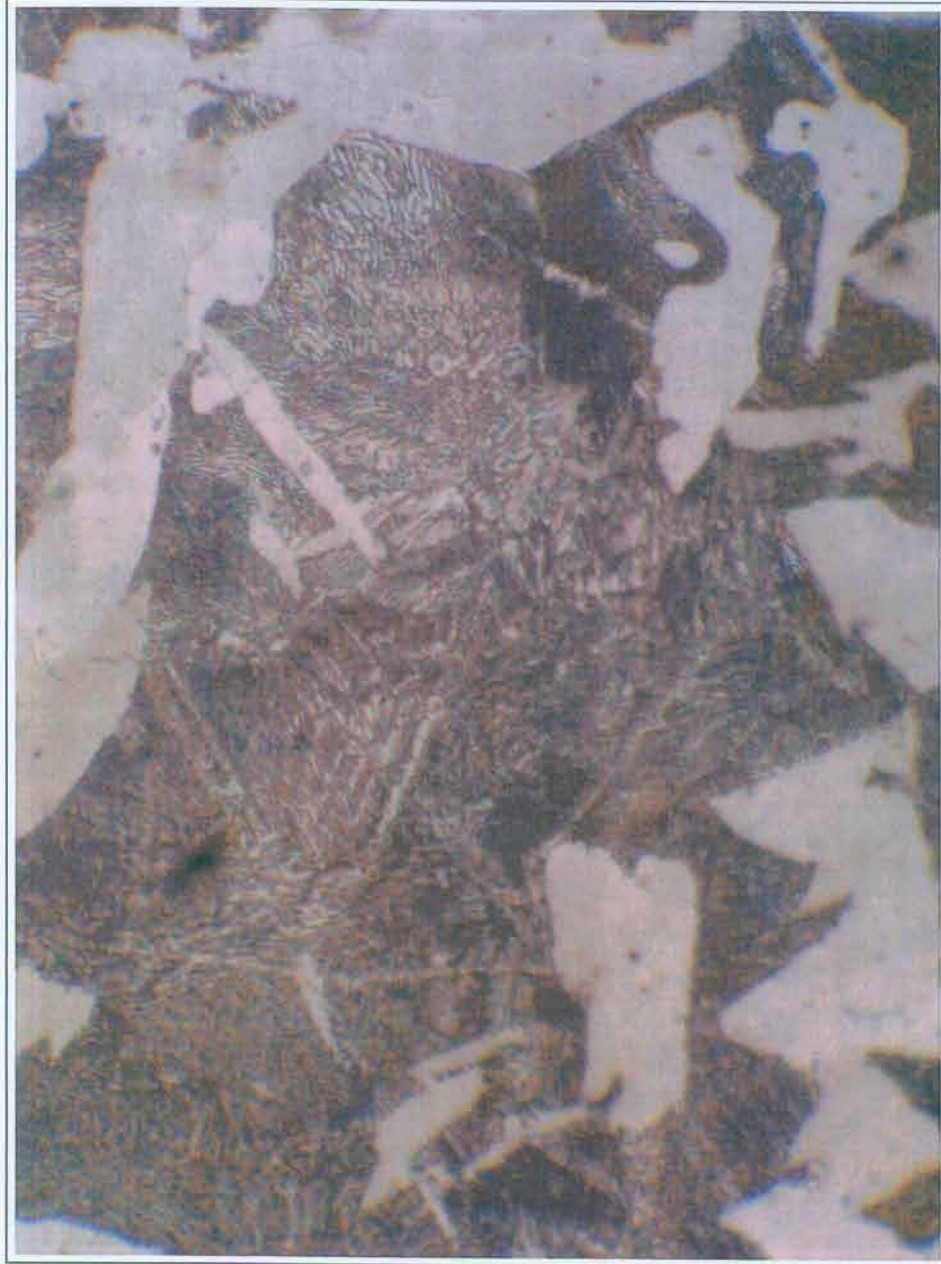
- 7.1 To further check the heat treatment condition a micro specimen was made, etched in 2% nital and examined under high power 1200x on a Olympus metallurgical microscope (see photograph 9 appendix 2)
- 7.2 The microstructure consisted of ferrite and pearlite in roughly equal proportions. In the pearlite the iron/iron carbide layers were very fine, however the crystals were large. The size of the crystals suggest that the steel may have annealed not normalized.

Photograph 9
Striped regions are pearlite. Light regions are ferrite.

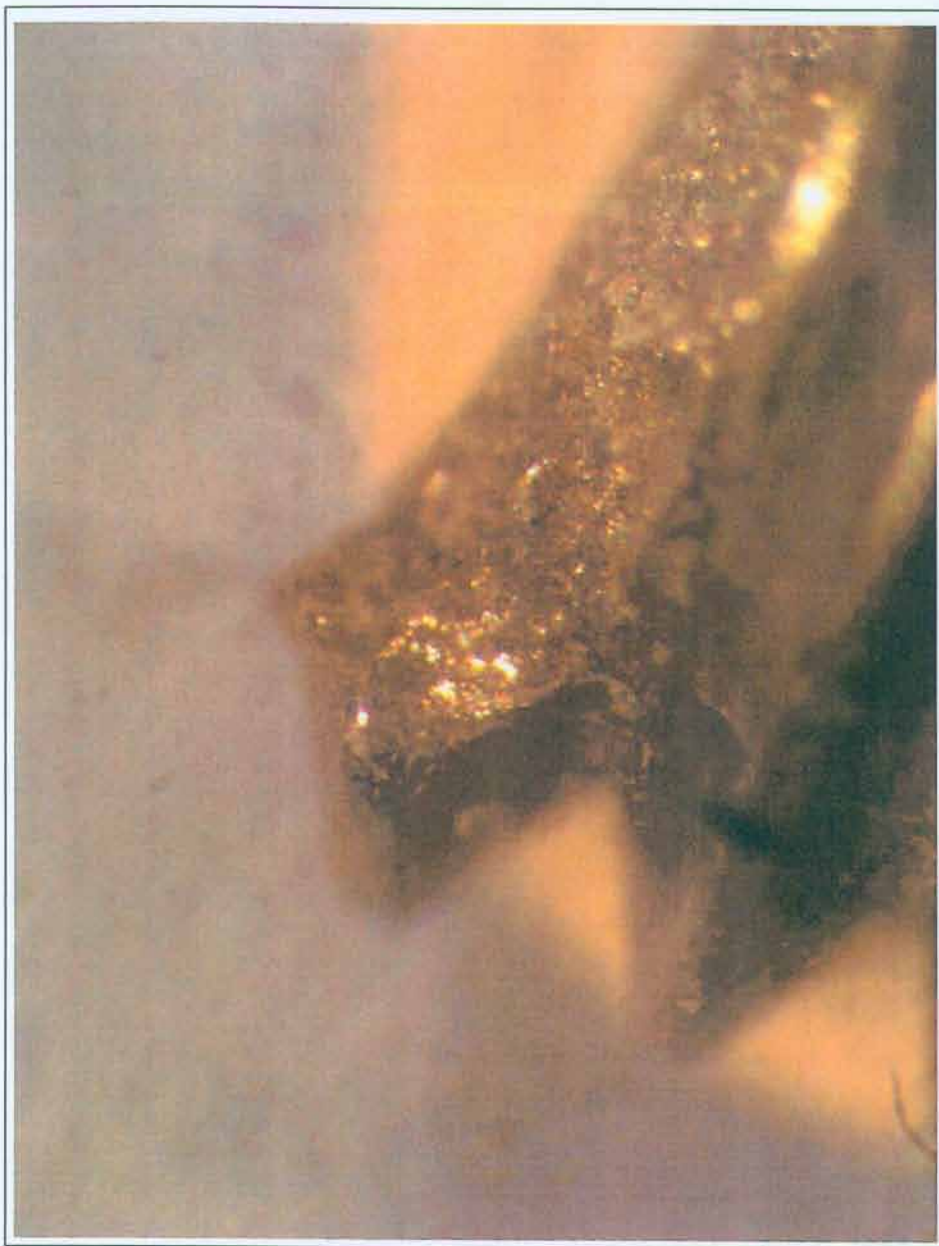
Photograph 10

- 8.1 Macro examination of the fractured thread shows a fine crack in the root of the thread extending up the flank into the fracture surface (see photograph No 10)
- 8.2 Macro examination of the cross-section fracture surface reveals evidence of bending stresses and also bending fatigue.
- 8.3 The fracture surface was coarse indicating failure had occurred at the grain boundaries. Some of the crystals were burnished where they had rubbed against other crystals before or at fracture.
- 8.4 I could not detect any evidence of torsional stresses on the fracture surface.

- 9.1 It is my opinion that the threaded part of the eye bolt failed because the stress raising (stress concentrations) effect of the 8 mm diameter coarse thread allowed the bending forces to produce a fine crack at the root of the thread. Further bending stresses enabled this crack to extend up the flank and eventually caused failure by bending fatigue and bending overload.

A fine crack can be seen in the thread root extending to the fracture surface.
