Report on the investigation of
The machinery space fire on board

Oscar Wilde

In Falmouth Bay

Report No 3/2011
March 2011

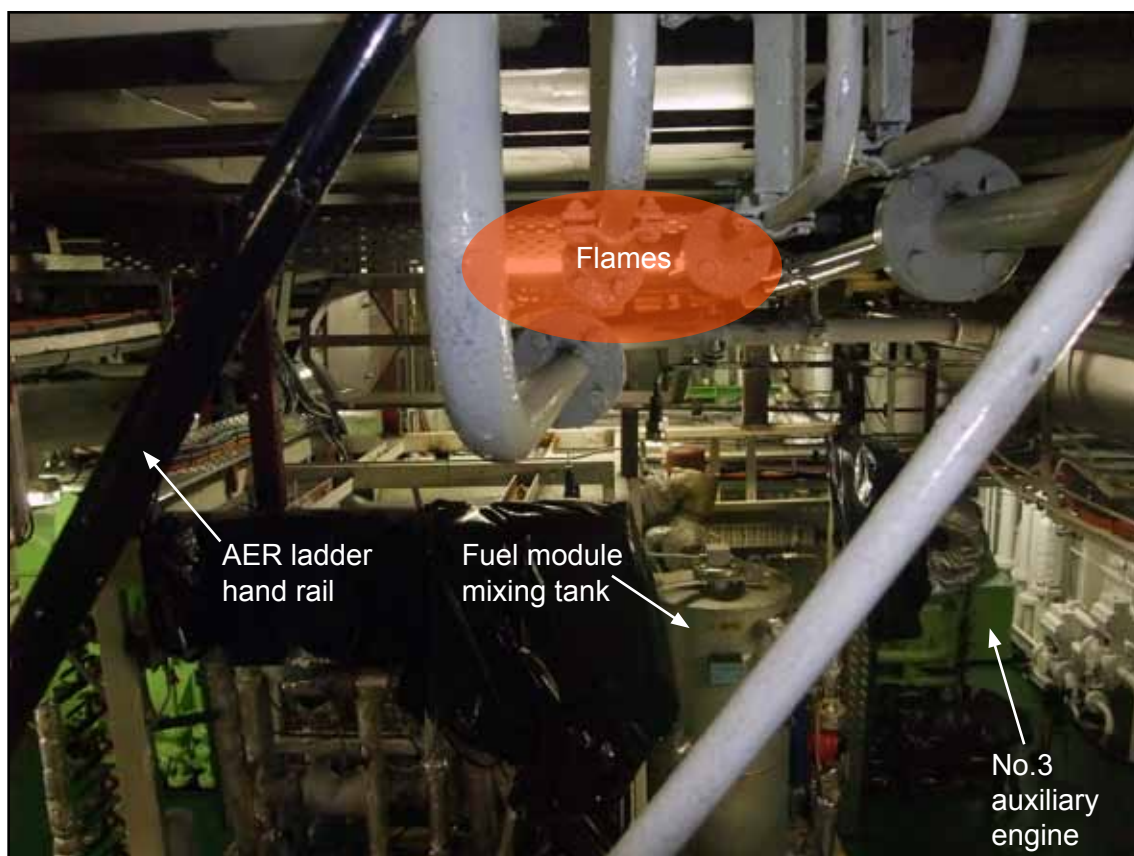
Figure 2

View of the fire from the auxiliary engine room ladder

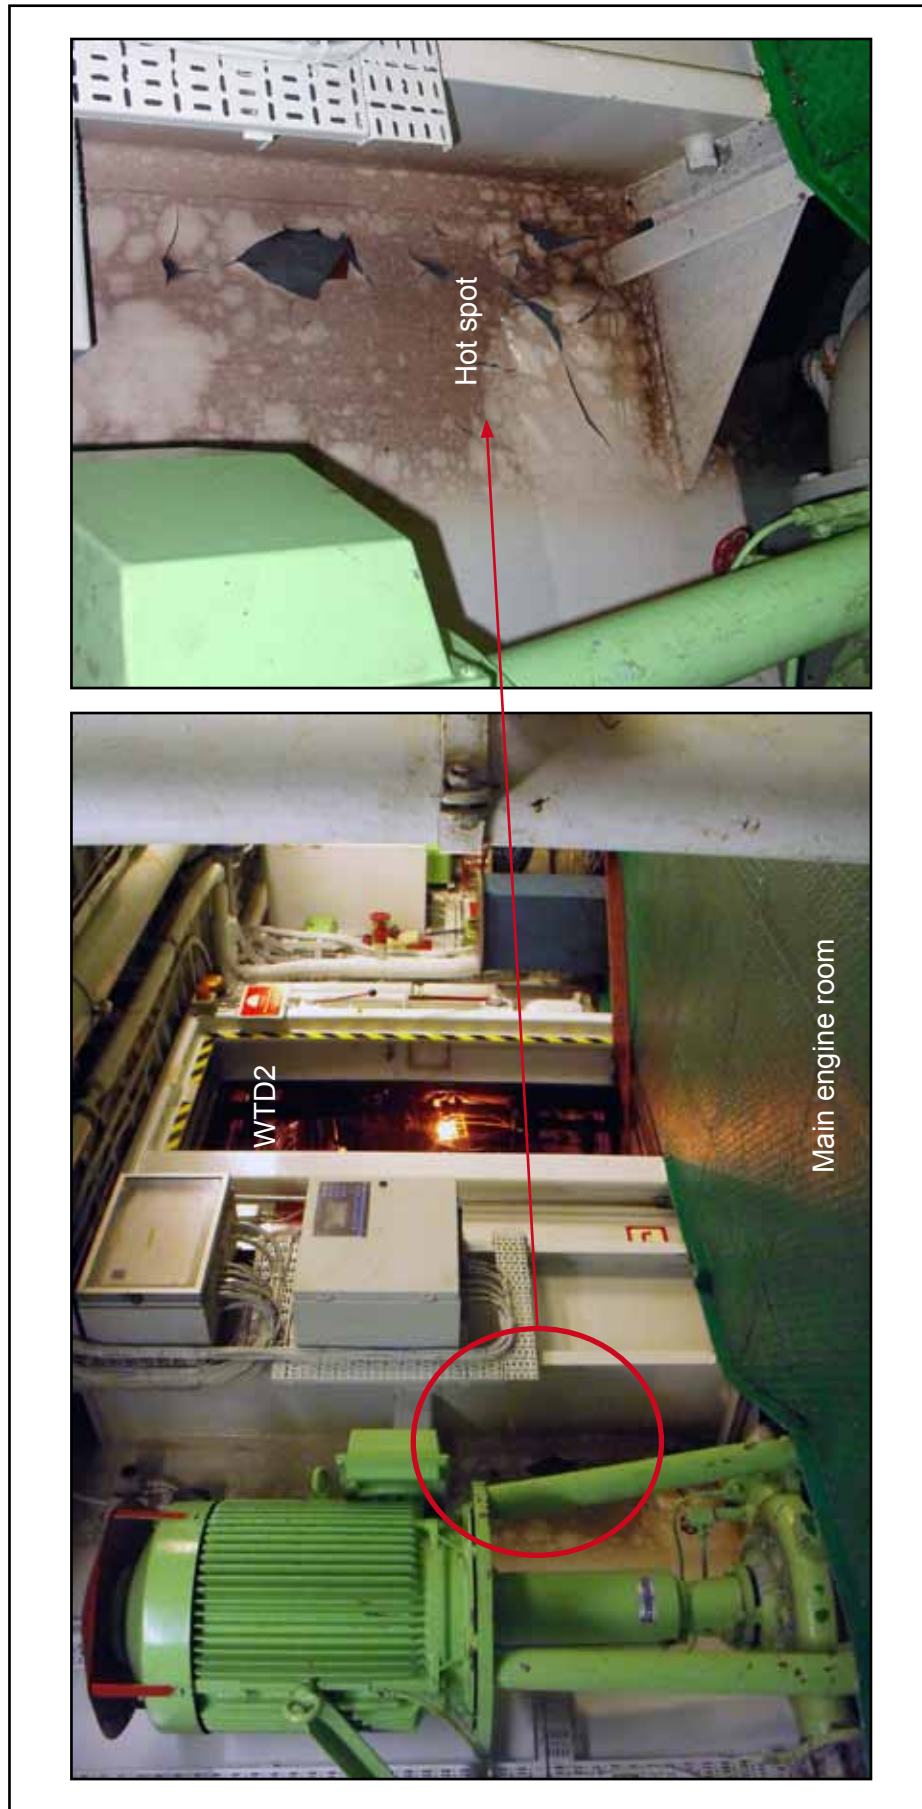
Figure 6

At 1927, the chief engineer reported hot spots on the deck of the lobby area outside the ECR. Two minutes later, the 2/E reported hot spots on the forward main engine room bulkhead next to WTD2 (**Figure 6**). The C/O interpreted this message to mean hot spots had been reported in the fire control station. This caused some confusion on the bridge as the control station was 2 decks above the AER (**Figure 7**).

Hot spots on main engine room bulkhead

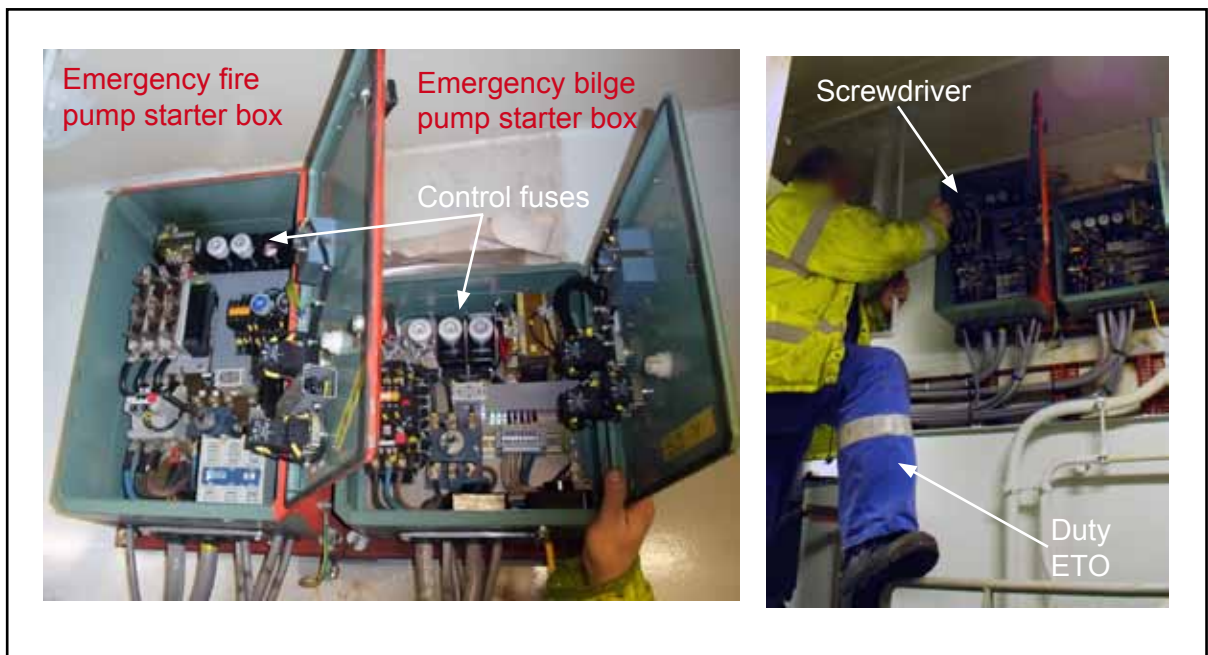
Figure 8

The emergency fire pump was not running. The 2/E opened its starter box and replaced a blown control fuse with a fuse taken from the adjacent emergency bilge pump starter box. This also blew when he attempted to restart the fire pump. The duty ETO climbed onto a set of guardrails next to the starter box, and used his screwdriver to push in the start control contactor (**Figure 8**). The pump started and fire main pressure was re-established. The EOOW was sent to close the engine room fire main isolation valve while the chief engineer went to the *Hotfoam* room, and the 2/E checked the *Hi-fog* system. The extra 2/E and the duty ETO remained in the bow thruster space.

Emergency fire pump starter box and actions of the duty ETO

In the bow thruster space, the duty ETO continued to hold in the emergency fire pump contactor which was sparking and generating smoke within the starter box. The extra 2/E advised the C/O that the pump might only last a further 5 minutes. A second ETO was dispatched to the bow thruster space with an emergency repair bag to assist his colleague.

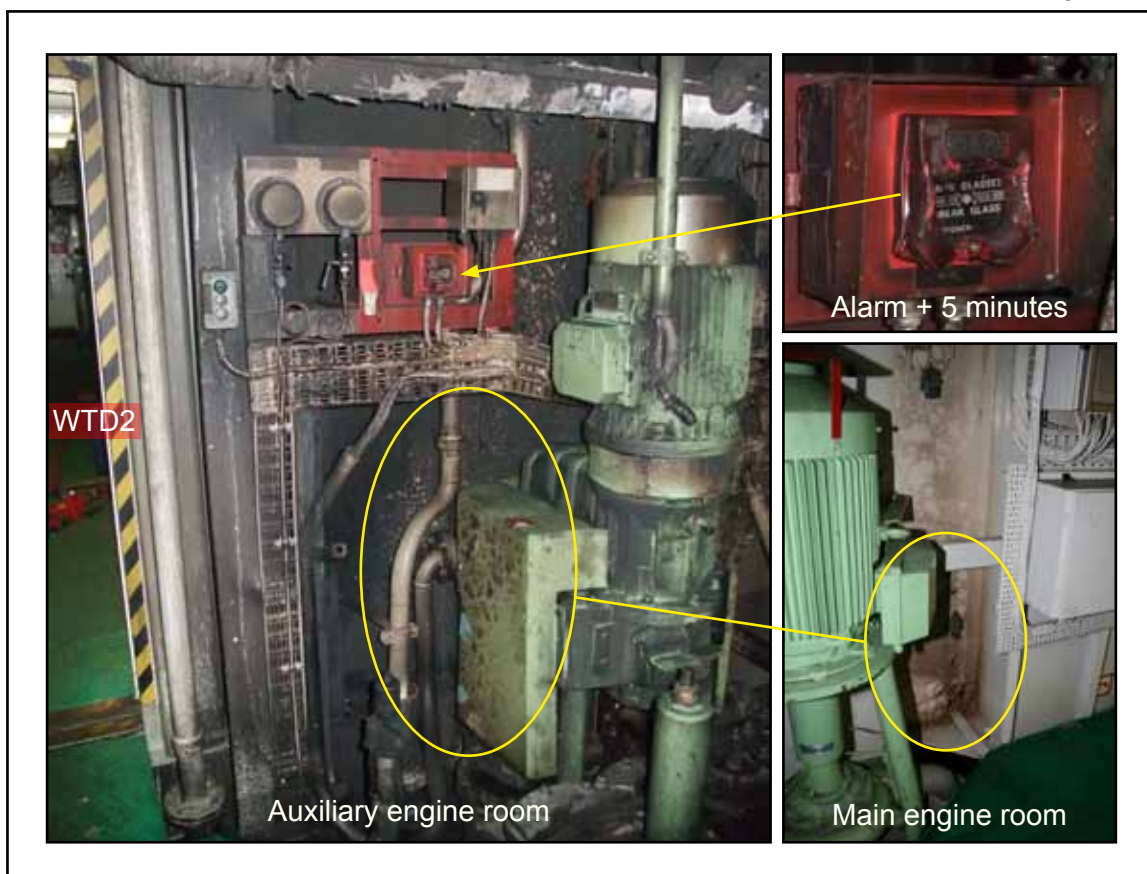
The heat from the bilge fires close to the aft AER bulkhead caused the casing of the manual break-glass fire alarm call point next to WTD2 to melt and the paint on the bulkhead in the main engine room to blister (**Figure 13**). The manual call point alarmed about 5 minutes after the initial flame sensor had activated.

Damage caused by bilge fire

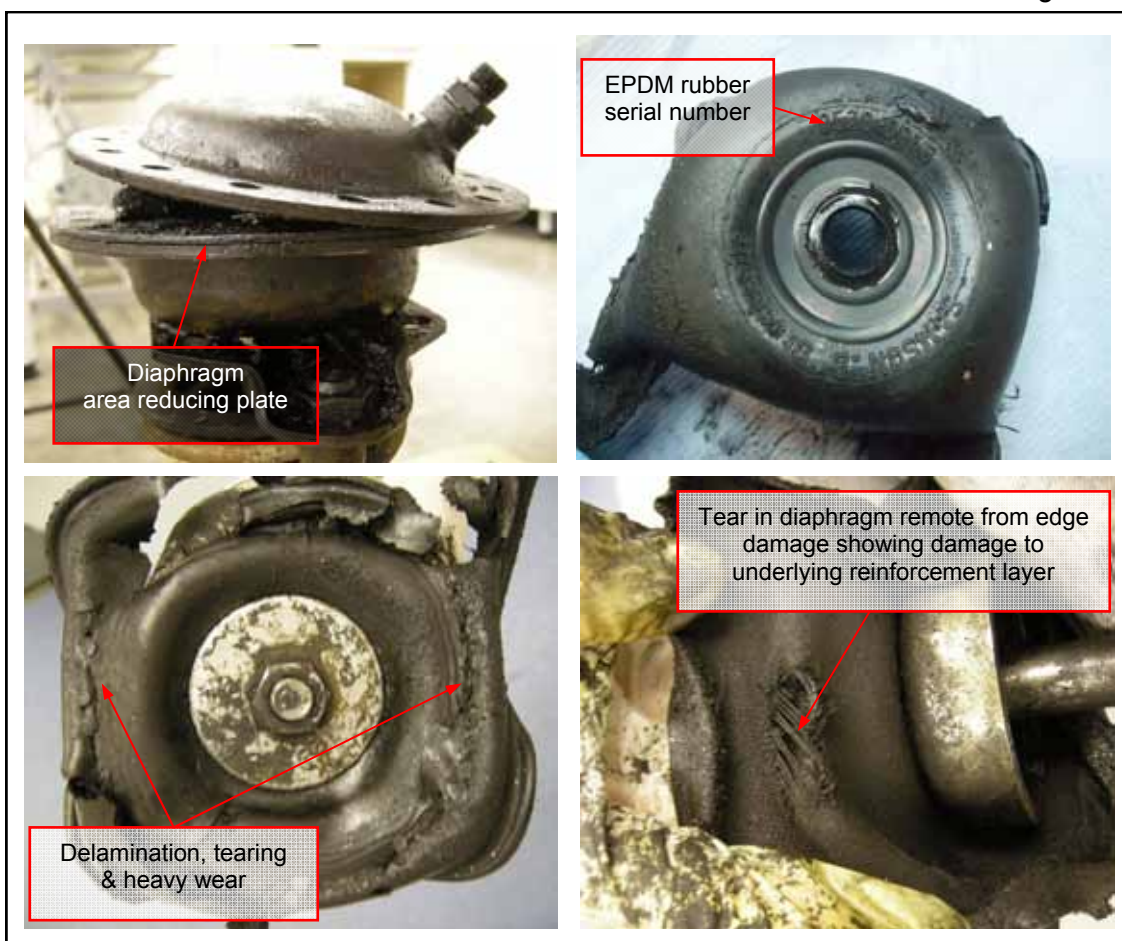
Figure 23

The test report on the diaphragm removed from the valve actuator identified deterioration of the rubber and a tear in its main flex region (**Annex B**). This damage was remote from the fire damage evident at its outer edge. The diaphragm was made from EPDM rubber and was therefore not suitable for use in fuel oil systems. The actuator had a diaphragm area reducing plate which increased the valves' operating pressure range to 4.5 to 10bar (**Figure 23**). The actuators fitted to the fuel modules on board *Oscar Wilde* were not fitted with any optional safety features.

Condition of the auxiliary engines' excess fuel pressure regulating valve diaphragm

Following the examination of damage to the diaphragm from the excess pressure regulating valve, similar valves fitted to the vessel's two main engine fuel modules were replaced. The diaphragms in the main engine valves were also made from EPDM rubber and found to be severely degraded in the main flex area (**Figure 24**). The replacement valves were fitted with FPM diaphragms, diaphragm leakage glands and rupture indicators.

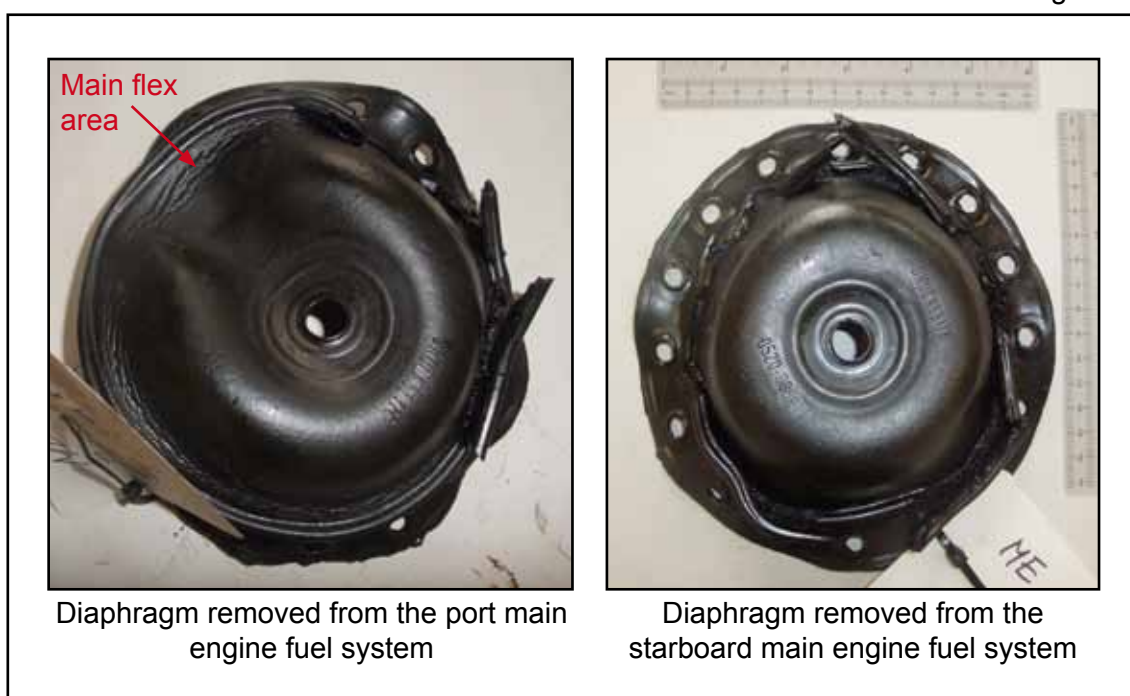
Figure 24

Main engine actuator diaphragms

The information on the actuator tally plates corresponded with that given for EPDM diaphragms and, in the case of the auxiliary engine system, the higher pressure range. No date stamps were found on any of the diaphragms. Neither Irish Ferries, nor the vessel's previous owners, had any record of the actuators being replaced or overhauled. Samson advised that the absence of date stamps on the diaphragms indicated that they were likely to be about 10 years old.

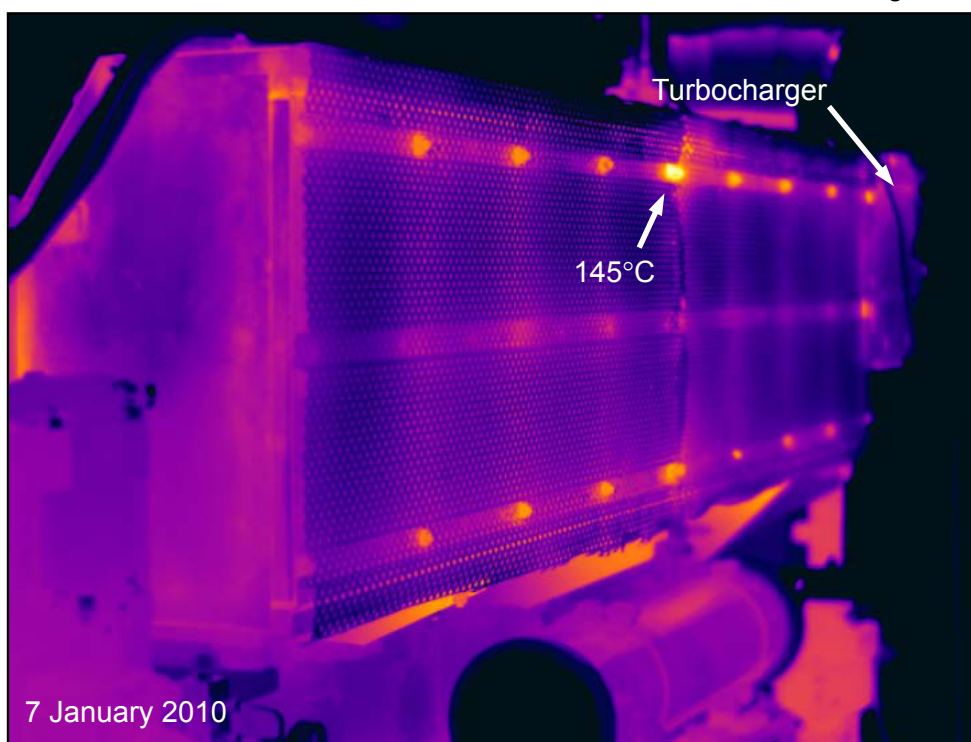
Figure 27

A thermal survey of the ship's electrical distribution system was carried out by a specialist contractor prior to the docking period. The main and auxiliary engines were not included in the work package but, at the request of the chief engineer, thermal images were taken of the auxiliary engine exhaust shields (**Figure 27**). These images identified hot spots, but information relating to the loading on the engines at the time of the survey was not available and no images were taken of the turbocharger or the outboard side of the engine. Work was carried out on the main and auxiliary engines during the docking period that would have required the removal of lagging and heat shields. However, a thermal survey was not carried out prior to the ship returning into service.

Thermal image taken of number three auxiliary engine exhaust manifold shielding prior to docking period

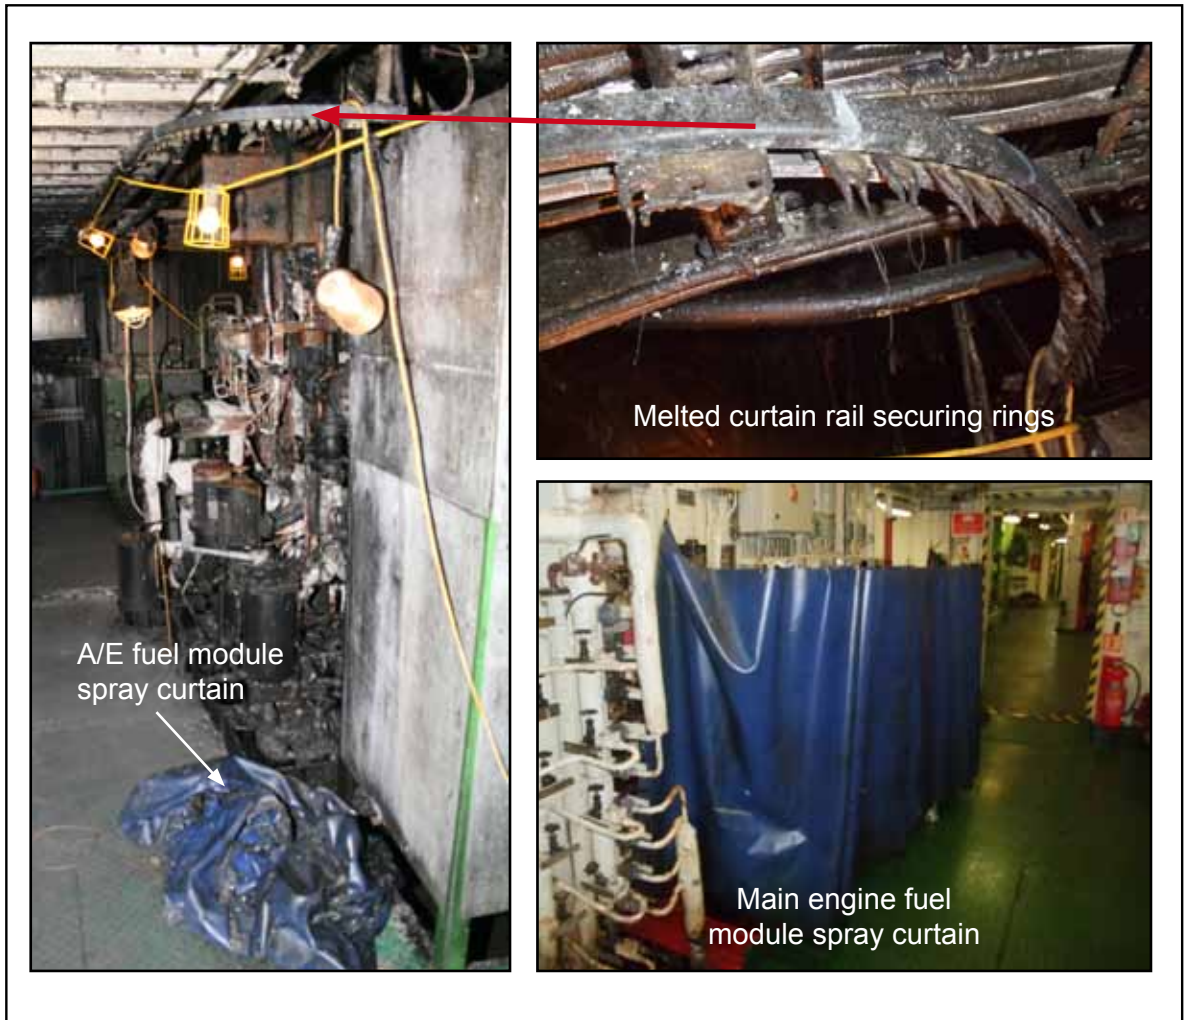
Figure 28

SOLAS also requires precautions to be taken to prevent any oil that escapes under pressure from any pump, filter or heater from coming into contact with heated surfaces. To help meet this requirement the vessel's previous owners had installed fuel spray curtains around the main and auxiliary engine fuel modules. The auxiliary engine fuel module's spray curtain securing rings had melted during the fire, and the curtain was found on the deck at the forward end of the module (**Figure 28**).

Fuel spray curtain

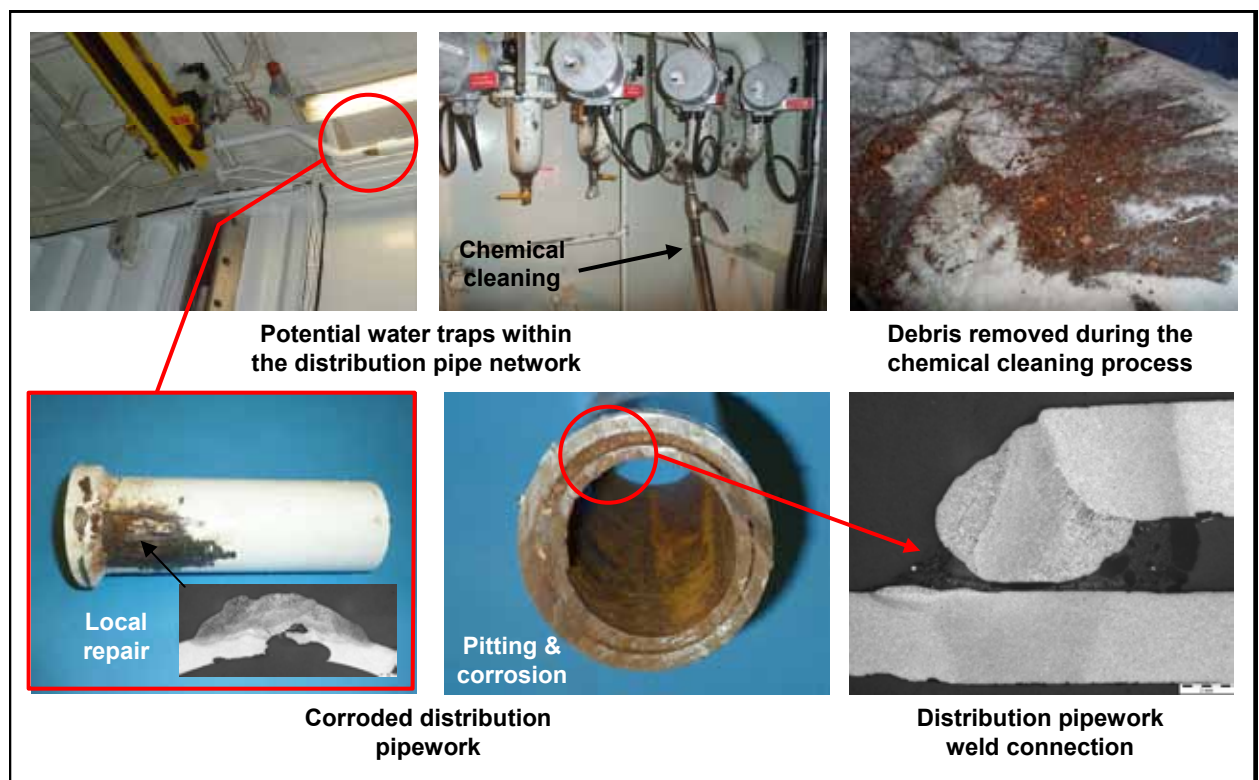
Figure 37

Hotfoam system distribution pipework

The distribution pipework was chemically cleaned and was proved clear of debris before being tested to the satisfaction of the class and flag surveyor. The manufacturer's investigation report included the following recommendations:
