Report on the investigation of the collision between
the bulk carrier
Alam Pintar
and the fishing vessel
Etoile des Ondes
15 miles north of the Cherbourg peninsula
on 20 December 2009
resulting in one fatality
and the loss of the fishing vessel

Marine Accident Investigation Branch
Mountbatten House
Grosvenor Square
Southampton
United Kingdom
SO15 2JU

Report No 11/2010
September 2010

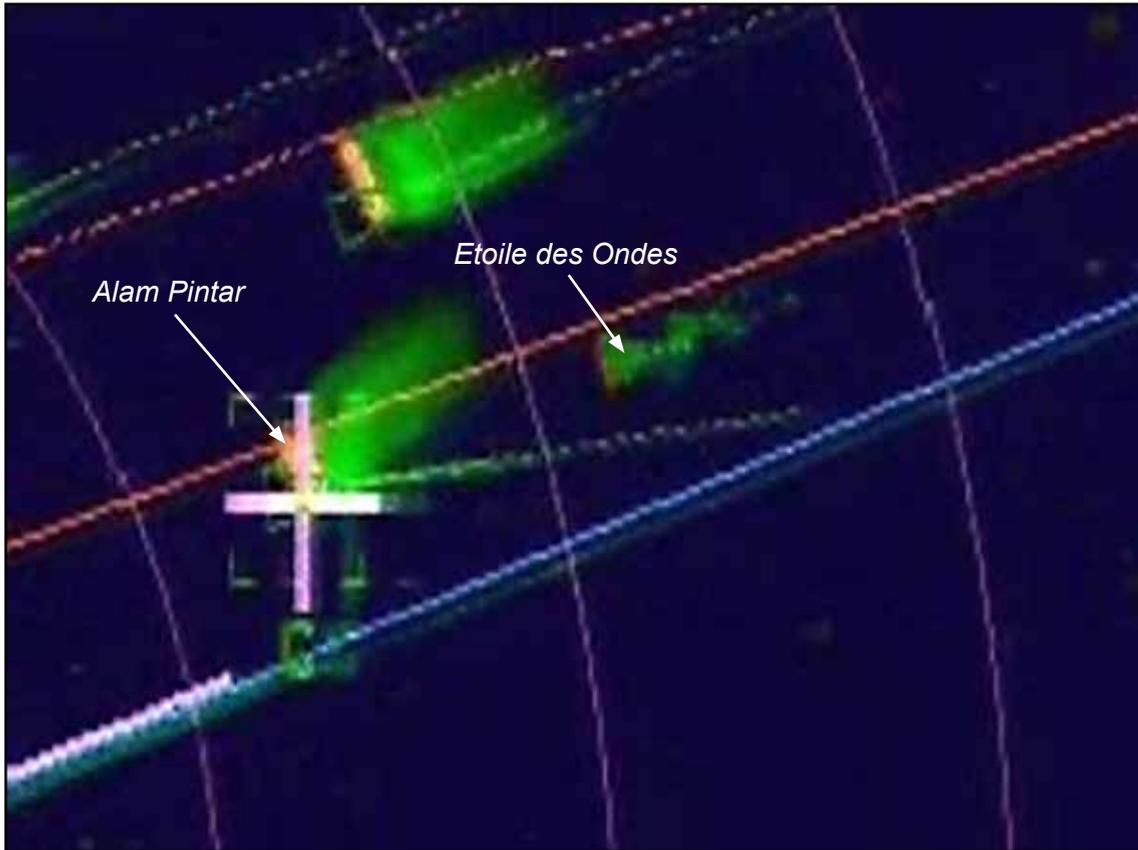
Figure 3

Radar screen shot* showing *Etoile des Ondes* on *Alam Pintar*'s port bow

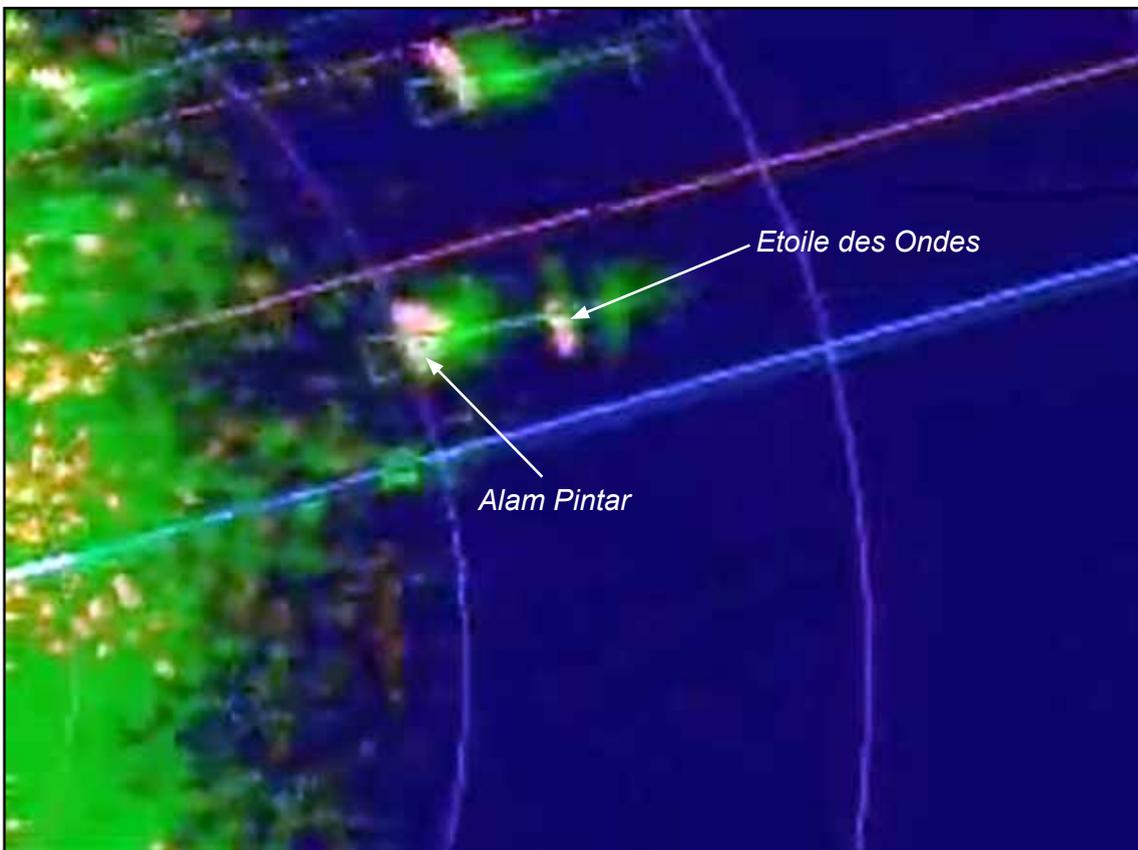
Figure 4

Initially, this action seemed to have been successful. However, as *Alam Pintar* drew closer, the fishing vessel's lights and radar target were observed to be tracking to starboard until, by 1846, the vessel had crossed over onto the starboard bow of *Alam Pintar* (**Figure 4**). At this time, the fishing vessel was less than 1 nm away.

Radar screen shot* showing *Etoile des Ondes* fine on *Alam Pintar*'s starboard bow

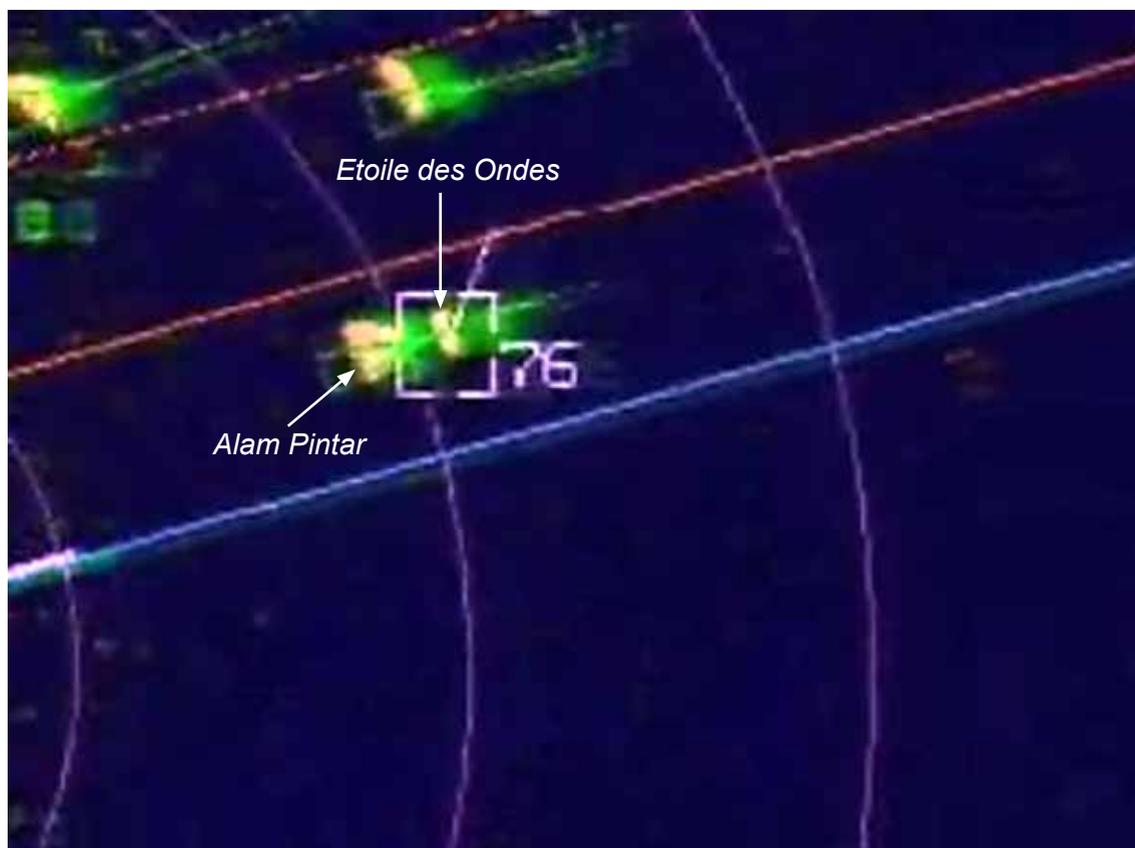
Radar screen shot showing *Etoile des Ondes* still ahead of *Alam Pintar* with a vector to the north

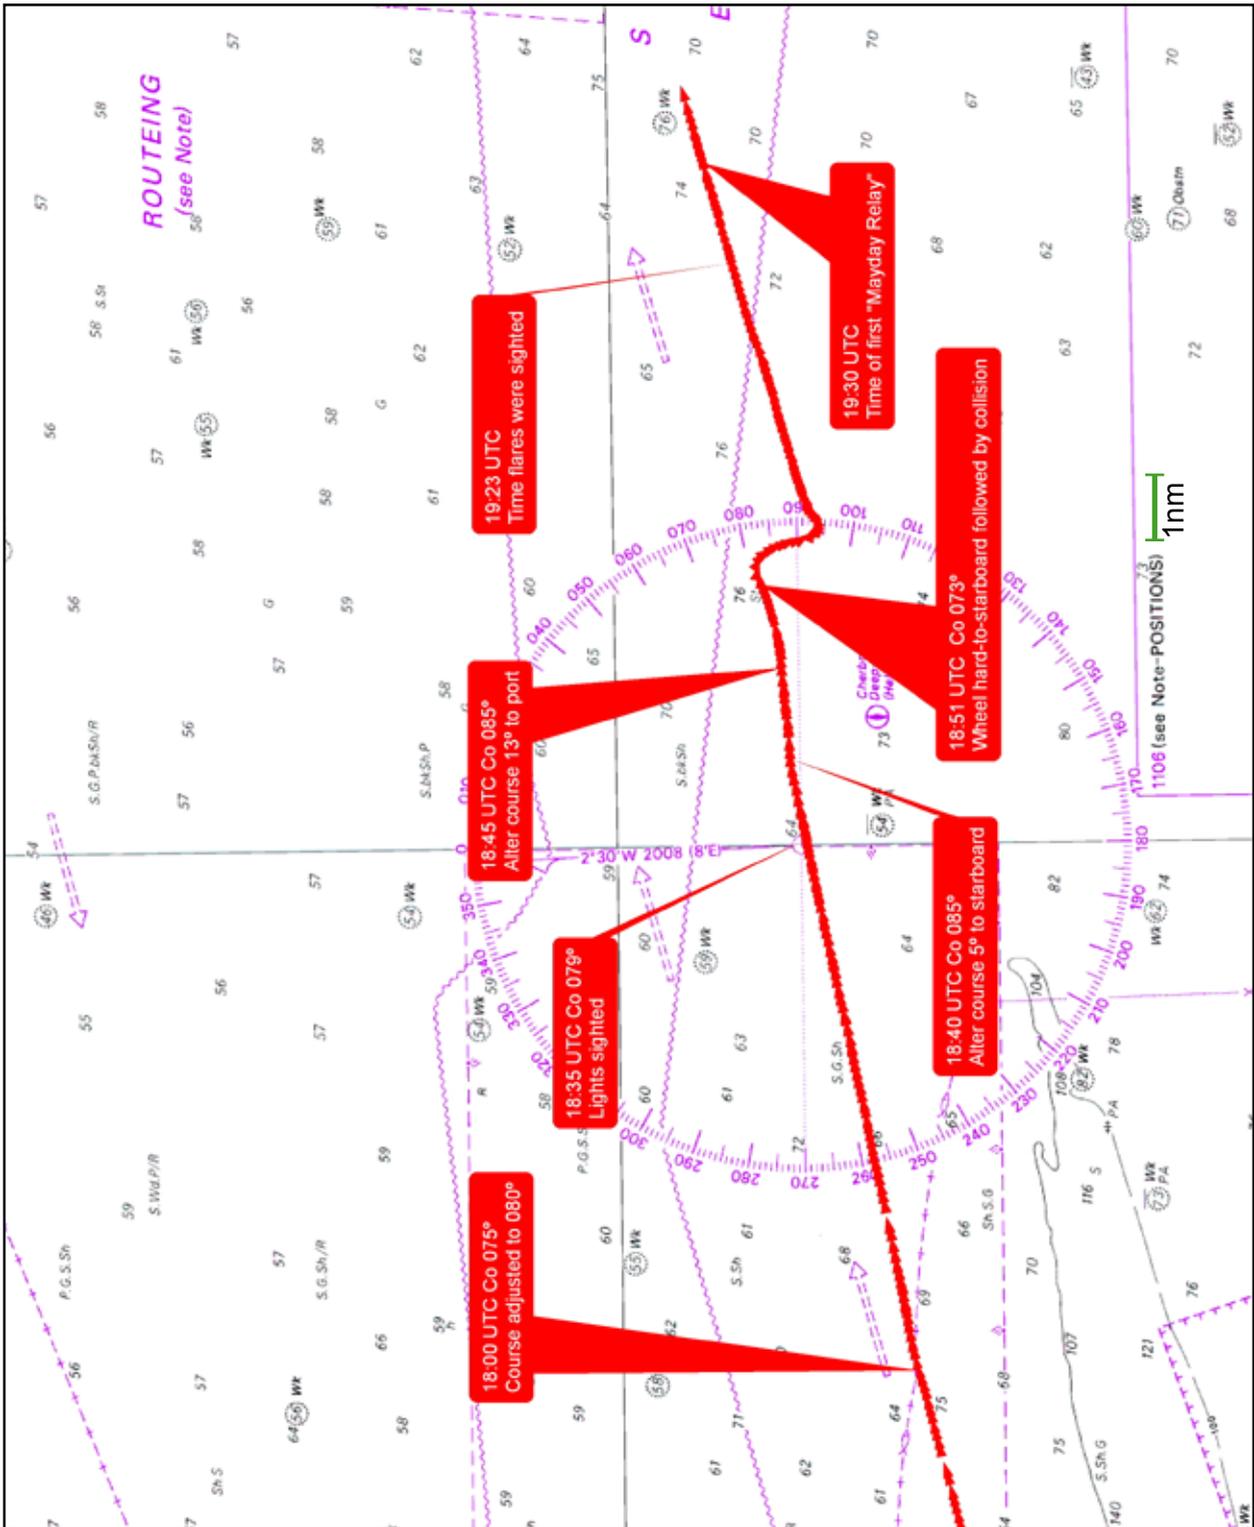
AIS record of the track taken by *Alam Pintar*

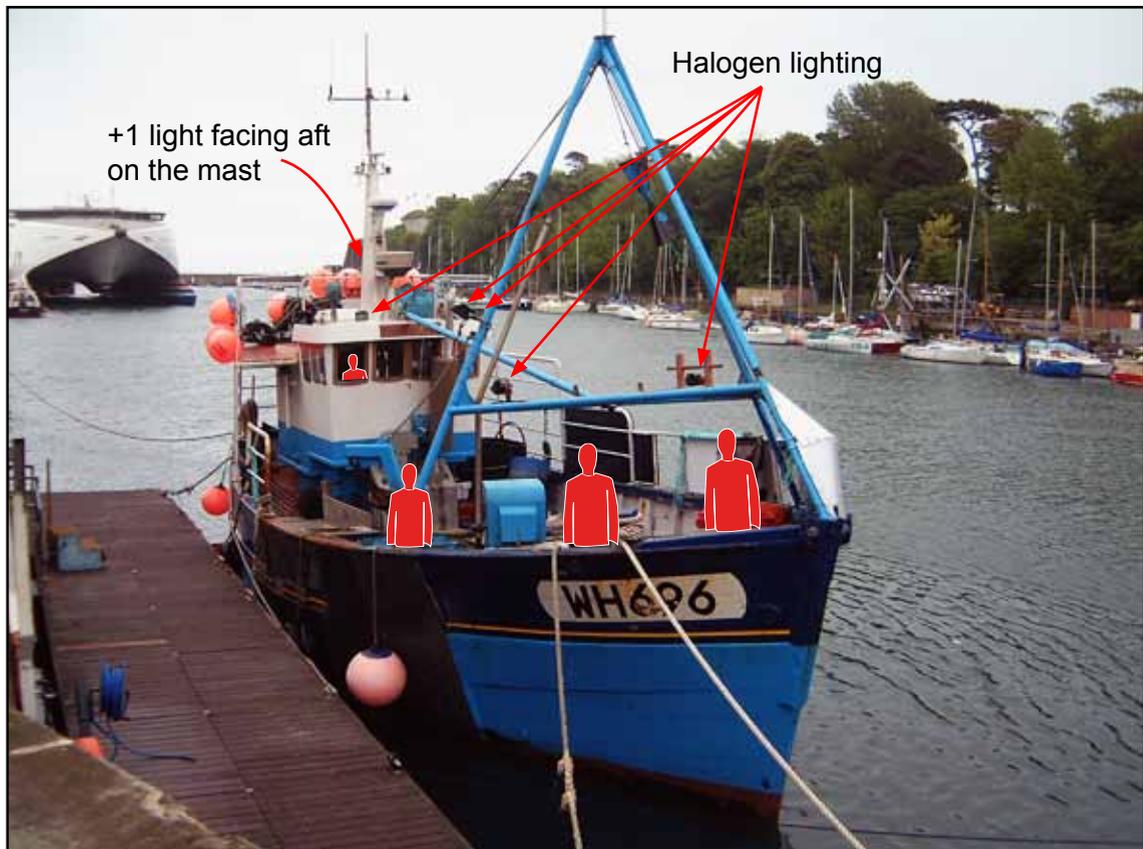
Etoile des Ondes - with halogen lighting and crew positions indicated
(whaleback omitted for clarity)

Initially, the alteration did seem to be effective, but it was subsequently counteracted by (from the perspective of the OOW) random changes of course by *Etoile des Ondes*. The OOW also found it difficult to identify the fishing vessel's navigation lights against the high powered halogen deck lights.

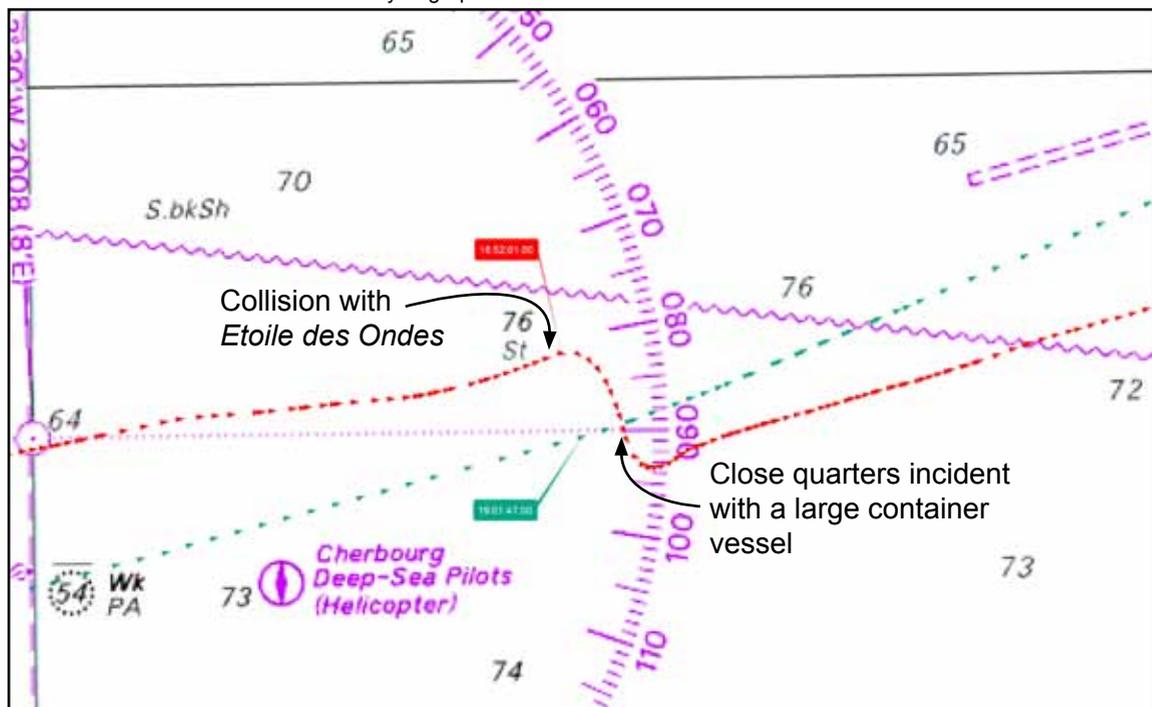
Figure 8

AIS track of *Alam Pintar* and a large container vessel

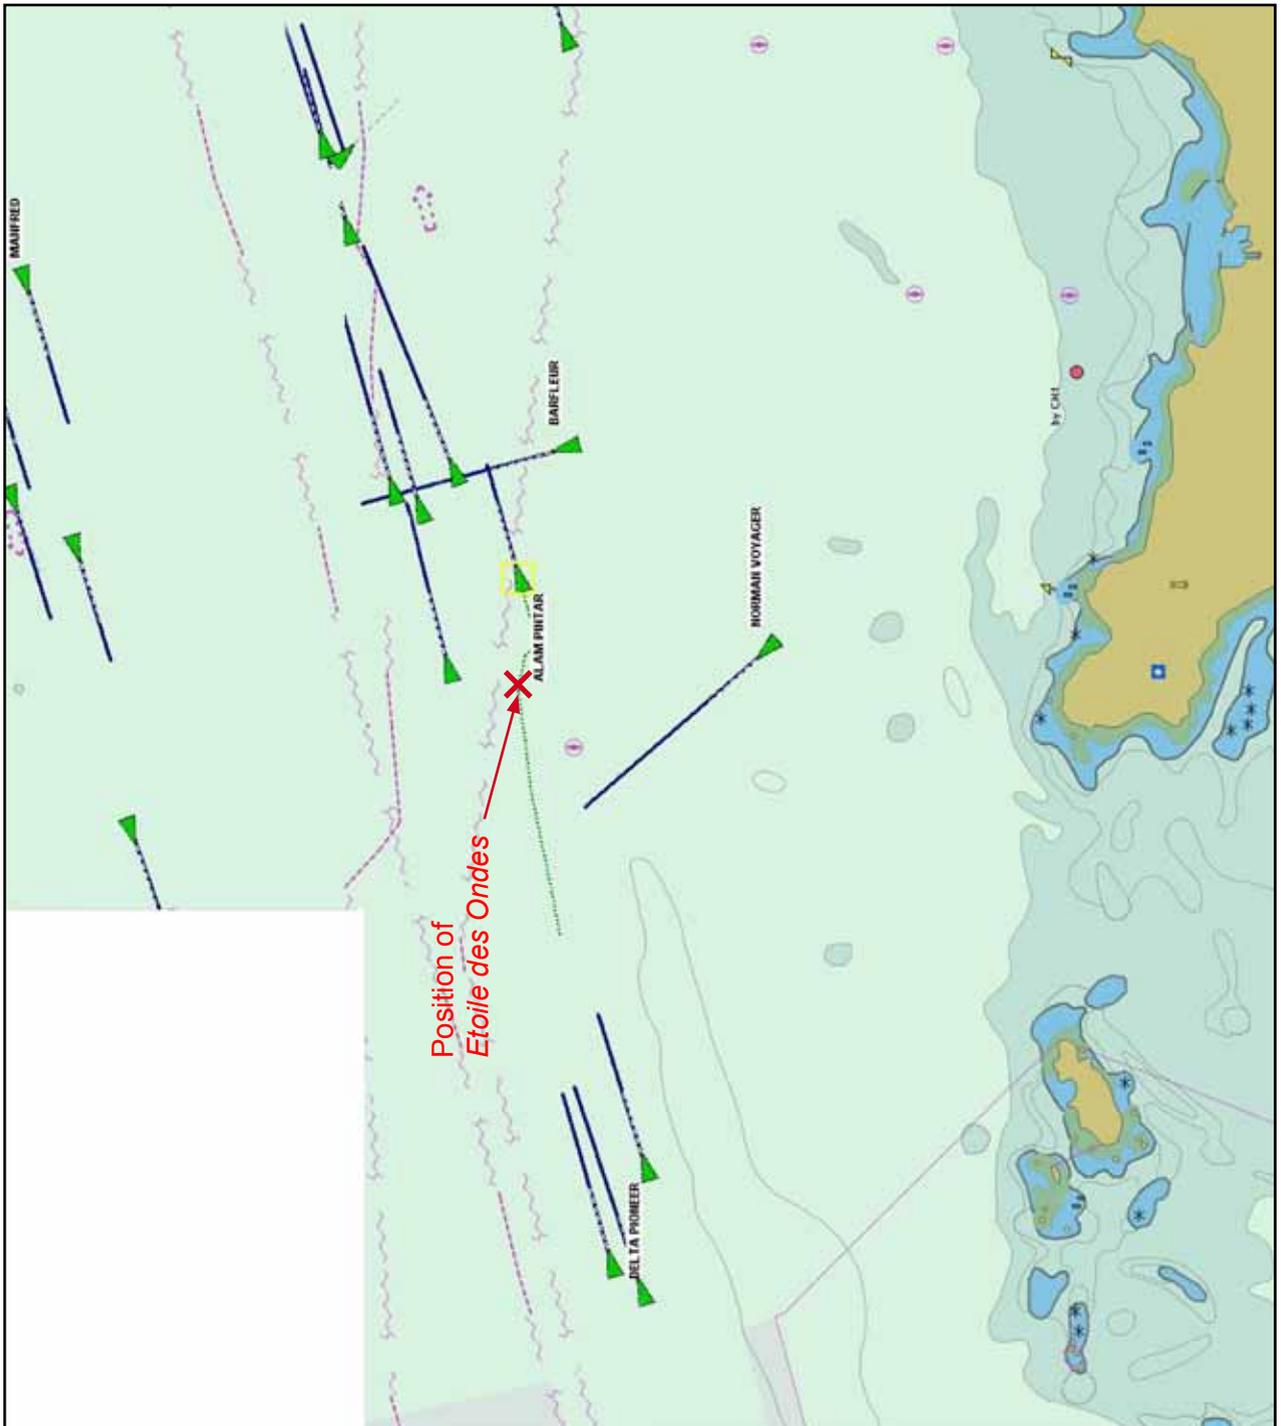
Figure 10

Several vessels were within 15 nm of the liferaft from *Etoile des Ondes* when her skipper fired the first of two red parachute distress flares (**Figure 10**). While it is not known how many actually saw the flares, they were seen by at least two vessels: *Norman Voyager* at 4.8 nm away, and *Manfred* at 14.6 nm away. Both these vessels reported the sighting to Jobourg MRCC and proceeded to render assistance.

General AIS positions of vessels in the area at the time flares were set off

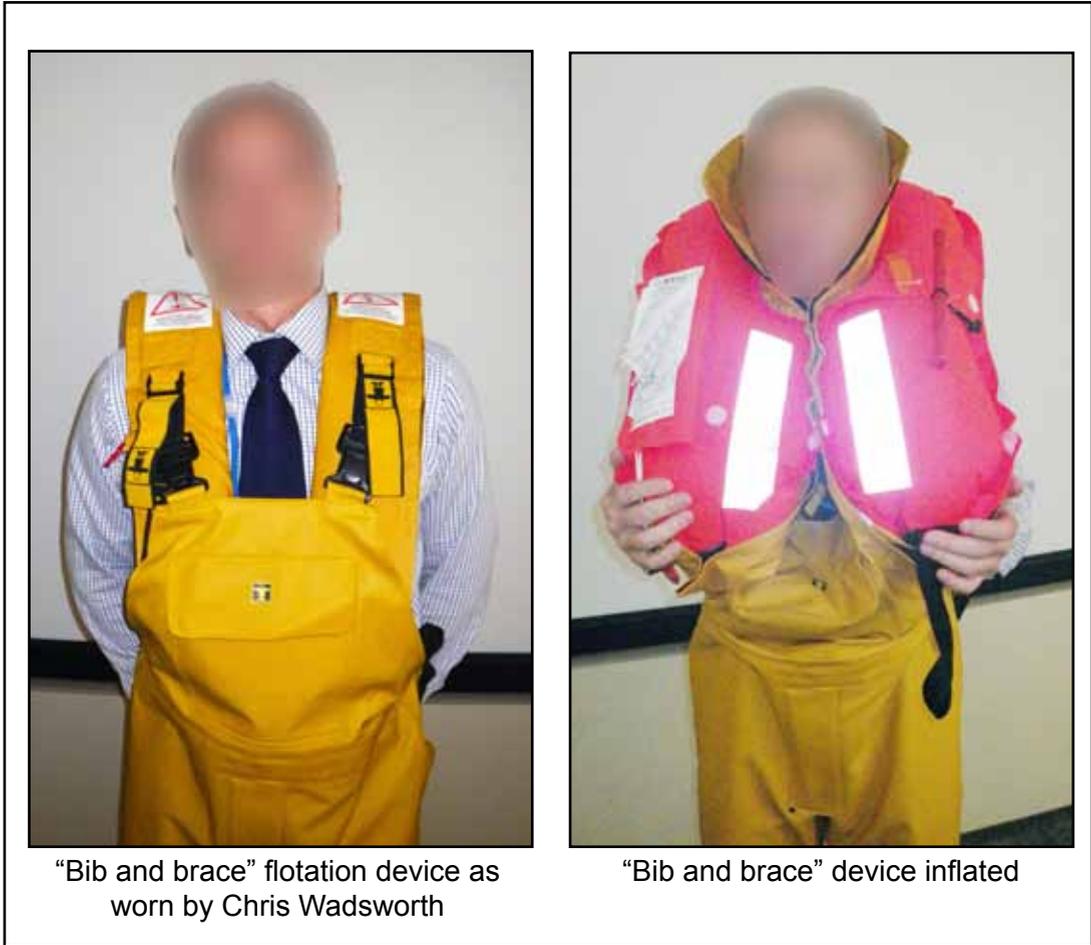
Figure 12

However, Chris had grown used to wearing his "bib and brace" device, with an incorporated lifejacket (**Figure 12**). He wore it whenever he was working on deck until a recent incident where the lifejacket had accidentally inflated. This had caused him some distress and made it difficult for him to breathe. The lifejacket needed to be punctured to deflate it for removal. After this incident, he stopped wearing any flotation device.

Ironically, the only crew member to continually wear a flotation device, of the "bib and brace" type (**Figure 12**), was Chris. He used a "Guy Cotton" unit until a few weeks before the collision, and only stopped wearing it because it had accidentally inflated, which restricted his breathing, causing him distress.

The device used by Chris was designed to operate automatically. When immersed in water, a soluble tablet dissolves and causes the unit to inflate. Accidental inflation incidents are not unheard of, but should not cause the wearer any distress. As part of the routine maintenance of the unit, the manufacturers recommended these tablets be replaced at regular intervals as they can degrade over time in a marine environment.

After the device inflated it should not have caused Chris any breathing restriction. However, if he had been wearing a standard fishing smock over the bib, this would have contained the inflating lifejacket and caused a significant restriction around his neck. To avoid this, only a smock specifically designed to be compatible with a lifejacket should be worn. These smocks are fitted with expansion gussets that open as the lifejacket inflates.

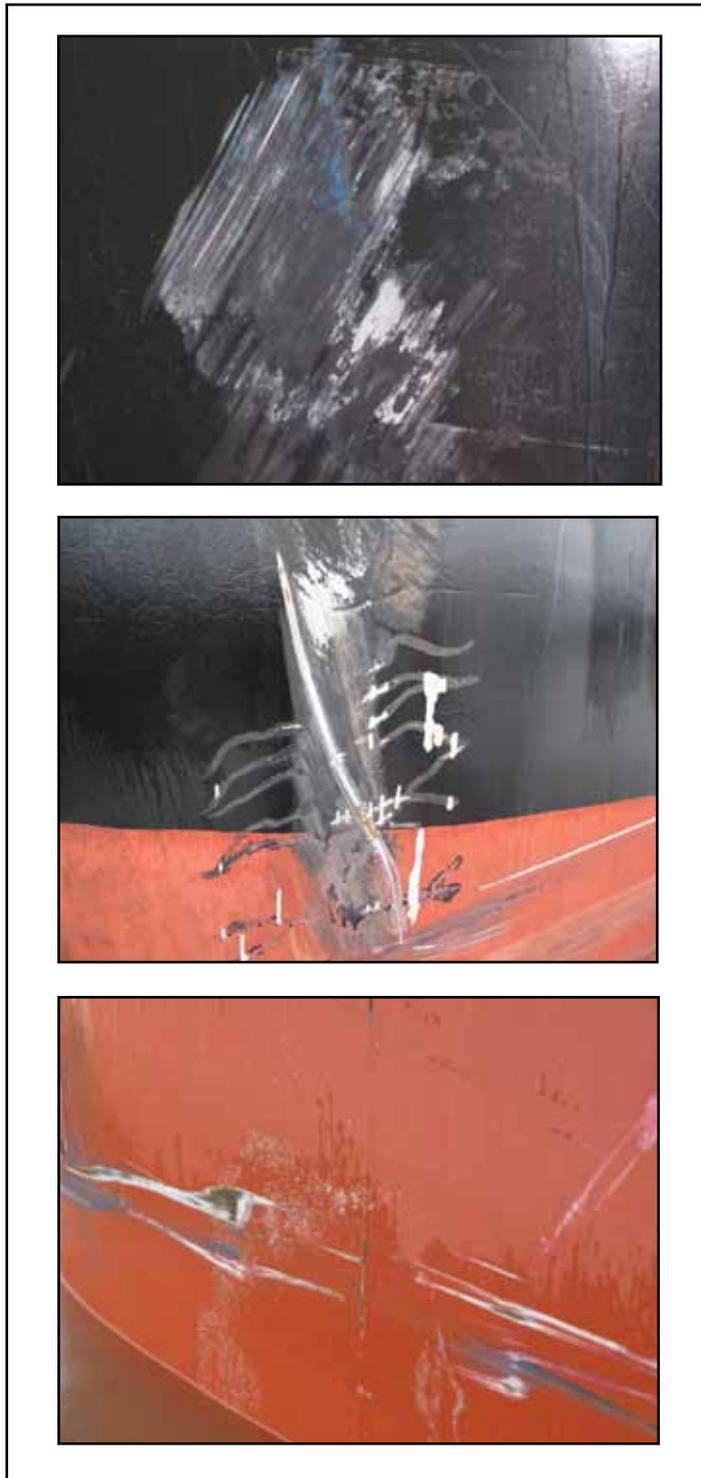
Figure 15

While alongside in Hamburg, *Alam Pintar*'s hull was inspected at close range from a mooring boat, for signs of contact. Cosmetic damage and traces of blue paint were found on the bow (**Figure 15**) and on the port quarter (**Figure 16**). As her hull was black, these blue paint traces were a strong indication of contact with another vessel.

Photographs of *Alam Pintar's* bow indicating contact and showing traces of blue paint

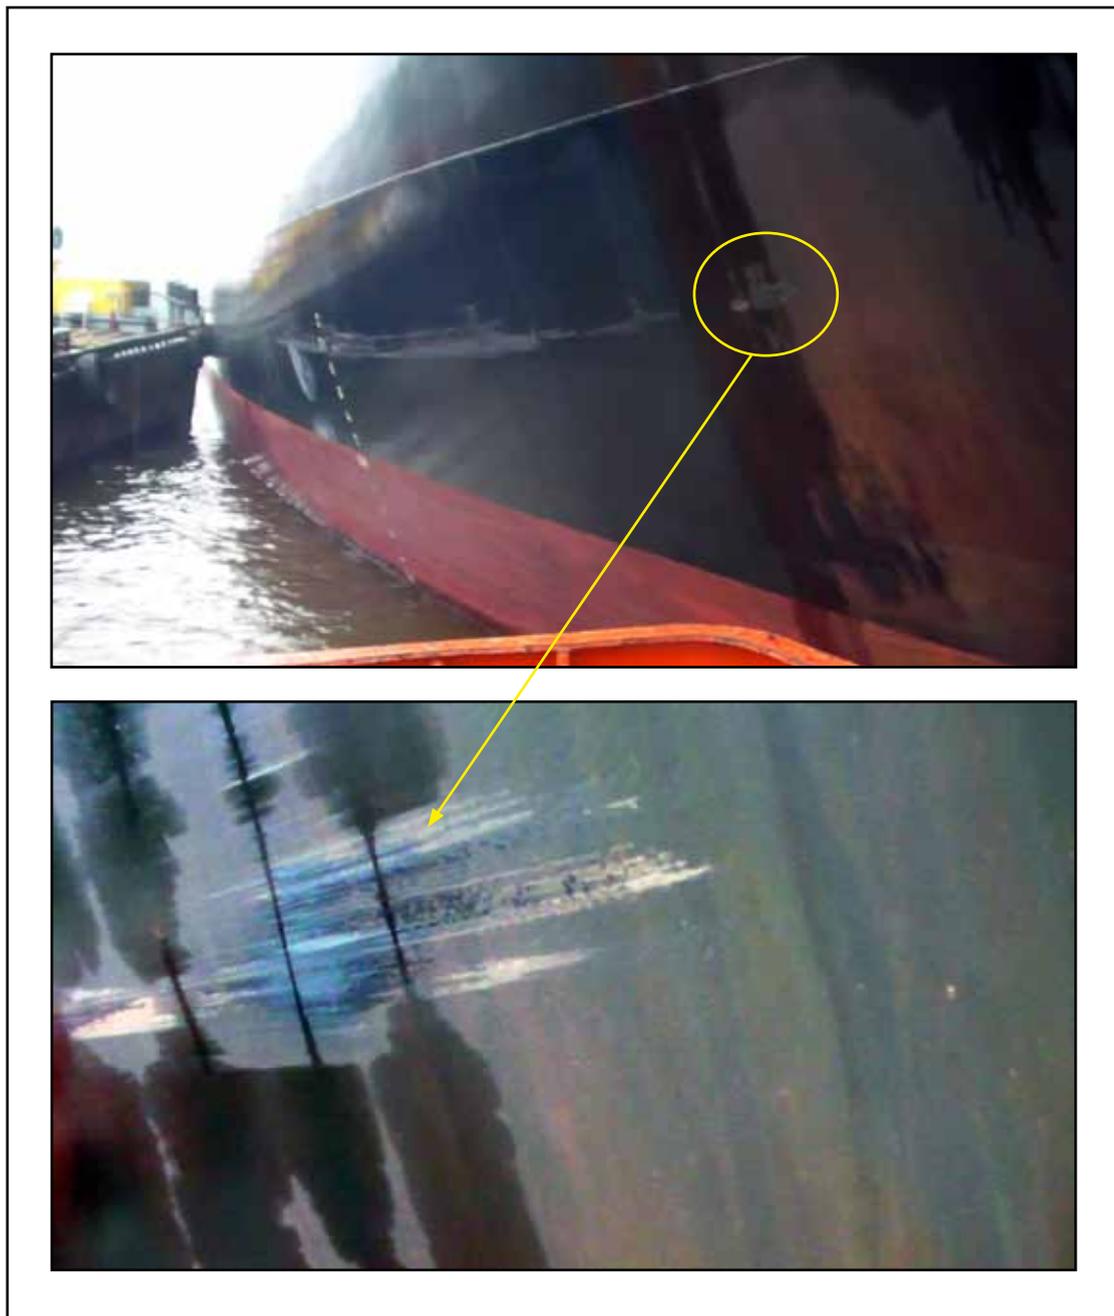
Figure 16

Further indication of contact and traces of blue paint with close-up detail

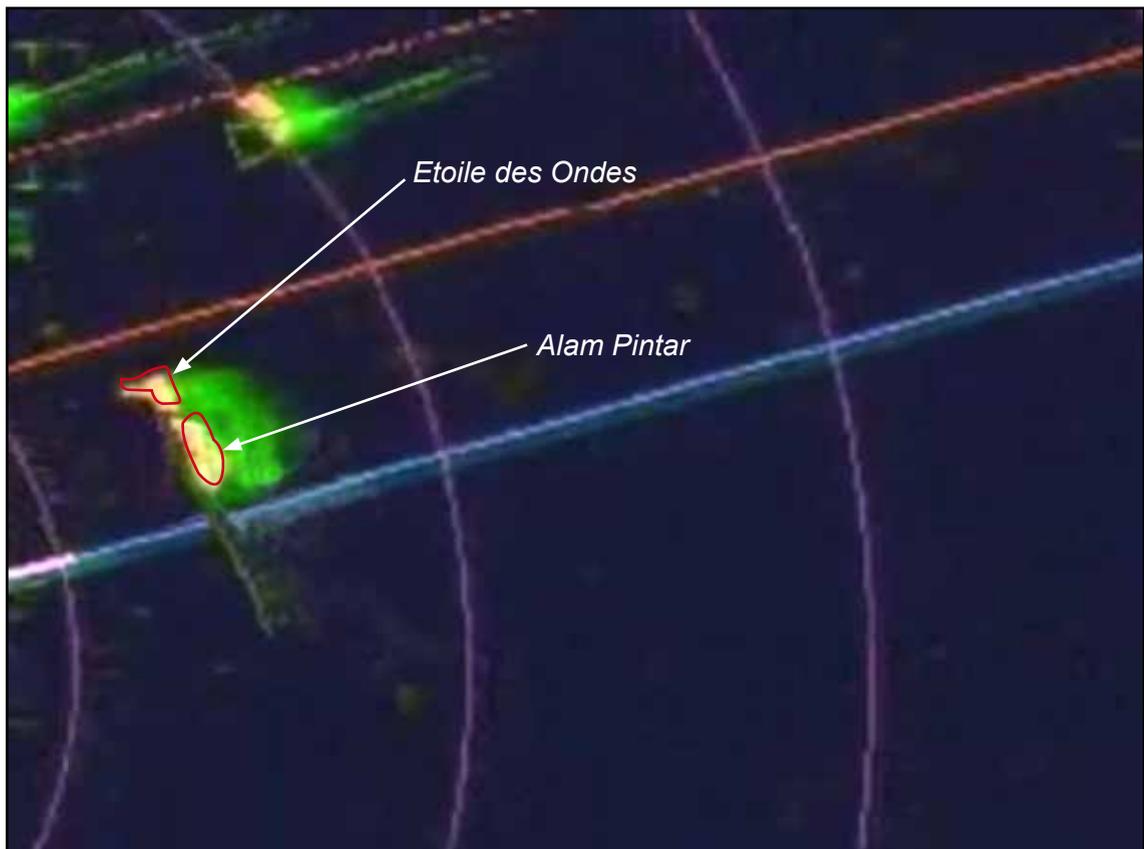
Figure 17

The master, by assuming *Etoile des Ondes* was still afloat, and deciding to continue, was in disregard of his responsibilities. However, once he had reason to believe that *Etoile des Ondes* and her crew were not safe, his action in ignoring the "Mayday Relay" and continuing on passage was illegal, immoral and against all the traditions of the sea.

Screen shot (enhanced) showing *Etoile des Ondes* left astern of *Alam Pintar*
