Report on the investigation of the collision between  
the bulk carrier  
***Alam Pintar***  
and the fishing vessel  
***Etoile des Ondes***  
15 miles north of the Cherbourg peninsula  
on 20 December 2009  
resulting in one fatality  
and the loss of the fishing vessel

**Report No 11/2010**  
**September 2010**

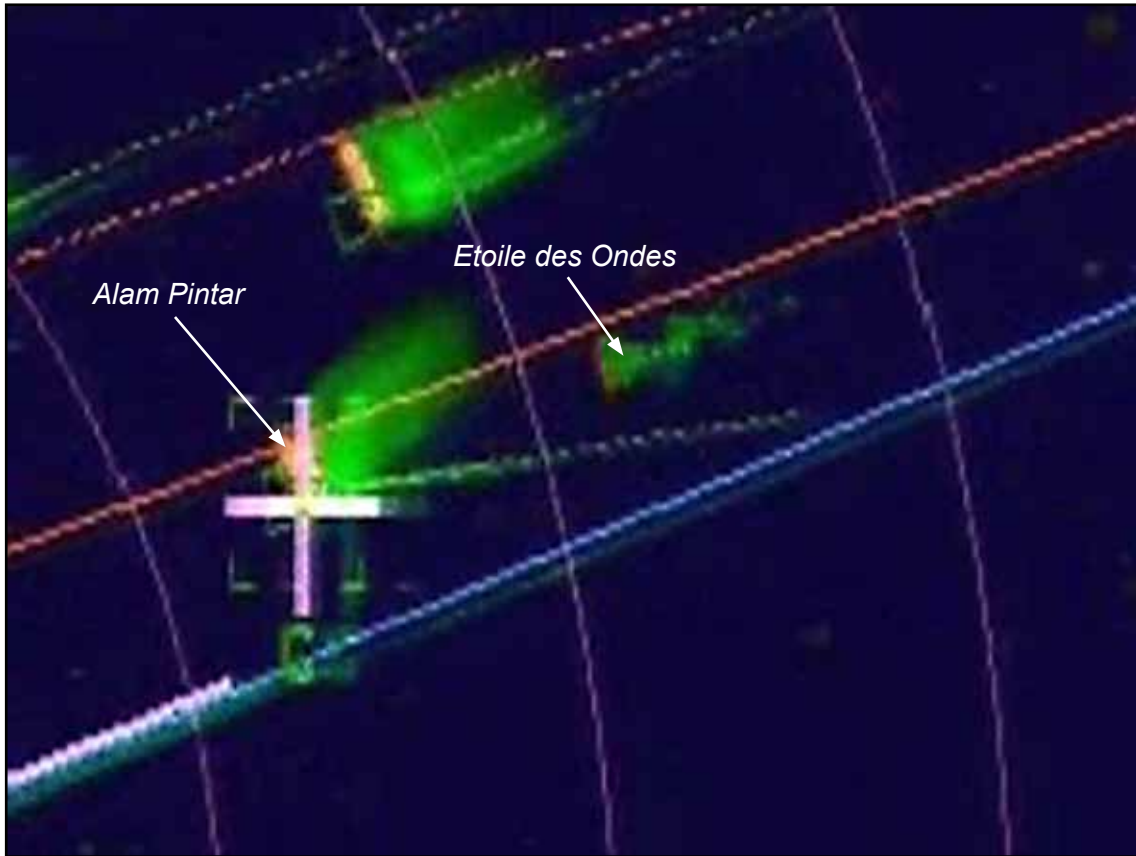
Figure 3

Radar screen shot\* showing *Etoile des Ondes* on *Alam Pintar*'s port bow

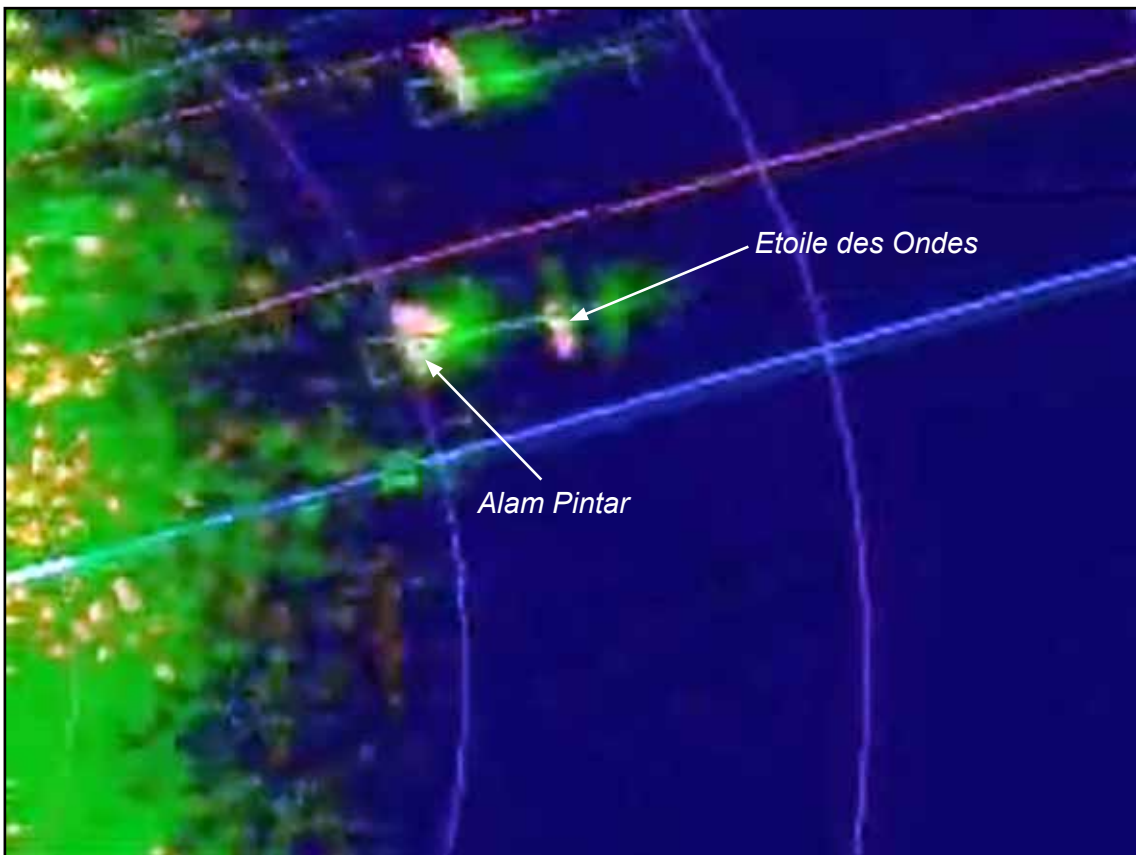
Figure 4

Initially, this action seemed to have been successful. However, as *Alam Pintar* drew closer, the fishing vessel's lights and radar target were observed to be tracking to starboard until, by 1846, the vessel had crossed over onto the starboard bow of *Alam Pintar* (**Figure 4**). At this time, the fishing vessel was less than 1 nm away.

Radar screen shot\* showing *Etoile des Ondes* fine on *Alam Pintar*'s starboard bow

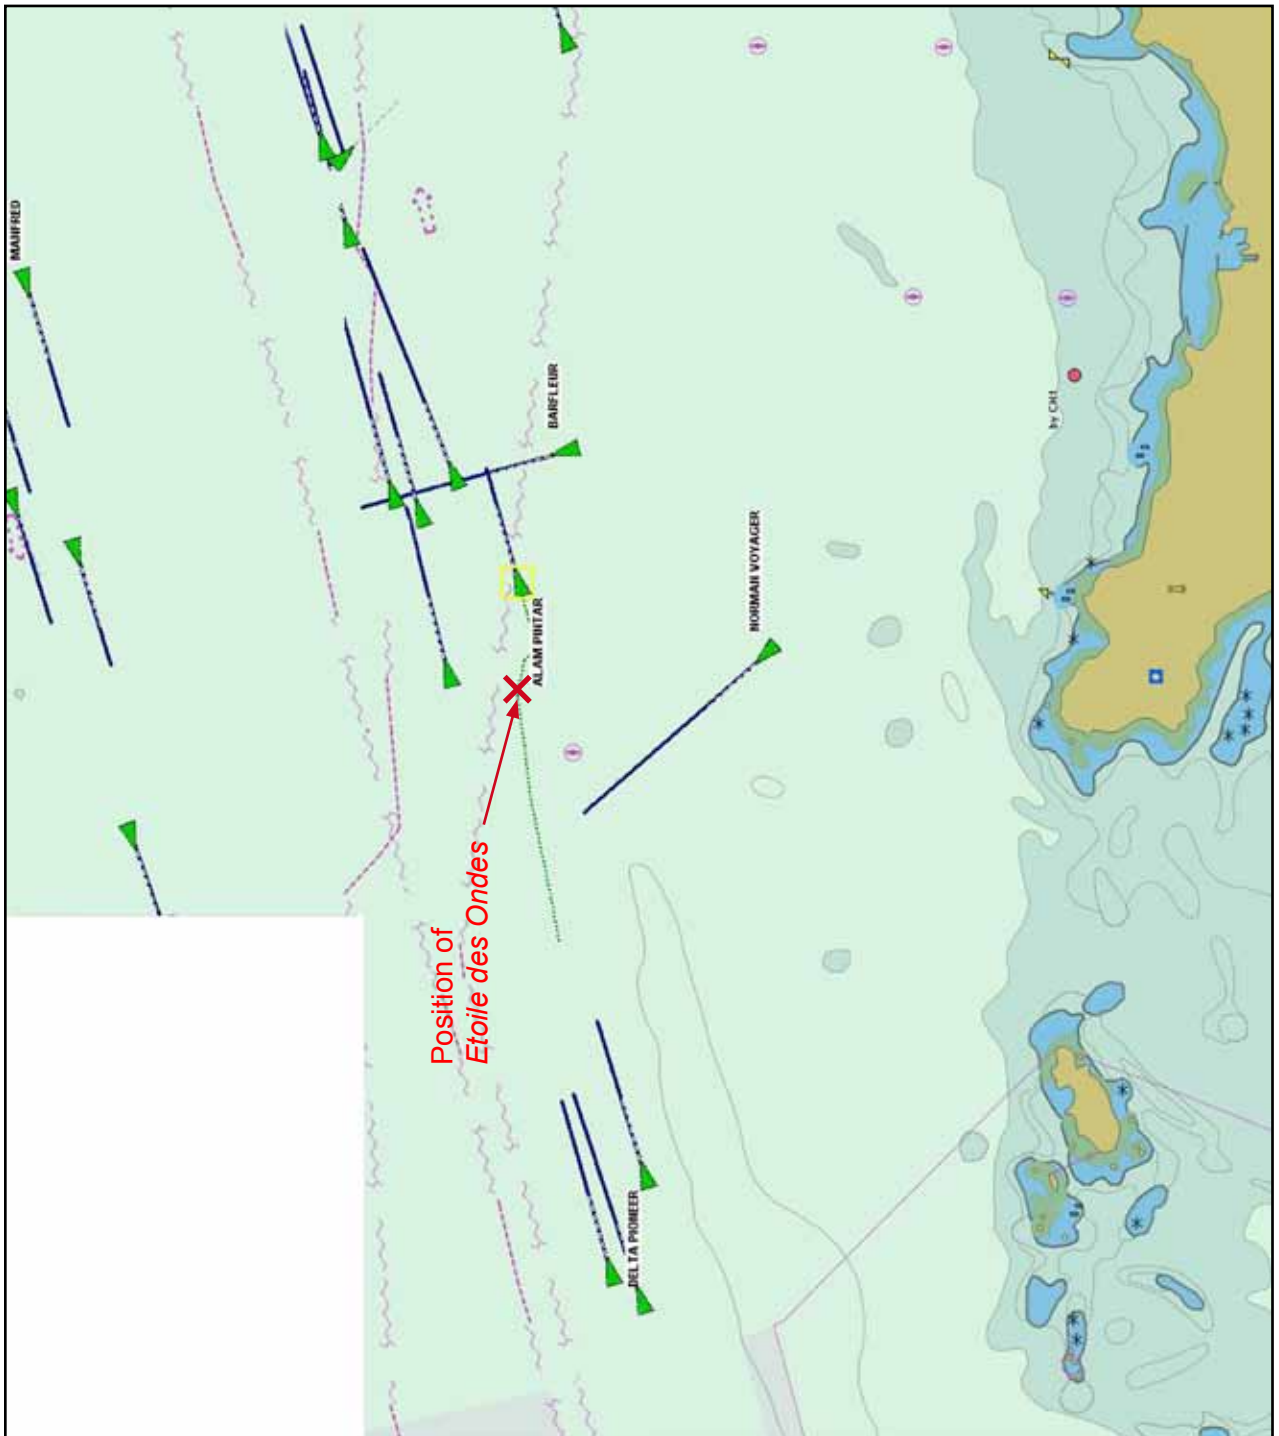
Figure 10

Several vessels were within 15 nm of the liferaft from *Etoile des Ondes* when her skipper fired the first of two red parachute distress flares (**Figure 10**). While it is not known how many actually saw the flares, they were seen by at least two vessels: *Norman Voyager* at 4.8 nm away, and *Manfred* at 14.6 nm away. Both these vessels reported the sighting to Jobourg MRCC and proceeded to render assistance.

General AIS positions of vessels in the area at the time flares were set off

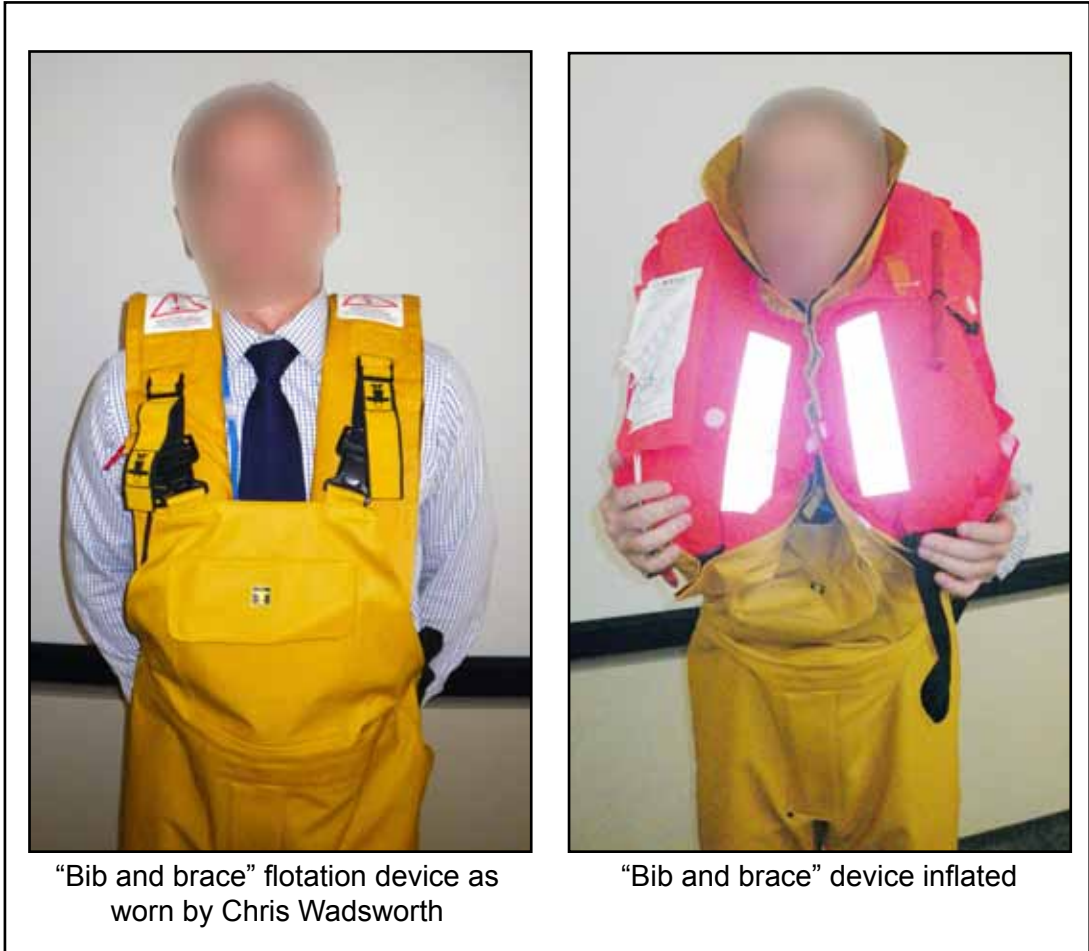
Figure 12

However, Chris had grown used to wearing his "bib and brace" device, with an incorporated lifejacket (**Figure 12**). He wore it whenever he was working on deck until a recent incident where the lifejacket had accidentally inflated. This had caused him some distress and made it difficult for him to breathe. The lifejacket needed to be punctured to deflate it for removal. After this incident, he stopped wearing any flotation device.

Ironically, the only crew member to continually wear a flotation device, of the "bib and brace" type (**Figure 12**), was Chris. He used a "Guy Cotton" unit until a few weeks before the collision, and only stopped wearing it because it had accidentally inflated, which restricted his breathing, causing him distress.

After the device inflated it should not have caused Chris any breathing restriction. However, if he had been wearing a standard fishing smock over the bib, this would have contained the inflating lifejacket and caused a significant restriction around his neck. To avoid this, only a smock specifically designed to be compatible with a lifejacket should be worn. These smocks are fitted with expansion gussets that open as the lifejacket inflates.

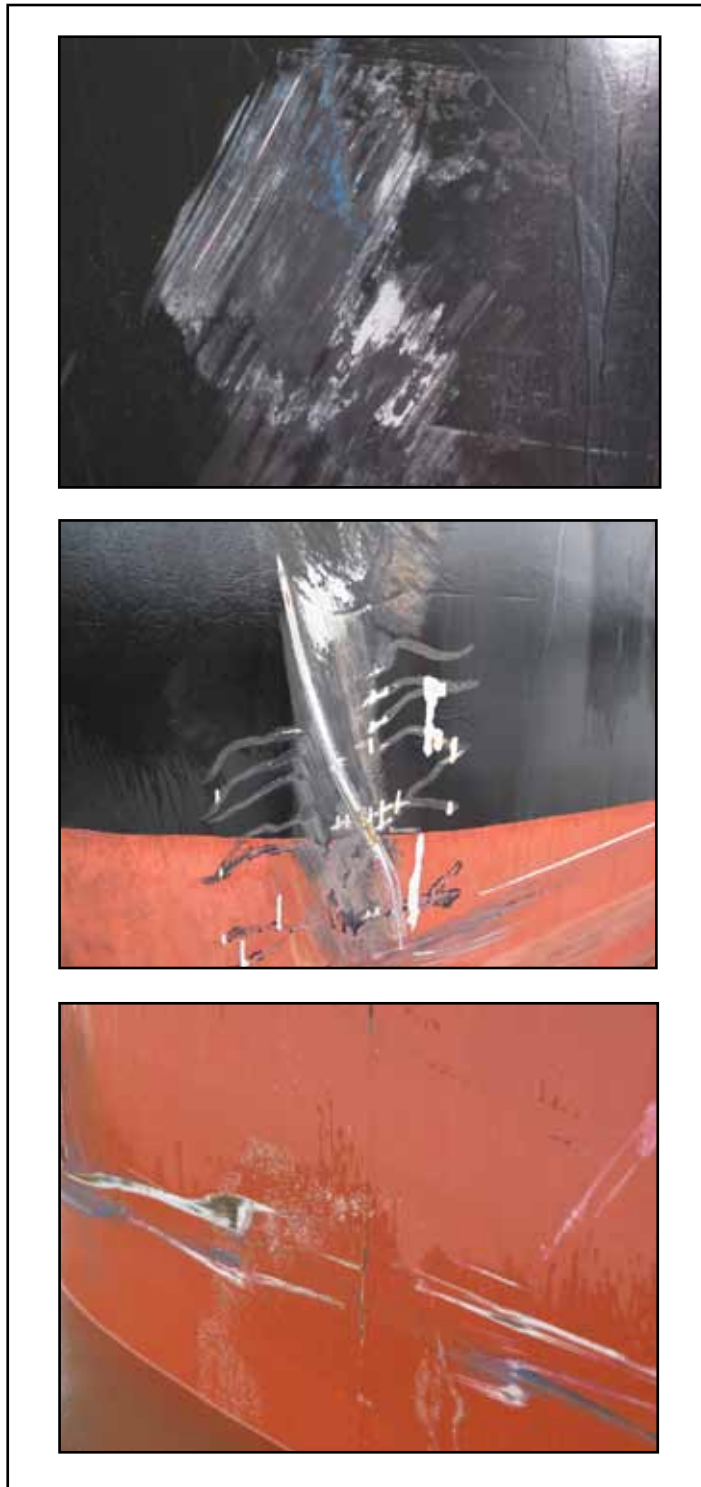
Figure 15

While alongside in Hamburg, *Alam Pintar's* hull was inspected at close range from a mooring boat, for signs of contact. Cosmetic damage and traces of blue paint were found on the bow (**Figure 15**) and on the port quarter (**Figure 16**). As her hull was black, these blue paint traces were a strong indication of contact with another vessel.

Photographs of *Alam Pintar's* bow indicating contact and showing traces of blue paint

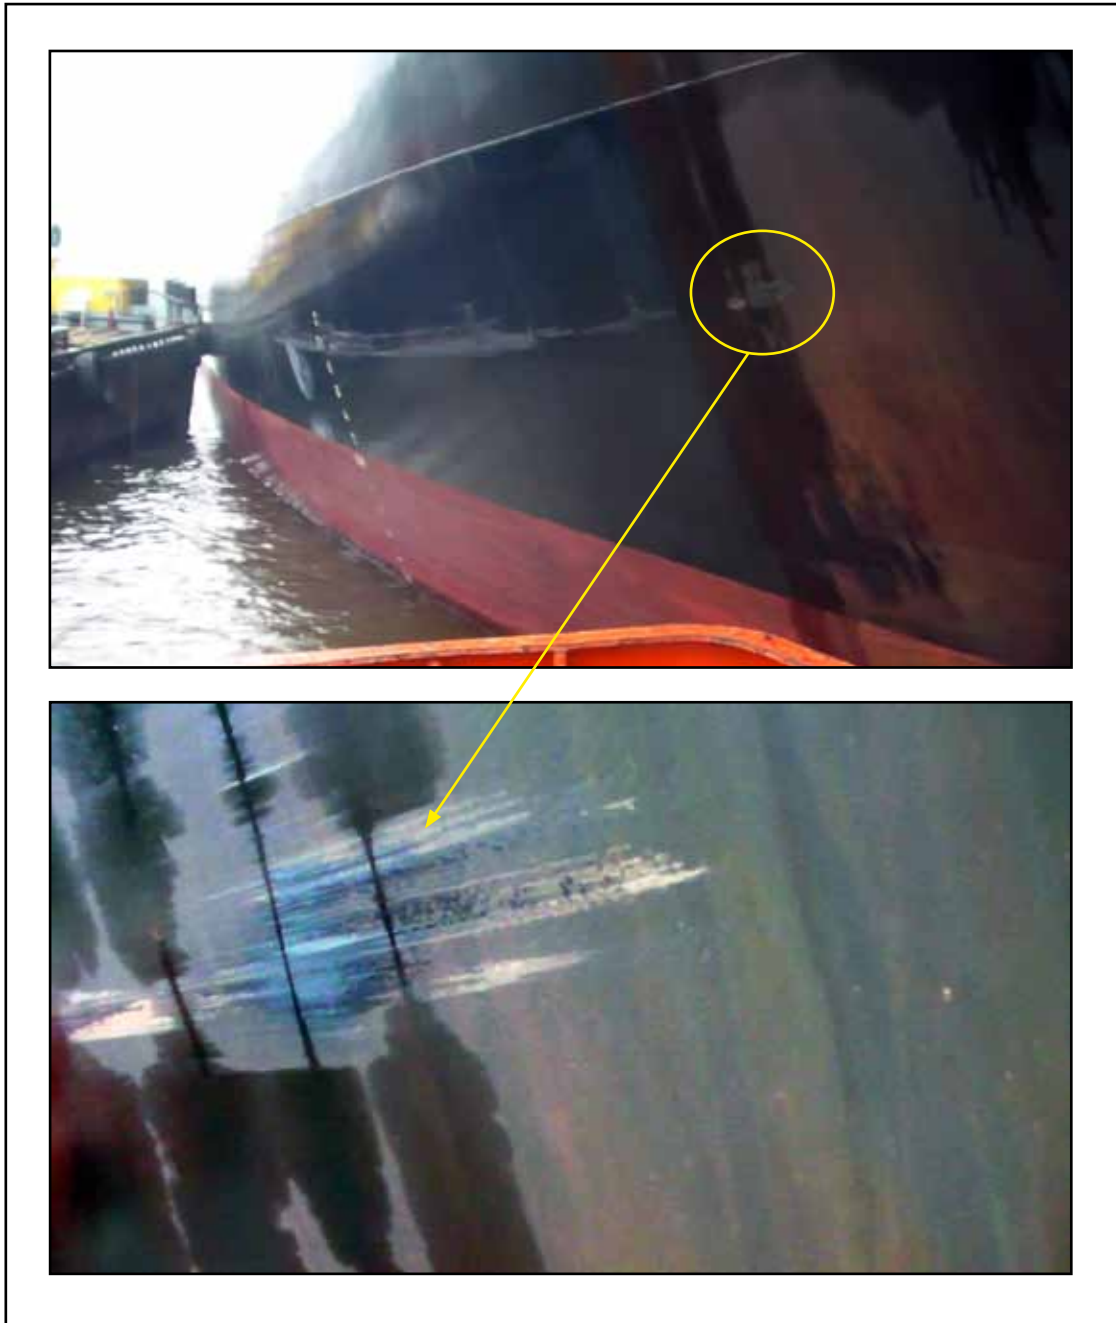
Figure 16

Further indication of contact and traces of blue paint with close-up detail

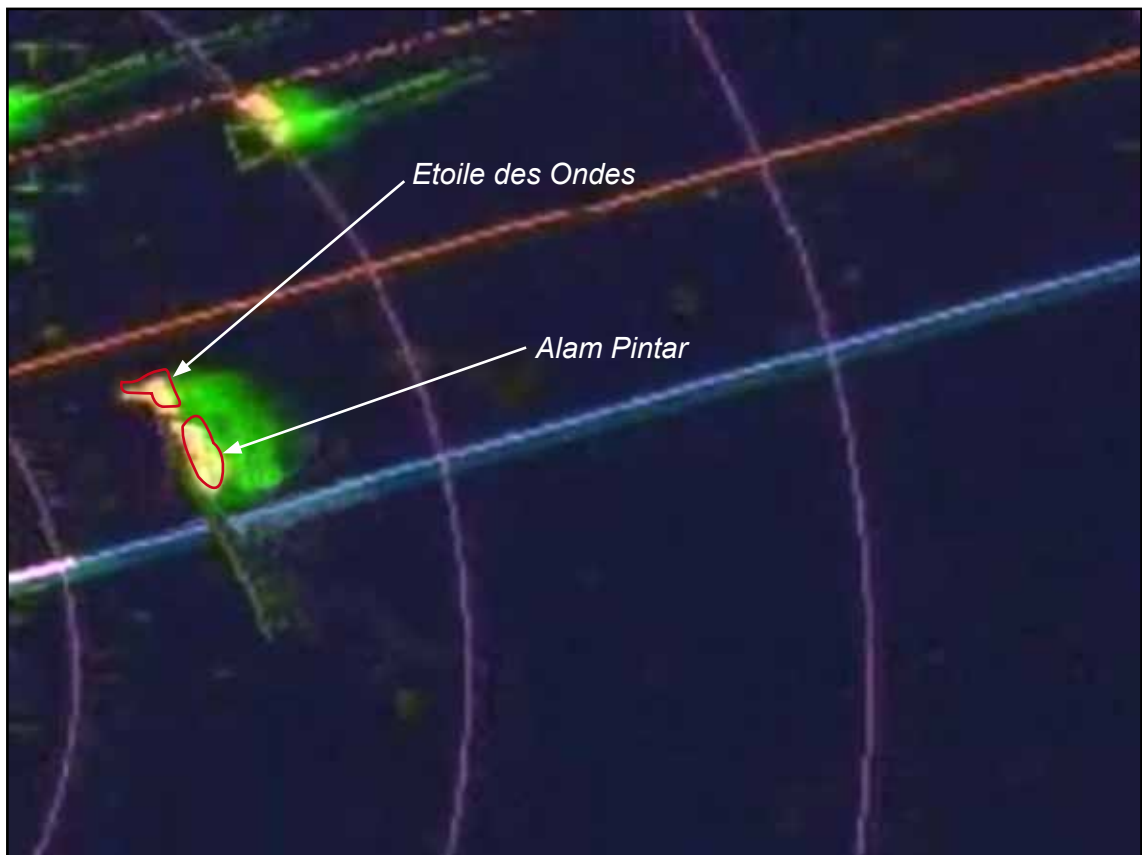
Figure 17

The master, by assuming *Etoile des Ondes* was still afloat, and deciding to continue, was in disregard of his responsibilities. However, once he had reason to believe that *Etoile des Ondes* and her crew were not safe, his action in ignoring the "Mayday Relay" and continuing on passage was illegal, immoral and against all the traditions of the sea.

Screen shot (enhanced) showing *Etoile des Ondes* left astern of *Alam Pintar*
