Report on the investigation of the collision between
the bulk carrier
Alam Pintar
and the fishing vessel
Etoile des Ondes
15 miles north of the Cherbourg peninsula
on 20 December 2009
resulting in one fatality
and the loss of the fishing vessel

Marine Accident Investigation Branch
Mountbatten House
Grosvenor Square
Southampton
United Kingdom
SO15 2JU

Report No 11/2010
September 2010

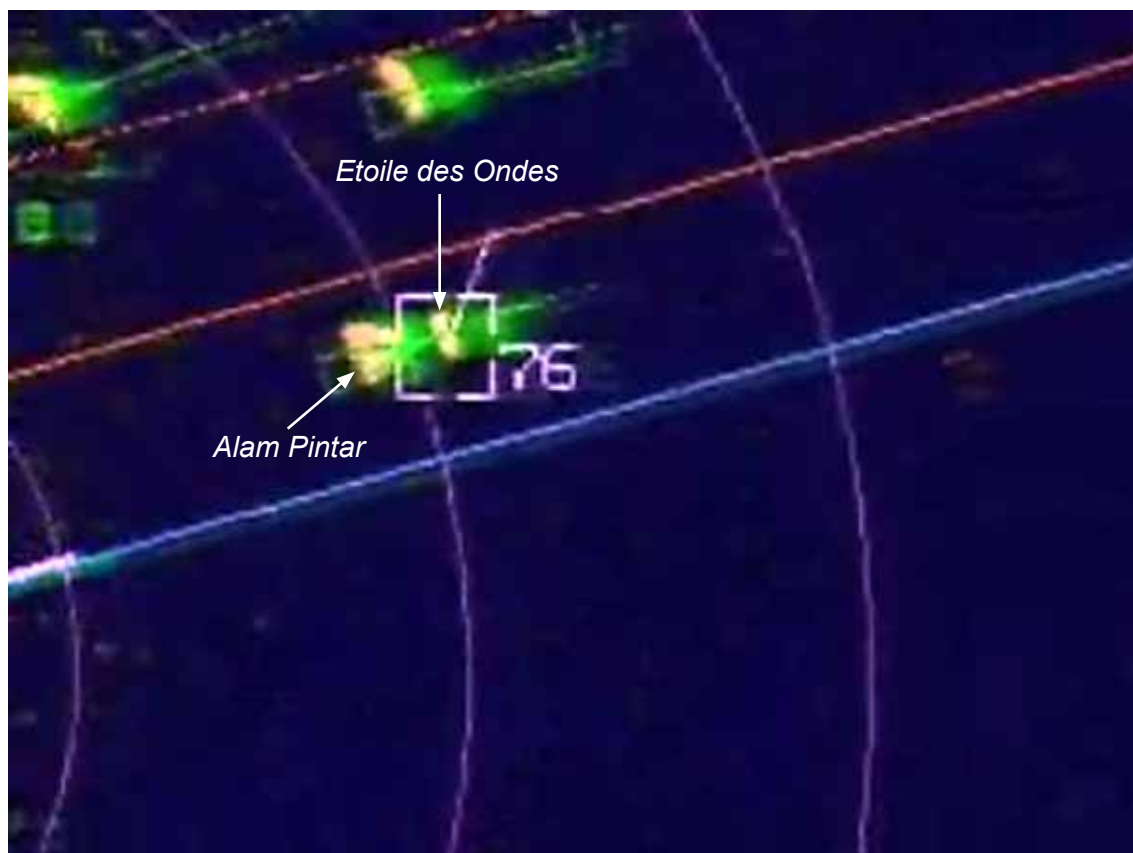
Although the 4th officer was unsure about the actions of the fishing vessel, he did not consider using the whistle to warn the other vessel, nor did he call the master. Instead, he engaged manual steering, instructed the cadet to take the wheel, and then altered the course back to port onto a heading of 072° (G). This was intended to place the fishing vessel at a broader angle on the starboard bow. However, both the radar target and working lights remained ahead of *Alam Pintar* (**Figure 5**).

Radar screen shot showing *Etoile des Ondes* still ahead of *Alam Pintar* with a vector to the north

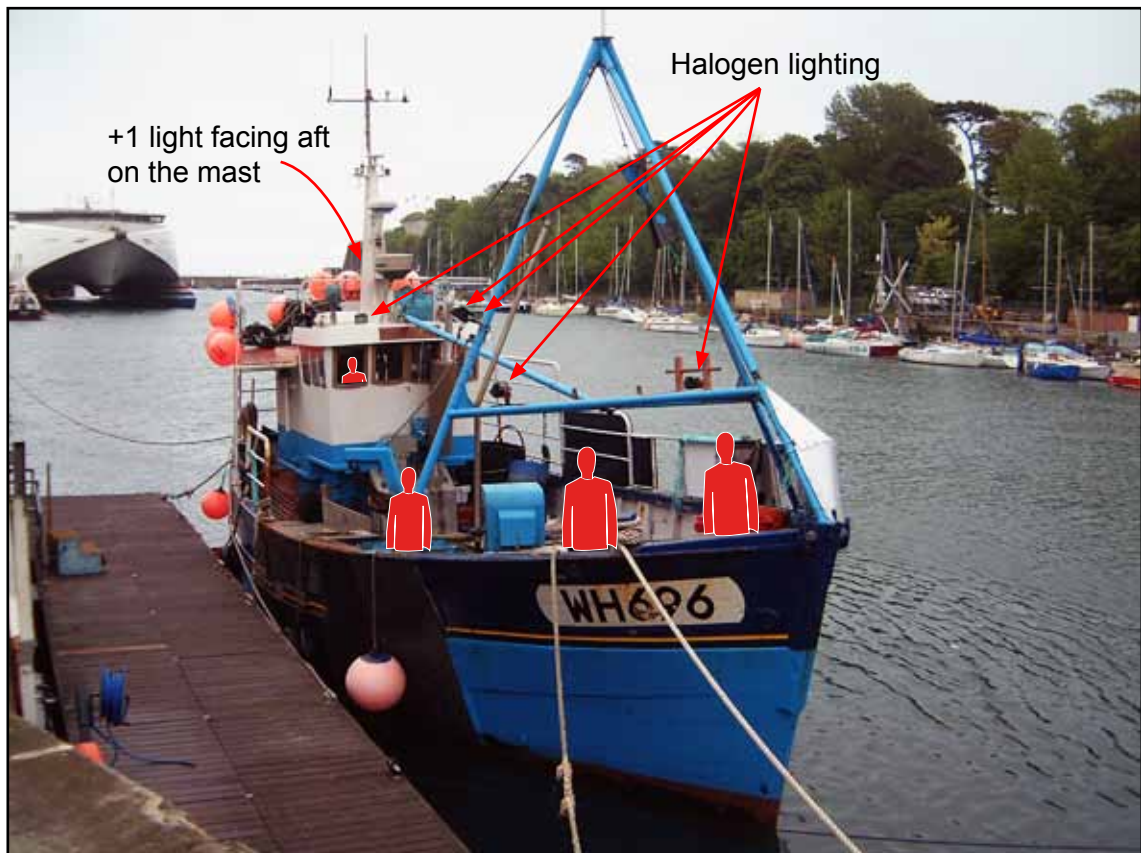
Etoile des Ondes - with halogen lighting and crew positions indicated
(whaleback omitted for clarity)

Initially, the alteration did seem to be effective, but it was subsequently counteracted by (from the perspective of the OOW) random changes of course by *Etoile des Ondes*. The OOW also found it difficult to identify the fishing vessel's navigation lights against the high powered halogen deck lights.

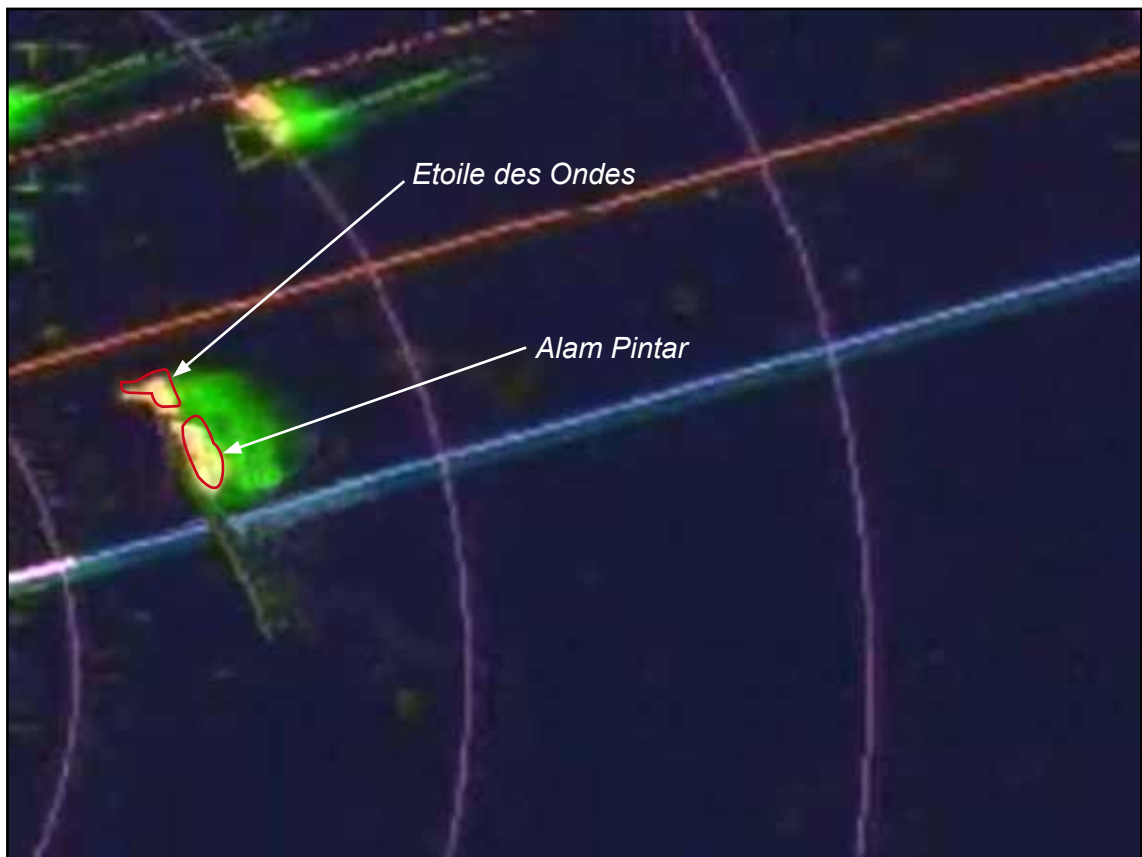
Figure 17

After the collision, *Alam Pintar*'s master was informed by his OOW that there had 'probably' been a collision and that the lights of the fishing vessel had since been observed still lit. When the master looked at the ARPA he saw a target, which he assumed to be *Etoile des Ondes*.

The master, by assuming *Etoile des Ondes* was still afloat, and deciding to continue, was in disregard of his responsibilities. However, once he had reason to believe that *Etoile des Ondes* and her crew were not safe, his action in ignoring the "Mayday Relay" and continuing on passage was illegal, immoral and against all the traditions of the sea.

Screen shot (enhanced) showing *Etoile des Ondes* left astern of *Alam Pintar*
