Report on the investigation of
the grounding of
mv Maersk Kendal
on Monggok Sebarok reef
in the Singapore Strait
on 16 September 2009

Marine Accident Investigation Branch
Mountbatten House
Grosvenor Square
Southampton
United Kingdom
SO15 2JU

Report No 2/2010
March 2010

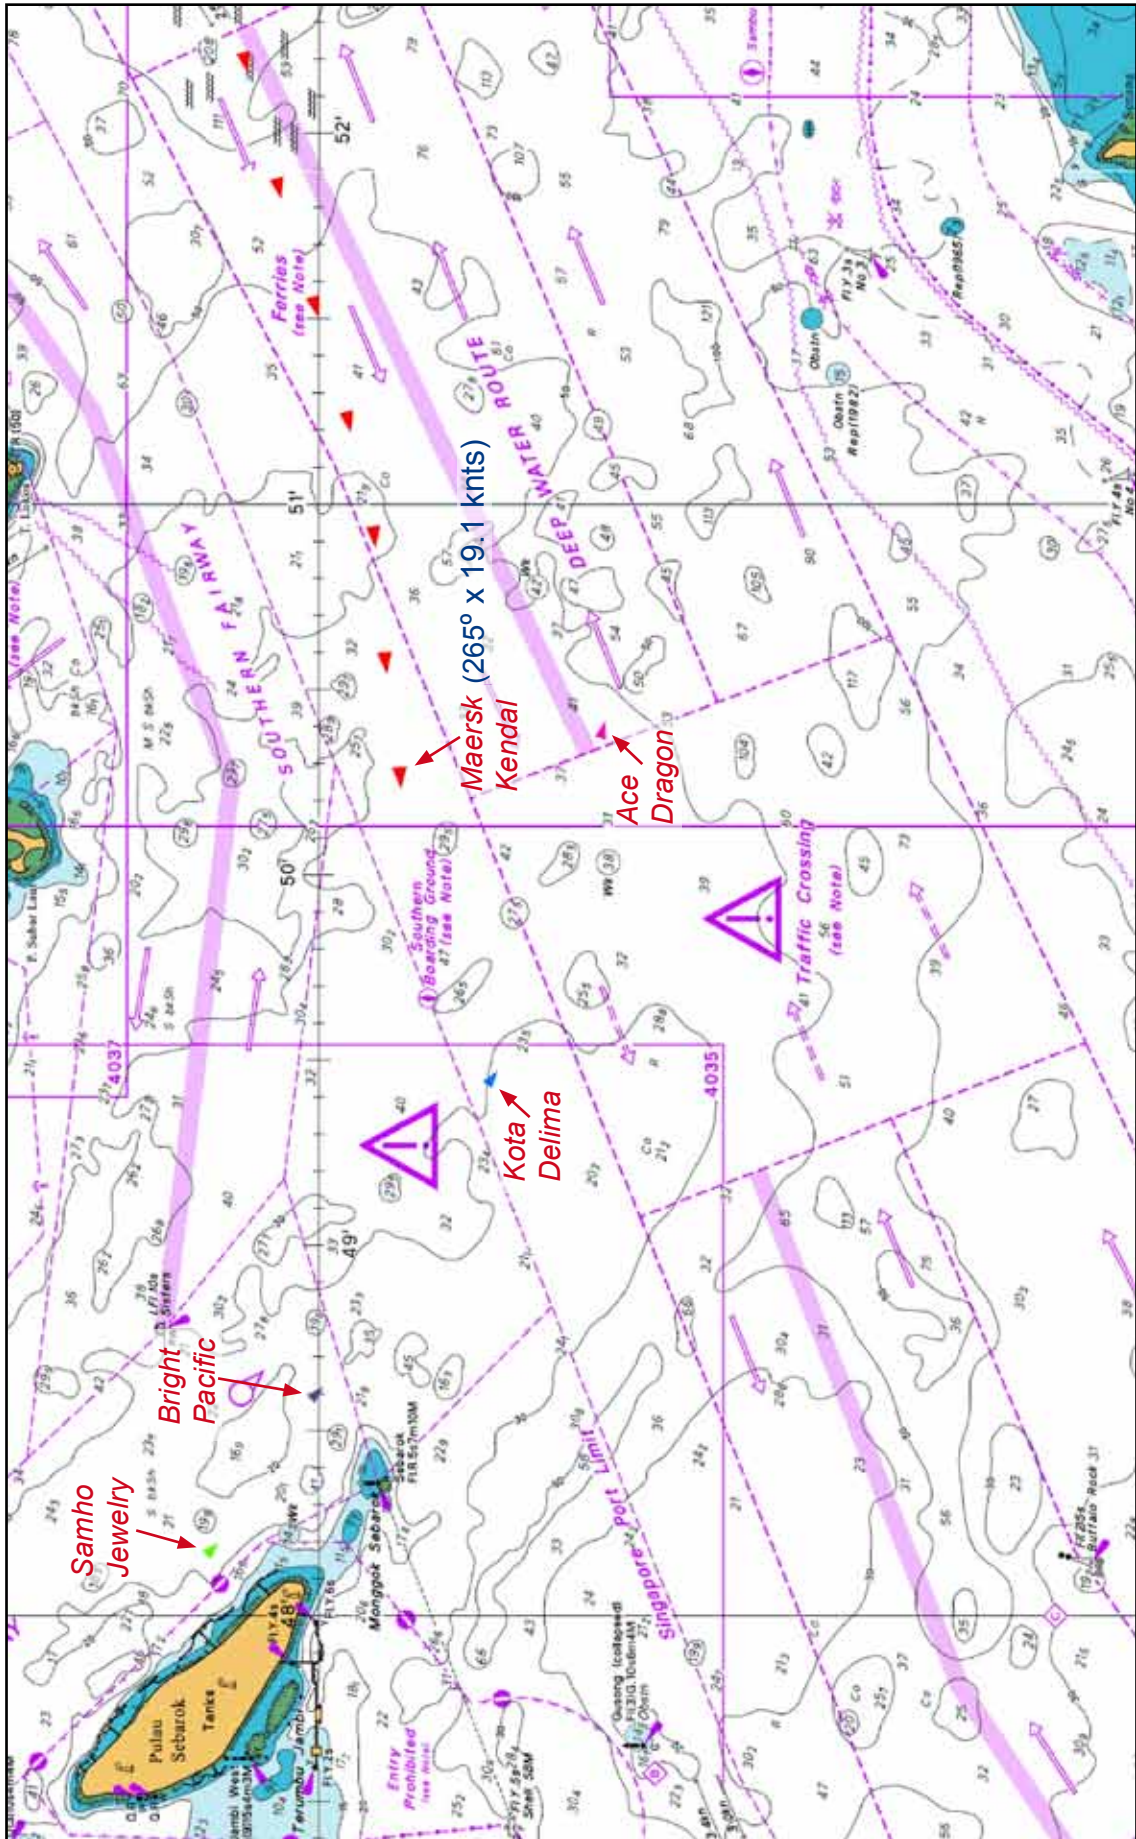
Figure 3

At 0708 (**Figure 3**), VTIS called *Maersk Kendal* and advised her to reduce speed as it was still high and the vessel was about to enter port limits. This message was acknowledged by the chief officer, and the master set the engine telegraph to slow ahead. Course and speed over the ground were recorded as 265° and 19.1 knots. The master then ordered a further alteration of course to starboard and steadied the vessel on a course of 273°.

Plot of vessels at 0700

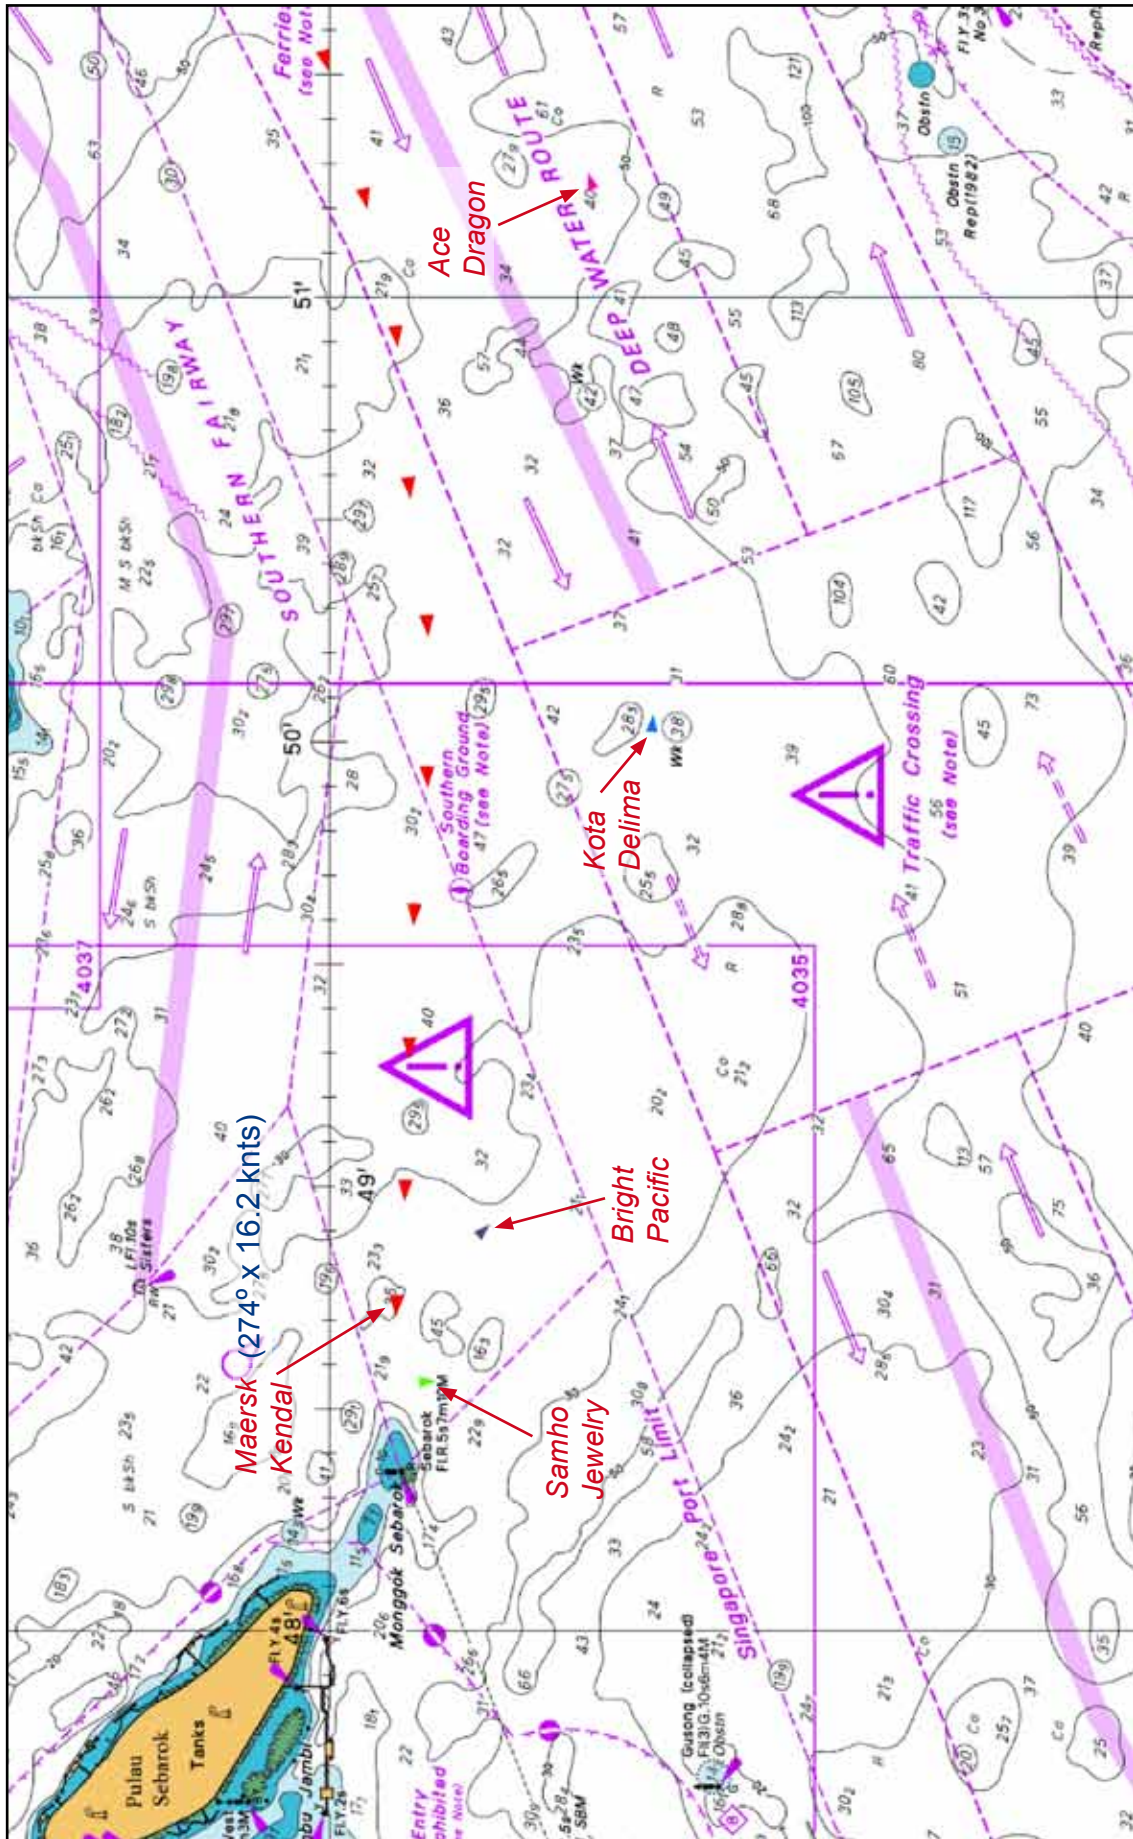
Figure 5

Plot of vessels at 0713

At 0713 (**Figure 5**), with *Maersk Kendal* still on a course of 274° and now at a speed of 16.2 knots, VTIS advised:

'Maersk Kendal, shallow water ahead of you, shallow water ahead of you.'

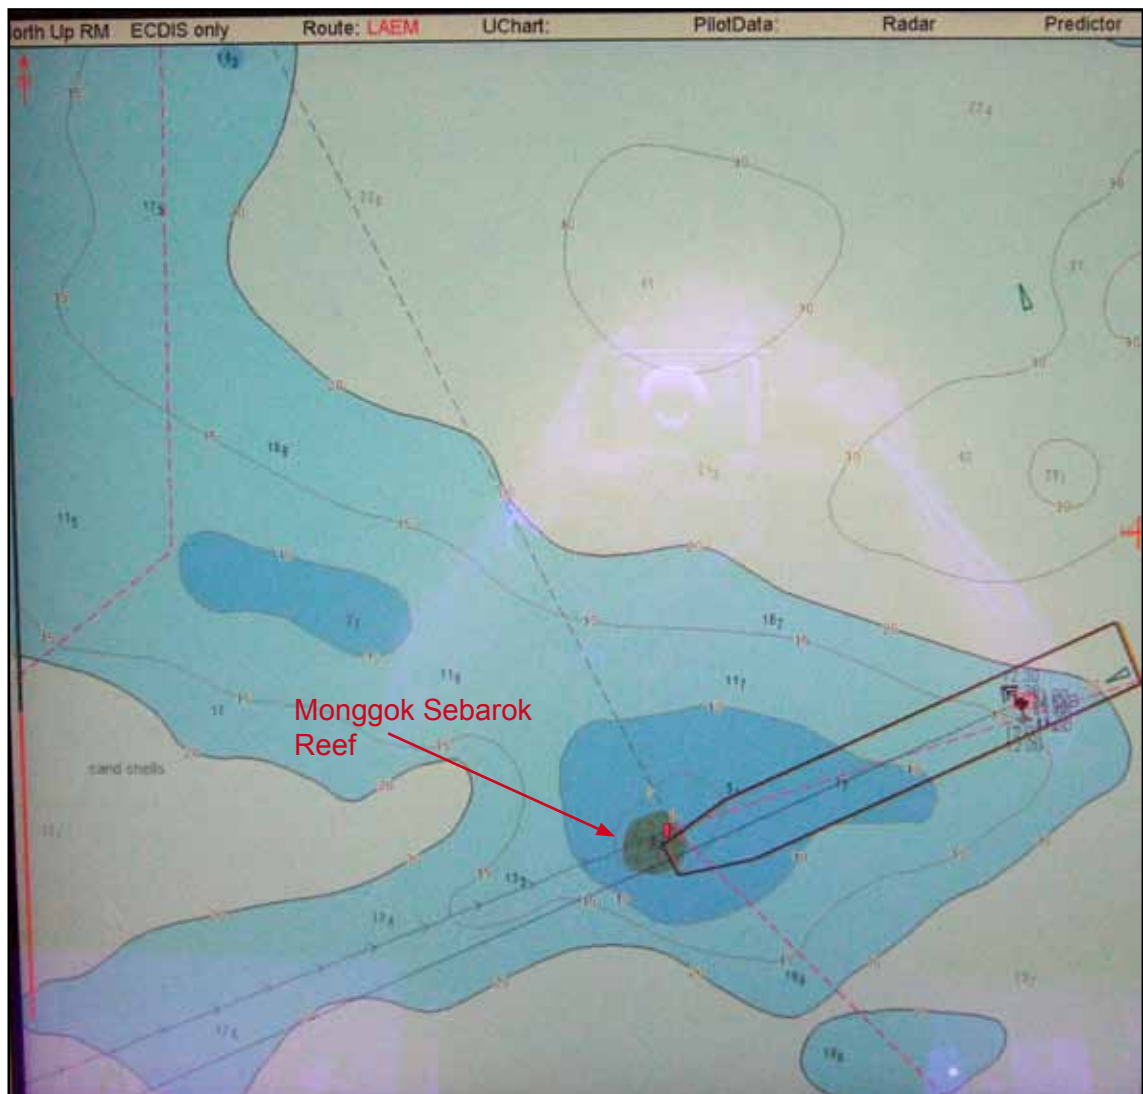
Figure 6

After *Samho Jewelry* had crossed the bow of *Maersk Kendal*, the master started following the stern of the other vessel to port. His initial helm order was 'port 10', followed by 'port 20' and then 'hard-a-port'. He then went onto the starboard bridge wing to assess whether the vessel would clear the beacon on Monggok Sebarok reef. As he returned to the wheelhouse, the vessel ran aground (**Figure 6**) on a heading of 246° and at a speed of about 14.2 knots.

ECDIS display showing *Maersk Kendal* aground on Monggok Sebarok reef

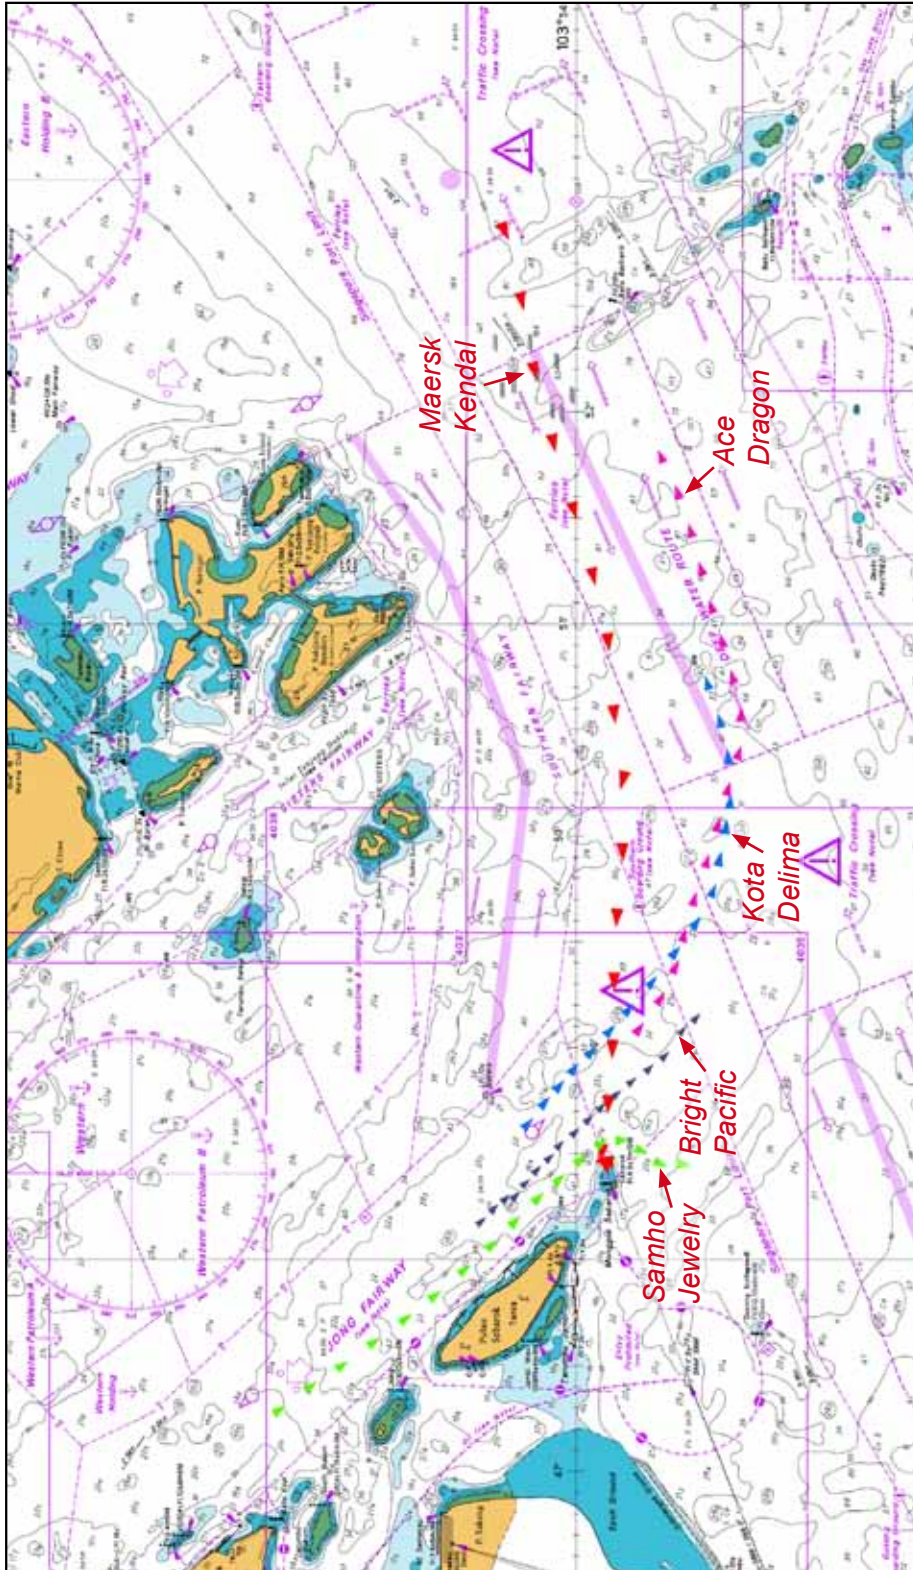
Figure 7

Overview of plot of all vessels between 0700 and 0716

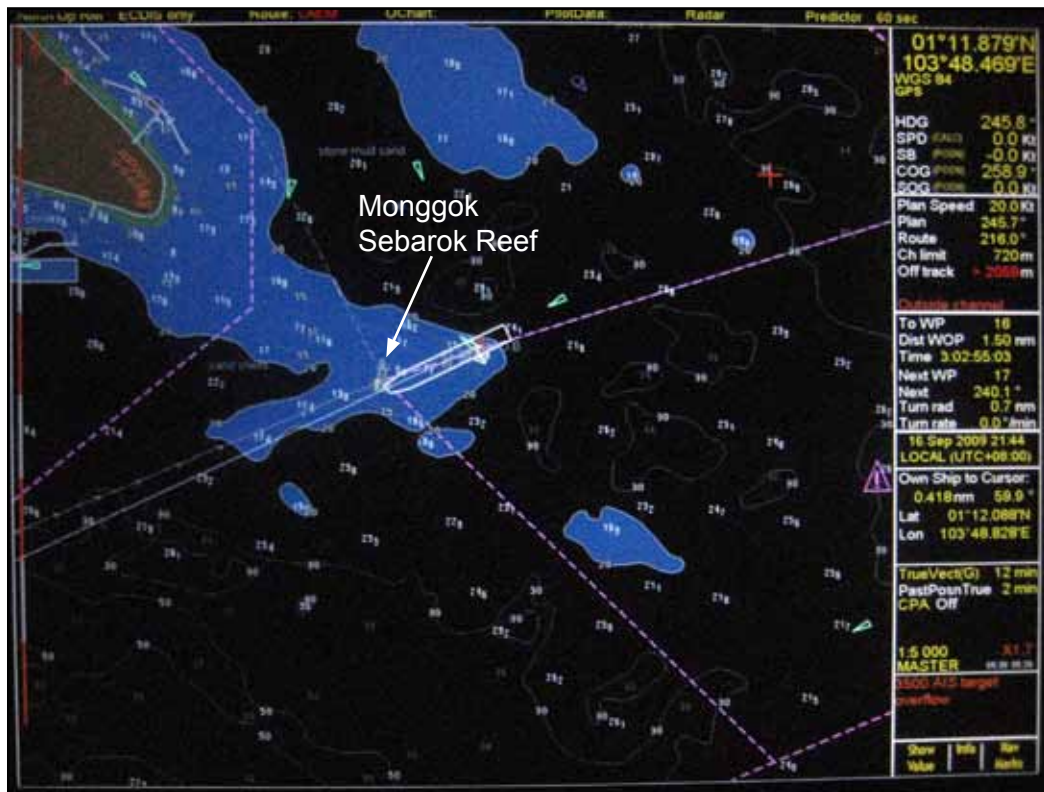
Figure 11

The master was predominantly positioned at the starboard radar and ECDIS displays (**Figure 10**). The engine telegraph was located on his inboard side. This was his usual position from which he had an unrestricted view of the conning display unit. At the time of grounding, the starboard ECDIS display was on a 1:5000 scale (**Figure 11**).

ECDIS - night view at 1:5000 scale
