Nakano technical investigation report, *Ever Elite*

Investigation Report
on Potential Causes of M/V EVER ELITE Accommodation Ladder Fall Accident
and Preventive Measures of Recurrence

November 30, 2009
Nakano Seisakusho Co., Ltd.

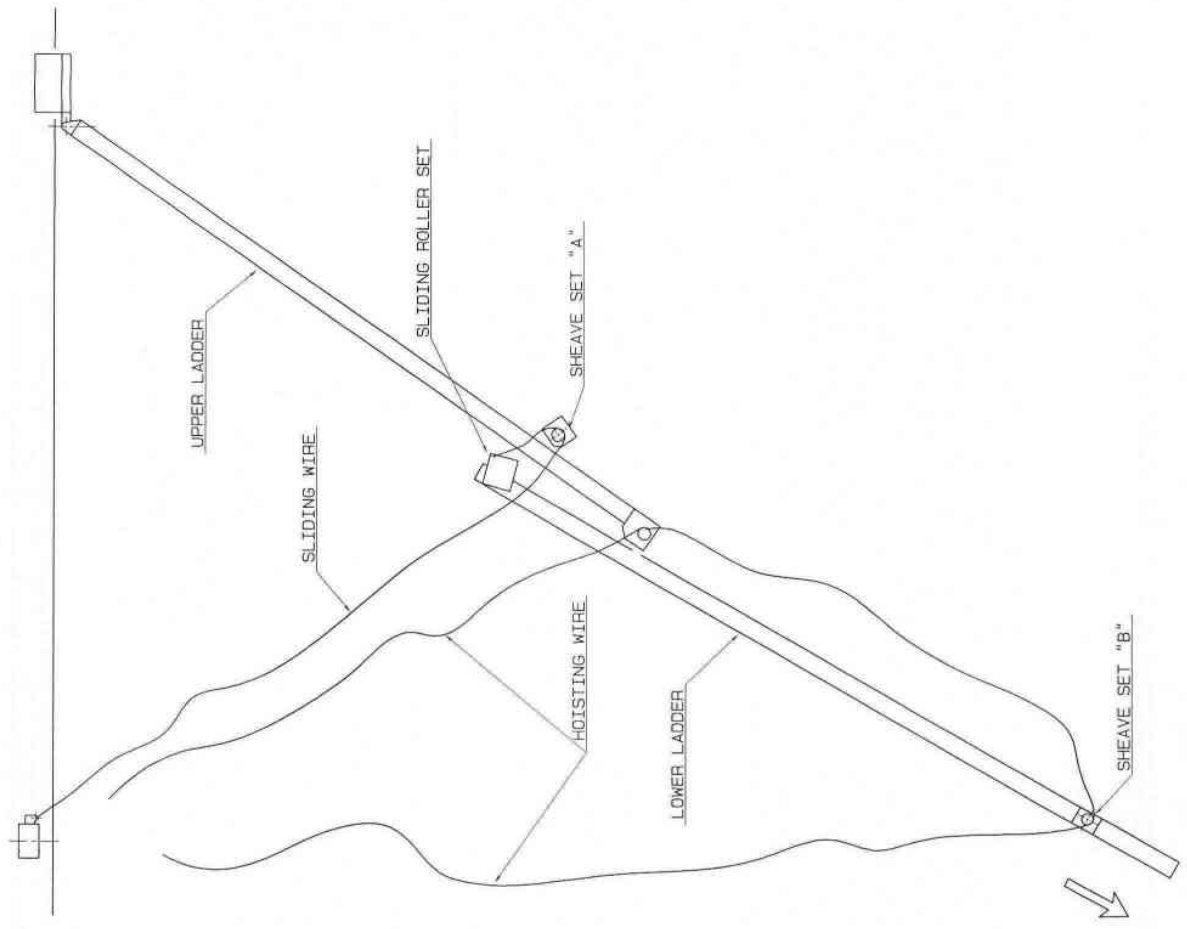
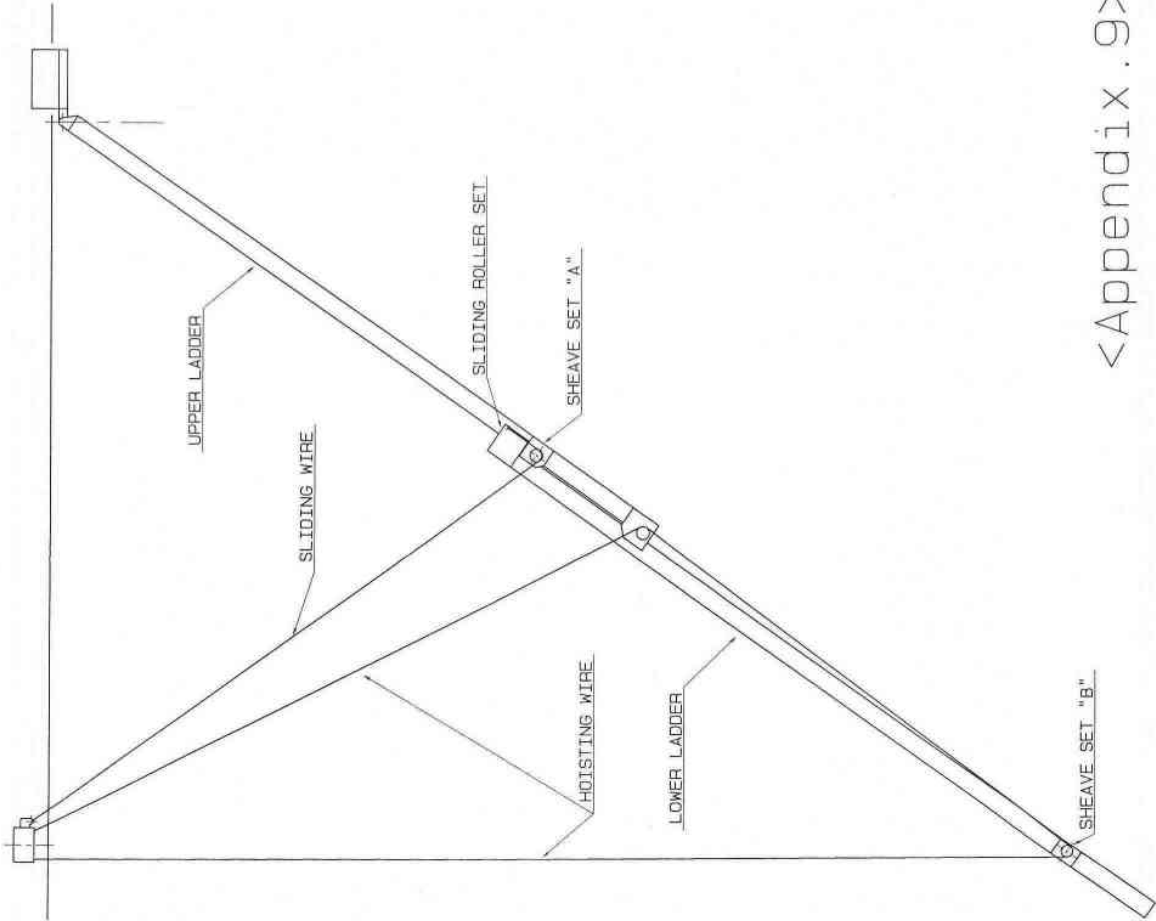
<Appendix .9>

The Sliding Wire is structured to maintain tension consistently from horizontal position to a 55-degree angle; however, disengagement between Bevel Gear Unit and Vertical Bevel Gear set Hoisting Drum free. Then,

Sliding Wire was set free as well and kept going down with Ladder fully extended. As Hoist Wire thoroughly came out of the uncontrolled Hoist Drum, Lower Ladder fell in the sea. (See Appendix 9.)

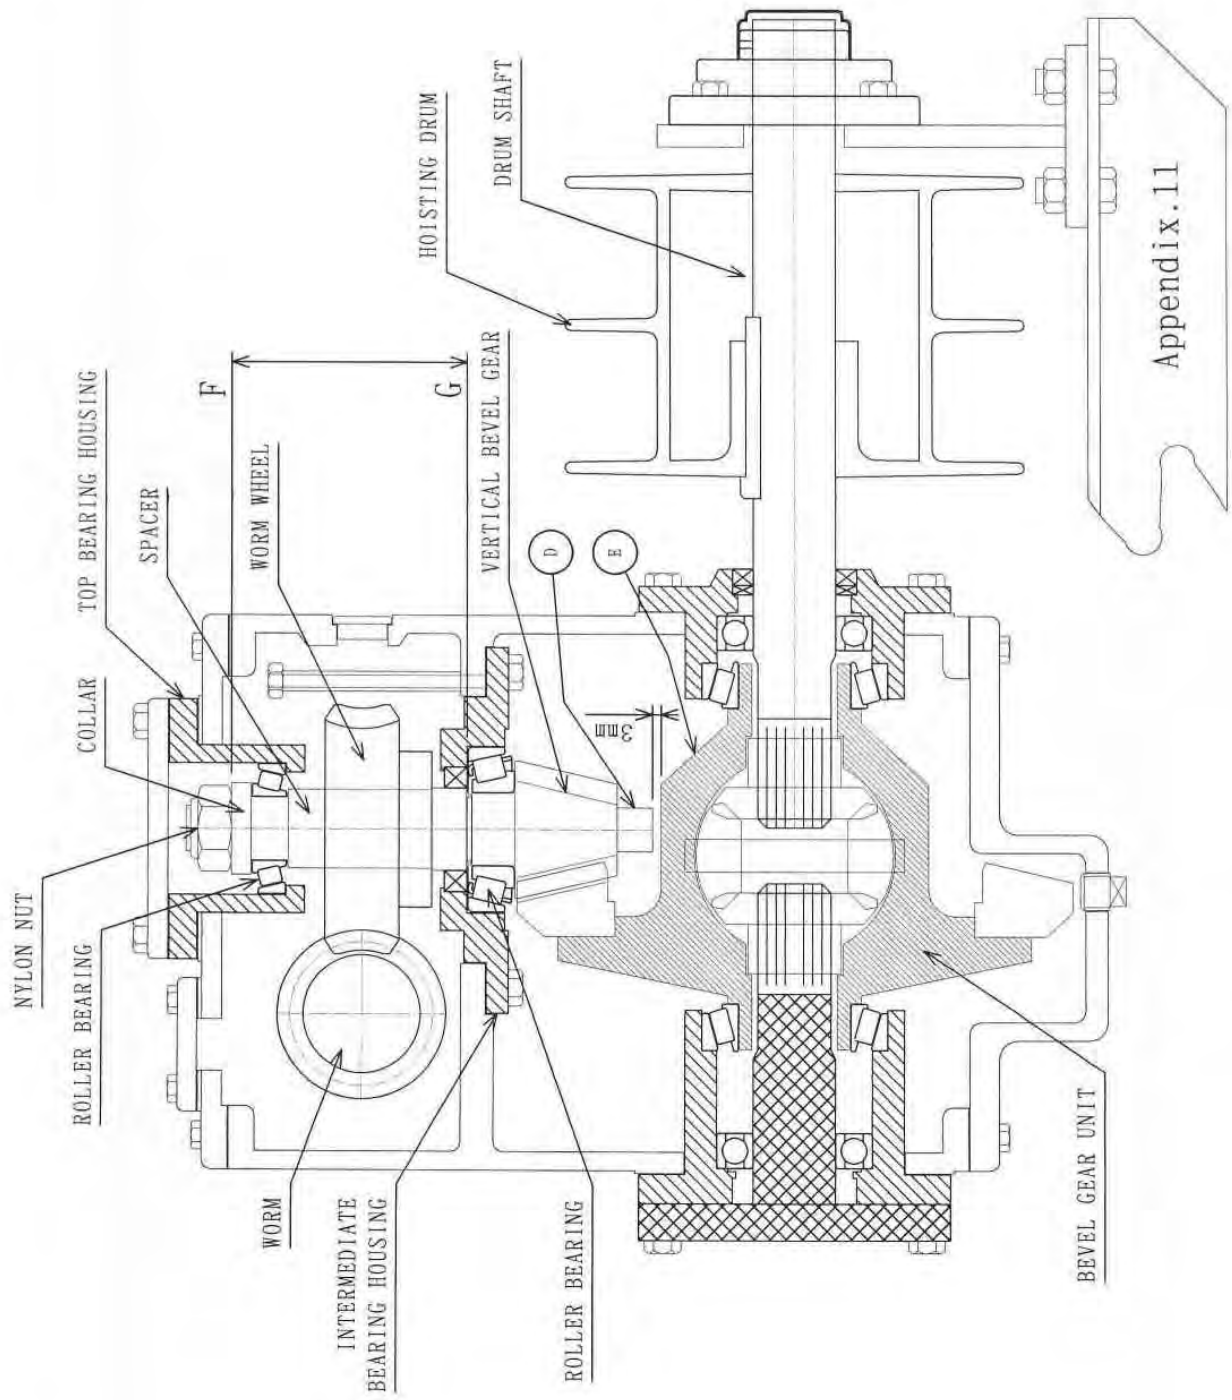
Appendix.11

As is in the Appendix A, Portion D of Bevel Gear Unit shows a trace of contact with Portion E of Vertical Bevel Gear (see Appendix 10: Inside photo of Gear Box of the same type at our factory; approximately 3mm gap between D and E). Hence, it is presumed that a gap of 3mm or more generated between F and G, Vertical Bevel Gear traveled to a lower position, Inside Ring of Roller Bearing contacted Bevel Gear Unit and was broken, then Roller Housing was broken, and disengagement between Bevel Gear Unit and Vertical Bevel Gear ensued. The possible cause of gap generation is foreign body intrusion, or fastening Nylon Nut where Spacer or Collar is not an authorized product. (See Appendix 11)

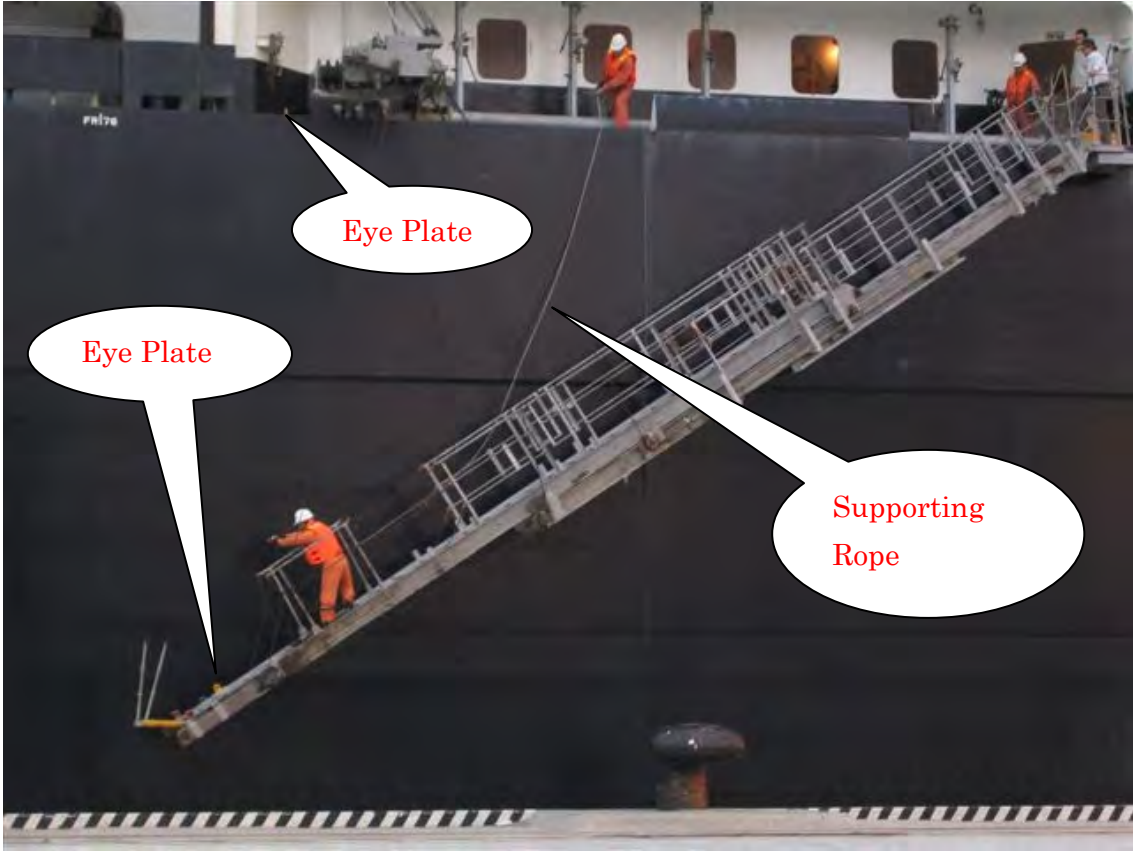
Eye Plate

Supporting
Rope

3. The investigators witnessed gangway ladder installment operation carried out by crew when the subject ship is docked in Taipei Port. To move Ladder with people on it is prohibited; therefore, Ladder is first put down to a certain angle and then crew got off the ship to set Handrail. Here, rope was provided from the deck to protect crew from falling in case of accident. (Appendix 12)

4. In accordance with crew suggestion, Eye Plate was installed each on deck and in the vicinity of Lower Platform of Lower Ladder and painted so as to draw attention. This way, Lower Ladder would be supported by Wire. Nevertheless, the Wire is not used because it can hamper crew's operation hanging always from the deck. (Appendix 12)

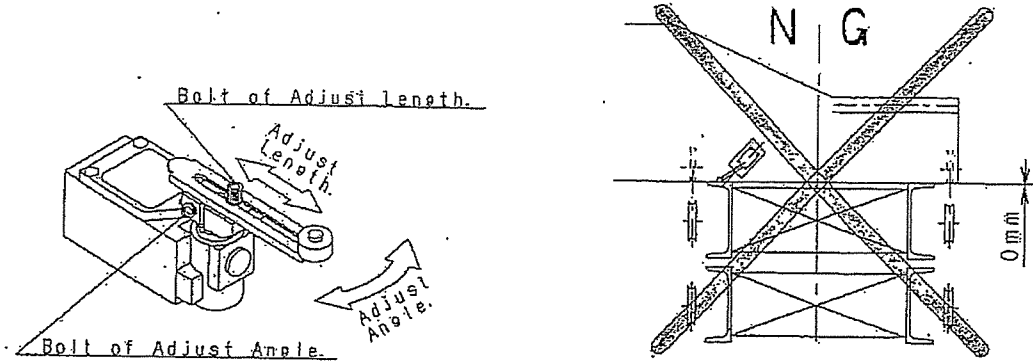
1-4. NG

* If the davit hits the ladder when the limit switch has stopped functioning (Finish of Hoist UP), this means a fault. So make adjustments to ensure that the davit does not touch the ladder.
