Report on the investigation of  
the capsizing of the fishing vessel

***Aquila***

with the loss of three lives  
Bo Faskadale Reef, Ardnamurchan  
on 20 July 2009

**Report No 5/2010**  
**April 2010**

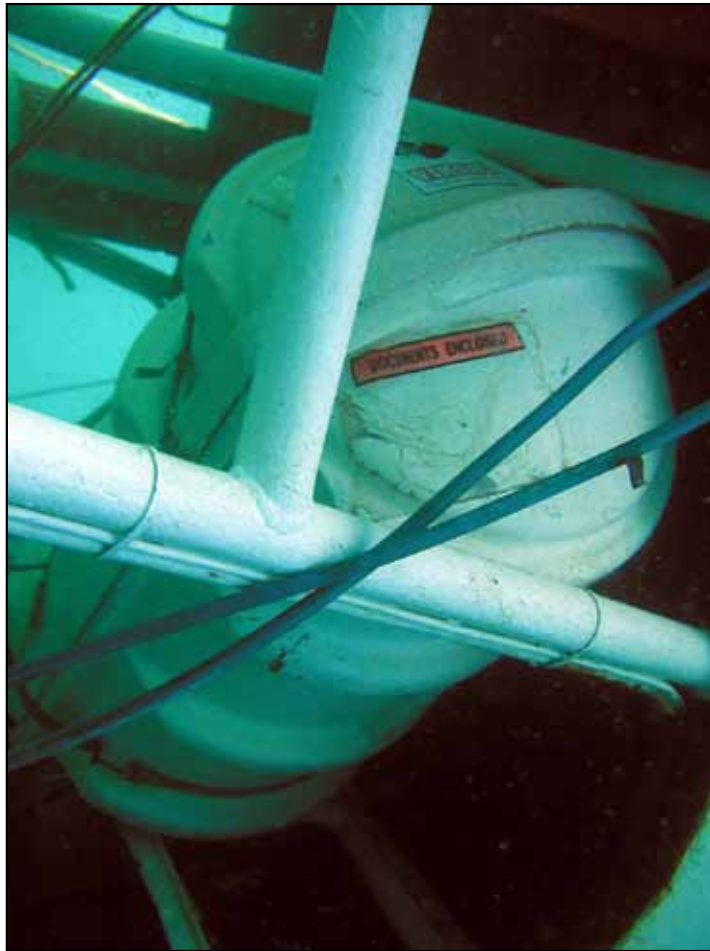
Figure 6

During this inspection it was observed that the Hydrostatic Release Units (HRUs) of the vessel’s liferaft and EPIRB had both activated correctly. However, both the liferaft and the EPIRB had become fouled on parts of the vessel’s superstructure (**Figures 6 & 7**), and had not floated free.

Liferaft fouled in *Aquila's* superstructure

Although not a statutory carriage requirement, *Aquila* had been fitted with an EPIRB as well as a requisite liferaft. HRUs were fitted to both, and it was found that these had activated as designed and allowed both the liferaft and EPIRB to be released from their housings. However, after release, they had both become trapped in the vessel's superstructure.

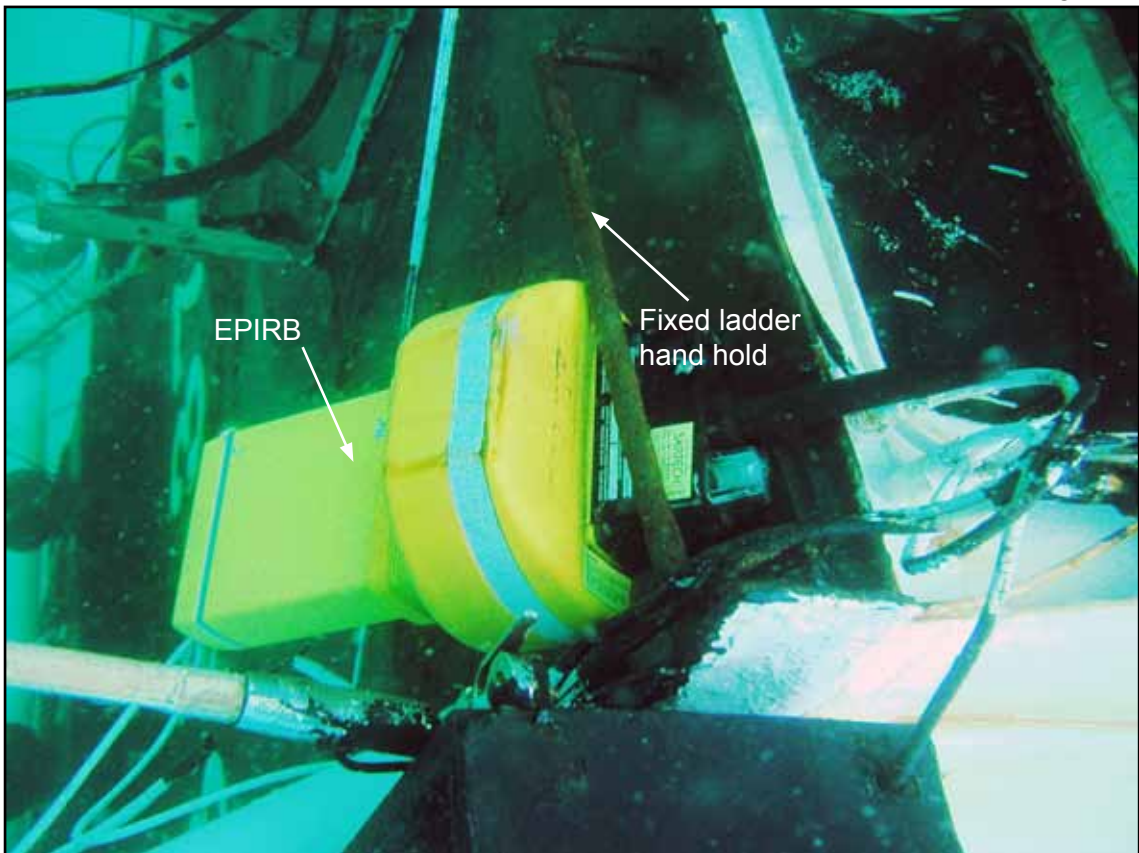
Figure 7

EPIRB fouled in hand hold of fixed wheelhouse external ladder

The EPIRB was examined after the accident, and it was found that it had last been serviced in 2002 and that its battery had been due for replacement in 2005. Once the prudent decision to carry an EPIRB had been made, it should have been serviced annually in accordance with the manufacturer's recommendations. Notwithstanding this, no evidence was found to suggest that the unit would not have operated had it floated free of the vessel.

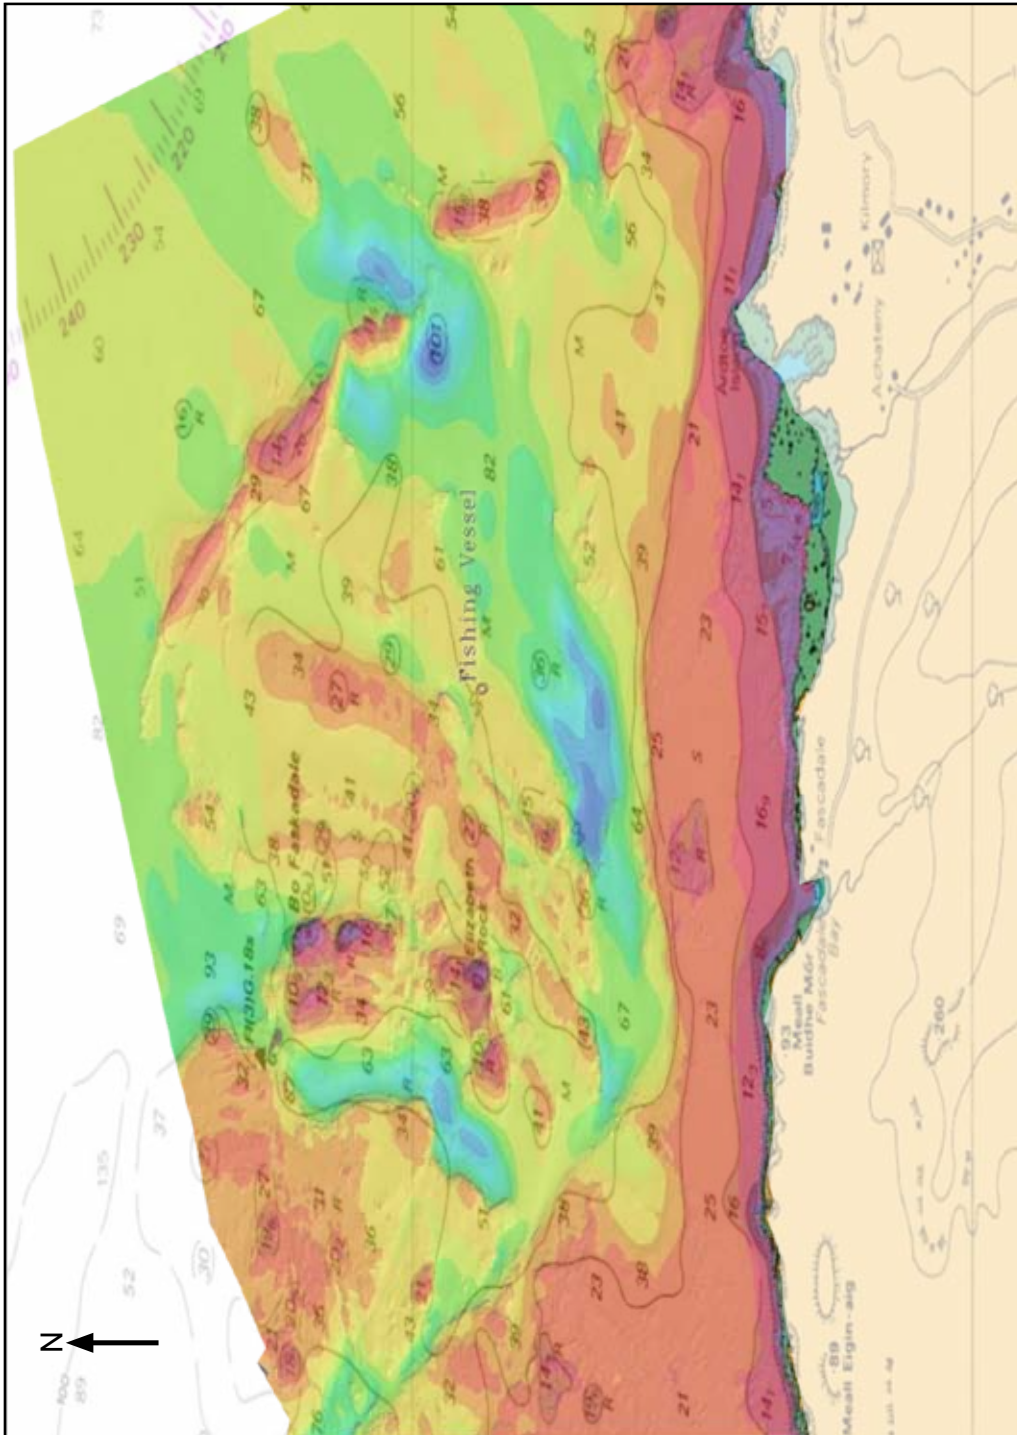
Figure 15

Seabed survey of west side of Bo Faskadale reef

At the time of the accident the tide was flooding, and in a strong south-westerly wind there was a 2m ground swell with wind waves in the area. In these conditions it is probable that standing waves were generated on the west side of the reef. The vessel probably encountered these larger than average waves when she yawed after her gear had snagged.

No warning of this standing wave phenomenon exists on the chart or in the Admiralty Sailing Directions. This information has now been added to both publications by the UKHO, to inform mariners navigating in the area, of the hazard.
