Report on the investigation of
the capsizing of the fishing vessel

Aquila

with the loss of three lives
Bo Faskadale Reef, Ardnamurchan
on 20 July 2009

Report No 5/2010
April 2010

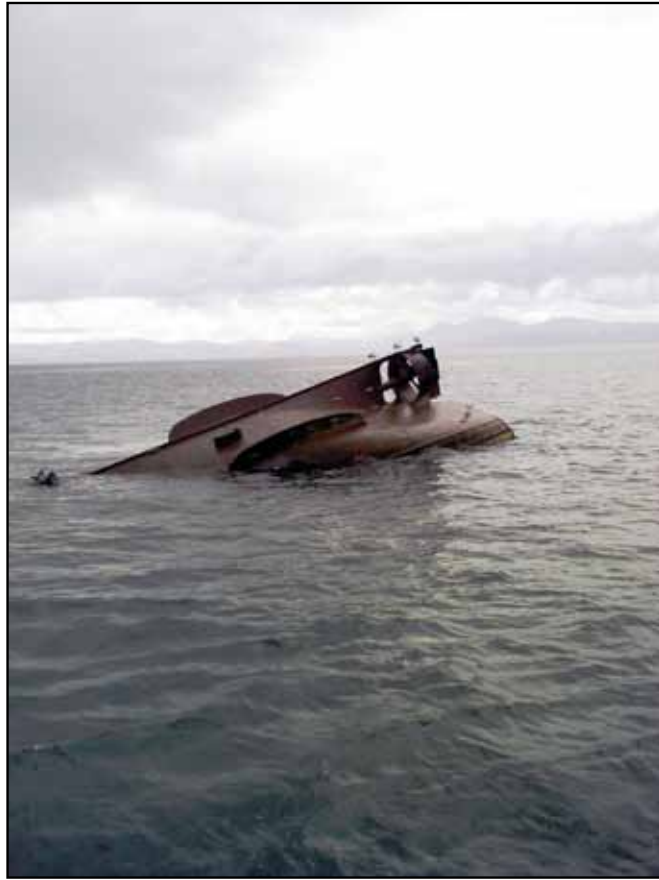
Figure 4

Upturned hull of *Aquila* in the capsized location

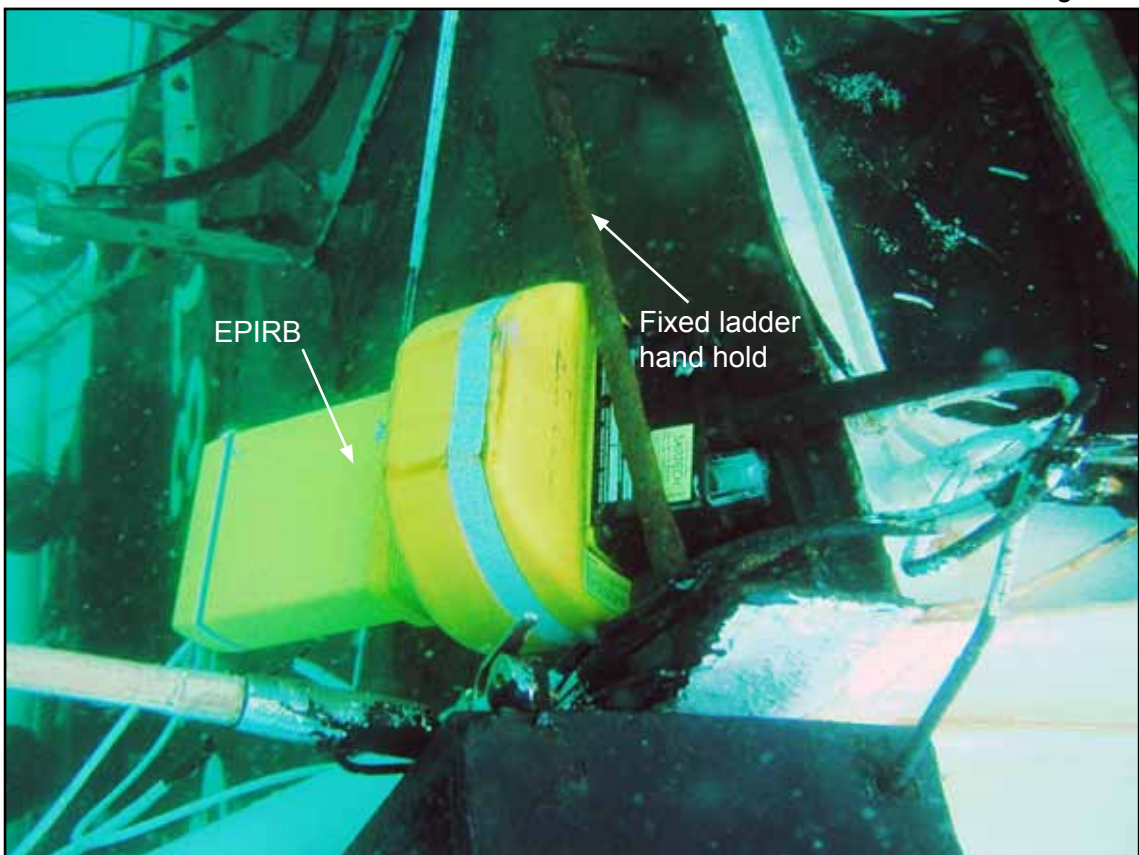
Figure 7

During this inspection it was observed that the Hydrostatic Release Units (HRUs) of the vessel’s liferaft and EPIRB had both activated correctly. However, both the liferaft and the EPIRB had become fouled on parts of the vessel’s superstructure (**Figures 6 & 7**), and had not floated free.

EPIRB fouled in hand hold of fixed wheelhouse external ladder

The EPIRB was examined after the accident, and it was found that it had last been serviced in 2002 and that its battery had been due for replacement in 2005. Once the prudent decision to carry an EPIRB had been made, it should have been serviced annually in accordance with the manufacturer's recommendations. Notwithstanding this, no evidence was found to suggest that the unit would not have operated had it floated free of the vessel.

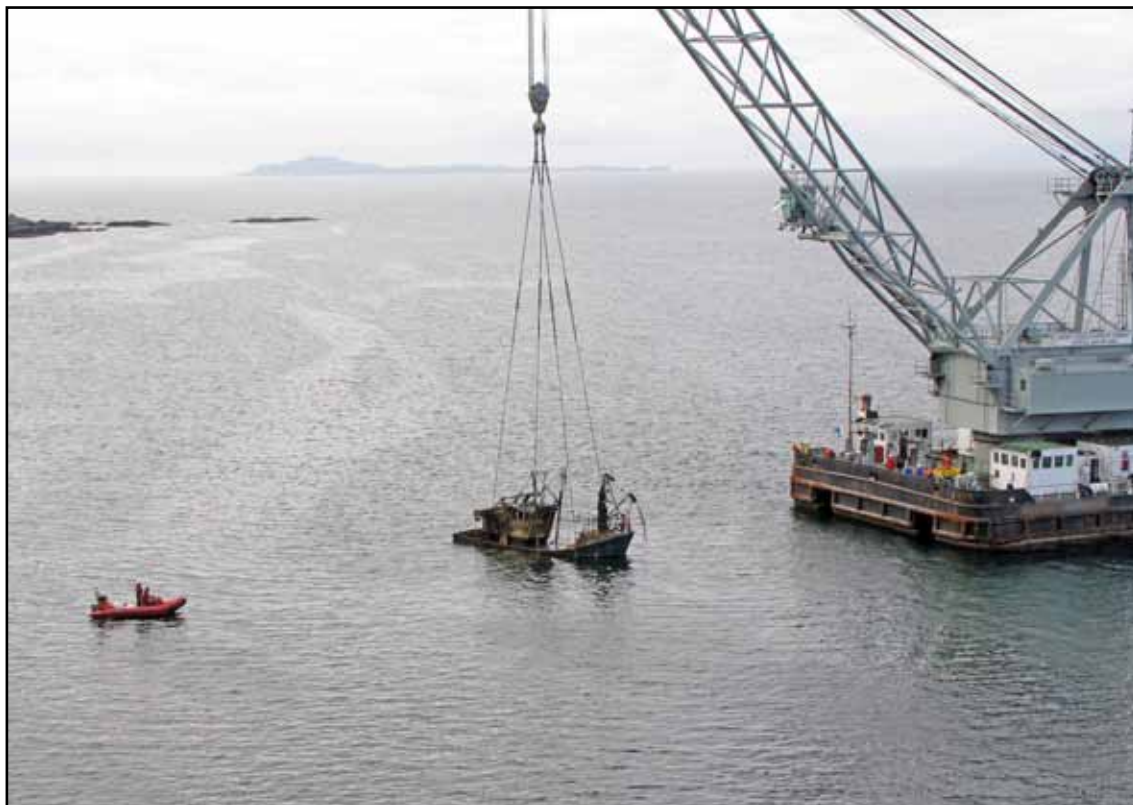
Aquila after salvage

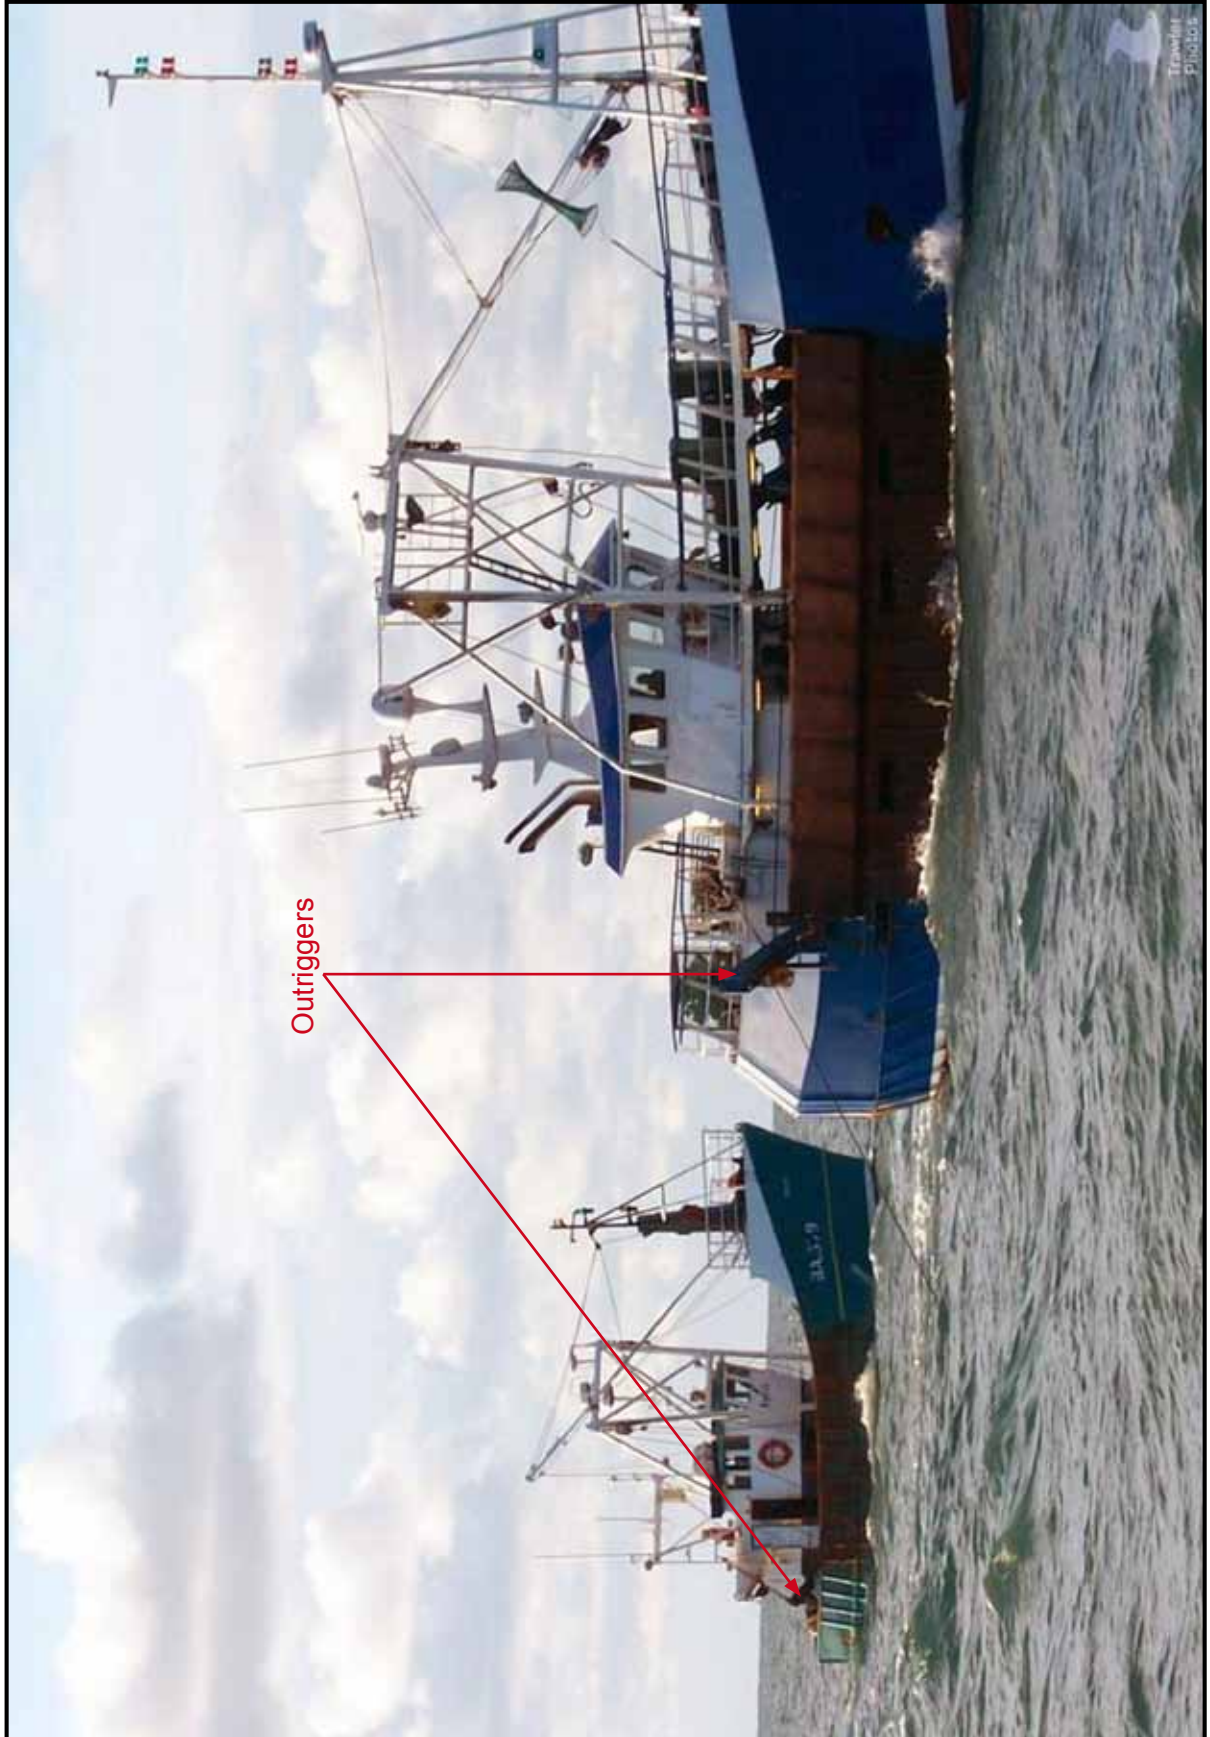
When her gear snagged, the vessel would have rotated about the starboard outrigger (**Figure 13**) and the large waves would have lifted her hull causing a further reduction in her stability. Fishermen should be reminded of the adverse impact on stability when trawling downwind in heavy seas.

Aquila, and another vessel, showing position of the outrigger
