Report on the investigation of
the capsizing of the fishing vessel

Aquila

with the loss of three lives
Bo Faskadale Reef, Ardnamurchan
on 20 July 2009

Report No 5/2010
April 2010

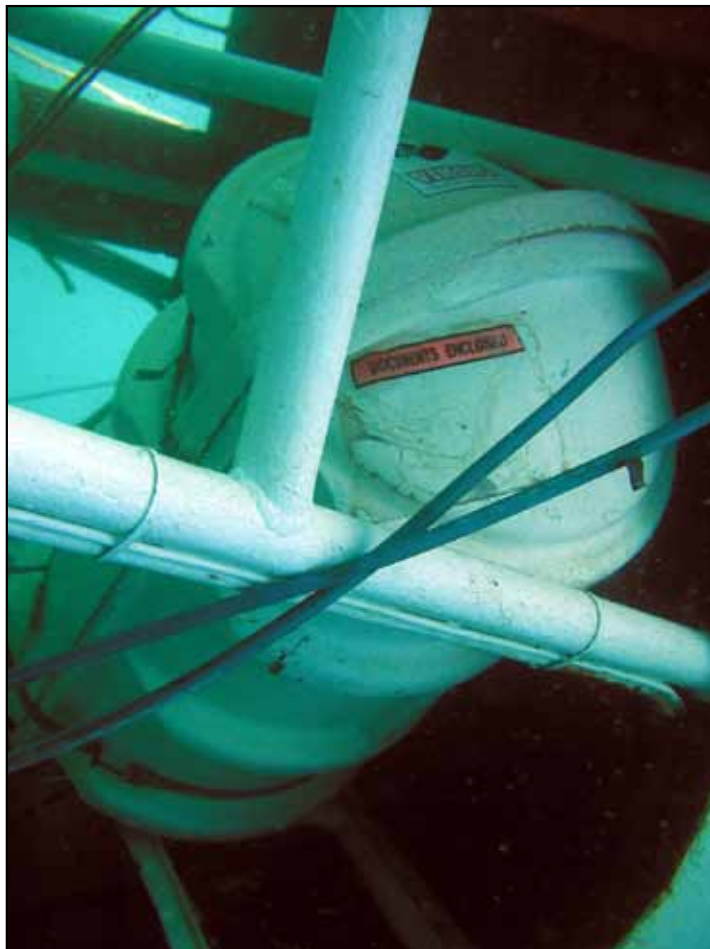
Figure 6

During this inspection it was observed that the Hydrostatic Release Units (HRUs) of the vessel’s liferaft and EPIRB had both activated correctly. However, both the liferaft and the EPIRB had become fouled on parts of the vessel’s superstructure (**Figures 6 & 7**), and had not floated free.

Liferaft fouled in *Aquila's* superstructure

Although not a statutory carriage requirement, *Aquila* had been fitted with an EPIRB as well as a requisite liferaft. HRUs were fitted to both, and it was found that these had activated as designed and allowed both the liferaft and EPIRB to be released from their housings. However, after release, they had both become trapped in the vessel's superstructure.

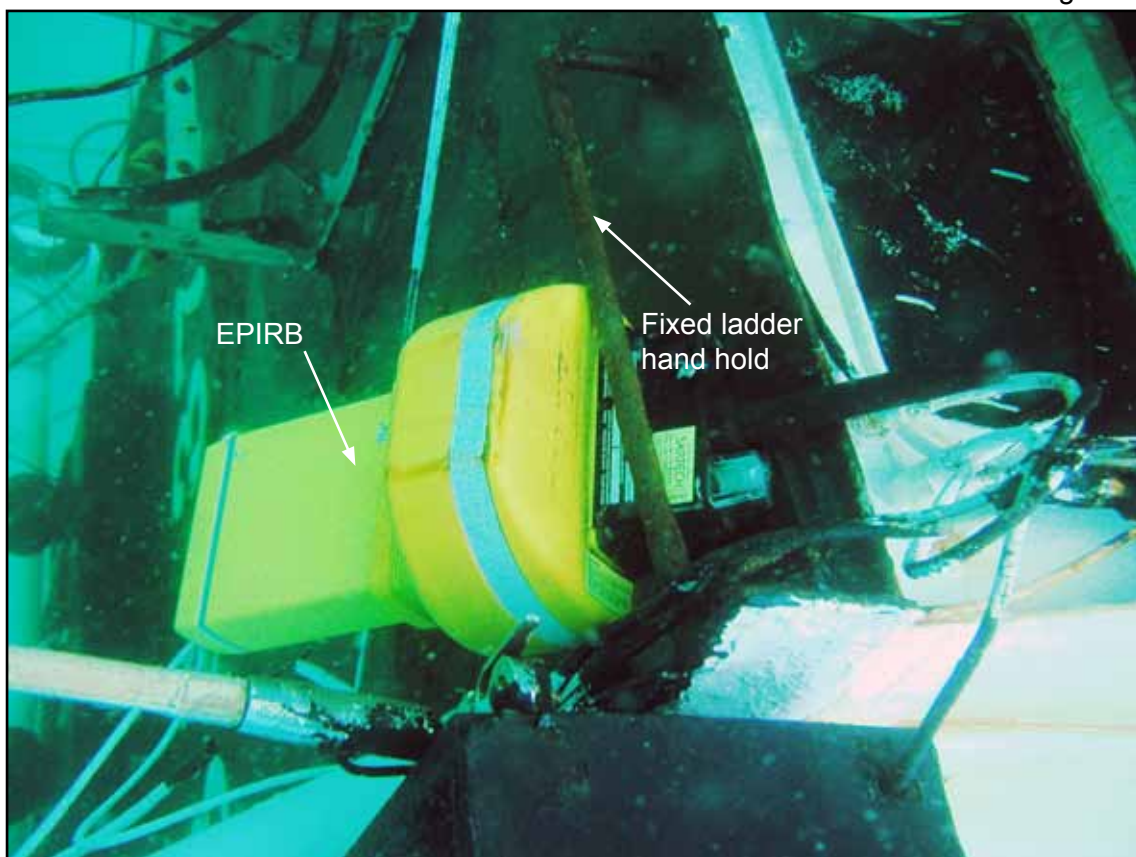
Figure 7

EPIRB fouled in hand hold of fixed wheelhouse external ladder

The EPIRB was examined after the accident, and it was found that it had last been serviced in 2002 and that its battery had been due for replacement in 2005. Once the prudent decision to carry an EPIRB had been made, it should have been serviced annually in accordance with the manufacturer's recommendations. Notwithstanding this, no evidence was found to suggest that the unit would not have operated had it floated free of the vessel.

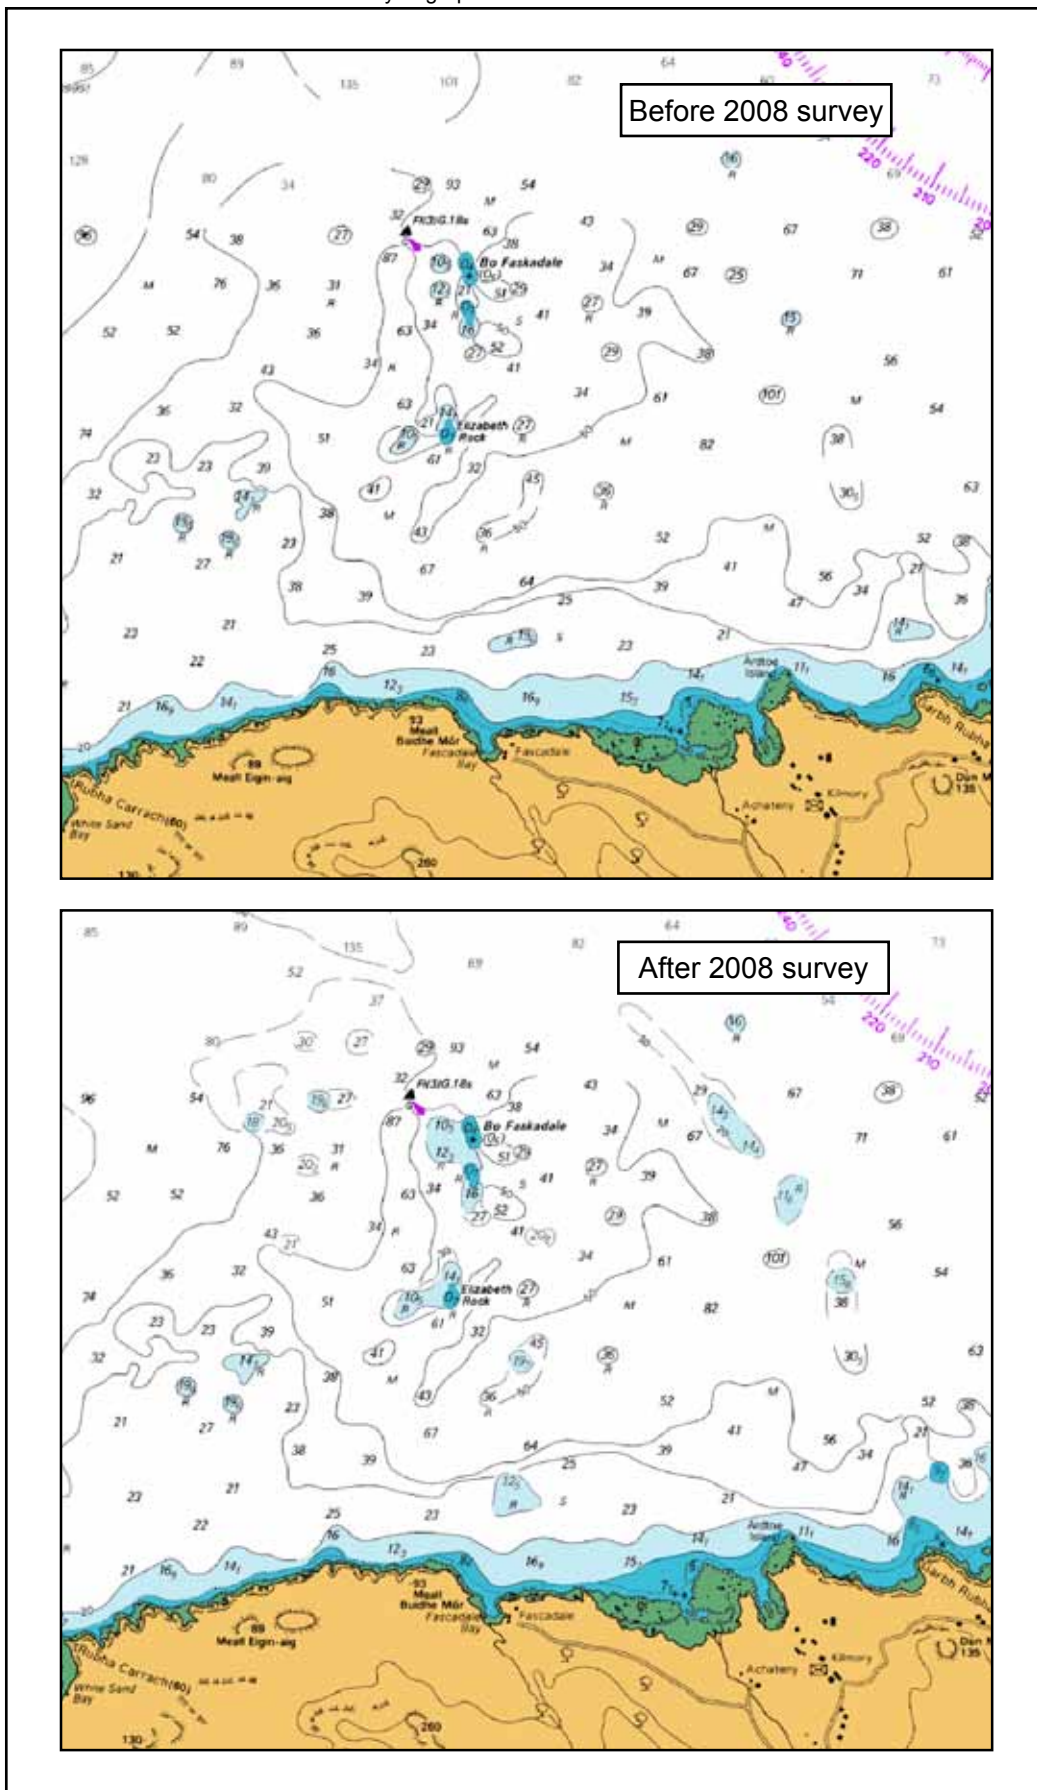
A hydrographic survey of the reef and surrounding area, using modern technology, was undertaken by the MCA in December 2008. The previous survey of this area had been undertaken in 1862 using a hand leadline only. As a result of the significant differences discovered in depths between the two surveys, a new edition of the chart of the area was published, as a matter of urgency, by the UK Hydrographic Office (UKHO) in January 2009 (**Figure 11**).

The electronic chart system in use on *Aquila* at the time of the accident had not been updated with the latest chart edition.

BA chart 2207 (showing depths before and after the MCA's survey, December 2008)
