Report on the investigation of  
the capsizing of the fishing vessel

***Aquila***

with the loss of three lives  
Bo Faskadale Reef, Ardnamurchan  
on 20 July 2009

**Report No 5/2010**  
**April 2010**

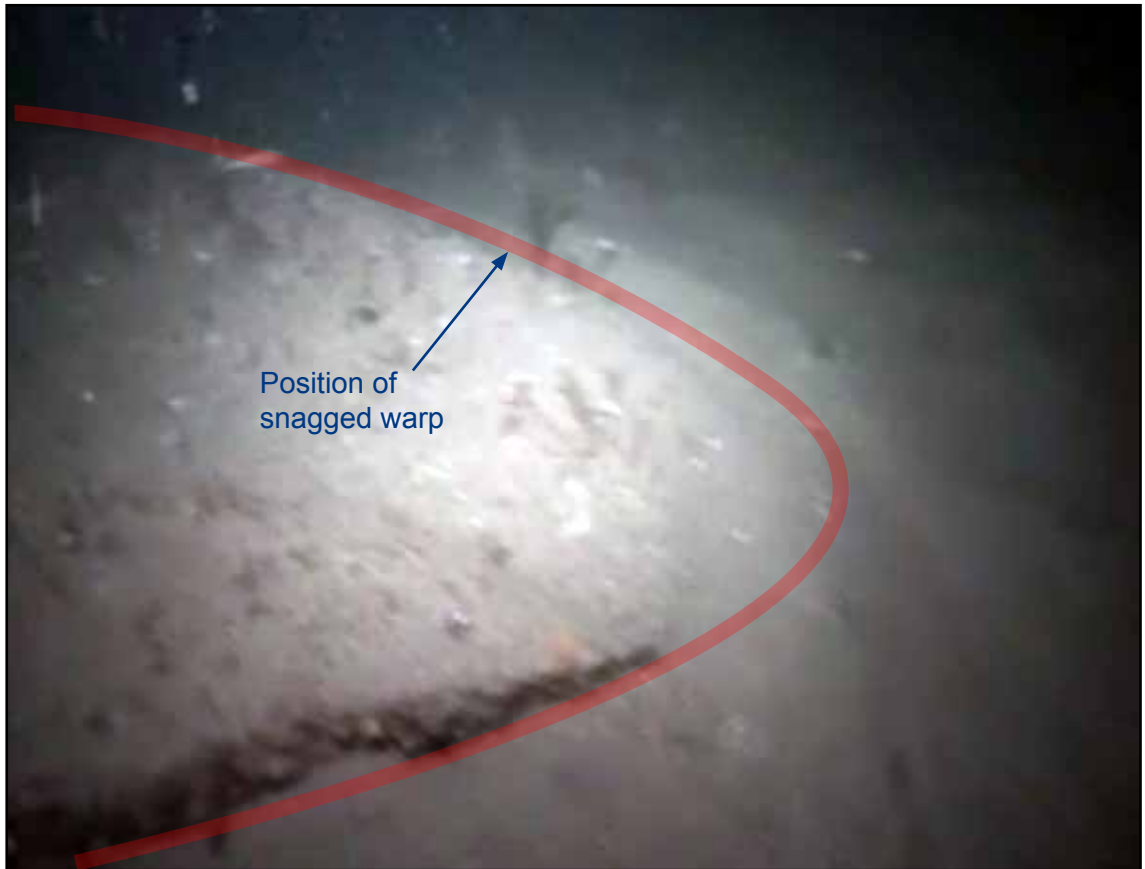
Figure 5

Starboard warp snagged on rock

When her starboard warp snagged, the vessel yawed rapidly to starboard and lay beam onto the sea. The fact that the skipper was heard to immediately put the engine into the neutral position, where it was found after the salvage, demonstrates that he was alert to the vessel's plight. However, the nature of the snag was such that the skipper could not prevent the yaw, which exposed her starboard side and the open wheelhouse door to the full force of the wind and waves.

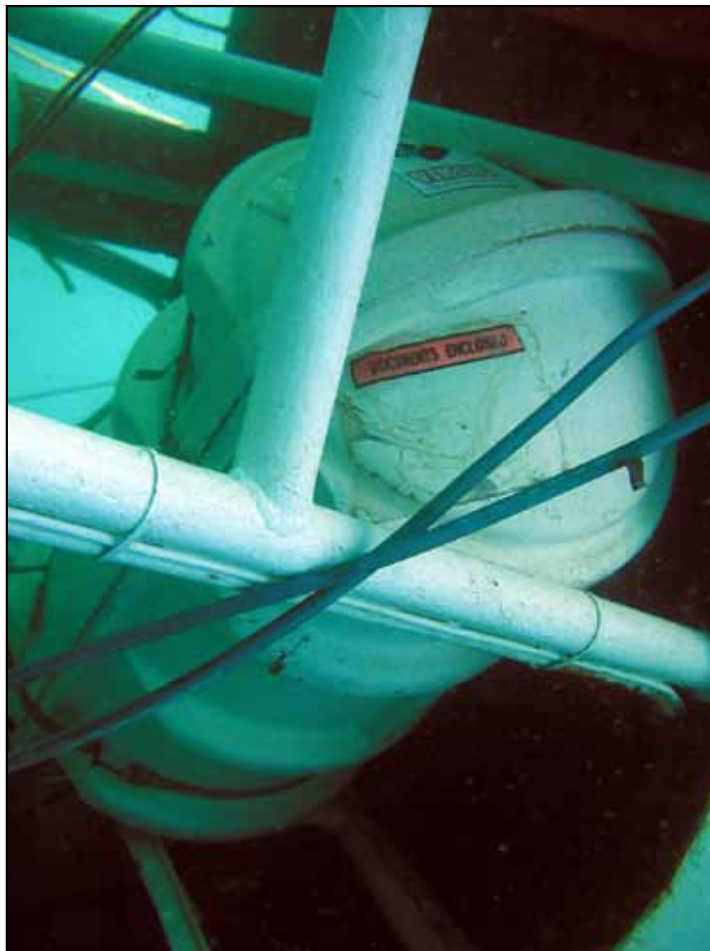
Figure 6

During this inspection it was observed that the Hydrostatic Release Units (HRUs) of the vessel’s liferaft and EPIRB had both activated correctly. However, both the liferaft and the EPIRB had become fouled on parts of the vessel’s superstructure (**Figures 6 & 7**), and had not floated free.

Liferaft fouled in *Aquila's* superstructure

Although not a statutory carriage requirement, *Aquila* had been fitted with an EPIRB as well as a requisite liferaft. HRUs were fitted to both, and it was found that these had activated as designed and allowed both the liferaft and EPIRB to be released from their housings. However, after release, they had both become trapped in the vessel's superstructure.

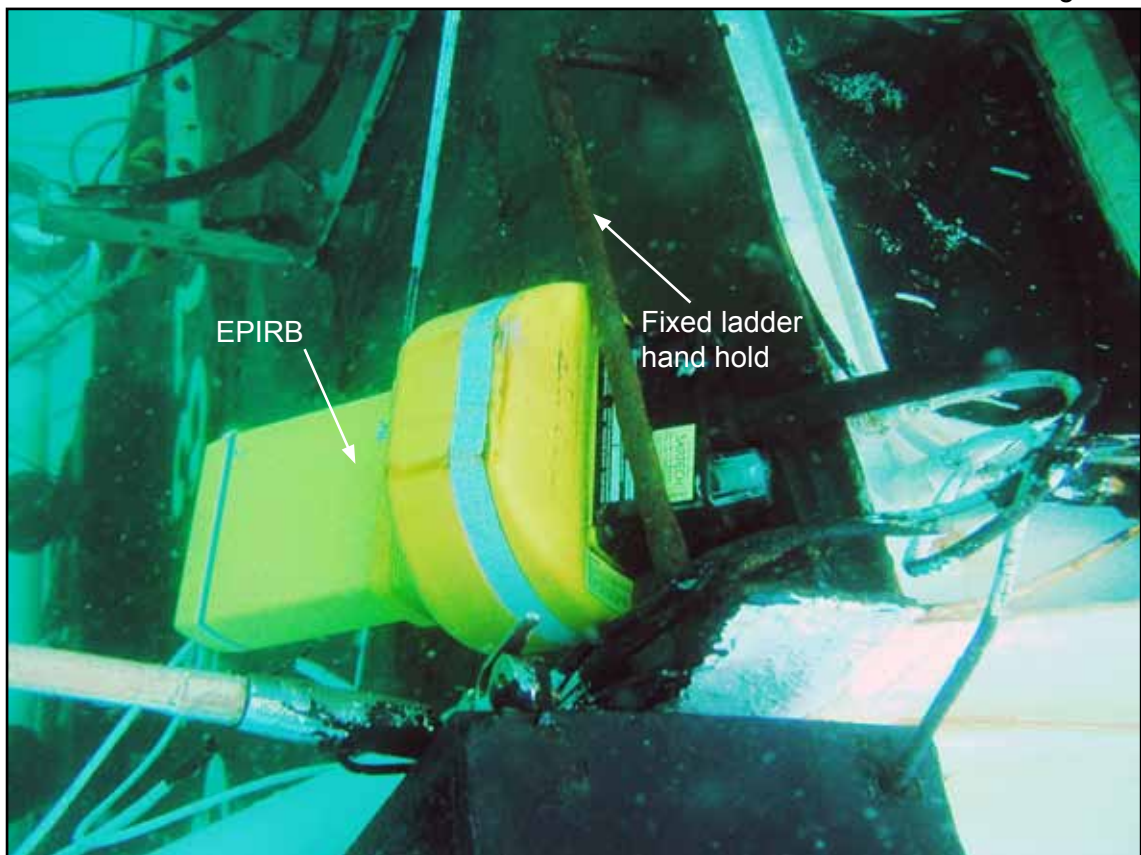
Figure 7

EPIRB fouled in hand hold of fixed wheelhouse external ladder

The EPIRB was examined after the accident, and it was found that it had last been serviced in 2002 and that its battery had been due for replacement in 2005. Once the prudent decision to carry an EPIRB had been made, it should have been serviced annually in accordance with the manufacturer's recommendations. Notwithstanding this, no evidence was found to suggest that the unit would not have operated had it floated free of the vessel.

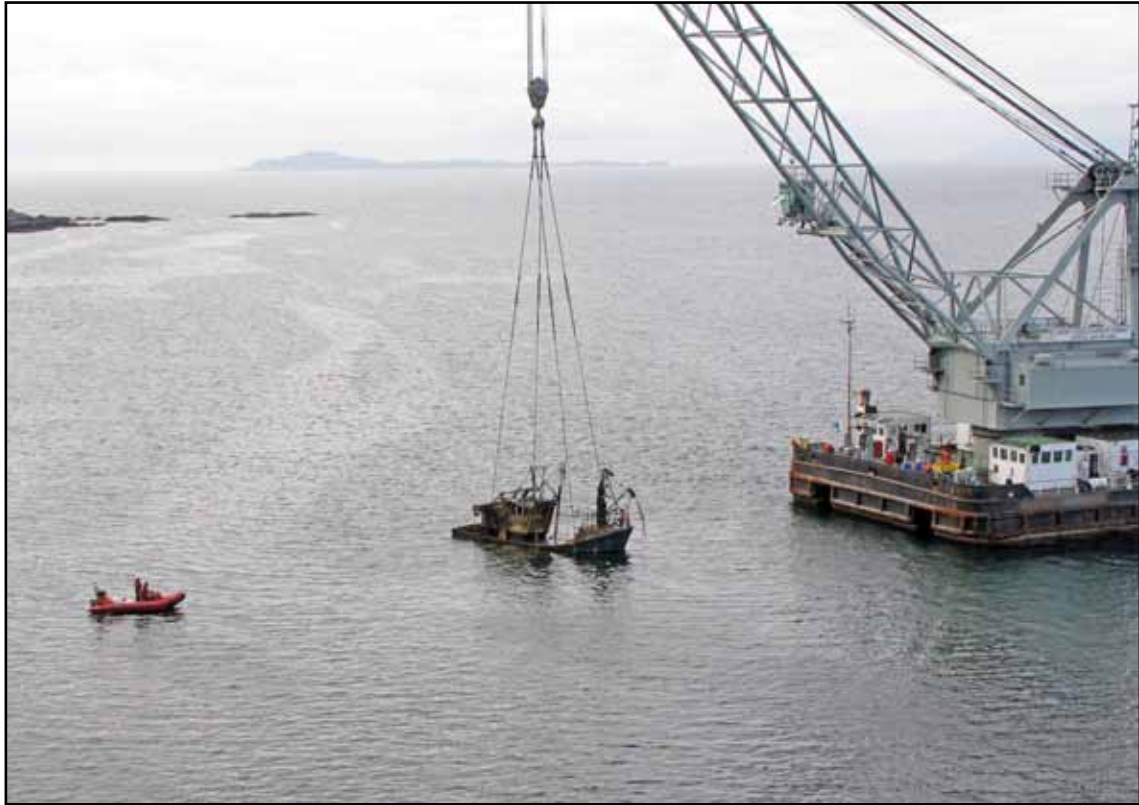
*Aquila* after salvage

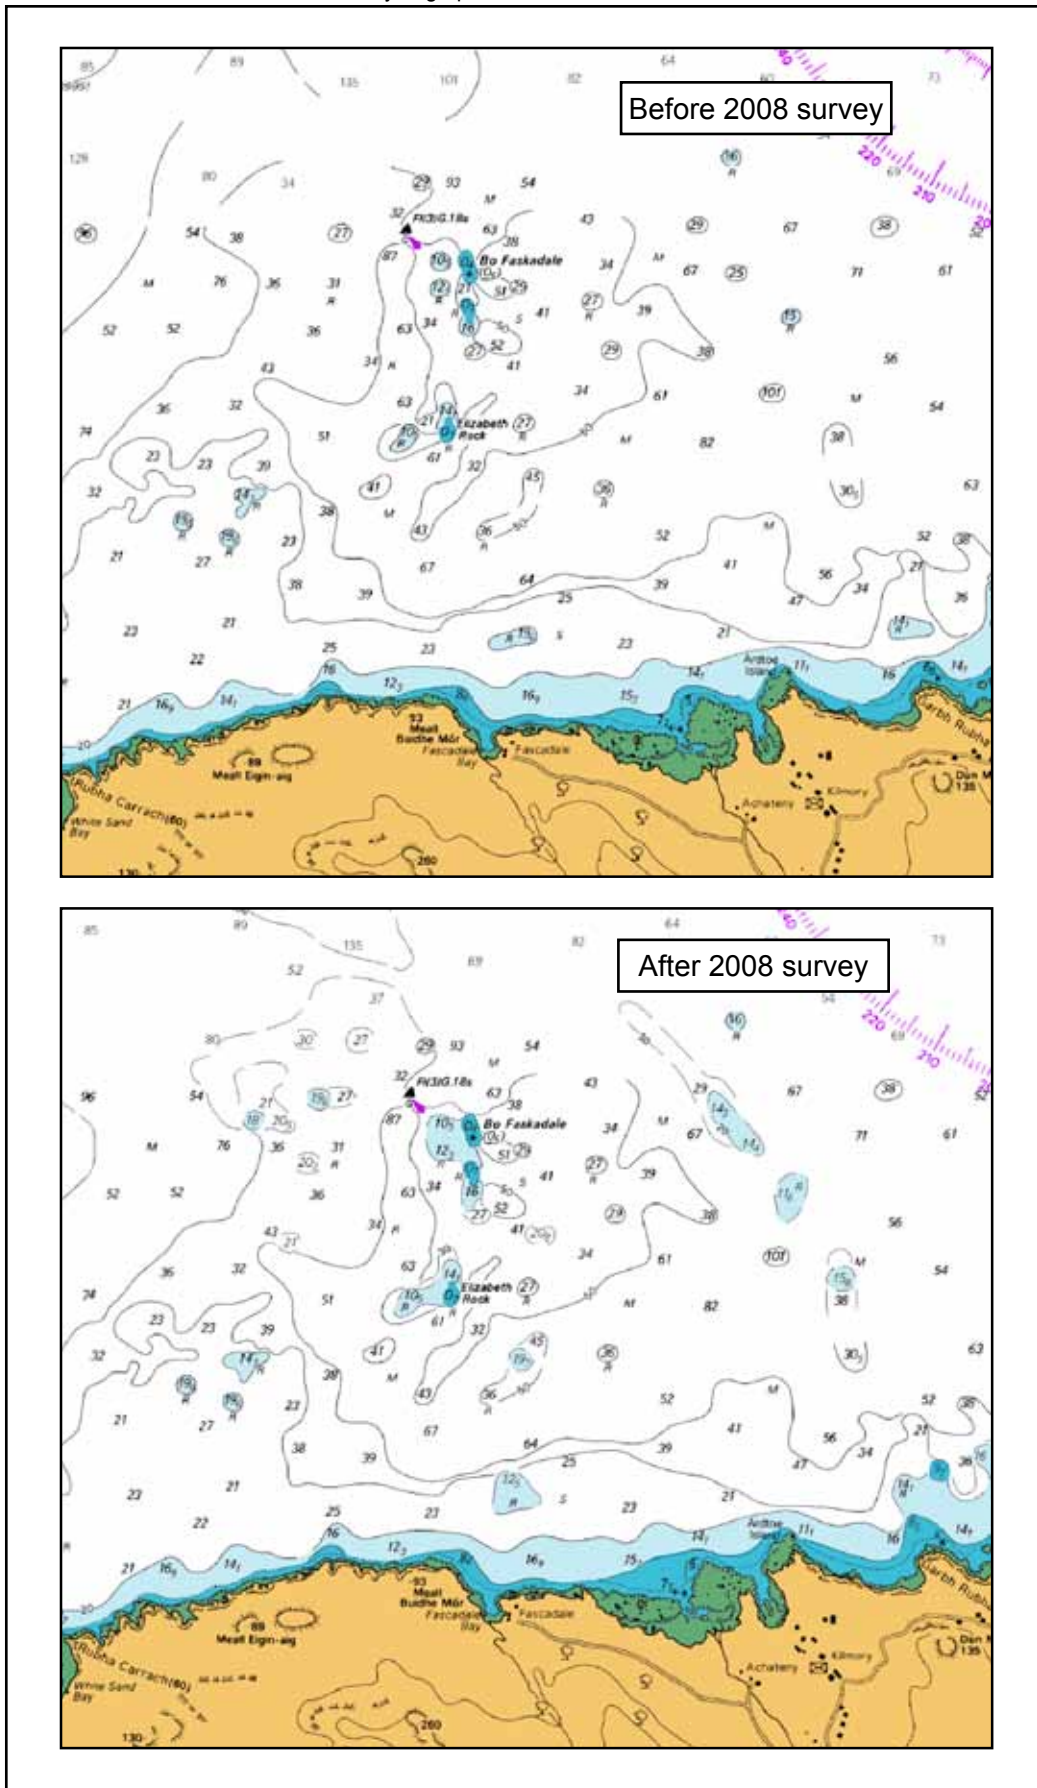
A hydrographic survey of the reef and surrounding area, using modern technology, was undertaken by the MCA in December 2008. The previous survey of this area had been undertaken in 1862 using a hand leadline only. As a result of the significant differences discovered in depths between the two surveys, a new edition of the chart of the area was published, as a matter of urgency, by the UK Hydrographic Office (UKHO) in January 2009 (**Figure 11**).

The electronic chart system in use on *Aquila* at the time of the accident had not been updated with the latest chart edition.

BA chart 2207 (showing depths before and after the MCA's survey, December 2008)

However, the vessel's fishing gear snagged in an area where the depths shown on the old and new chart editions were similar, and it is not considered that failure to carry the latest edition of the chart contributed to this particular accident.

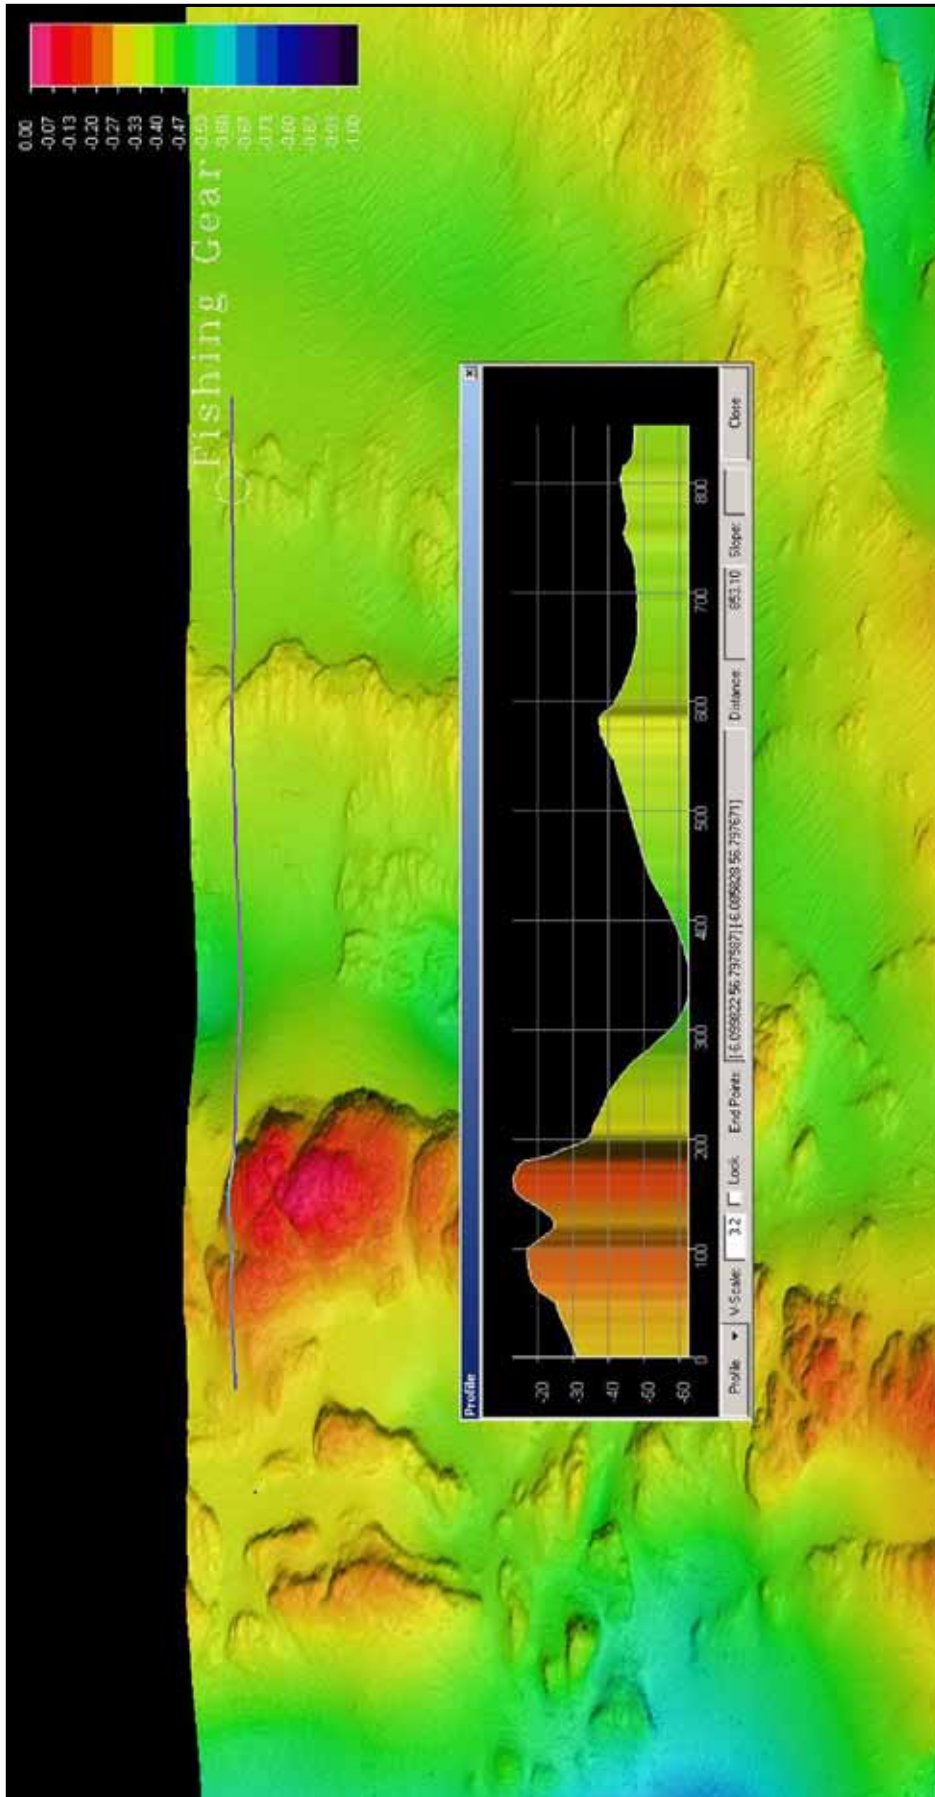
The position of the accident, and *Aquila*’s probable course at the time of the accident, were superimposed onto the latest seabed survey information obtained from the MCA (**Figure 12**). Analysis of this information showed that, while dredging, several metres of the trawl warp would have been in contact with the seabed before it became snagged.

Seabed profile showing track of fishing gear

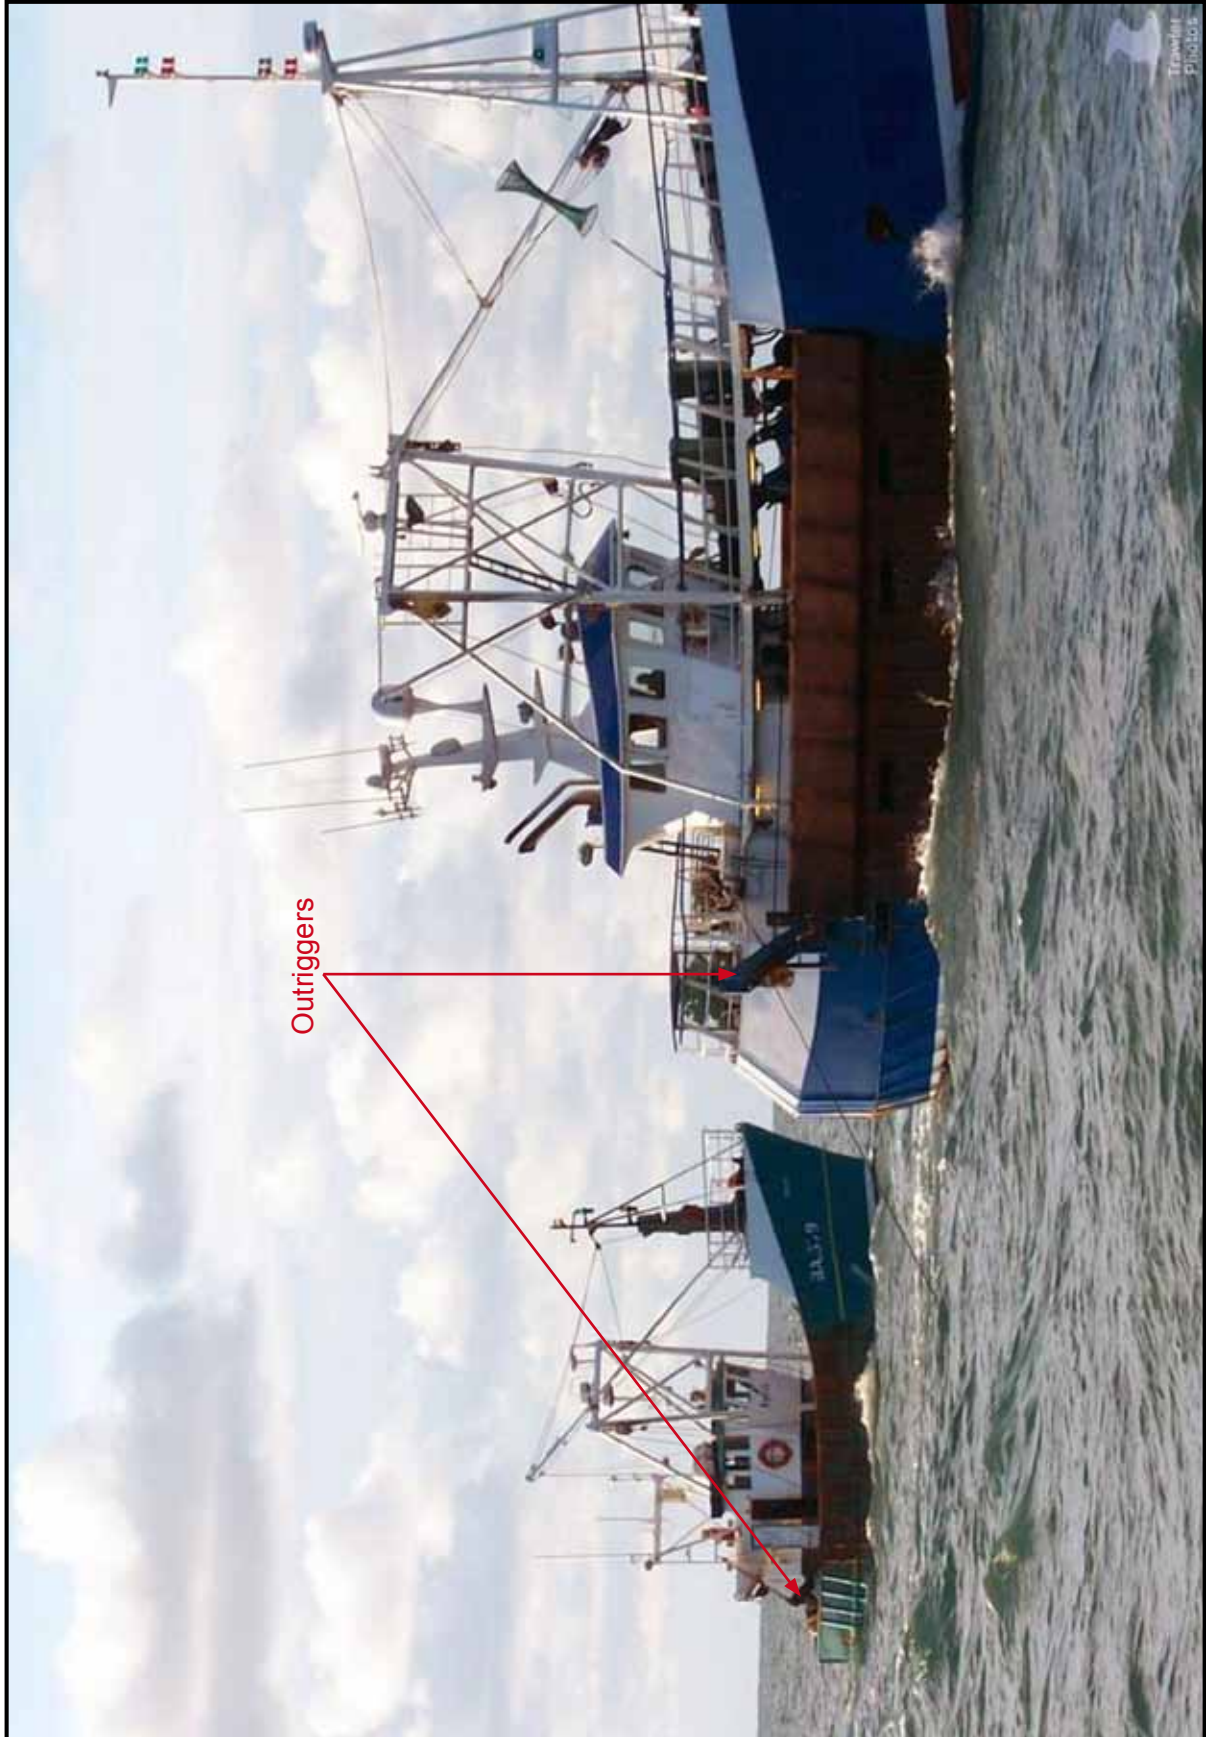
When her gear snagged, the vessel would have rotated about the starboard outrigger (**Figure 13**) and the large waves would have lifted her hull causing a further reduction in her stability. Fishermen should be reminded of the adverse impact on stability when trawling downwind in heavy seas.

*Aquila, and another vessel, showing position of the outrigger*

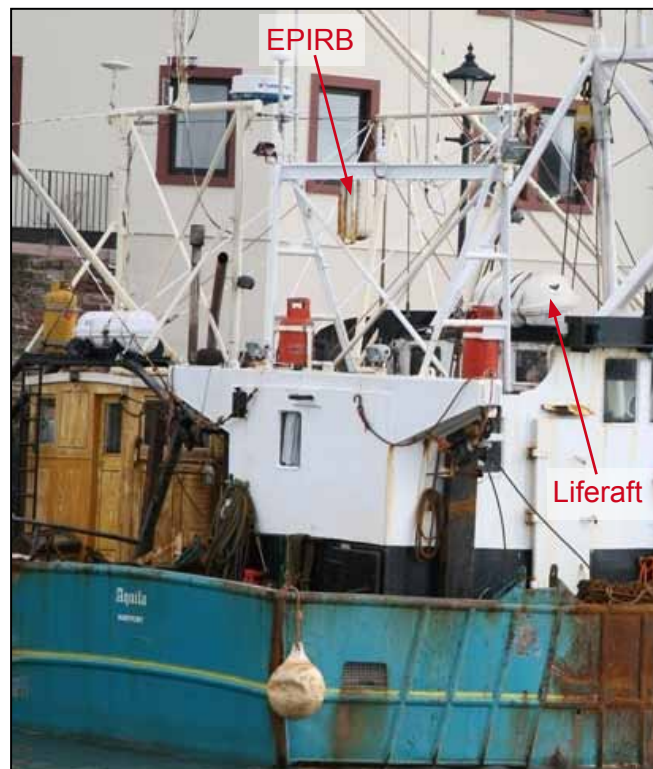
Figure 14

EPIRB and liferaft stowage positions  
on *Aquila*

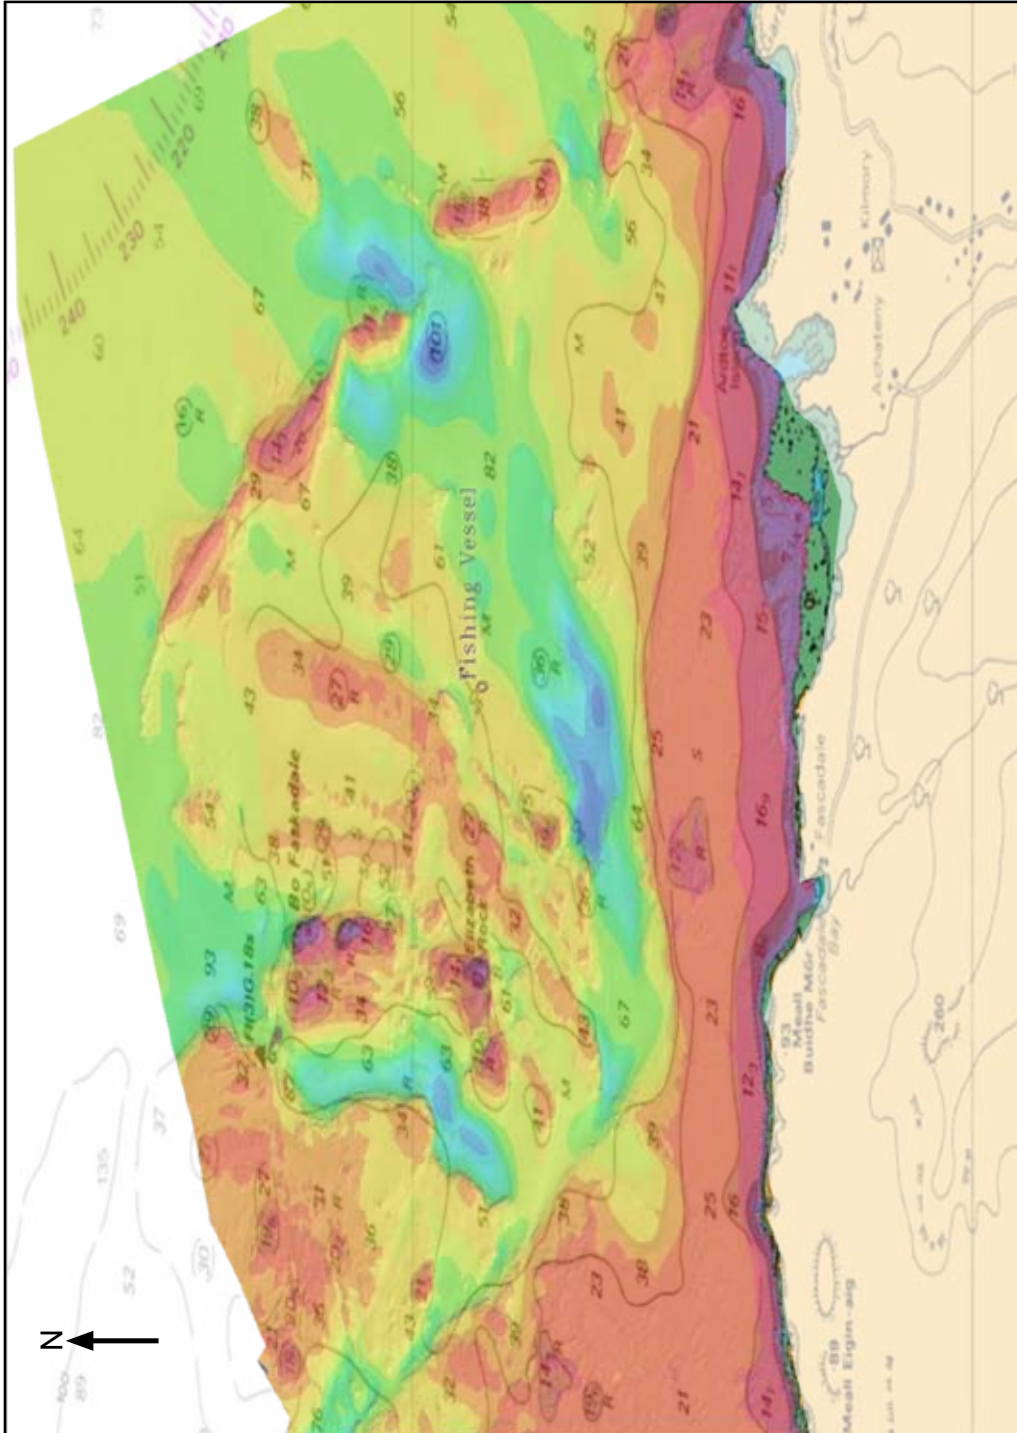
Figure 15

Seabed survey of west side of Bo Faskadale reef

At the time of the accident the tide was flooding, and in a strong south-westerly wind there was a 2m ground swell with wind waves in the area. In these conditions it is probable that standing waves were generated on the west side of the reef. The vessel probably encountered these larger than average waves when she yawed after her gear had snagged.

No warning of this standing wave phenomenon exists on the chart or in the Admiralty Sailing Directions. This information has now been added to both publications by the UKHO, to inform mariners navigating in the area, of the hazard.
