Stability Assessment
Investigation into capsizing of MFV 'Aquila'
Marine Accident Investigation Branch

December 2009

Report on Stability Investigation - FV 'Aquila'

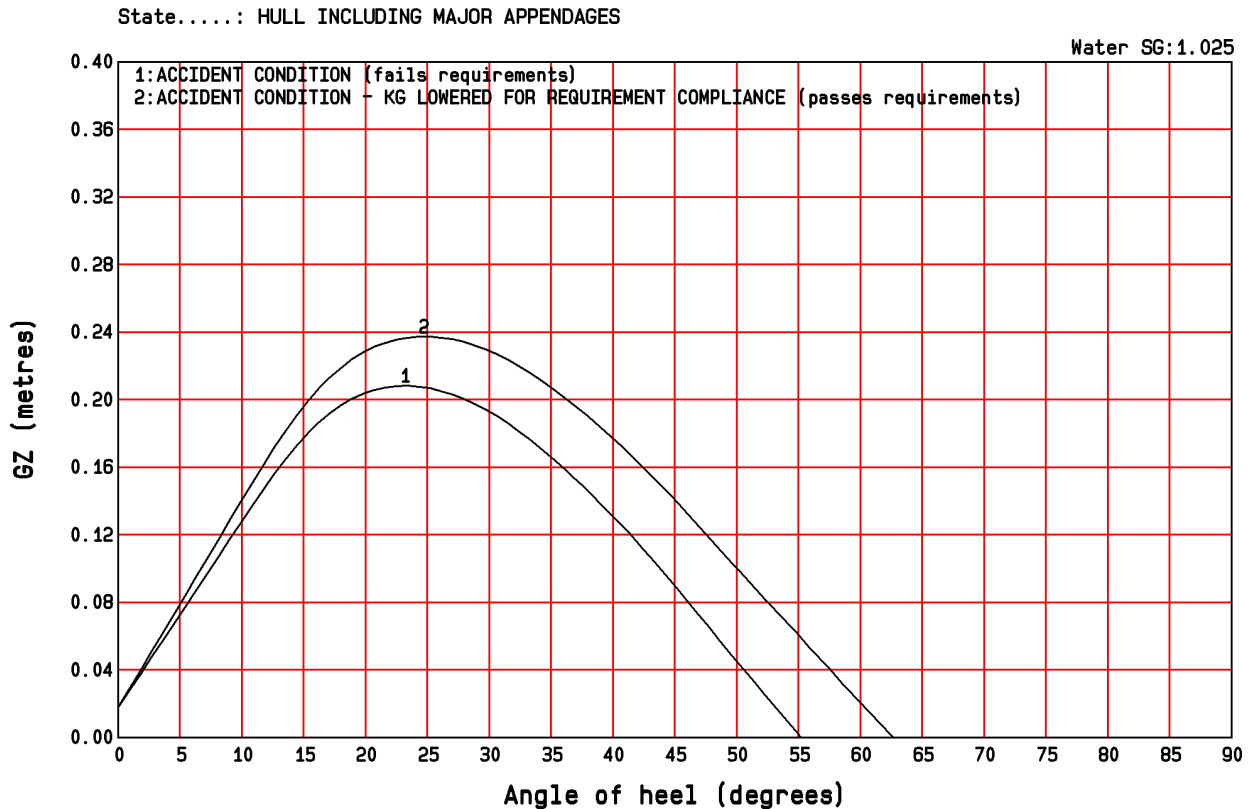
Diagram 5 – Righting lever plots for accident condition and with KG lowered to comply

The deadweight table in Appendix 9 is the estimated condition of the vessel at the time of the accident. It has been drawn up from information derived from the 2009 inclining trial, and from interviews with the accident survivor, equipment suppliers and individuals who had knowledge of the boat and its operation. It therefore represents the best estimate of the accident condition. Items 21 and 22 in the deadweight list represent the estimated 0.315 tonnes per side vertical element of the loads imposed on the port and starboard jockey pole ends by the dredge wires which were assumed to be running aft of the pole ends at about 15 degrees to the horizontal. The righting lever curve for the condition (curve 1) is reproduced in diagram 5 below. In this condition, the vessel did not comply

with three of the six stability criteria - the minimum area under the righting lever curve between 30 and 40 degrees (0.03 metre.radians required, 0.029 metre.radians achieved), the angle of heel at which the maximum righting lever occurs (25 degrees required, 23.3 degrees achieved) and the maximum righting lever between 30 and 90 degrees (0.20 metres required, 0.193 metres achieved). For the purposes of comparison, a second righting lever (curve 2) is shown indicating the level of stability which would have complied, albeit marginally. Compliance has been achieved by lowering the condition KG by 0.087 metres from 2.305 metres to 2.218 metres. Note that the curves do not commence at the 0,0 origin because the vessel had a transverse centre of gravity approximately 18mm to port at the time of the accident and the righting levers shown assume heeling to starboard as in the accident.

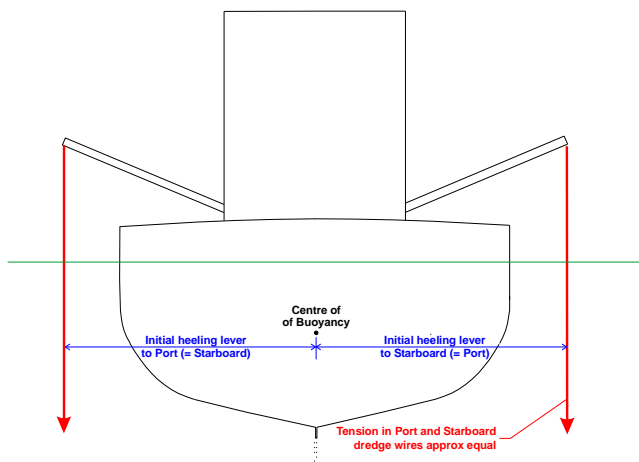
Diagram 6a – Dredge wire heeling and righting levers - vessel upright

Diagram 6a shows the Aquila at equilibrium before the accident occurred with the stern pulled down equally by the tension in the port and starboard dredge wires.

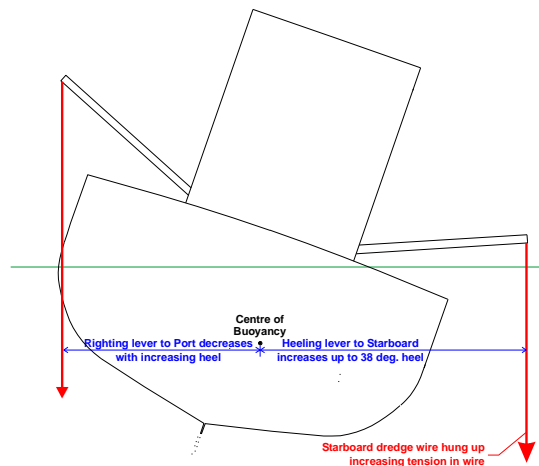
Diagram 6b – Dredge wire heeling and righting levers - vessel heeled

When the starboard dredge wire caught fast, the immediate effect would have been to heel and yaw the vessel to starboard (see diagrams 6b and 7b). The initial yawing moment (the horizontal element of the additional force imposed on the starboard jockey pole end times the normal distance from the line of action of this force to the centre of buoyancy) would have been greater than the heeling moment. However, since roll inertia (i.e. the tendency of a body to resist acceleration) is much lower than yaw inertia for conventional hull shapes, it is considered that heel would have increased more rapidly than yaw.

As the vessel heeled and yawed, the heeling (or capsizing) moment caused by the starboard dredge wire would have been growing as the heeling lever, measured about the centre of buoyancy, increased in length. At about 20 degrees heel the jockey pole end was at the same height as the centre of buoyancy and thereafter, the lever length and consequently the heeling moment would have reduced. Similarly, the righting moment from the port wire, albeit less because the dredge wire was not caught, would have been dropping and would have reduced to zero at about 50 to 55 degrees of heel. As heel increased beyond this angle, tension in the port wire would start to contribute to the heeling moment. Diagrams 6a and 6b illustrate the increasing heeling lever to starboard and the decreasing righting lever to port as heel increased.

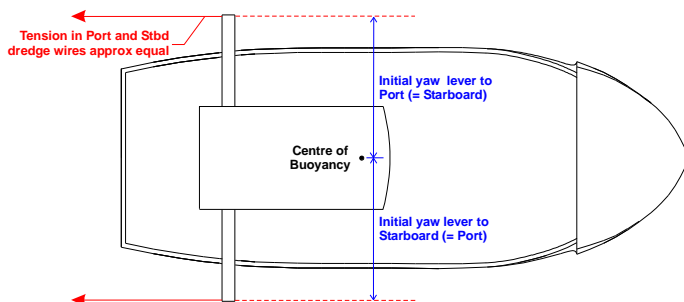
Diagram 7a – Dredge wire yaw levers before accident occurred

The yaw lever arms were also changing as the accident developed. The starboard yaw lever arm was reducing rapidly in length as the vessel yawed to starboard whilst the port lever arm lengthened - See diagrams 7a and 7b below.

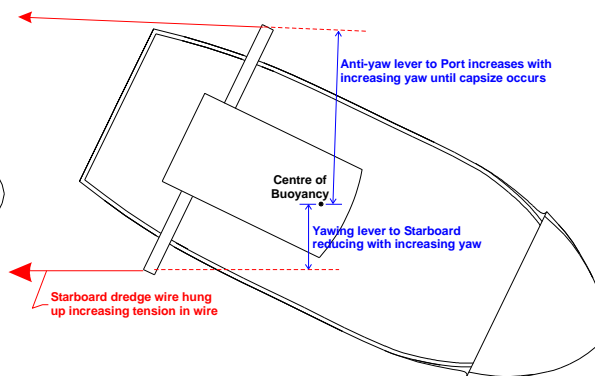
Diagram 7b – Dredge wire yaw levers changing as accident developed

Effectively, the vessel was pinned at the starboard jockey pole end, a point which although well off the centreline was also well aft of amidships. It is therefore considered that high yaw inertia (relative to roll inertia), coupled with decreasing yaw moment to starboard and an increasing 'anti-yaw' moment to port, albeit with lower tension in the port wire, would have resulted in capsizing through the mechanism discussed above before the vessel had reached a high angle of yaw.

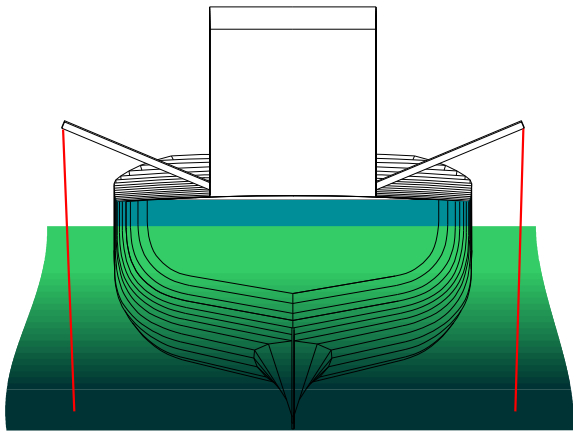
Diagram 8a – Aquila towing port and starboard dredges before accident. Waves coming from astern

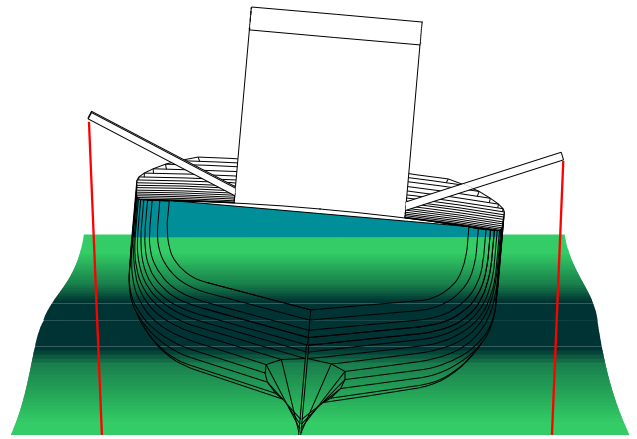
Diagram 8b – Starboard dredge wire becomes trapped. Vessel heels in response to increased tension in starboard wire

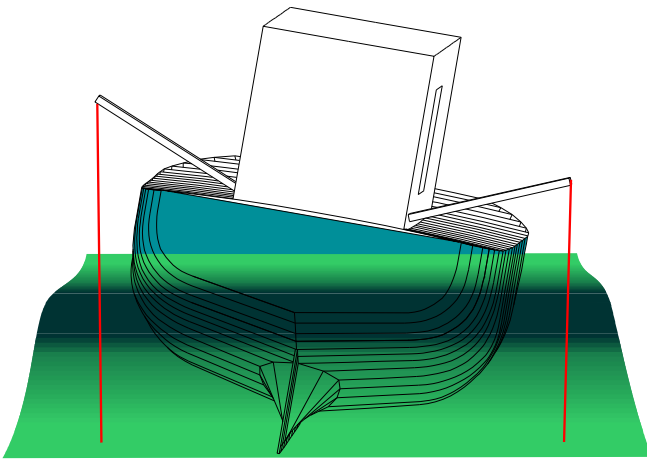
Diagram 8c - Heel to starboard increases and vessel starts to yaw to starboard, both in response to greater tension in starboard dredge wire

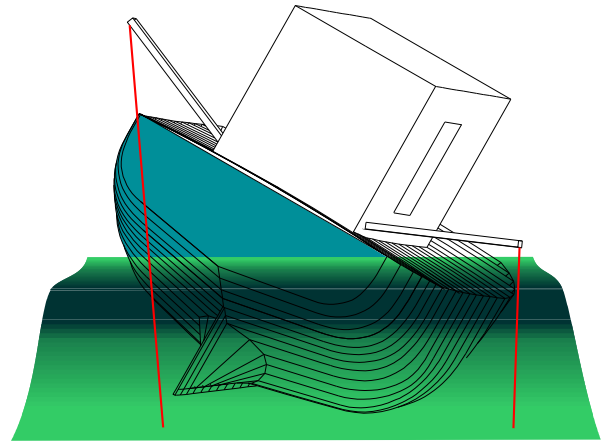
Diagram 8d - Heel and yaw to starboard increase. Righting moment from port dredge wire reduces with increasing heel

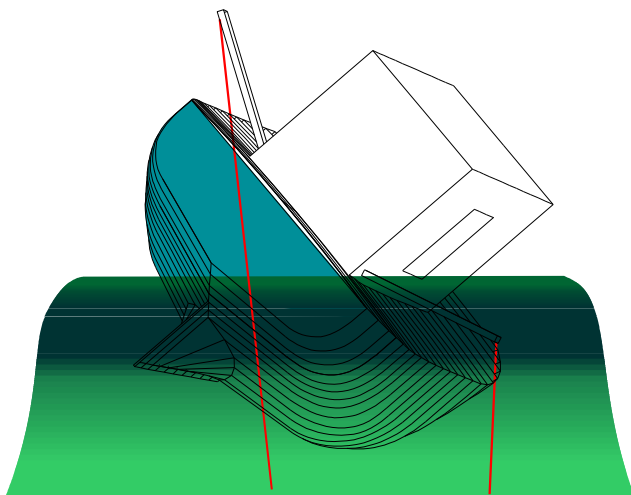
Diagram 8e - Vessel continues to heel and yaw to starboard. Wave from astern lifts stern sections increasing capsizing moment about starboard jockey pole end. Righting moment from port dredge wire reducing to zero as heel and yaw increase

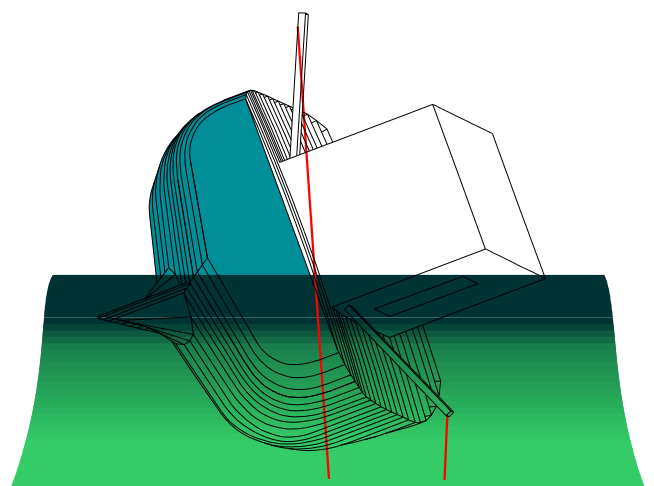
Diagram 8f - Tension in both port and starboard dredge wires now contributing to heeling moment. Vessel now beyond 54 degree angle of vanishing stability making capsizes inevitable

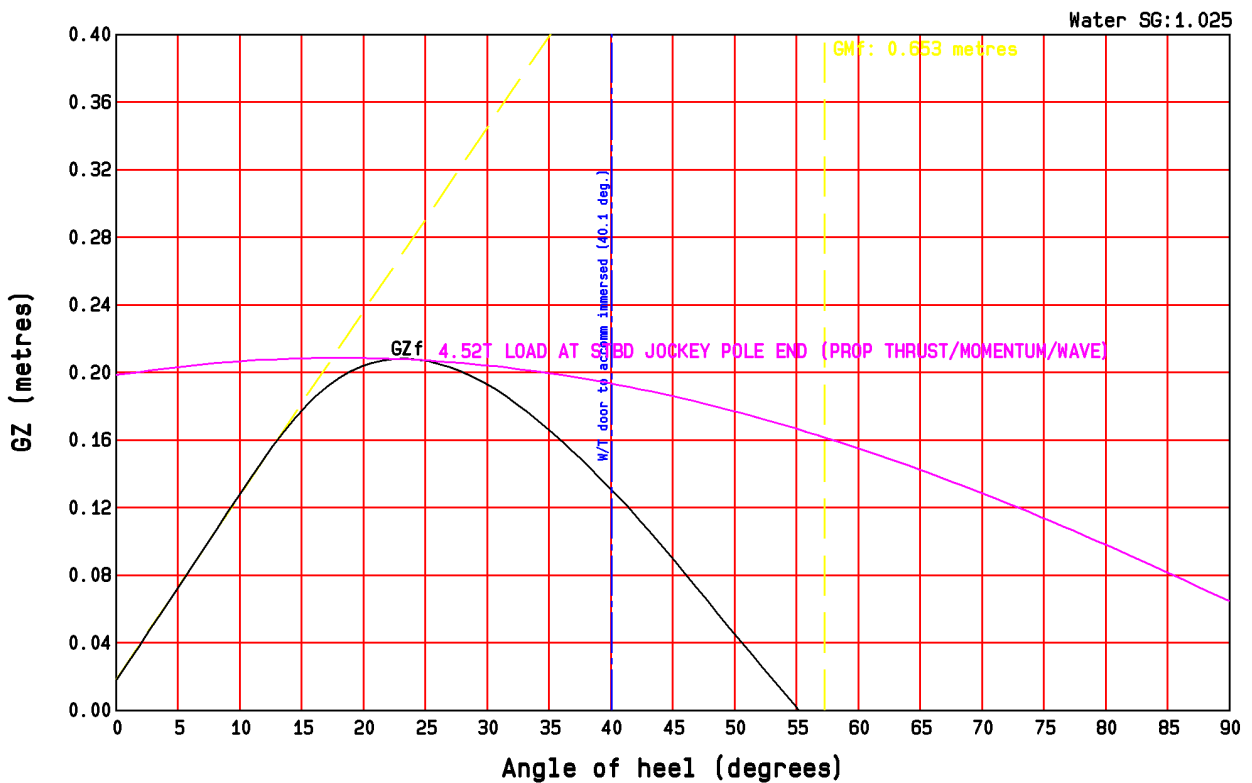
Diagram 9 – Righting and heeling lever curves for accident condition

The heeling lever analysis indicates that using a hydrostatic analysis the minimum load acting vertically downwards at the starboard jockey pole end would have to be at least 4.52 tonnes in magnitude to capsize the Aquila in flat water. The plot reproduced in diagram 9 below, illustrates this minimum heeling lever superimposed on the righting (GZ) lever.

NB Vessel capsizes with this heeling lever applied

It should be emphasised that the heeling lever shown in the plot is the minimum that would have been required to capsize the Aquila in the accident condition. It is very probable that the sum of the forces acting about the starboard pole end were in fact considerably greater than the 4.52 tonnes minimum. In light of this, a further heeling lever was assessed, using the righting lever shown in diagram 5 (curve 2) that would have complied with the requirements, i.e. with the KG at a reduced height of 2.218 metres rather than the 2.305 metres estimated. This analysis indicates that the vessel would have capsized in this condition if the sum of the forces acting about the starboard pole end were greater than 5.18 tonnes.

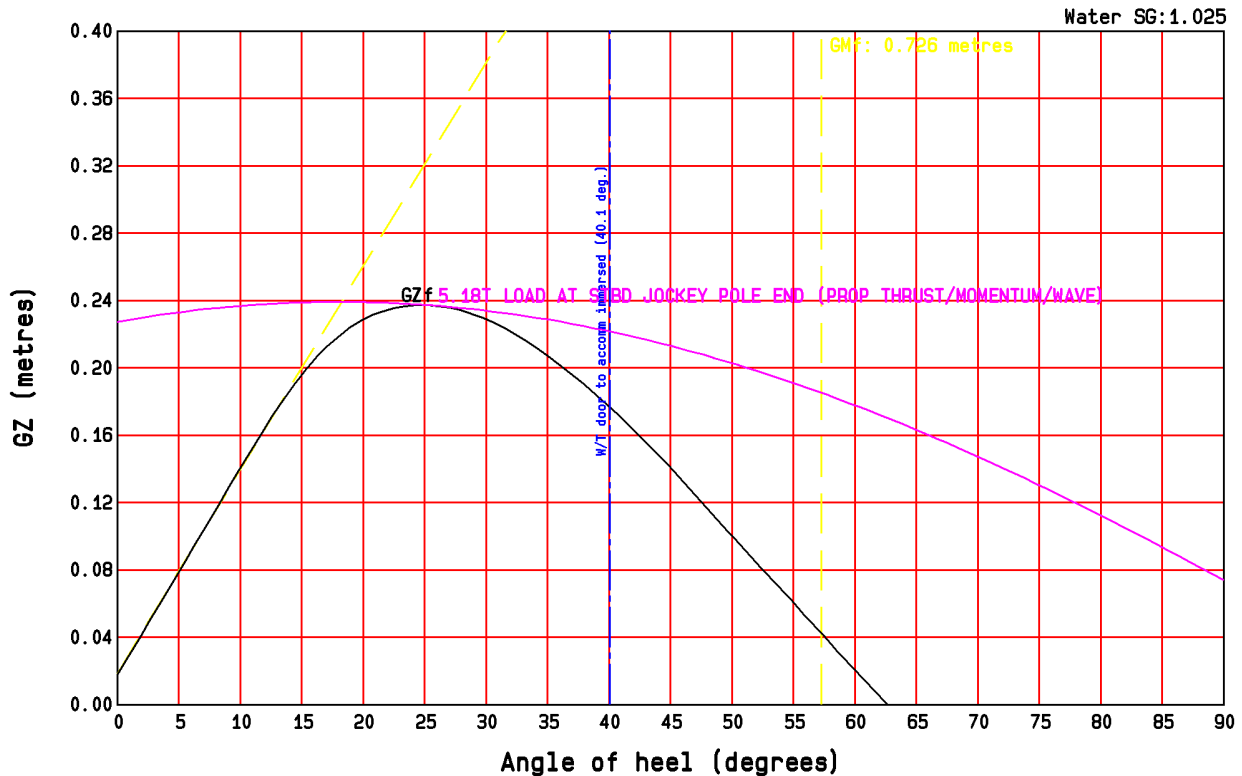
Diagram 10 – Righting and heeling lever curves for accident condition with KG lowered to comply

NB Vessel capsizes with the applied heeling lever

It is considered that the combination of forces acting at the starboard jockey pole end, particularly the buoyancy upthrust in the prevailing sea conditions, would have been in excess of the minimum 5.18 tonnes required to capsize the boat in this condition with a lowered KG. It follows that the Aquila would in all probability have capsized whether or not it complied with the stability requirements at the time of the accident.

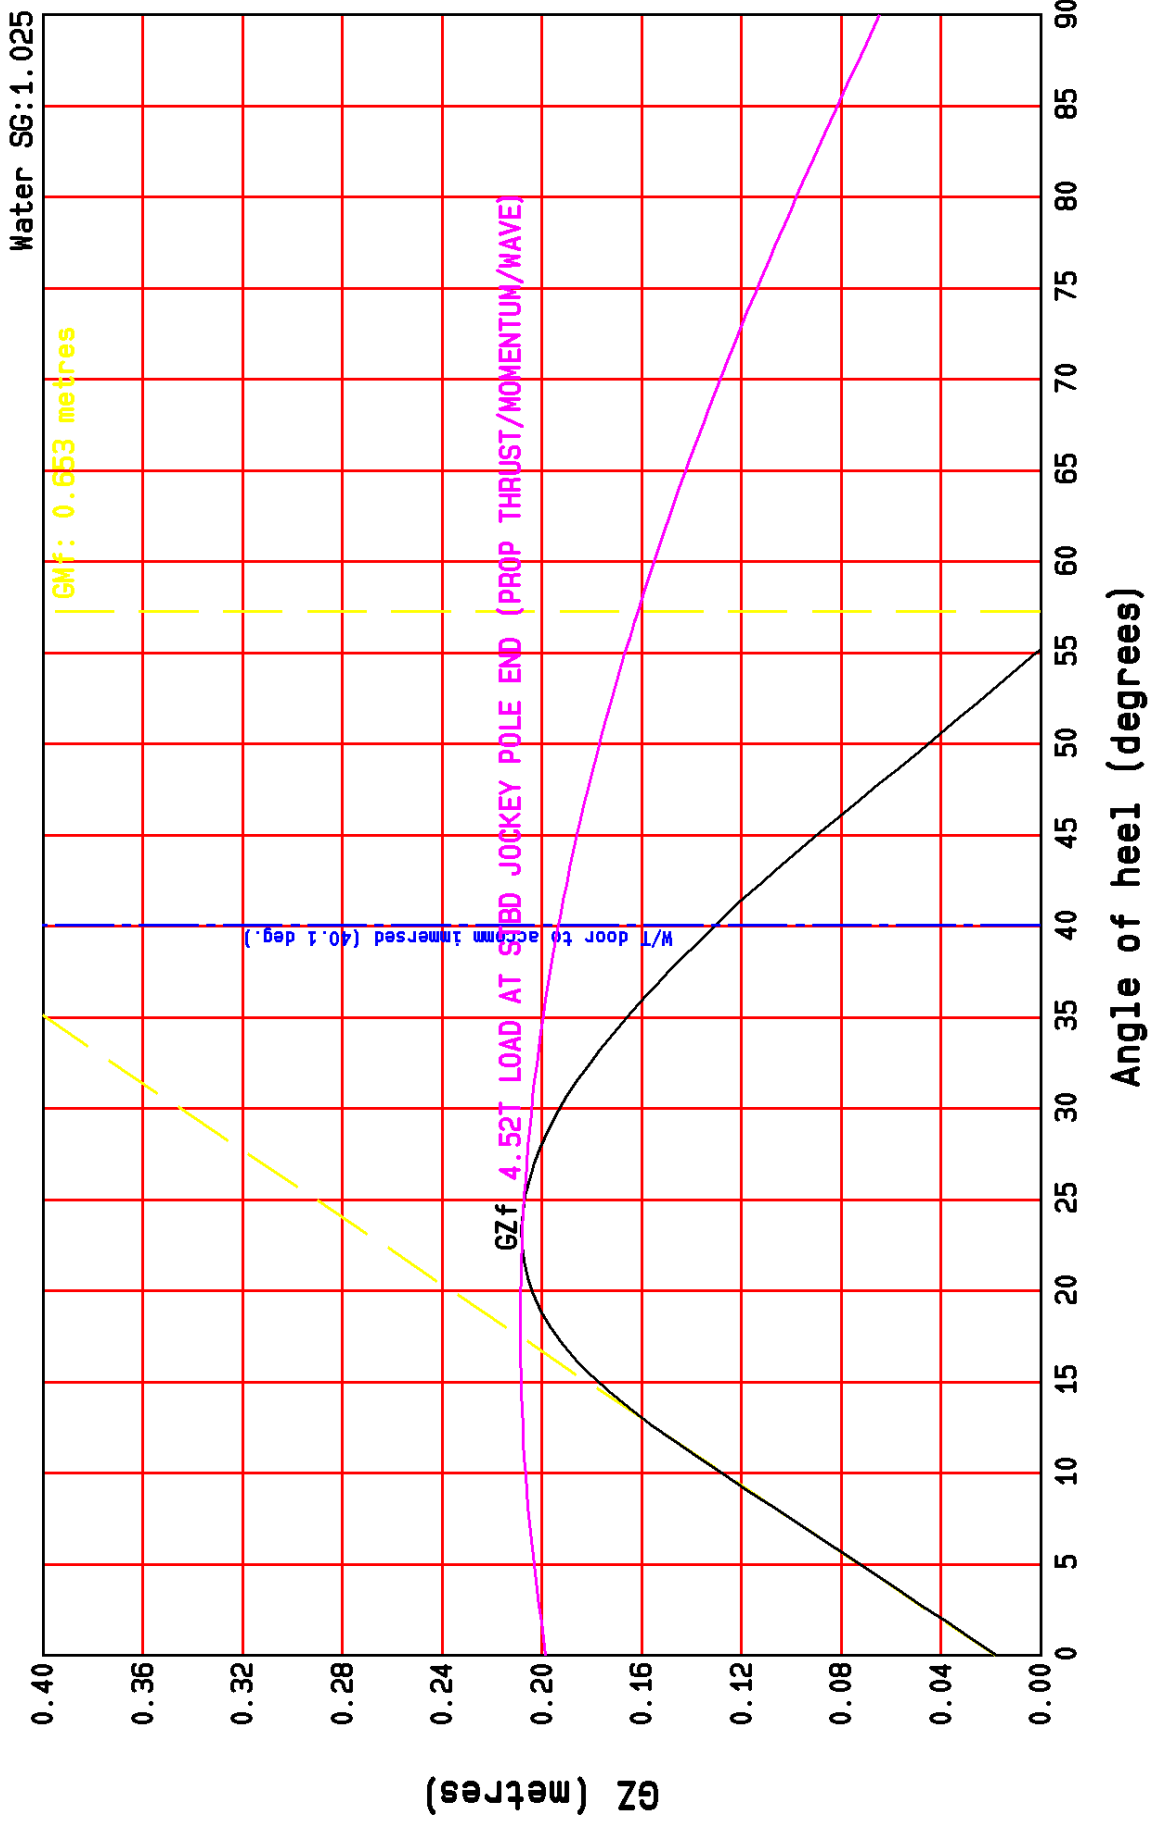
GZ PLOT NB Vessel capsizes with this heeling lever applied

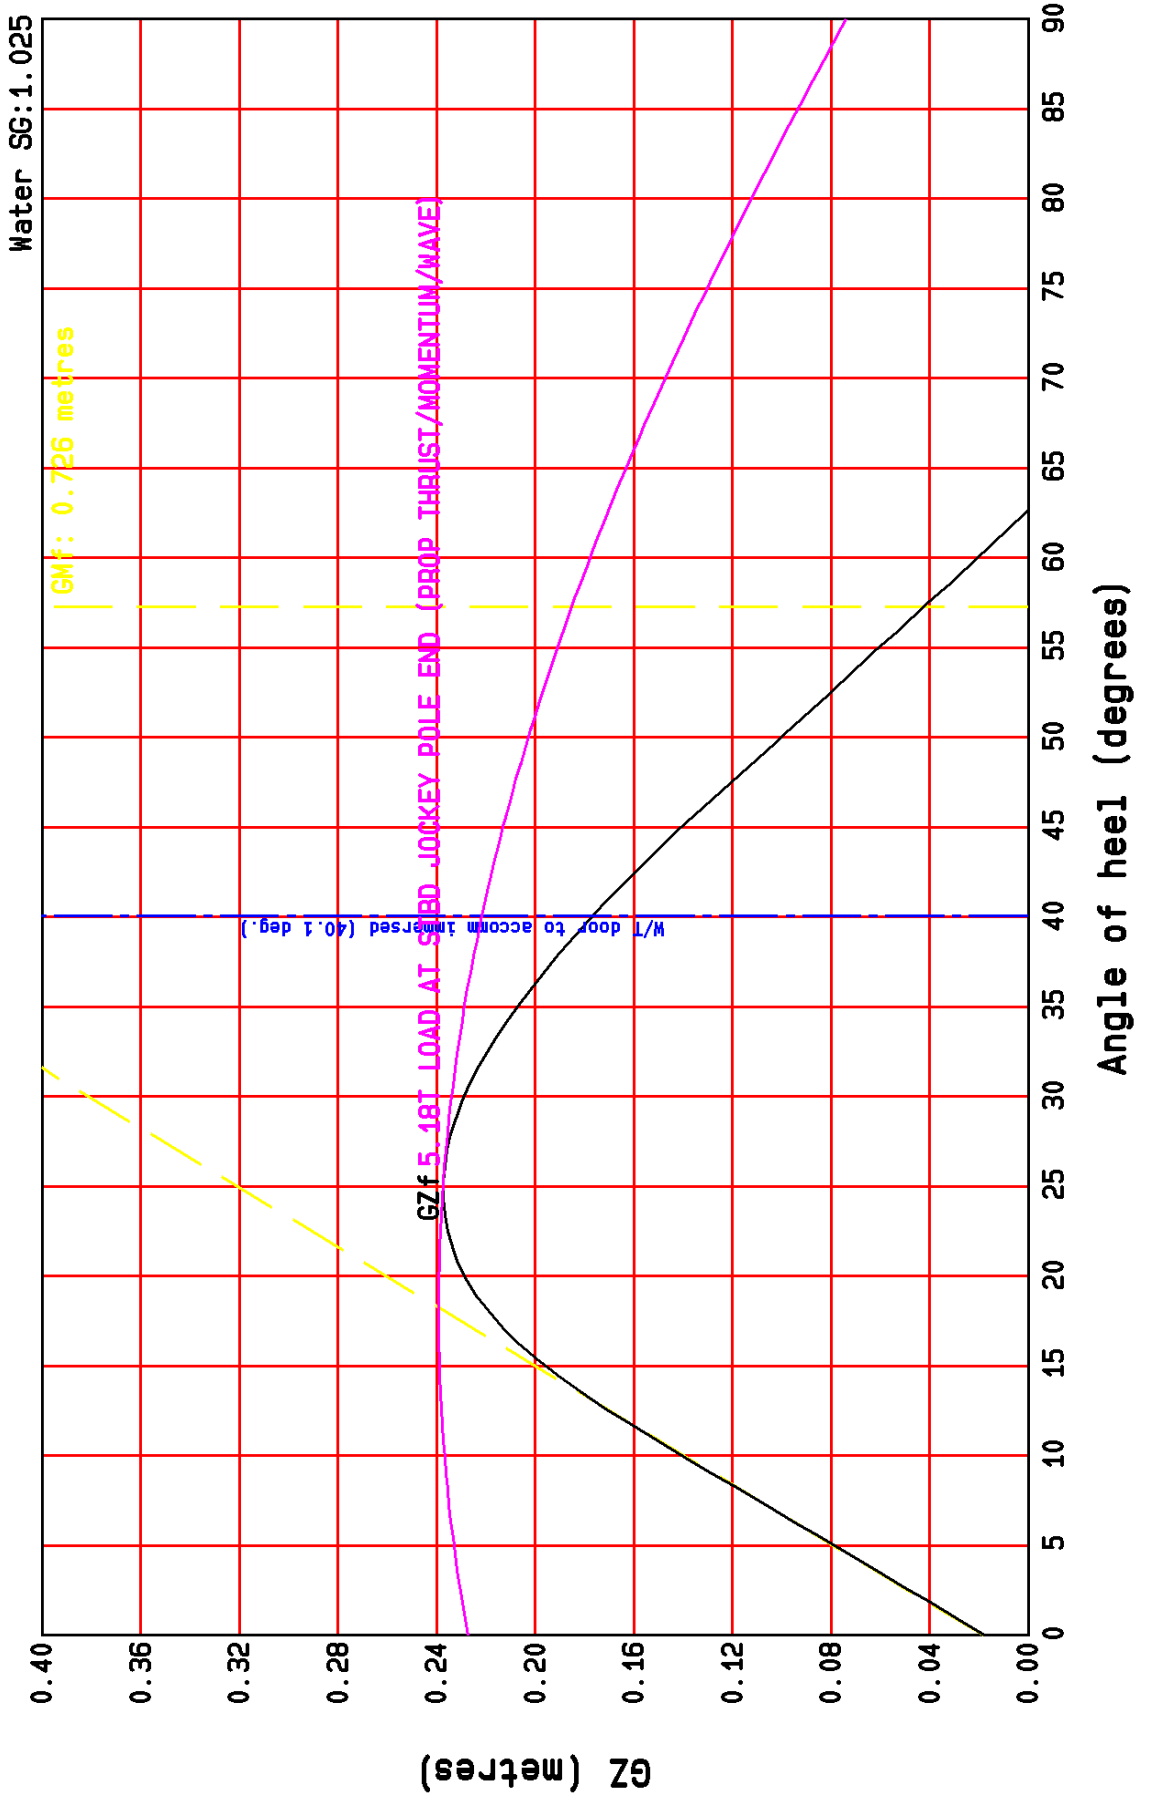
GZ PLOT NB Vessel capsizes with the applied heeling lever
