Report on the investigation

into the loss of the tug

Ijsselstroom

Report No 4/2010
April 2010

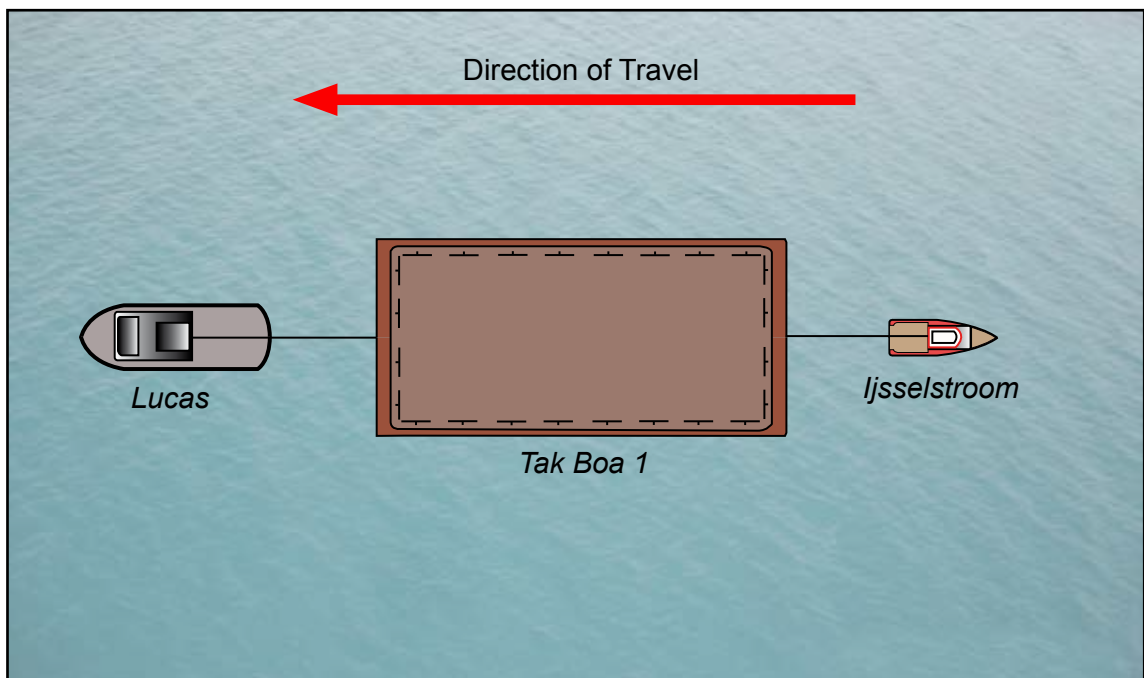
Figure 5

At 0430 *Lucas* and her tow were 8 cables from the entrance to Peterhead Bay. The pilot informed *Ijsselstroom* that he was reducing *Lucas's* speed. *Ijsselstroom's* skipper acknowledged this and replied that he would start to make fast. He then manoeuvred *Ijsselstroom's* stern to the barge and the tug's towing wire was passed to *Tak Boa 1* (Figure 5).

Diagram of the towing arrangement

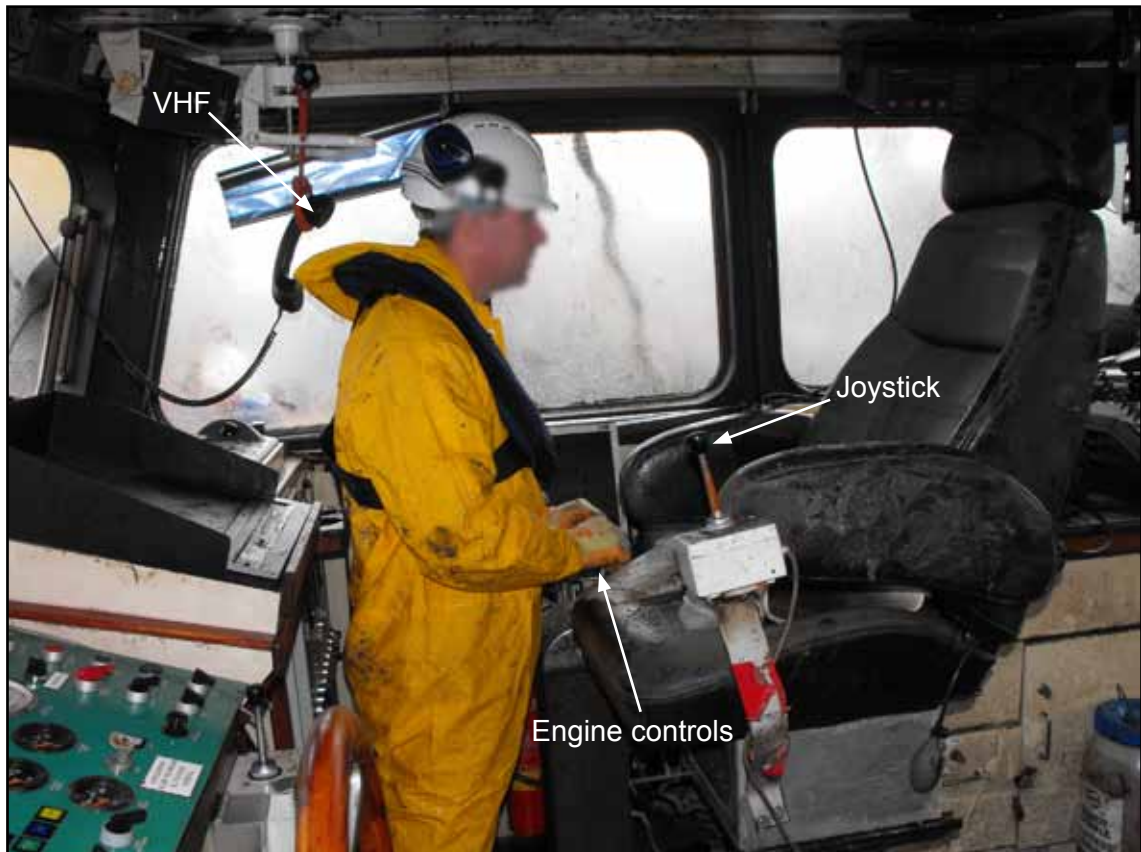
Figure 6

Ijsselstroom was conned from a swivel chair that could be locked in a forward or stern facing position. *Ijsselstroom*'s skipper had placed the chair in the normal forward facing position as he followed *Lucas* and *Tak Boa 1* towards the entrance to Peterhead (**Figure 6**). Once the skipper had manoeuvred his vessel's stern towards the barge, he swivelled the chair to face astern.

Conning position showing skipper's chair facing forward

The skipper had three options as to how to conn *Ijsselstroom*: standing facing aft but with the chair facing forward (**Figure 6**); sitting, with the chair facing aft; or sitting, with the chair facing forward.

Van Wijngaarden Marine Services gave no instruction or guidance to skippers regarding the conning position or use of controls on board *Ijsselstroom* when making sternway and towing over the stern. The skipper recalls that when he observed other skippers during his training period, each had their own preference. Some would sit facing forward, others swivelled the chair and sat facing aft, and some would stand.

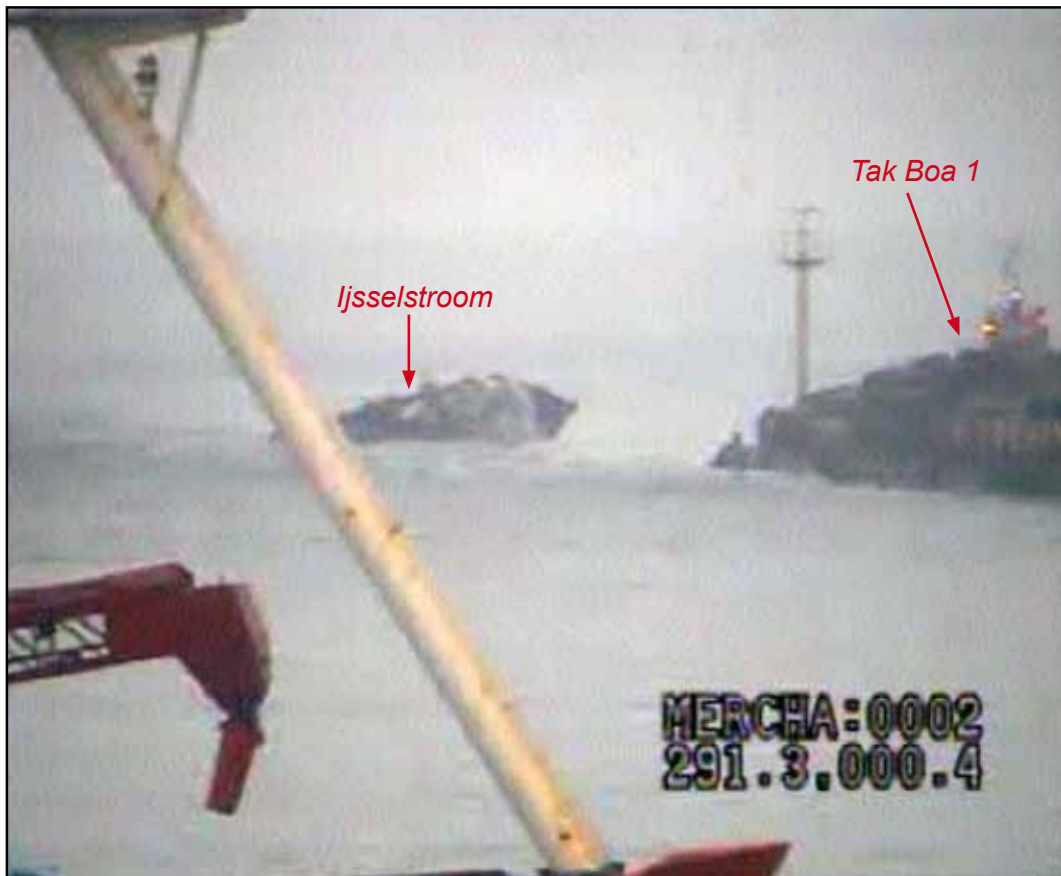
Figure 7

Still from Peterhead CCTV showing *Ijsselstroom* shortly after girting

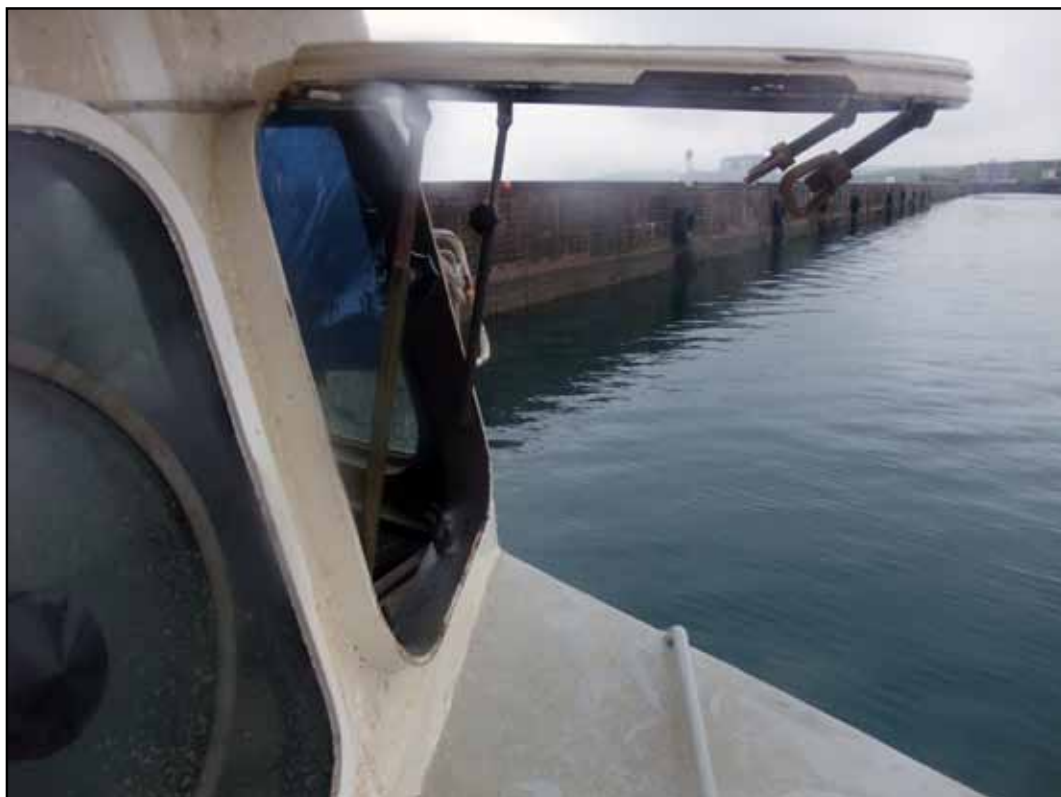
Figure 8

Ijsselstroom's skipper was in the wheelhouse, and as the tug sank by the stern he was unable to exit through the aft door. However, he was able to climb through the port forward window of the wheelhouse (**Figure 8**). Having recovered the two men in the water, the pilot boat made its way to *Ijsselstroom*, which by then was lying vertically in the water with her stern fully submerged and her bow pointing up (**Figure 9**). The skipper was found standing on the now horizontal wheelhouse front, and he was able to step off into the waiting boat. He was not wearing a lifejacket.

Wheelhouse window through which the skipper escaped

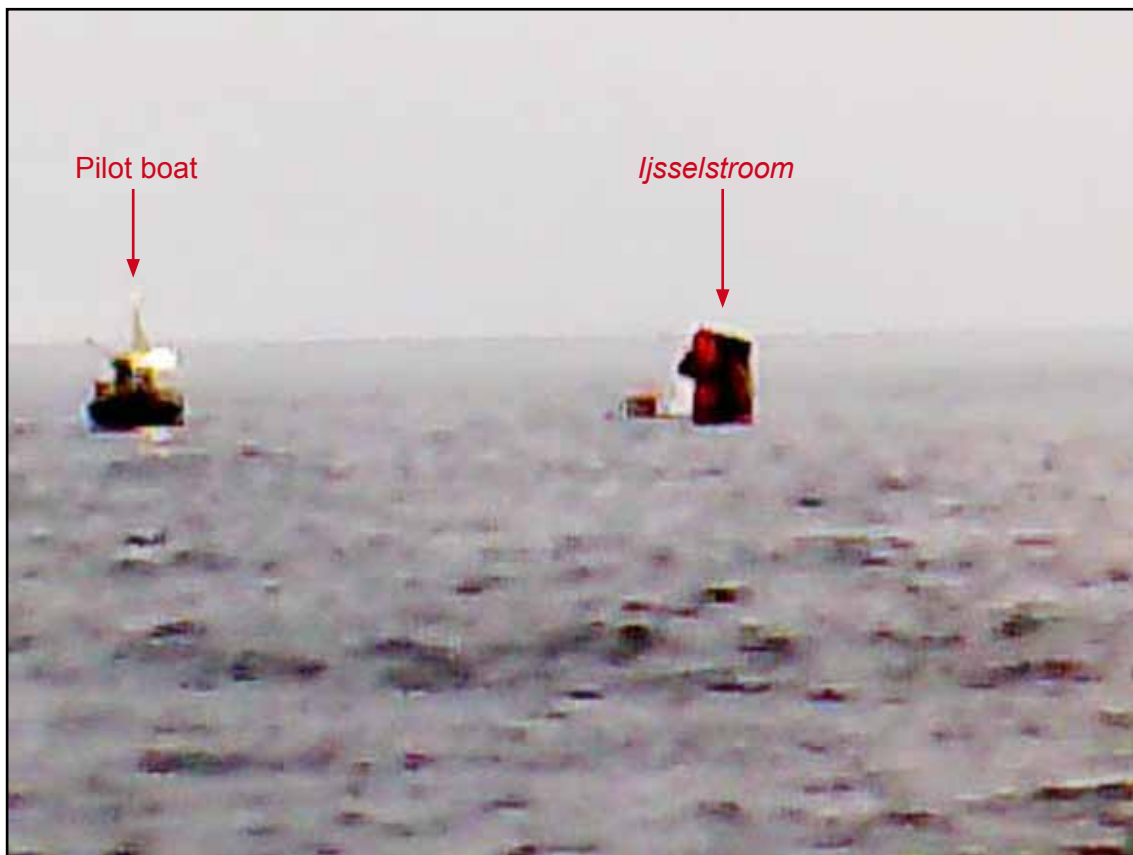
Still from eyewitness' mobile phone showing *Ijsselstroom* just prior to sinking

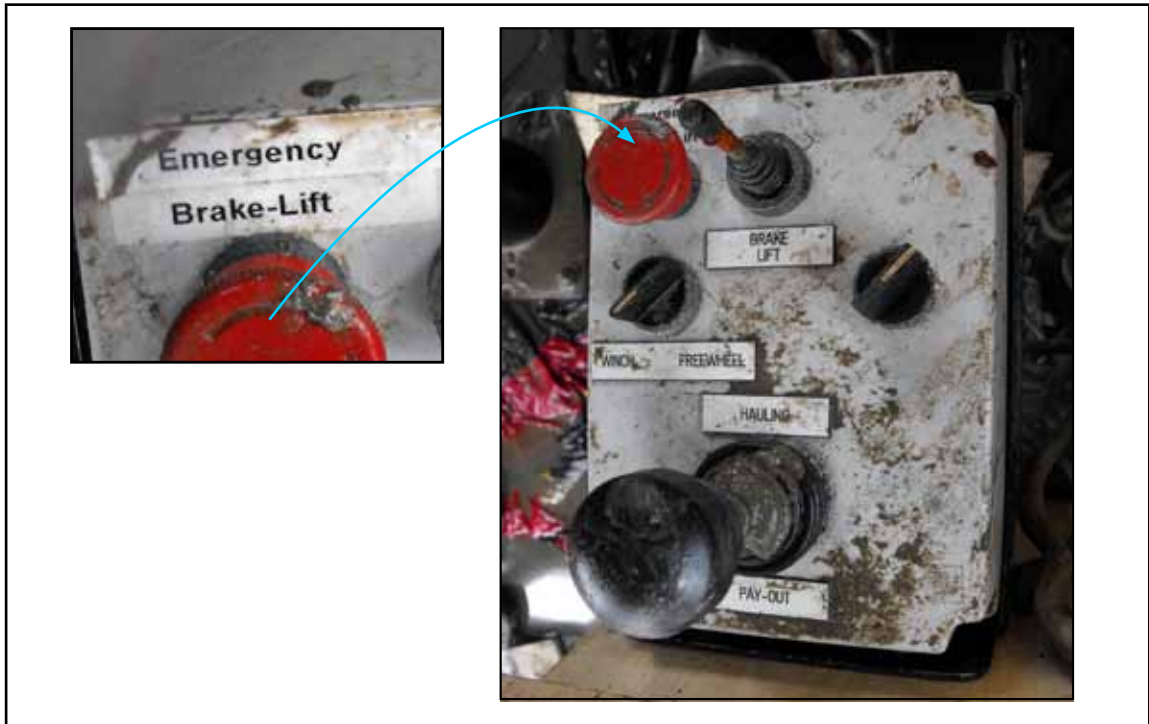
Figure 11

Ijsselstroom's towing winch had two modes of operation: “winch” and “freewheel” (**Figure 11**). “Winch mode” allowed the skipper to easily adjust the length of the towing line by using the hauling / payout joystick. For this reason the skipper chose to carry out the arrival in “winch mode”.

Wheelhouse winch control unit

The hydraulic system of the winch brake was powered by a power take-off from the starboard shaft. If the starboard engine failed for any reason then the brake would be permanently applied. It is not known when the starboard engine stopped during *Ijsselstroom's* capsizing at Peterhead.

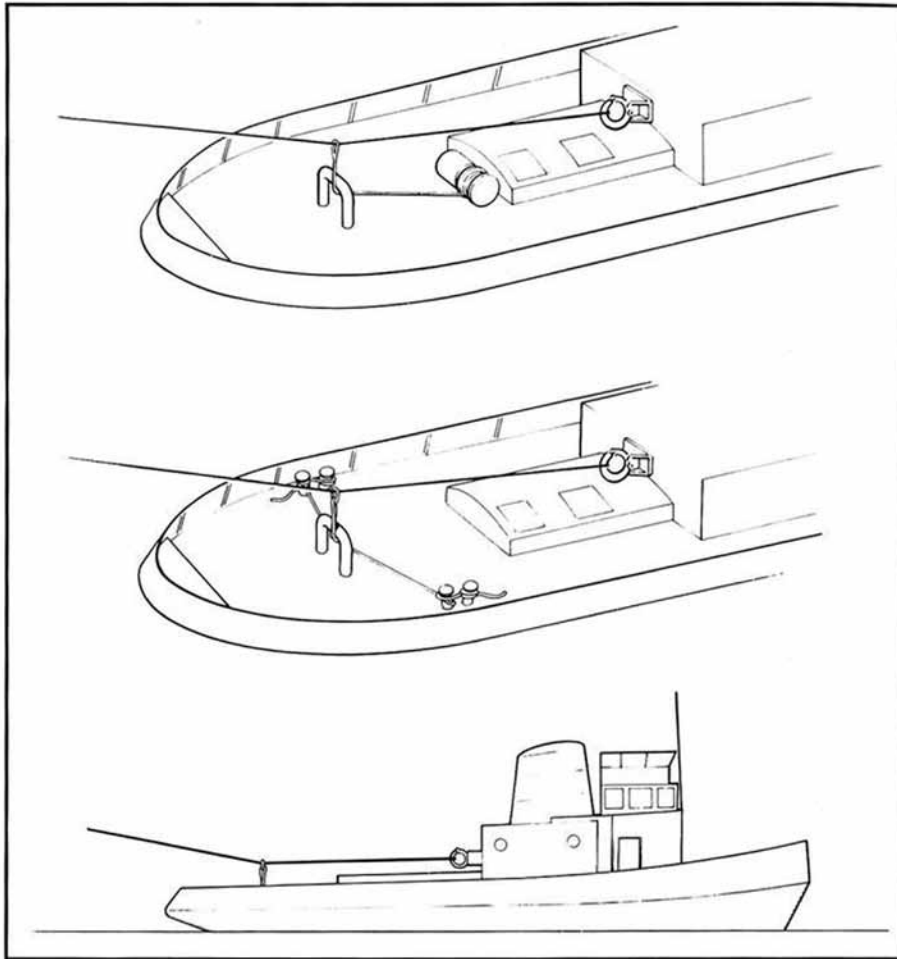
- The lack of a bridle wire or gob rope meant there was no physical safety device to prevent *Ijsselstroom* from girting when directional control of the tug was lost.

A bridle wire can be rigged in two ways (**Figure 17**). Firstly by using a length of wire secured to the tug that passes through a fairlead or H-shaped bollard on the centre line of the work deck. The end of the wire holds a large shackle which is attached around the towline. The large shackle is free to slide along the towline. When the towline moves towards the tug's beam, the bridle wire comes tight and keeps the towing point aft and close to amidships.

Bridle arrangements

- 2010/103 Develop a training programme that ensures that its skippers fully understand:
- The control issues and hazards associated with a conventional tug acting as a stern tug.
 - The benefits of using a bridle rope.
 - The capabilities and limitations of the towing winch operating modes, and the use of their associated safety systems.
- 2010/104 Review its fleet and identify tugs that are unsuitable to make sternway while acting as a stern tug due to:
- Low freeboard and the possibility of the tug shipping water at speed or low angles of heel.
 - Sub surface stern clutter adding to a destabilising moment.
 - Poor ergonomics making it difficult to monitor the tow and easily control the tug at the same time.
- 2010/105 Introduce a system of risk assessments and briefings to be used by its tug skippers as standard operating procedures prior to engaging in towing operations.

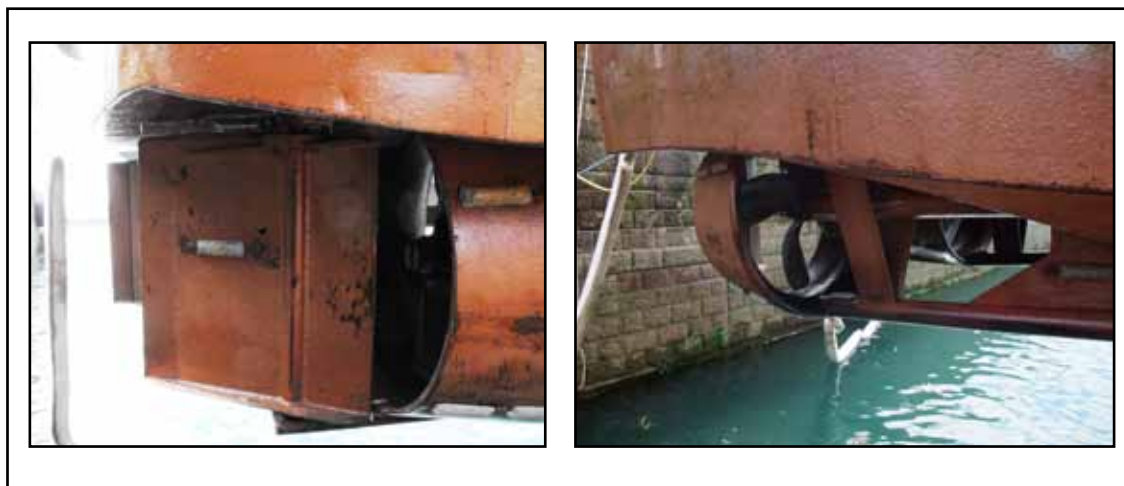
Figure 20

BMT noted that the large A-frames that supported the ducts, the braces for the propeller shafts, the hard chine edges of the hull and the unbalanced rudder, all created underwater obstructions towards the stern of the vessel (**Figure 20**). When moving astern, these obstructions could all have added to the destabilising moment, and the destabilising effect would increase as the speed astern increased.

Stern gear showing 'A' brackets, nozzles and rudders

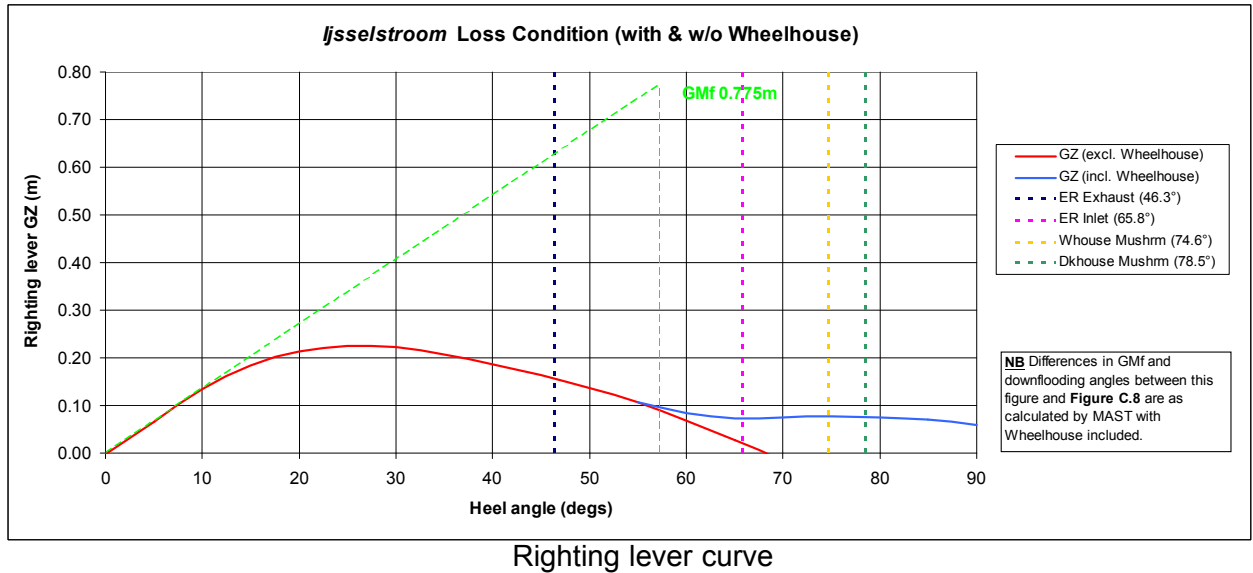
Ijsselstroom had a very low freeboard, and it was calculated that the aft working deck would have become immersed at an angle of only 7.6°. The first major downflooding point was the starboard engine room exhaust at 46.4°; the second was the inboard face of the starboard funnel at 65°; the third was the wheelhouse mushroom vents at 73.2°; and the fourth was the deckhouse mushroom vents at 75.7°. The angle of vanishing stability, that is the angle at which the vessel would capsize and not be able to right herself, was found to be 67.9°. However, at further angles of heel the volume of the deckhouse acted to provide a righting moment (**Figure 21**).
